Accelerated Cleanup at the Hanford Site

Waste Management 1992
Tucson, Arizona
March 1, 1992

ACCELERATED CLEAN-UP AT THE HANFORD SITE

J.M. Frain and W.L. Johnson
Westinghouse Hanford Company

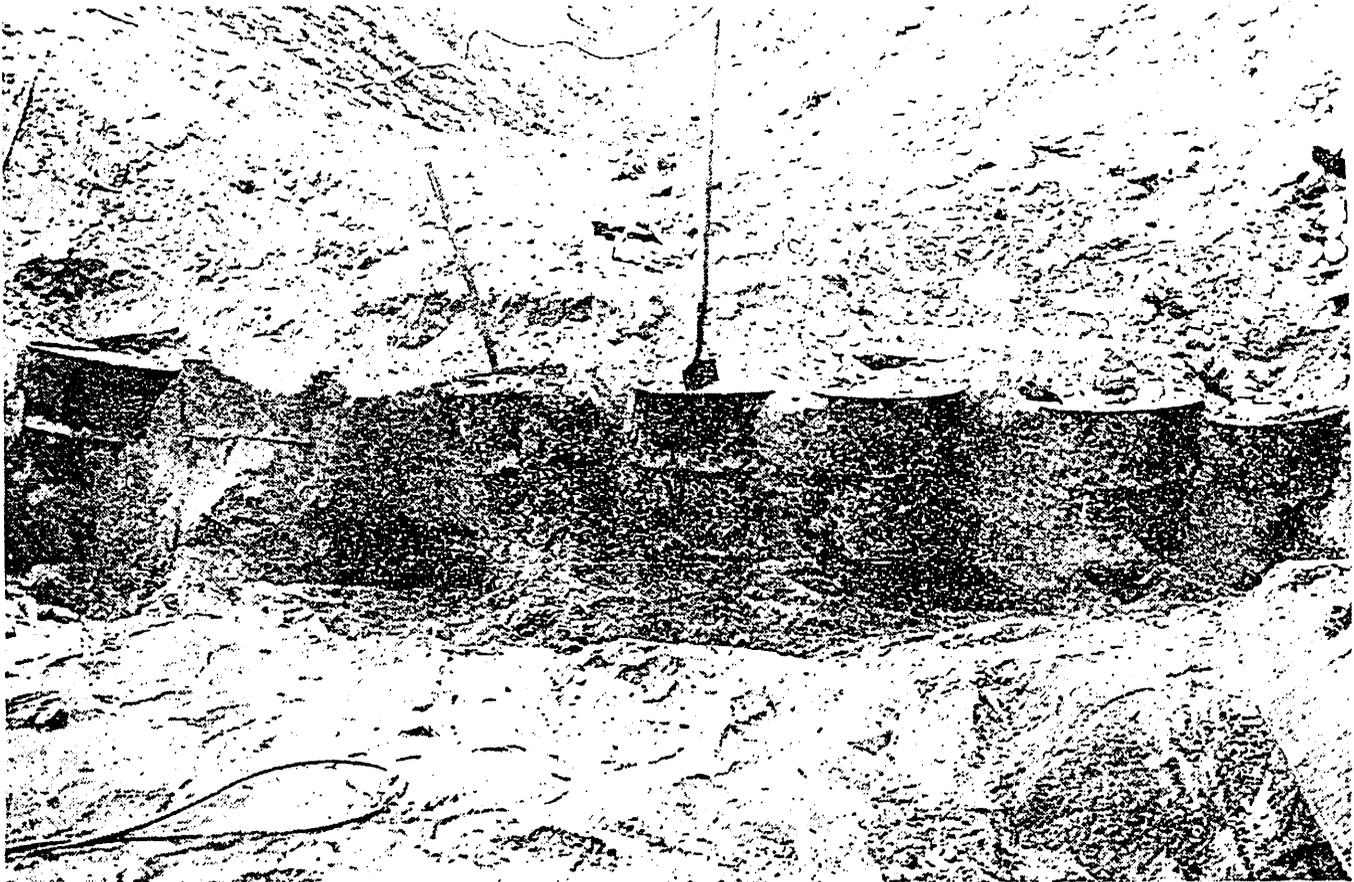
Initially, the excavation revealed a variety of debris covered by 1.2 m (4 ft) of backfill. The debris included such items as, empty waste drums, a wheel barrow, construction debris (corrugated siding), breached bags of ammonium nitrate fertilizer, unidentified white powders, and several lead bricks. Since the historical information stated that there was 1.2 m (4 ft) of backfill over the drums, and did not mention a large volume of debris, it was assumed that the anomalies seen in the ground-penetrating radar data were drums, not debris. The large volume of debris found was unexpected. The drums were found on either side of the debris, with a minimum of 2.4 m (8 ft) of backfill. Figure 2 shows a side view of the drums found in the bottom of the west end of the trench, and how they were approached. Note that the center drums did not contain solvents. Over the years, the tops had collapsed and filled with the overlying sand.

Fig. 2. Side view of drums as found in the trench.

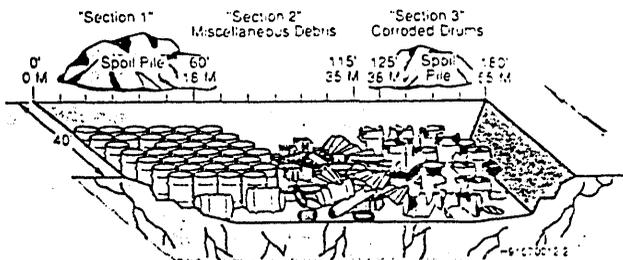
Drums in the western end of the trench were fairly well preserved, and approximately 6,050 L (1,600 gal) of solvents were recovered. Drums in the eastern end of the trench were severely corroded and only parts of the drums remained. Figure 3 depicts the three sections of the trench (this figure is not to scale).

Fig. 3. Three sections of the burial ground.
