ORNL/RASA-96/10

**Results of the Independent Radiological  
Verification Survey of  
Remediation at Building 31,  
Former Linde Uranium Refinery,  
Tonawanda, New York (LI001V)**

Date Issued—November 1998

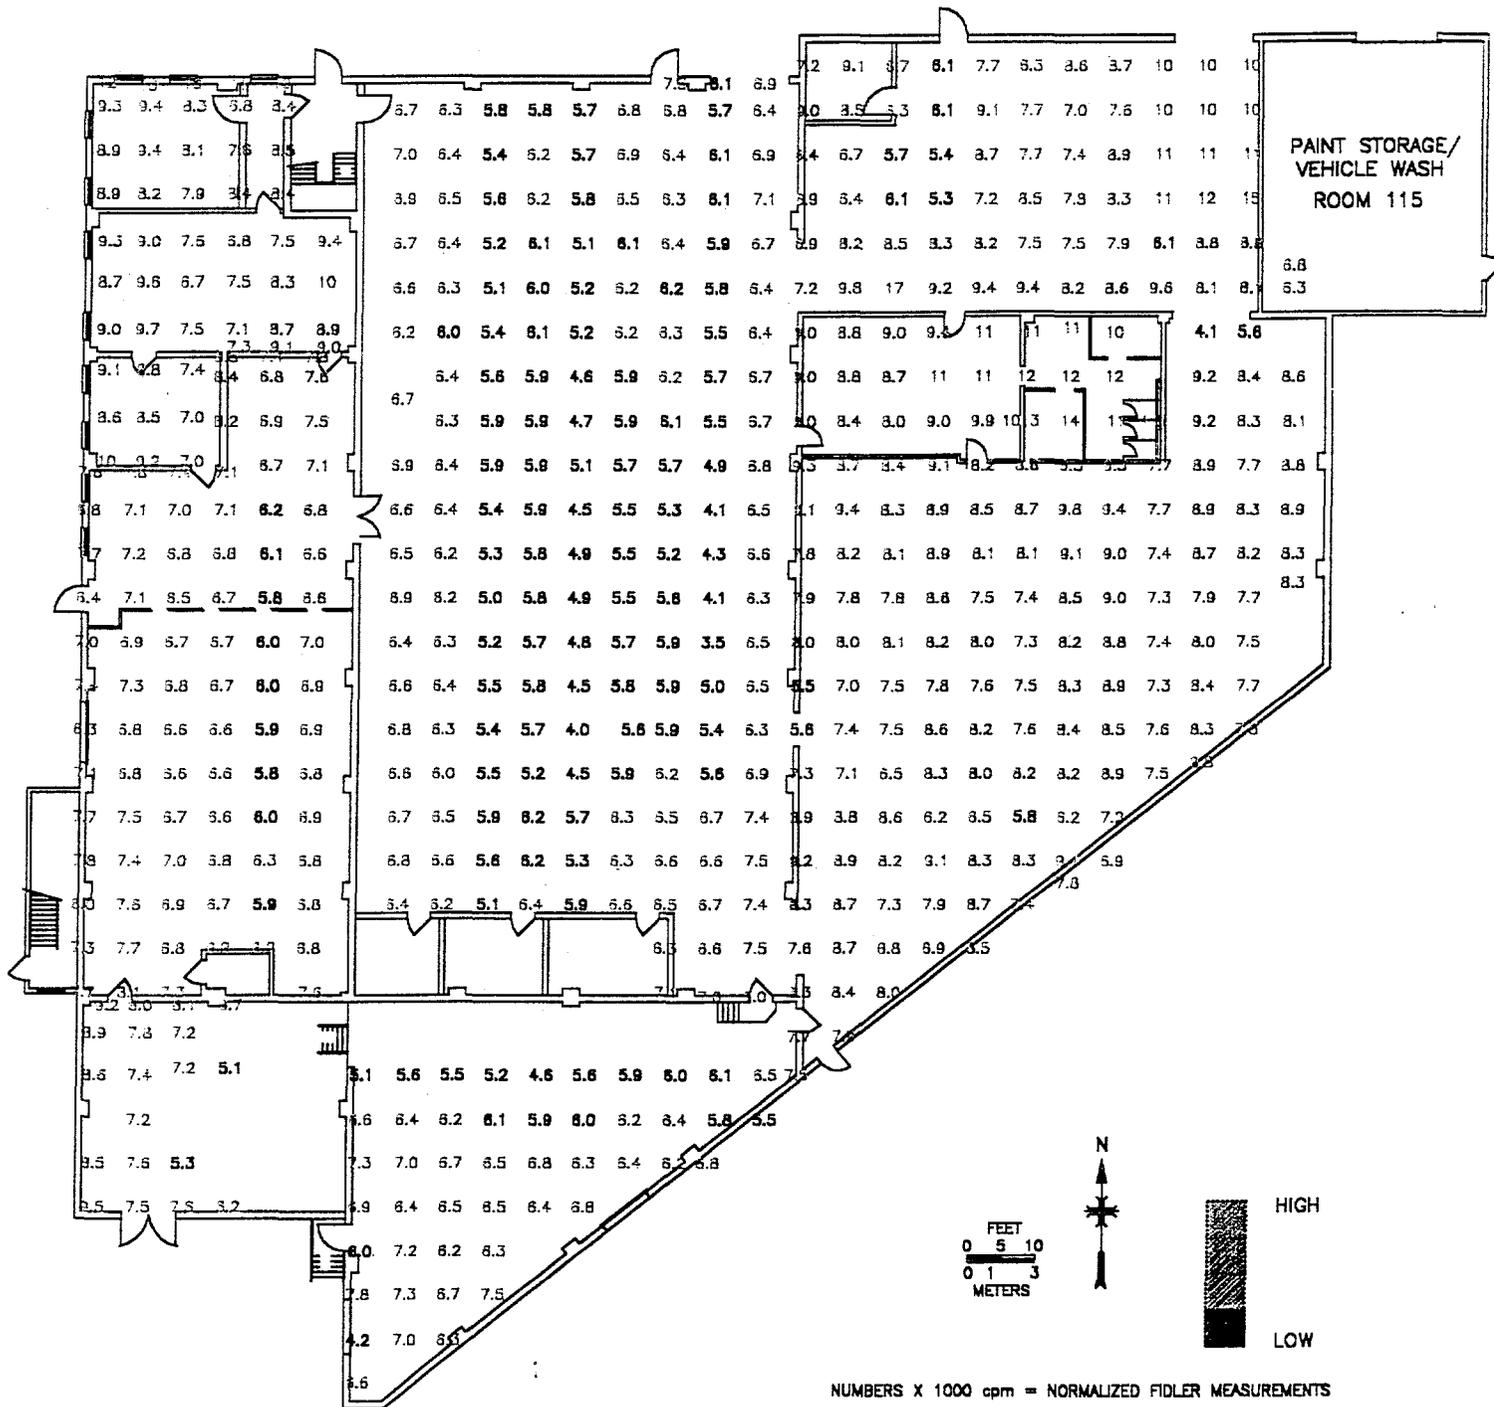
Fig. 3. Diagram showing first floor FIDLER measurements at Building 31.

Results of FIDLER measurements on the surface of the first floor are shown on Fig. 3. Normalized measurements ranged from 3500 to 17,000 cpm. Discounting slightly increased readings due to the geometry of a corner/wall measurement, most of the higher measurements were concentrated in the east, and particularly the northeast, part of the building. This grouping of elevated FIDLER measurements suggested that subsurface contamination might be present beneath the concrete floor. Elevated FIDLER measurements were used to select locations for the collection of subsurface soil samples, which confirmed the presence of contamination. FIDLER measurements also confirmed that excessive beta-gamma emitting contaminants were not present on the surface.

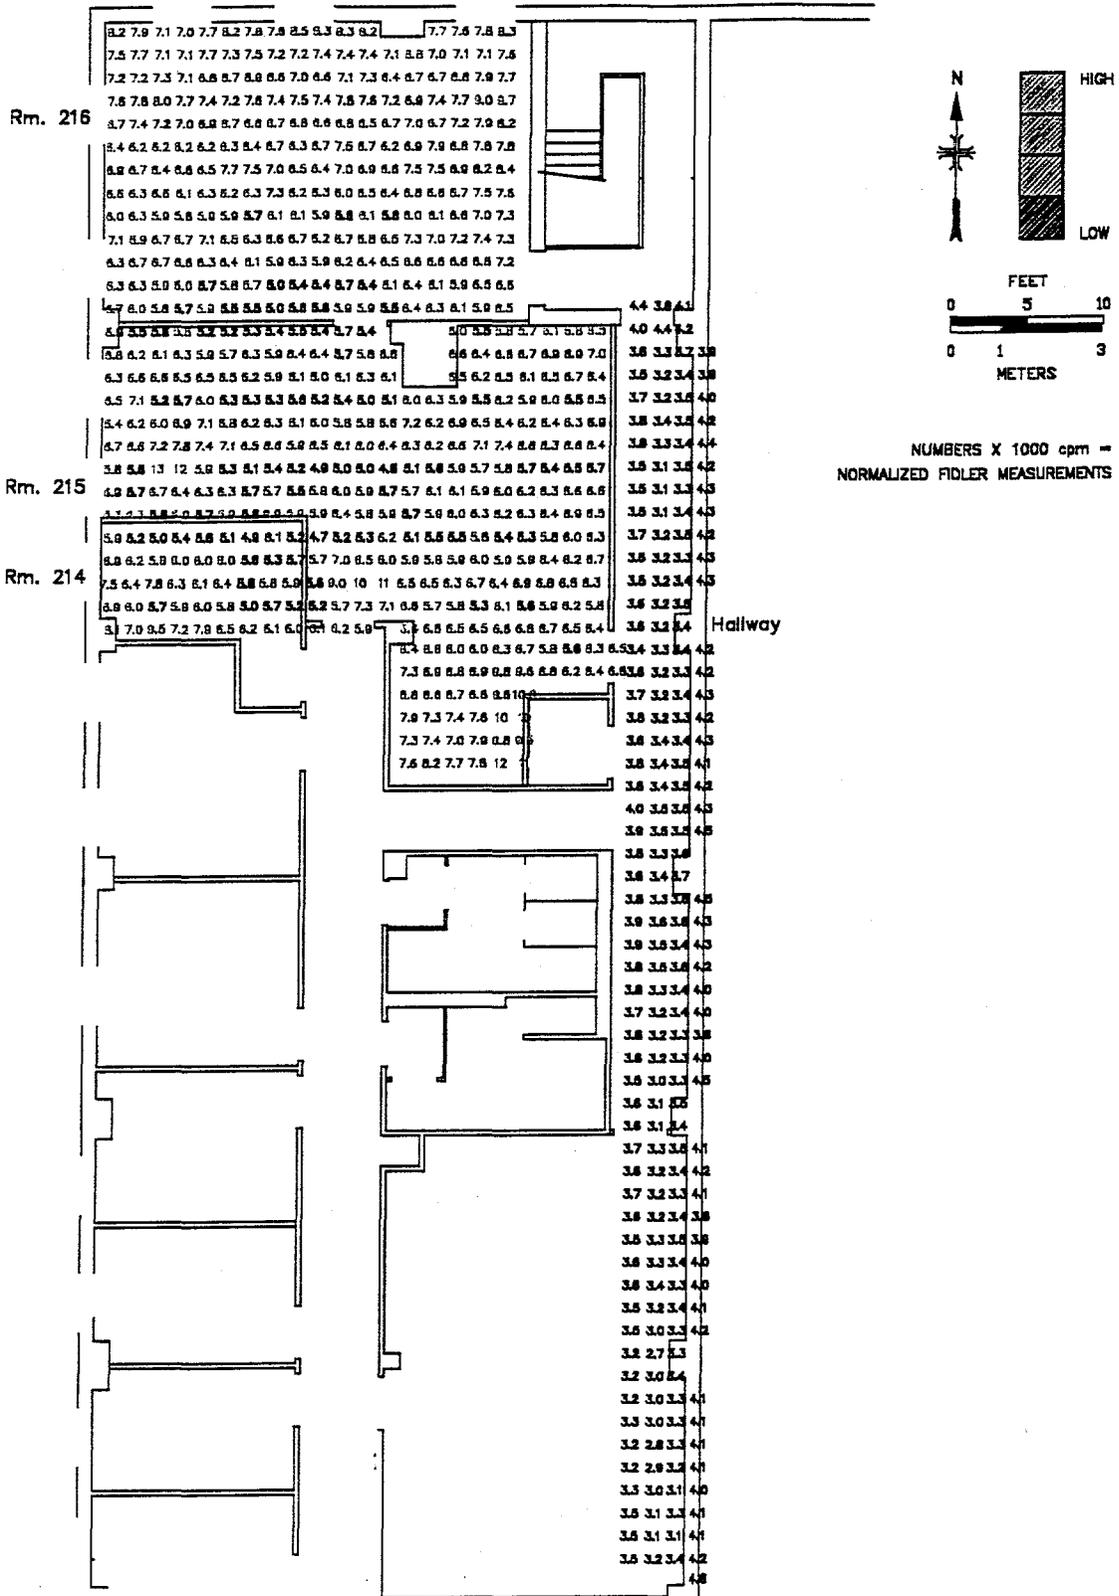
Fig. 4. Diagram showing second floor FIDLER measurements at Building 31.

Results of FIDLER measurements on the second floor are shown on Fig. 4. Normalized measurements ranged from 2700 to 13,000 cpm. Elevated FIDLER measurements on the tile and mastic material in rooms 214, 215, and 216 prompted further investigation. These rooms were used as labs during the time of the MED contract. Removal of tiles and analysis with a portable NaI gamma spectroscopy system indicated strong  $^{226}\text{Ra}$  peaks in Room 215 and  $^{238}\text{U}$  peaks in Room 216. This method identified contamination in excess of cleanup guidelines beneath the tiles. The tiles were removed and the contaminated areas remediated (see section on Beta-Gamma Activity Levels) by the BNI radiological support subcontractor. (The  $^{226}\text{Ra}$  in Room 215 was later determined to be a component in the concrete.)

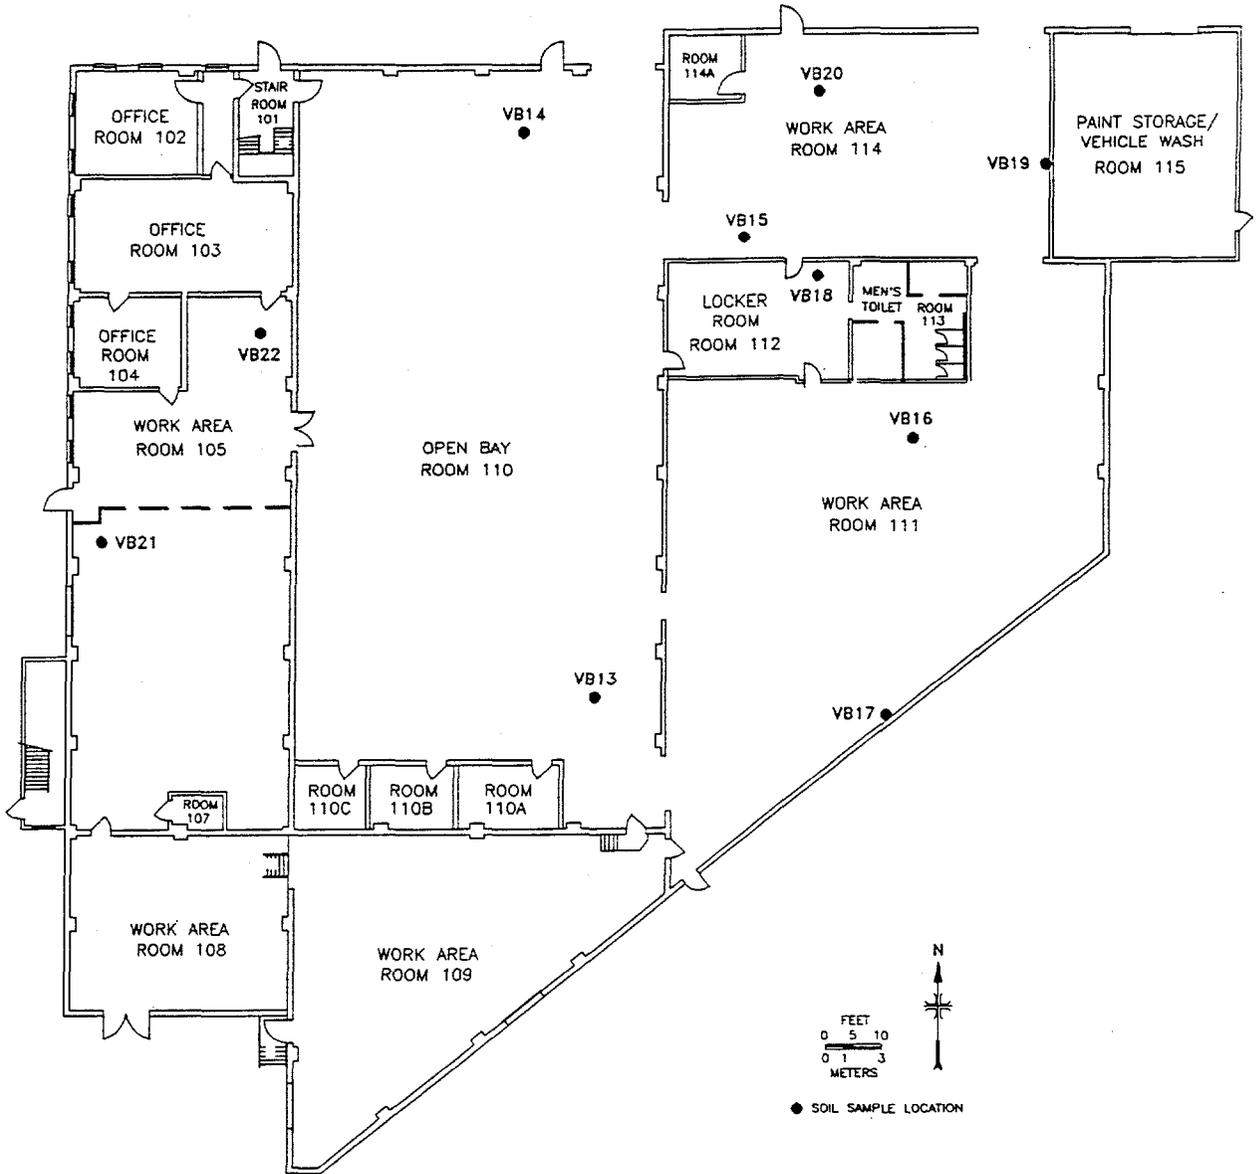
**Fig. 5. Diagram showing location of biased soil samples collected underneath the first floor at Building 31.**

Biased soil sample locations are shown in Fig. 5, and results of radiological analyses are listed in Table 3. Surface samples (0 to 15 cm) consisted of the concrete plugs, which were returned to the core holes. Concentrations of  $^{238}\text{U}$  in subsurface soil (15–46 cm) ranged from 0.52 to 5.6 pCi/g at seven sample locations and from 40 to 230 pCi/g at the remaining three locations. Concentrations of  $^{226}\text{Ra}$  in subsurface soil ranged from 0.53 to 6.2 pCi/g at seven sample locations and from 21 to 250 pCi/g at the remaining three locations. The same three sampling locations (VB15, VB19, and VB20) exceeded applicable guideline values for both  $^{238}\text{U}$  and  $^{226}\text{Ra}$ . All three sampling locations were located beneath Room 114. Typical background levels for  $^{238}\text{U}$  and  $^{226}\text{Ra}$  in the Tonawanda area (Table 2) were exceeded at sampling locations VB13, VB16, VB17, and VB18, which were located beneath rooms 110, 111, and 112. Concentrations of  $^{232}\text{Th}$  in subsurface soil ranged from 0.22 to 3.0 pCi/g with one sample above typical background levels for  $^{232}\text{Th}$  (Table 2), but all samples were well below applicable guideline values (Table 1) for this radionuclide.

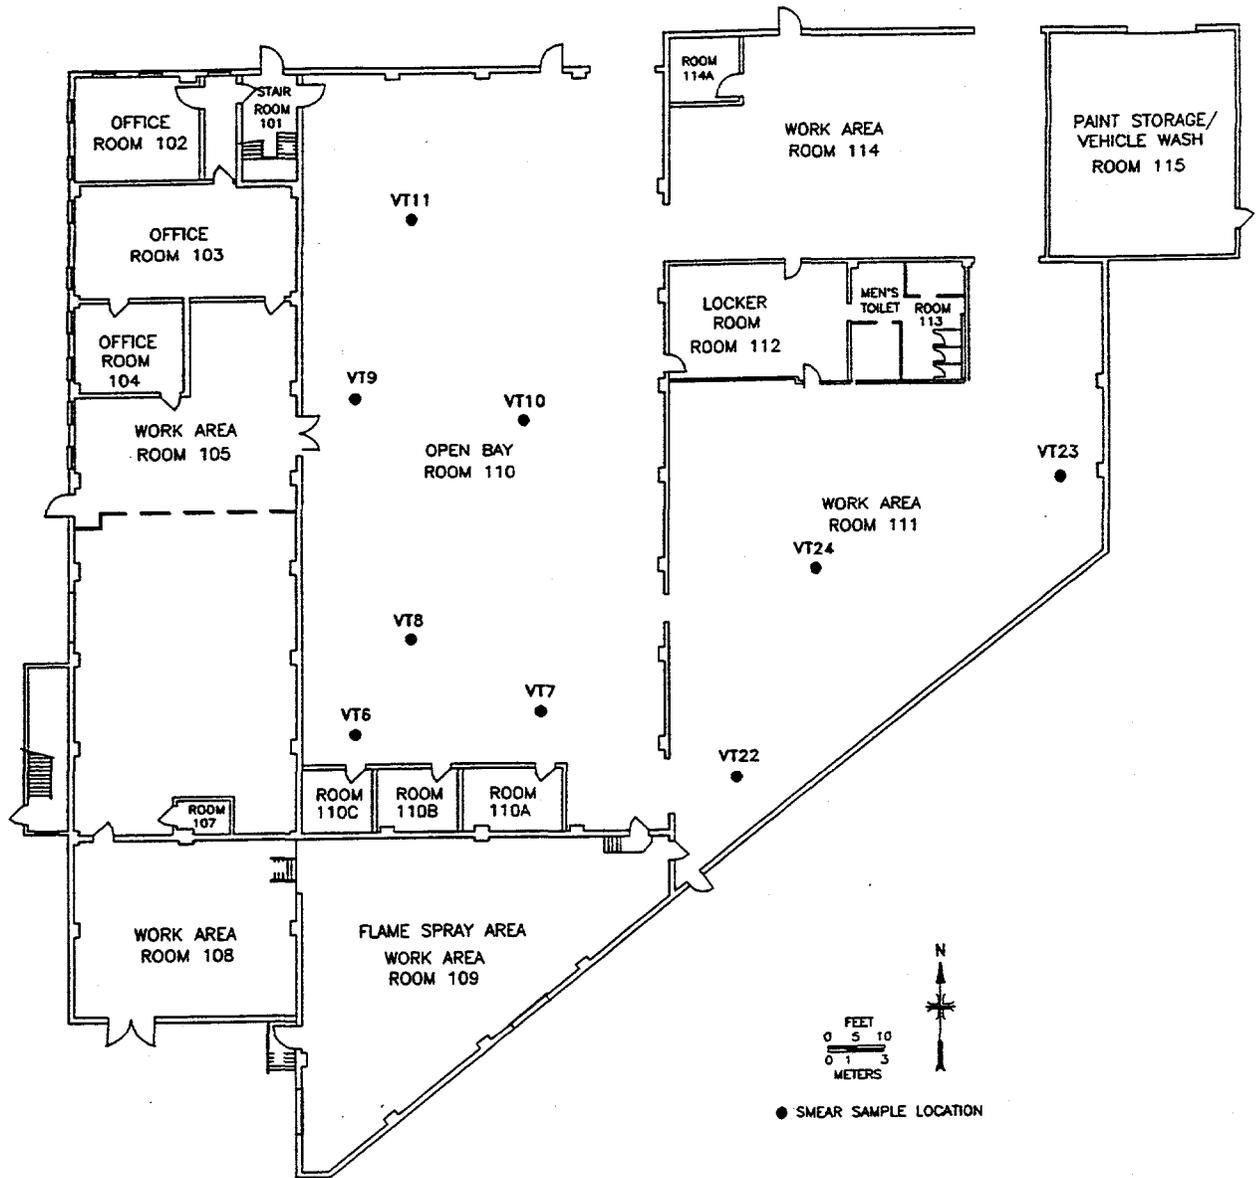
Fig. 6. Diagram showing first floor smear sample locations at Building 31.

First floor smear sample locations are shown in Fig. 6, and second floor locations are shown in Fig. 7. Results of smear sample analysis are given in Table 4. No removable alpha or beta-gamma emitting material was measured in smear samples collected on the first floor. Before final remediation, second floor smear samples showed small amounts of removable alpha emitting material in samples VT1 and VT2 (Room 203), VT3 (Room 207), and VT19 (second floor hallway), and a small amount of removable beta-gamma emitting material in sample VT1 (Room 203). These areas were not verified below guidelines on the dates these smears were taken (See Table 5). More remediation was recommended and conducted in these rooms. The small amounts of removable radioactivity in smears VT5 (Room 205), VT12 (Room 215), and VT18 (Room 202) were well below guideline values. Based on these and other survey results, these rooms were verified below guidelines on the dates the smears were taken. After all remediation and verification activities were completed at Building 31, all removable radioactivity levels were well below applicable guidelines (Table 1).

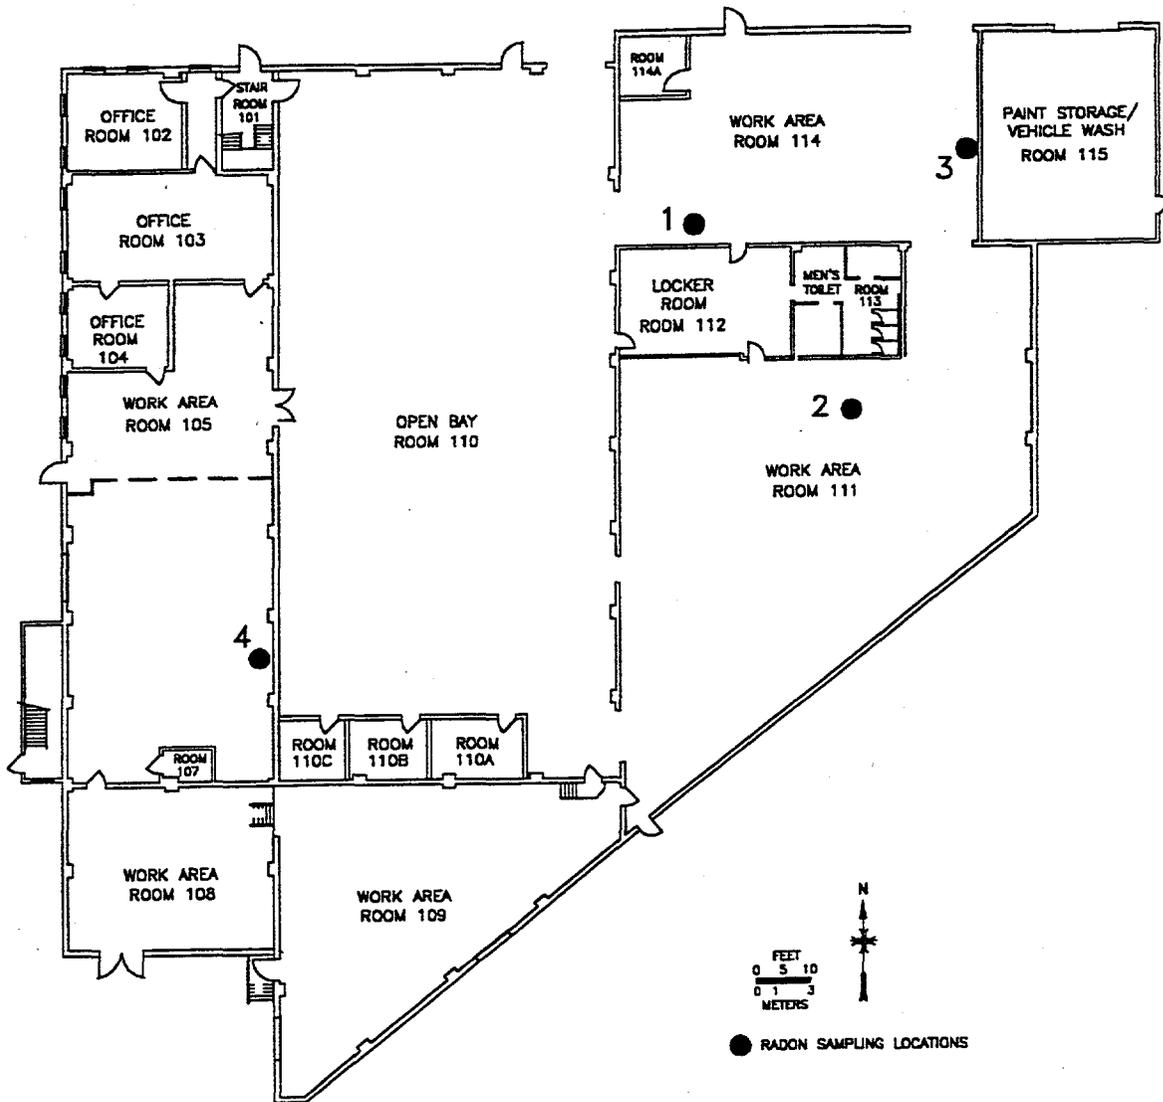
Fig. 8. Diagram showing 7-day radon sampling locations at Building 31.

Six electret radon monitors were deployed for 7 days at four locations from March 17 to 24, 1998, and an additional four monitors were deployed for 31 days at four different locations from May 28 to June 29, 1998. The first four sampling locations are shown in Fig. 8. Sampling locations were selected to coincide with the highest subsurface soil radionuclide levels (Table 3 and Fig. 5) and the highest FIDLER measurements (Fig. 3). Results from all radon measurements are given in Table 6. One of the 7-day electrets showed radon concentrations of 5.2 pCi/L in Room 111. This is slightly above the EPA action level of 4 pCi/L. Two 31-day follow-up measurements in Room 111 showed concentrations of 0.5 and 0.8 pCi/L, which falls within the range of the other seven radon measurements (0.3 to 1.7 pCi/L) and well below the EPA action level.
