**Radiological Survey Results
at Building 22,
Washington Navy Yard,
Washington, D.C.
(WSN001)**

**Radiological Survey Results at Building 22, Washington Navy Yard,
Washington, D.C. (WNS001)**

Date Issued—March 1996

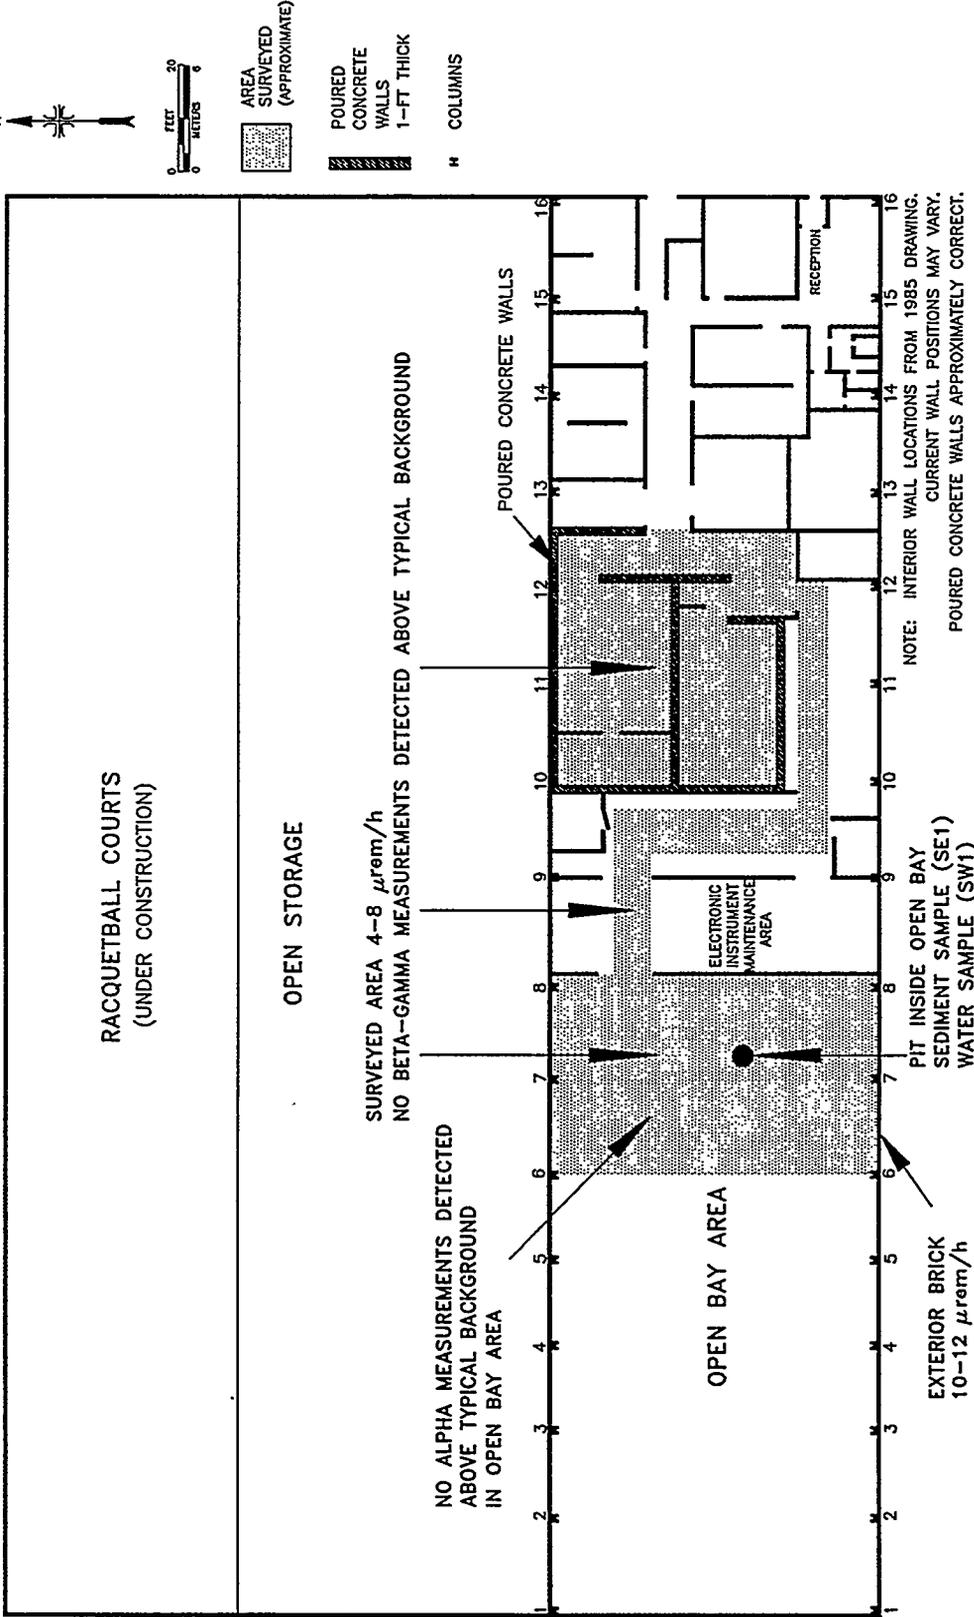
Fig. 1. Diagram showing general outline of Building 22 at the Washington Navy Yard. Shading indicates the surveyed area.

The survey was designed to detect any radioactive anomaly that might be present in the survey area. Gamma radiation and beta-gamma radiation were measured on floors in the shaded areas (Fig. 1). Measurements were taken underneath the carpet at several locations, but floor tiles were not removed. Alpha measurements were taken only on the original concrete floor in the open bay area because all other surveyed areas were covered with new tile or carpet.

Likewise, no elevated alpha radiation measurements were detected in the surveyed section of the open bay. All radiological survey results are indicated on Fig. 1.

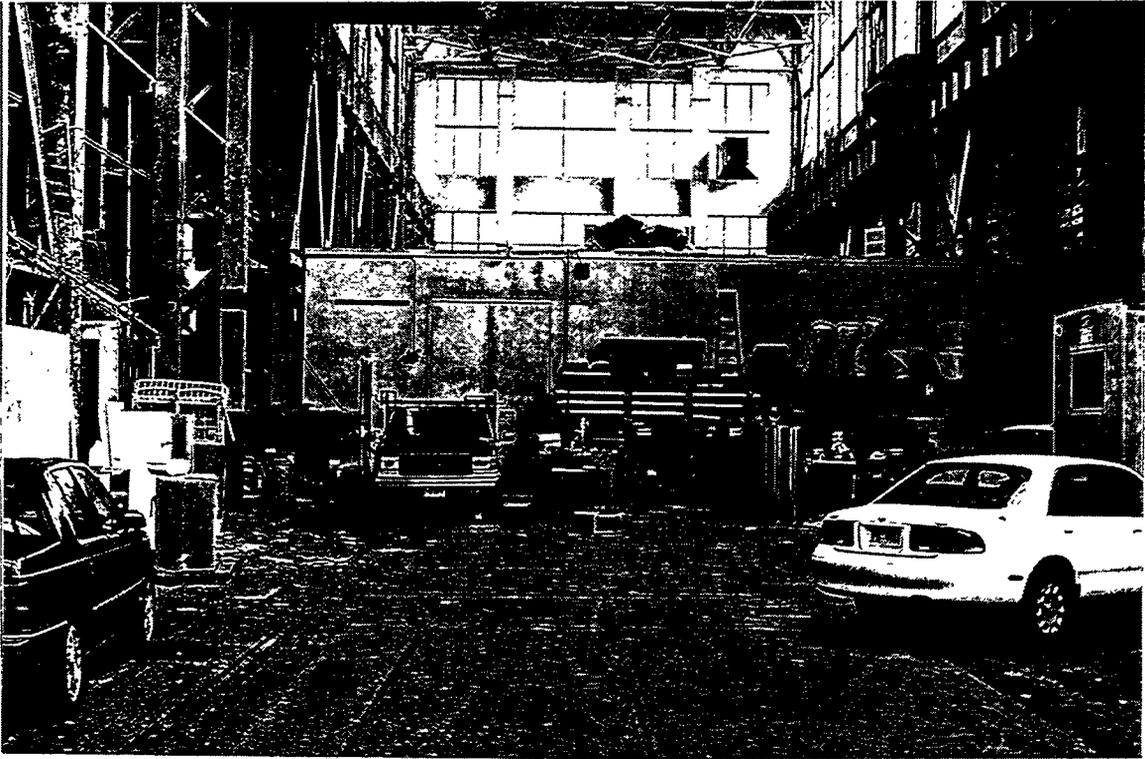
Fig. 3. View from open bay area looking east at entrance to electronic instrument maintenance area.
