Submitted for inclusion in 21st Aging, Compatibility and Stockpile Stewardship Conference

Evaluation of the Metal/Adhesive Interfaces in the MC2370 Fire Set

Kevin R. Zavadil

Sandia National Laboratories

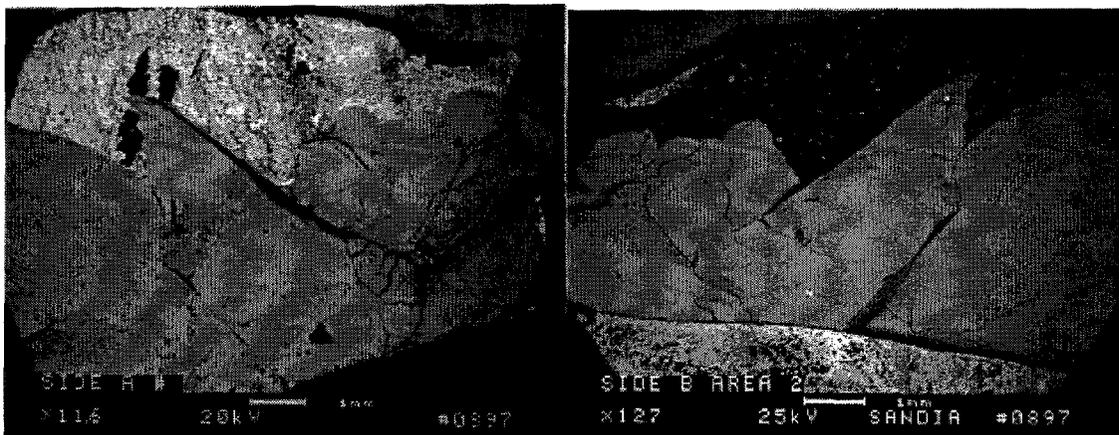
Secondary electron imaging coupled with energy dispersive x-ray analysis provides specific information on interface structure. Figure 2a and 2b shows a set of micrographs acquired from opposing fractured faces (see Fig. 1). The fracture process has exposed an electrode region several millimeters in width and extending several centimeters in length. These secondary images show bright emission from the electrode region in Fig. 2a and attenuated emission in Fig. 2b. X-ray analysis demonstrates that the bright image in 2a is the Au electrode while the darker region in 2b is adhesive covered Cu, based on Si K shell emission. The adherence of the silicone to Cu during the fracture indicates adhesive failure at the interface. The darker regions that show up on the Au electrode can be matched with brighter emission regions on the Cu electrode, specifically at both the cusp that appears in the upper right hand corner and along the upper step of Figure. 2a. These features are produced by silicone adhesion to the Au and indicate that the fracture process can propagate across the adhesive moving from side-to-side of the electrode/adhesive/electrode structure. The particulate structure that shows up on the Au and silicone surfaces is predominantly PBZT debris that is produced by the fracture process.

Figure 2a and 2b: Secondary Electron Micrographs Showing Opposing Fracture Faces - left image (a) is the Au electrode, right image (b) is the silicone covered Cu electrode

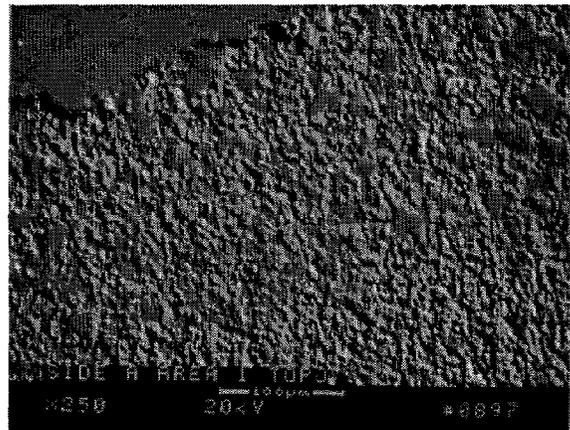
The predominant fracture mechanism appears to be adhesive. No clear trend exists showing a greater tendency for failure at the Au versus the Cu interface. However, regions of the electrode interface do exist where evidence of cohesive failure is apparent. Figure 3 shows a backscattered electron micrograph of a transition region along a Au surface. The mesa structure at the top of the image is the edge of the silicone while the highly textured region at the micrograph base is the sputter deposited Au electrode. This image was generated by selective biasing of the four quadrant detector to highlight topography. The center region of the micrograph shows considerable residual silicone filling in the large areas of the nodular Au microstructure. The plane of fracture has clearly moved out into the adhesive layer in this transition region and has become significantly more cohesive. Similar observations have been made on select areas for the Cu electrode. However, the Cu electrode possesses much less intrinsic texture preventing a microstructural determination of cohesive failure. Large scale variation in the relative intensities for Si K and Cu L shell emission measured on adhesive covered Cu regions indicate varying adhesive layer

Figure 3: Backscattered Electron Micrograph of a Transition Region Showing Cohesive Failure

thickness. These findings suggest that local cohesive failure can occur in this system.

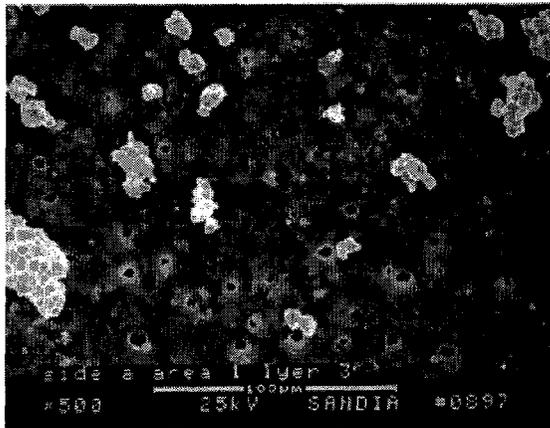
Additional types of structure show up in the adhesive that might be indicative of electrical property variation. Figure 4 show a secondary electron image of a typical region of adhesive exposed by the fracture method. The adhesive is perforated with a moderate density of pinholes that vary in diameter from approximately 1 to 20 μm . These pinholes are assumed to be a result of electrical breakdown of the adhesive when the units are exposed to short 450 to 500 V pulses. This value of voltage corresponds to an exposure of 50% the field strength of the adhesive (20.5 kV/mm) and, given the 20 μm layer thickness, could result in catastrophic local breakdown of the silicone. Electrical conduction might be supported by carbonization of the adhesive adjacent to the pinhole. These pinholes are not observed in all regions of the adhesive. If these pinhole signify ohmic paths, their absence in large enough regions could require that more charge flow must be supported by the several thousand angstrom thick Au electrode over longer lateral distances, resulting in the larger series resistance indicated by impedance measurements.

Figure 4: Micrograph Showing Pinholes in the RTV511 Adhesive
