**CORROSION ANALYSIS OF DECOMMISSIONED CARBON STEEL
WASTE WATER TANKS AT BROOKHAVEN NATIONAL LABORATORY**

P. SOO and T.C. ROBERTS

JULY, 1995

**ENGINEERING RESEARCH AND APPLICATIONS DIVISION
DEPARTMENT OF ADVANCED TECHNOLOGY
BROOKHAVEN NATION LABORATORY
UPTON, NY 11973-5000**

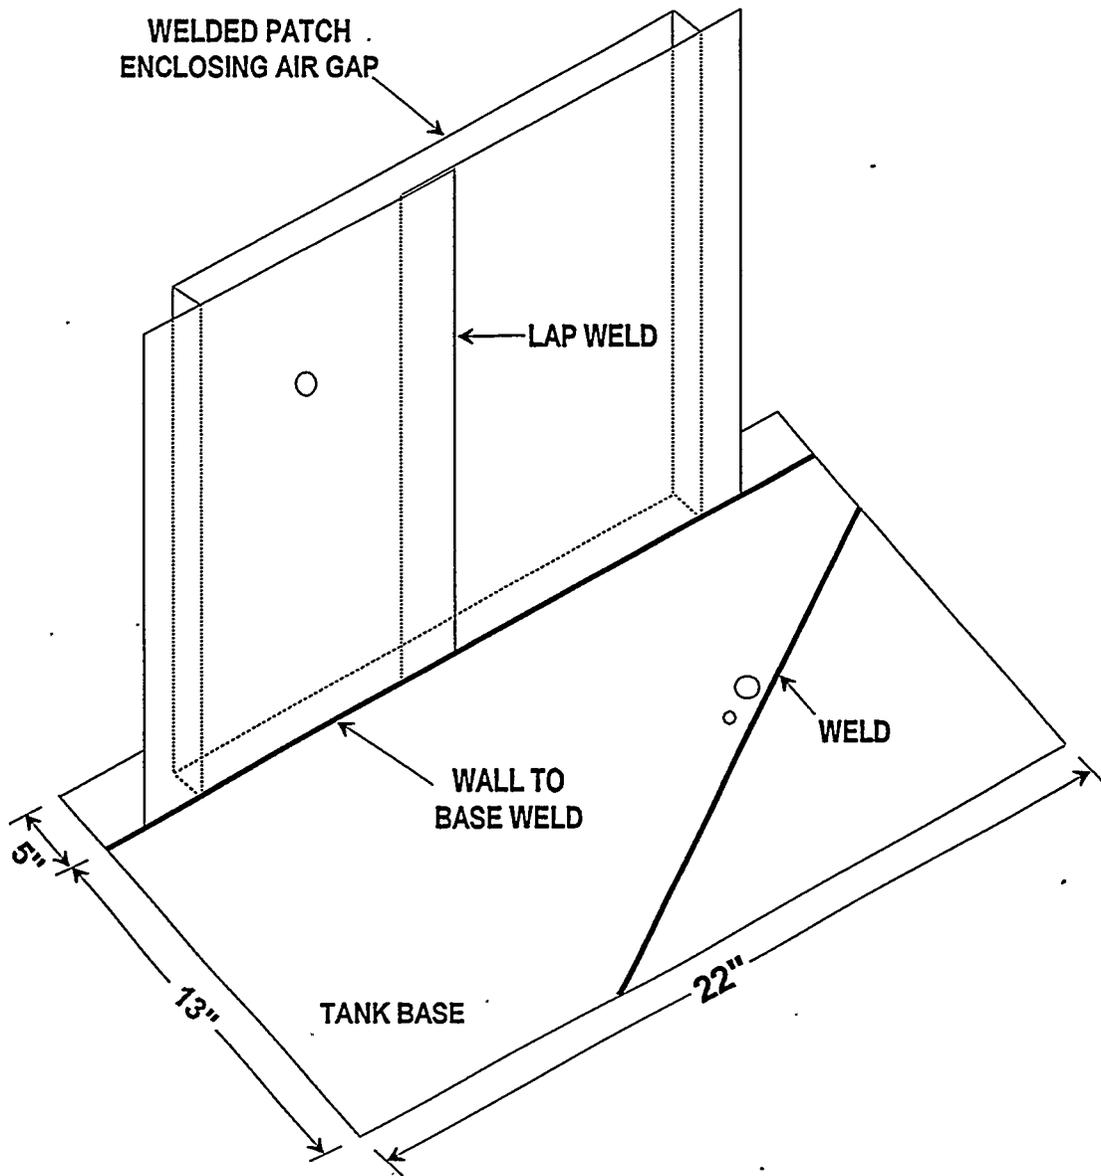
Figure 8. Schematic of Piece #3 from Tank D3 Showing Locations of the Three Holes.

- c) The distance between the two holes in the base of the tank is about two inches, which is approximately equal to the average pitch of the coils. Thus, these holes were probably formed by contact with adjacent loops in the coil. The coil also contacted the tank wall and gave rise to the first pinhole failure. Since the coil was dropped into the tank in 1963, and the pinhole leak was detected in 1985, it took 22 years to cause tank failure by galvanic attack. In the following years of service, the hole continued to increase in size, but the patch prevented further leakage from this area.

- d) The tapered metal loss around the holes is readily explainable in terms of the small angles of contact that a coil would have with the base and walls of the tank. This would encourage a large area of corrosion to occur around the points of coil-to-tank contact. Such a geometry is not consistent with a pitting type of attack. Indeed, if pitting alone was the cause of this failure, it is improbable that the three holes would have appeared in the same general location.

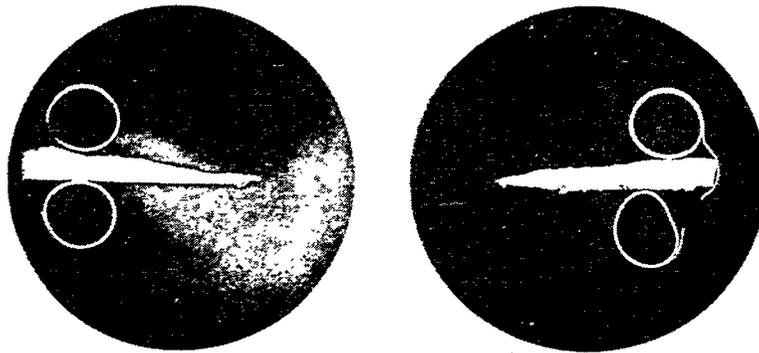
Figure 9 is a horizontal section through the hole in the Tank D3 wall. Material on either side of the hole was mounted in separate epoxy samples. The circular structures in the figure are spring clips used to orient the metal specimens during mounting. The large loss in wall thickness is very evident, and the extended area of tapered metal in the vicinity of the hole is clearly seen. The flat side of the tapered material corresponds to the external surface of the tank. Figures 10 and 11 show, respectively, sections through the large and small holes in the base of Tank D3. Tapering of the steel in the vicinity of the hole is, again, very noticeable.

Figure 9. Horizontal Section Through the Hole in the Tank D3 Wall. Note the Tapering of Material as it Nears the Edge of the Hole. Magnification 2.1X.

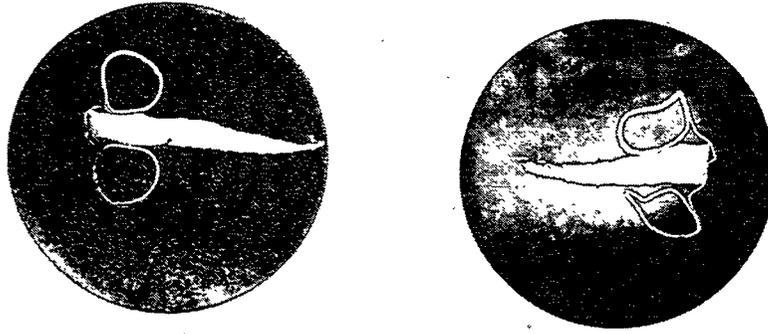
Figure 10. Section Through the Larger Hole in the Tank D3 Base. Magnification 3X.

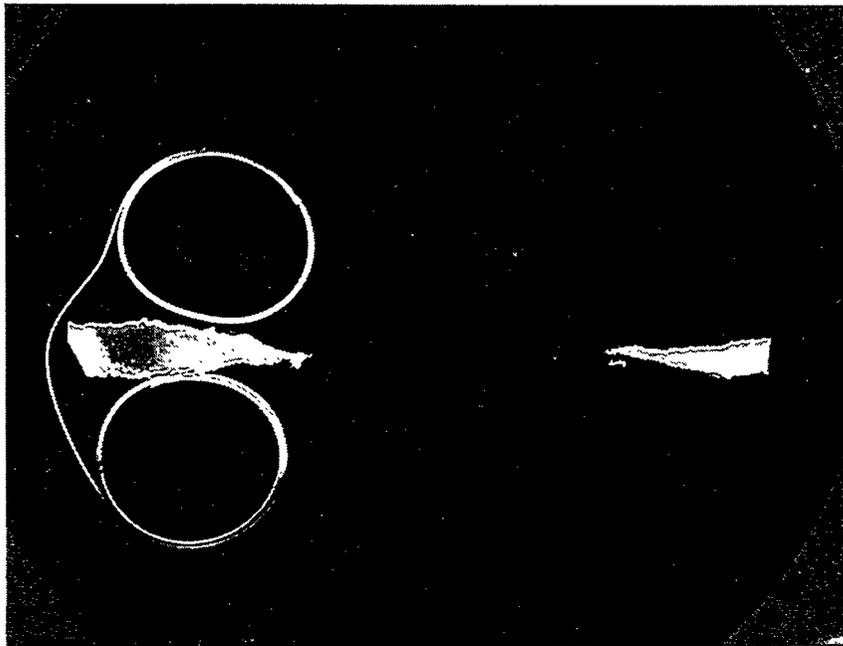
Figure 11. Section Through the Smaller Hole in the Tank D3 Base. Magnification 3.3X.

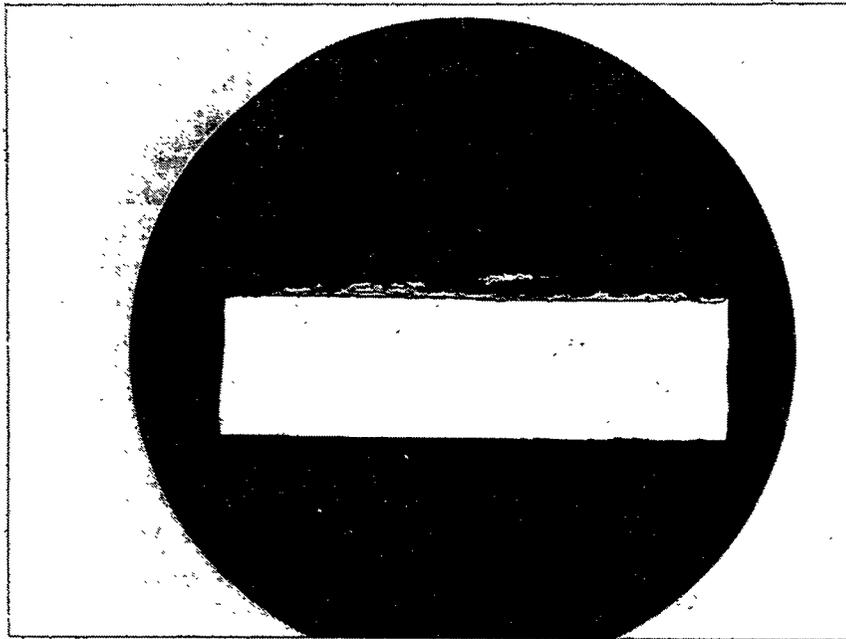
Figure 14 show a section through the Tank D3 wall about 4 in. below the site of the large hole. The presence of corrosion scale, and perhaps the Amercoat paint, is just visible as a gray broken layer. Little corrosion is seen and the wall thickness remains at the original 5/16 in. However, Figure 15, which is a section through the base also close to the hole, shows severe metal loss. The wavy nature of the inner tank surface indicates that there were local differences in the rate of corrosion, but attack was basically "uniform" at a rate of about 4 mils/y. This may be compared with the corrosion rate of 10 mils/y for low-carbon steel in water saturated with 6 ppm of oxygen⁽⁷⁾. If the sludge effectively reduces the oxygen level to a lower value, the observed 4 mils/y rate seems reasonable.

Figure 14. Section Through the Tank D3 Wall About Four Inches Below the Site of the First Pinhole Leak. Magnification 2.3X.

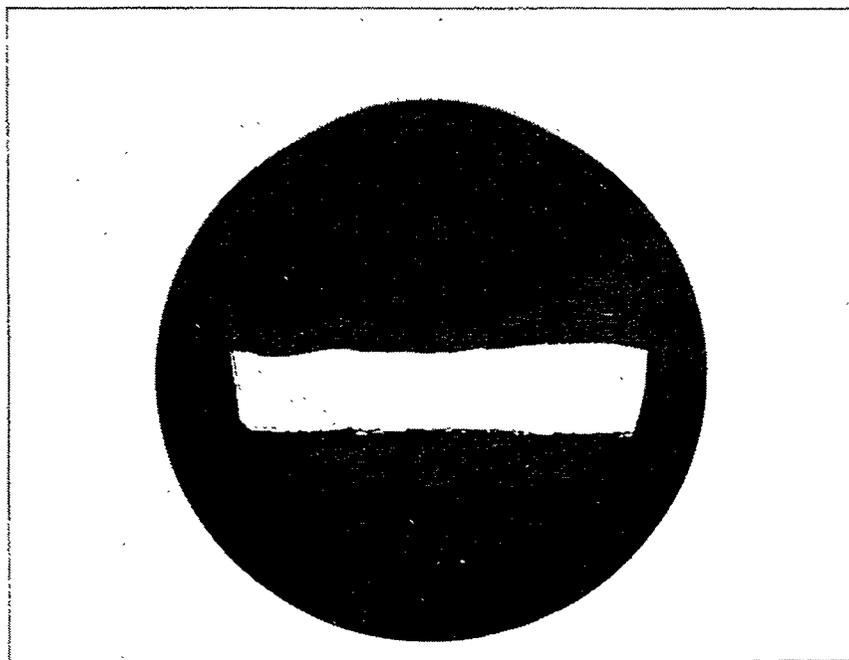
Figure 15. Section Through the Tank D3 Base About Twelve Inches from the Two Holes. Magnification 1.8X.

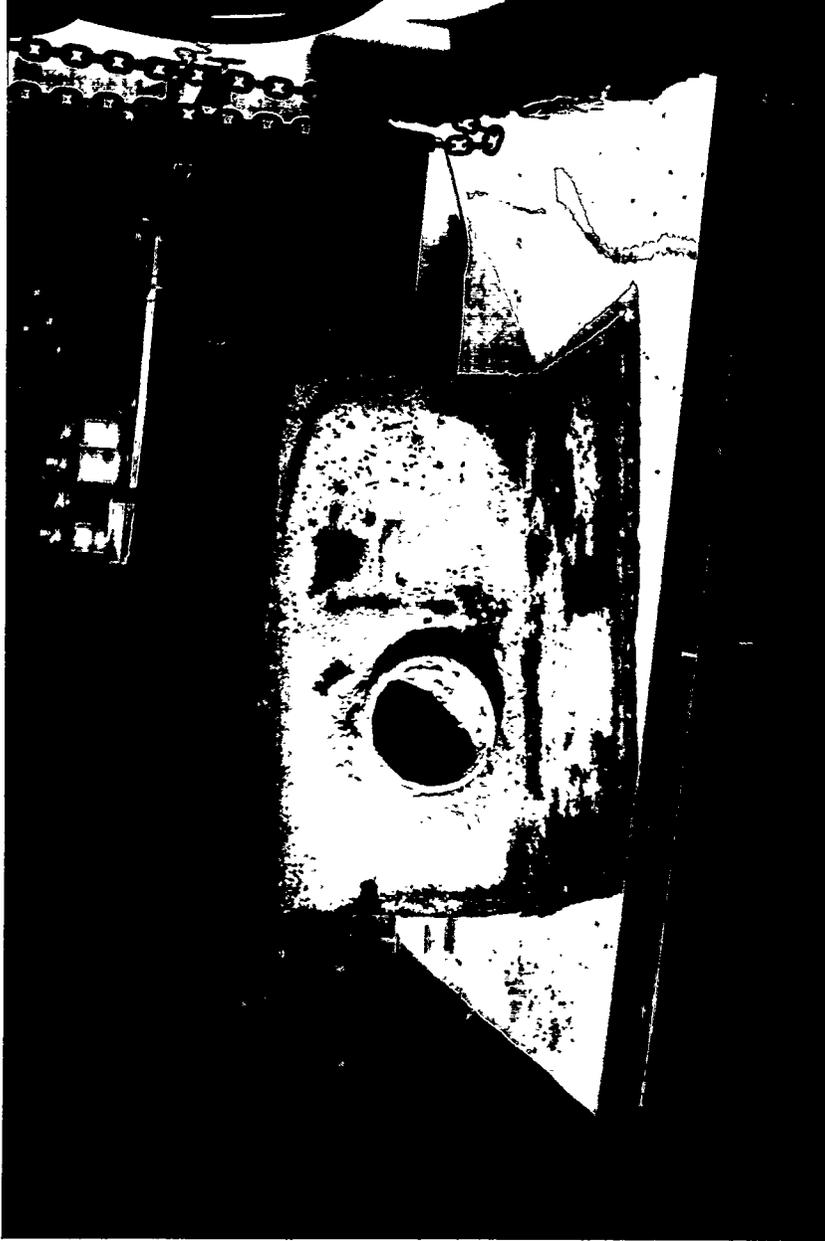
Piece #1 from Tank D3 was also examined for evidence of corrosion, although this tank location, which contained a 6 in. drain line, had not been a source of leakage during service. Figure 16 shows the blanked off pipe on the tank's exterior. The arrow points to the remains of insulation that had been originally applied over the pipe-to-wall weld joint. Figure 17 shows the pipe from the inside of the tank. The inner surfaces still show the presence of the white Amercoat paint. A sharp instrument was used to remove the paint and corrosion scale from welded regions around the pipe and at wall-base locations. Following this, a small grinding tool attached to an electric drill was used to remove oxide scale until bare weld metal was reached. Dye penetrant tests were then conducted to determine if any of the welds had cracks present. None were observed. From the studies carried out on Piece #1, all weld material studied appears to be of good quality.

Figure 17. Drainage Line in Tank D3 Seen From Within the Tank. Scale From Wall-to-Base Weld Was Removed to Check Weld Integrity.

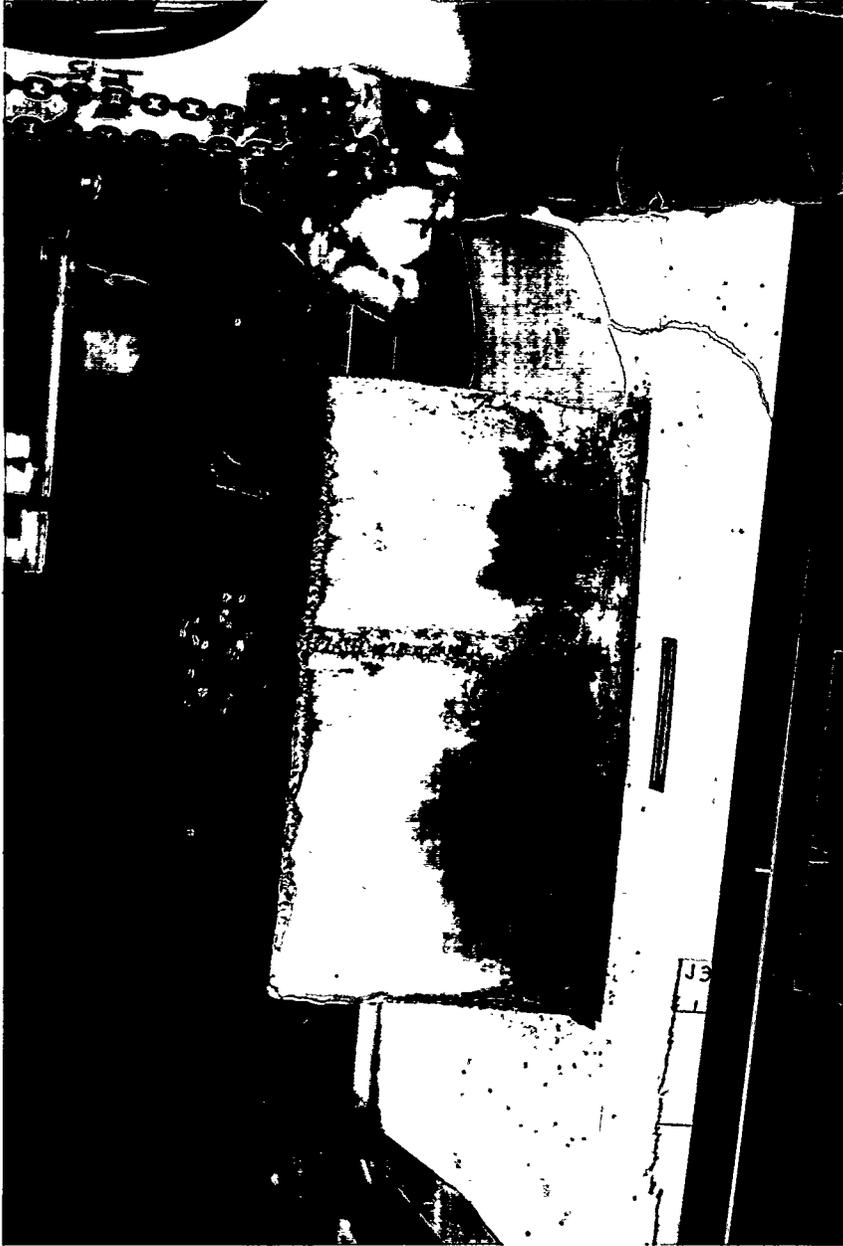
Piece #4, a control from the northeastern section of Tank D3, was examined also. Figures 18, 19, and 20 show the outer surface including a vertical lap weld, the inner surface, and the tank base, respectively. Visual observation indicated that all welded material was in good condition with no signs of attack. The base of the tank, which was in contact with the concrete pad, showed severe scaling but there did not appear to be any region where penetration was imminent. The other control sample, Piece #2, is shown in Figures 21 and 22. It was cut from the north wall and base of the tank. The Amercoat paint is still present on the internal wall but it had been lost from part of the tank base, possibly as a result of desludging operations or water jet cleaning prior to dismantlement. No evidence for excessive weld corrosion or cracking was found by visual examination.

Figure 18. Outer Surface of Piece #4 from Tank D3 Showing Vertical Lap Weld.

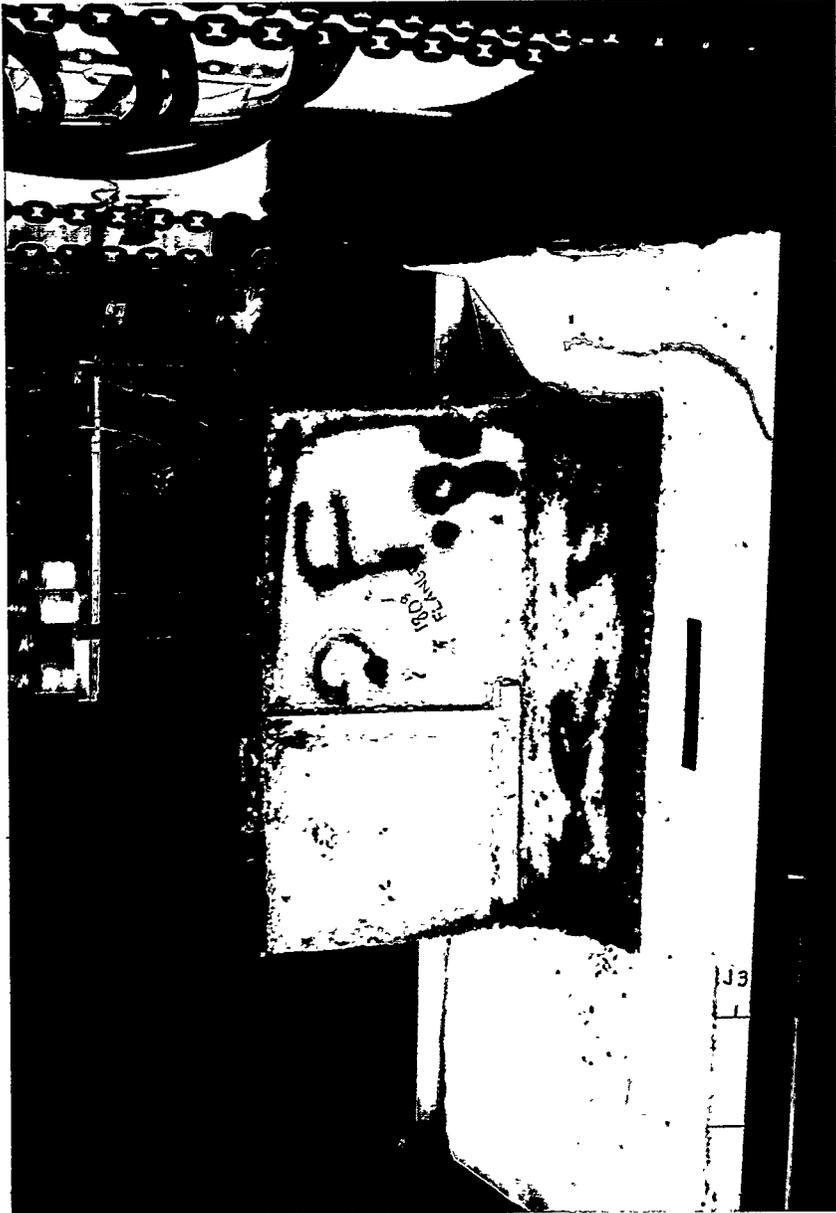
Figure 19. Inner Surface of Piece #4 from Tank D3 Showing Lap Weld.

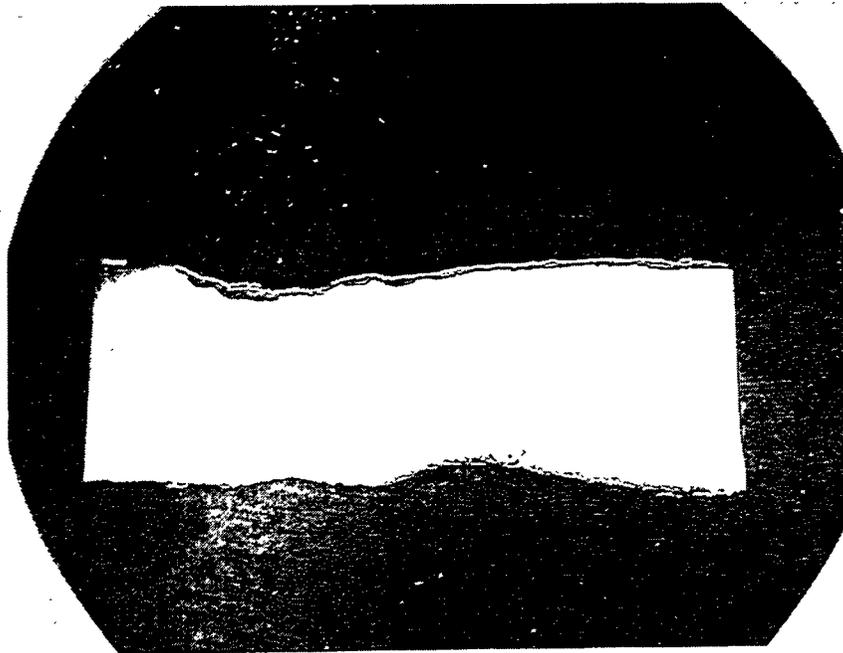
A sample was taken from the base of Tank D1 during dismantlement. The only leak in the tank was at a threaded nipple on a valve which, unfortunately, was unavailable for study. Figure 23 shows a section through one of most corroded locations. The Amercoat layer is still visible as a gray layer on the upper surface, but it did not prevent relatively severe corrosion from occurring. As was mentioned above, examination of the coating shortly after application showed that it had blistered and some regions had flaked away from the steel substrate. For the surface in contact with the concrete pad, non-uniform corrosion was also observed, including a large indented area.

Figure 23. Section Through the Base of Tank D1 in an Area Showing Severe Attack. Amercoat Paint Layer is Seen on Upper Surface. Magnification 3.1X

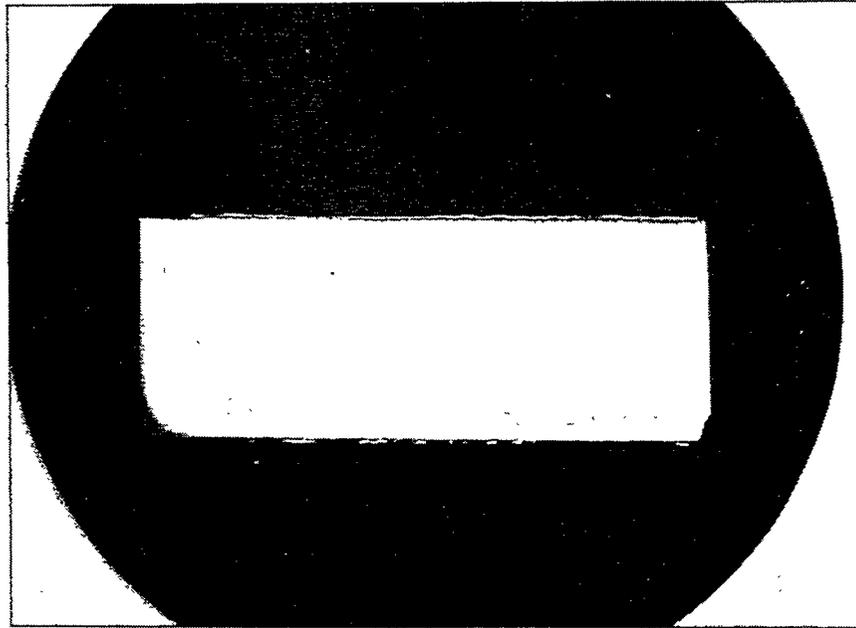
Figure 24 is a section through the base in a region that was not severely corroded. After 32y of service and 10y in retirement, this section of the tank base had experienced little metal loss. Apparently, the Amercoat paint (shown on upper surface) was quite effective in this location. Also, little attack is seen for the surface that contacted the concrete pad.

Figure 24. Section Through the Base of Tank D1 in an Area Showing Minimal Attack. Magnification 3X.
