Creep damage development in welded X20 and P91

M08-803

VÄRMEFORSK Service AB
101 53 STOCKHOLM · Tel 08-677 25 80
Mars, 2011
ISSN 1653-1248

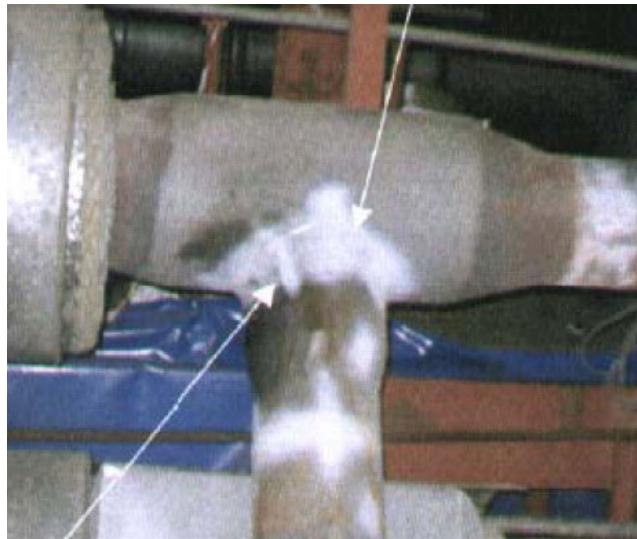
Branch connection RA11. Arrows at standard replica position and ground indication.

Re-inspection of RA11 branch weld in 2004 after total 146.000 service hours showed a 40 mm crack indication with magnetic particle testing close to the upper flank position. No indication was observed after 0,2 mm grinding. In the standard upper flank replica position an extensive amount of microcracks and extensive amount of orientated cavities was observed in branch body HAZ. Further grinding showed decreasing creep damage class with extensive amount of isolated cavities in approximately 3mm depth. Lower flank position showed extensive amount of oriented cavities in branch body HAZ.

All four HP-bypass branch connections were replaced in 2005. RA11 branch connection was stored for further investigations, which is reported separately in this Värmegeforsk project.

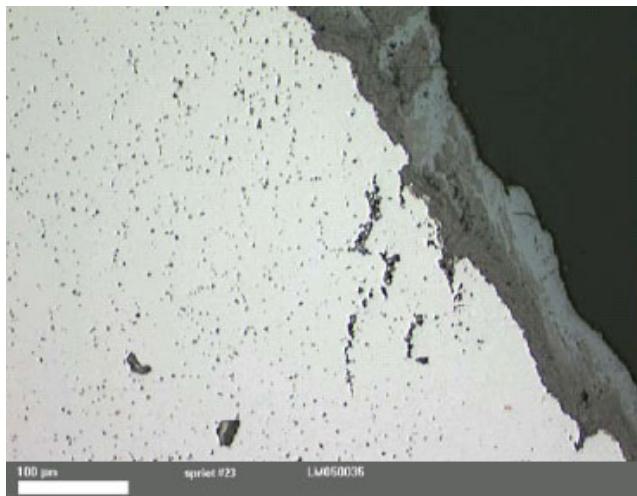
Case MV1 shows creep-fatigue damage at the tube side of header-stub connections due to inflexible super heater layout. Selected inspections over the years seemed not to have prevented failure in time.

Cross section at failure location showing creep voids and oxidized crack on the stub side (MVI)

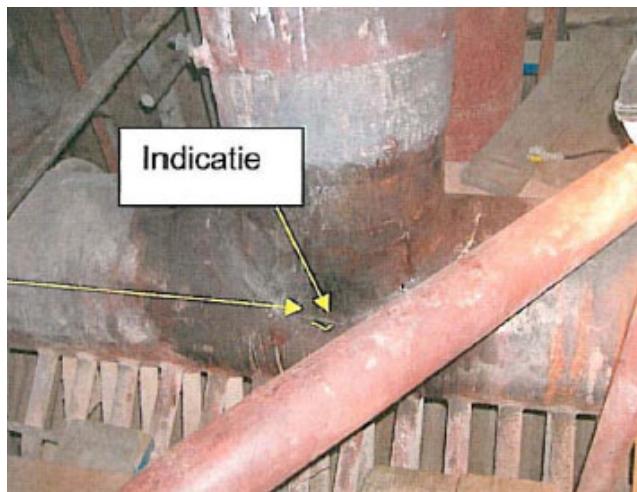
Case AC8 shows that creep damage of welded header-stub connections may develop rather fast at longer operation times. Fitness For Service analysis was needed to estimate relevant re-inspection intervals which have been restricted from 14.000 to 4.000 hrs.

Crack indications at the header-nozzle connection, nozzle 570 south (Case AC8)

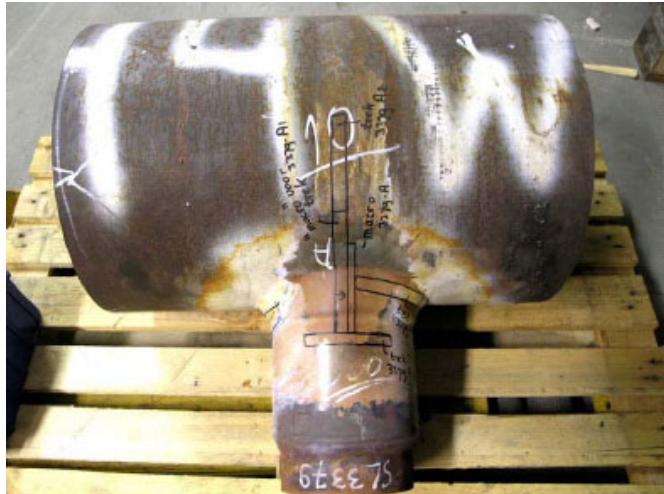
Case GL13 shows that creep damage in welded header - stub connections may penetrate from outer surface (damage class 3B) into the header wall up to a maximum of 36% of the wall thickness (damage class 2A) . Fracture toughness of X20 after 175.000 hrs at 516°C is still acceptable 75 J. It is proposed to perform additional creep testing to estimate the residual life time.

GLD13 Header 600, Nozzle 10, side A. Location of samples for testing

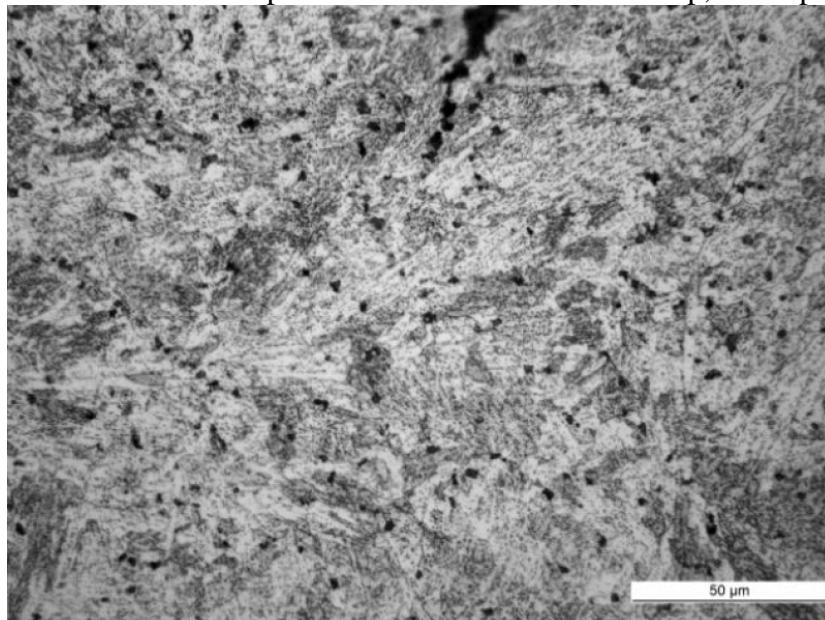
The observed creep damage in the HAZ of the branch weld has been severe enough to result in creep cavitation and cavity linking to growing creep cracks. Crack initiation, at least after several times of surface grinding for inspections, has been in the outer HAZ but growth has been mainly across the HAZ towards the parent steel approximately in the longitudinal-radial plane of the header body. The maximum cavity density in the HAZ at the crack tip was about 9000 cavities/mm², decreasing to about 200 cavities/mm² at a depth of 5-6 mm below the crack tip, in the parent steel.

Creep cavitation damage at the crack tip region

The cracks have grown relatively slowly (up to about 1.7 mm in five years, starting from class 3 (orientated cavitation) to 4 (microcracking), and exhibited significant bridging at the front line. It is possible that the growth rate has been slowing down due to the damage progressing across the HAZ into the presumably stronger parent steel.

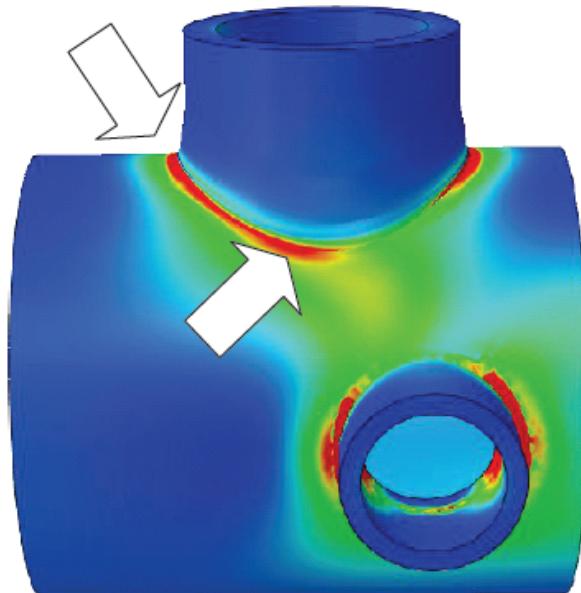
The simulation of the 3-D branch weld with the Comsol FEA implementation using logistic creep strain prediction (LCSP) strain model predicted largest strains and extensive creep exhaustion in the HAZ of both crotch and flank positions of the header

Locations of largest creep exhaustion for the branch of interest (arrows); the impact on the flank position at the “dead end” branch is clearly visible

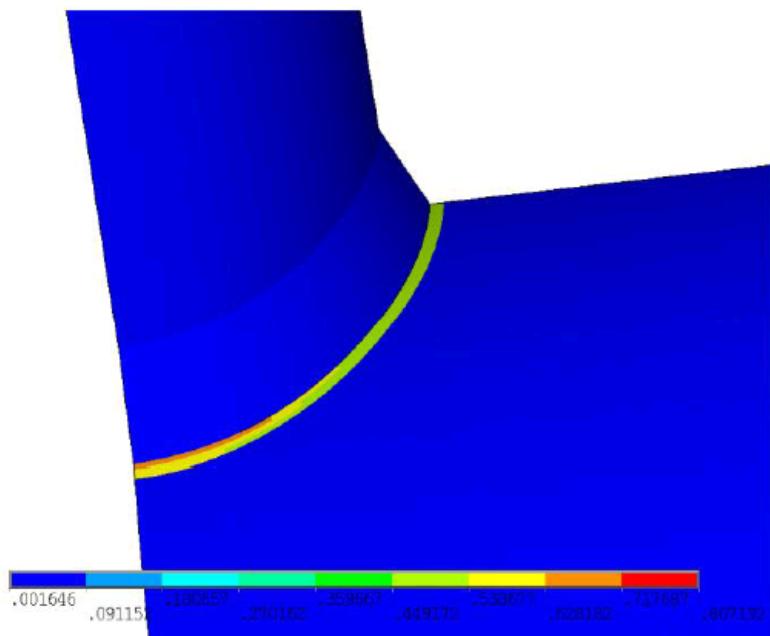
The modeling case with the P91 header/branch joint show severe creep damage after 100.000 hours when the header is modeled with weak creep properties. With a minimum creep strain rate ten times higher in the header material than in normal P91, the creep damage parameter was calculated to 0.8 after 100.000 hours.

Creep damage parameter after 100,000 hours with weak header material - outside view.

This level of creep strain rate in the header is considered realistic due to the low N:Al relationship in this component. The model predicted damage initiation in the flank at the HAZ which corresponds closely to the observed position.

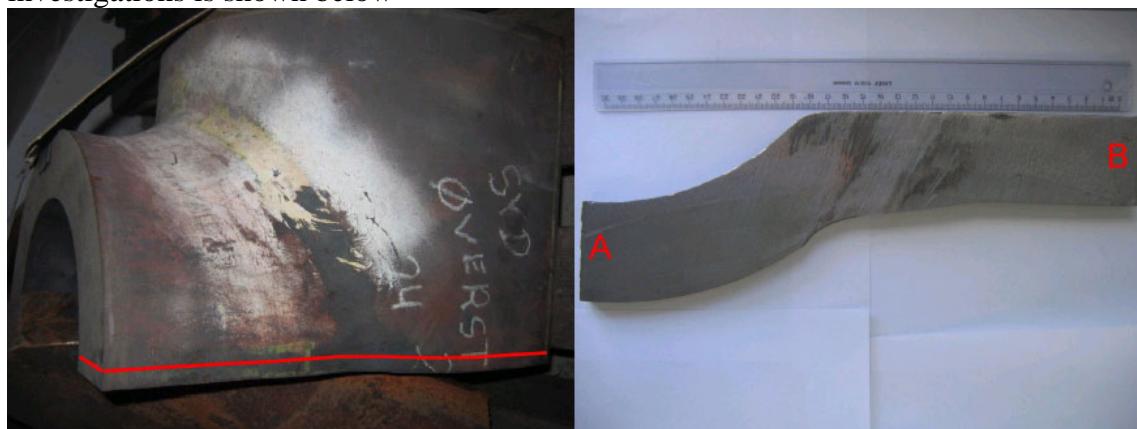
Sectioning of branch joint and position of material used for LOM and TEM

The header was replaced in 2008 due to the findings of creep cracks in the HAZ zones of stub and branch welds. The failure occurred long before reaching design life. It was speculated that the premature failure was due to an unfavorable N/Al ratio of the used P91. Studies indicate that the nitrogen to aluminum (N/Al) ratio is very important for the creep properties of the 9% chromium steels, because a low N/Al ratio results in a reduction of strengthening MX particles since the nitrogen is bound in non-strengthening aluminum-nitrides.
