**PROCESS SYSTEMS OF PHWR  
INDIAN EXPERIENCE**

TECHNICAL COMMITTEE MEETING  
ON  
EXCHANGE OF OPERATIONAL SAFETY EXPERIENCE  
OF PRESSURISED HEAVY WATER REACTORS  
EMBALSE, CORDOBA, ARGENTINA  
3-5 APRIL 1991

T.S.V. RAMANAN  
DY. CHIEF SUPDT.,  
MAPS, INDIA.

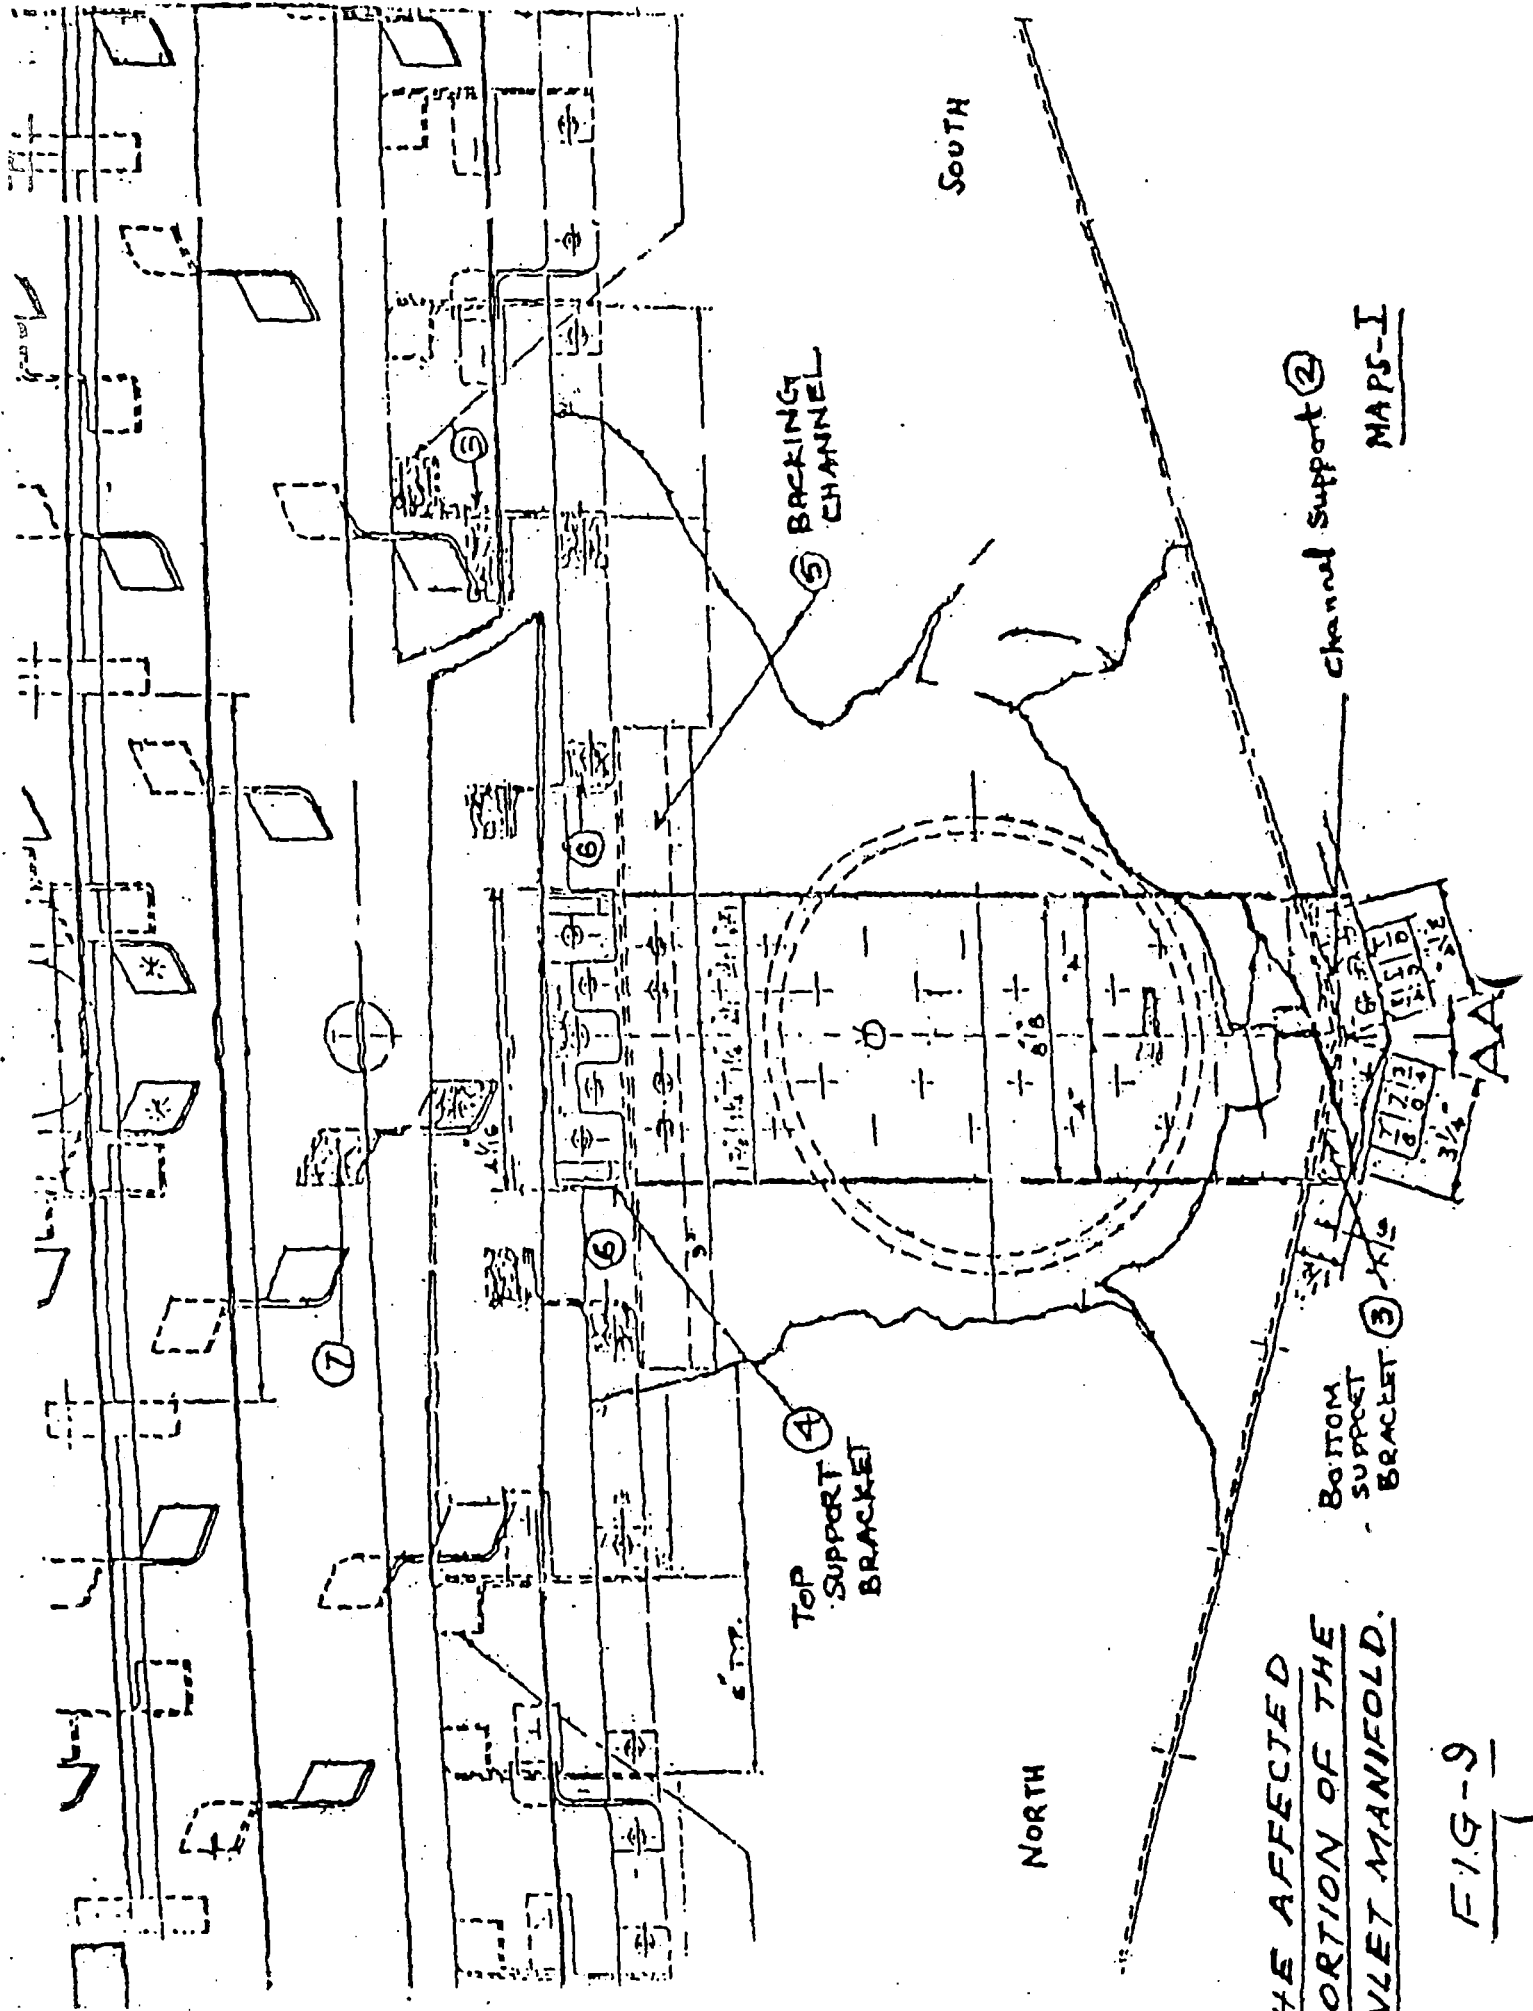
FIG-9

In early 1989, following a leak detected in a calandria tube in Unit-2, inspection of the calandria internals revealed that a portion of the inlet manifold located just in front of the inlet nozzle had sheared off and fallen on the dump ports. Surprisingly similar incident was also found to have occurred in the other MAPS Unit when it was later inspected. As an interim measure, alternate routing of moderator piping was done externally directing heavy water into the calandria through the original outlet manifold. The calandria spray flow (for cooling internal structures of calandria) was increased in order to enhance total flow into calandria. The heavy water in calandria was allowed to spill over the dump ports continuously and to return from dump tank to suction of the pumps. Since the total inflow into the calandria is less than the design, the reactors are being operated at 75% of capacity.

Calandria tubes at these locations in both units were removed and inspection of the internals of the calandria with a camera, revealed that a portion of the zircalloy plate forming part of the inlet plenum chambers just in front of the moderator inlet pipe connection had given way in both units (Refer Figure-9). Some of the pieces from the manifold were lying on top of the dump ports. The failure of the calandria tubes/pressure tube was attributed to direct impingement by jet of heavywater from moderator inlet pipe. The failure of the manifold is believed to have been initiated by failure of welding of the holding studs to the calandria shell. This has to be confirmed by metallurgical examination of the failed portions of the plate and studs, which are planned to be retrieved shortly.

THE AFFECTED  
 PORTION OF THE  
 INLET MANIFOLD.

The damaged portions lying on the dump port were picked up and deposited in a cavity adjacent to the tube sheet where the forces during dumping will not dislodge them. The calandria tube sheet opening was blanked. After

performing necessary stress analysis and thermal hydraulic analysis, it was decided to connect moderator inlet to the original outlet pipe so that the heavywater enters the calandria through the original outlet manifold but the flow rate was kept lower as a matter of caution and consequently the power was limited to 75% FP. The heavywater was allowed to spill over the dump ports continuously into dump tank and return to moderator pump suction through dump tank outlet line. The modified scheme is shown in Figure-2.

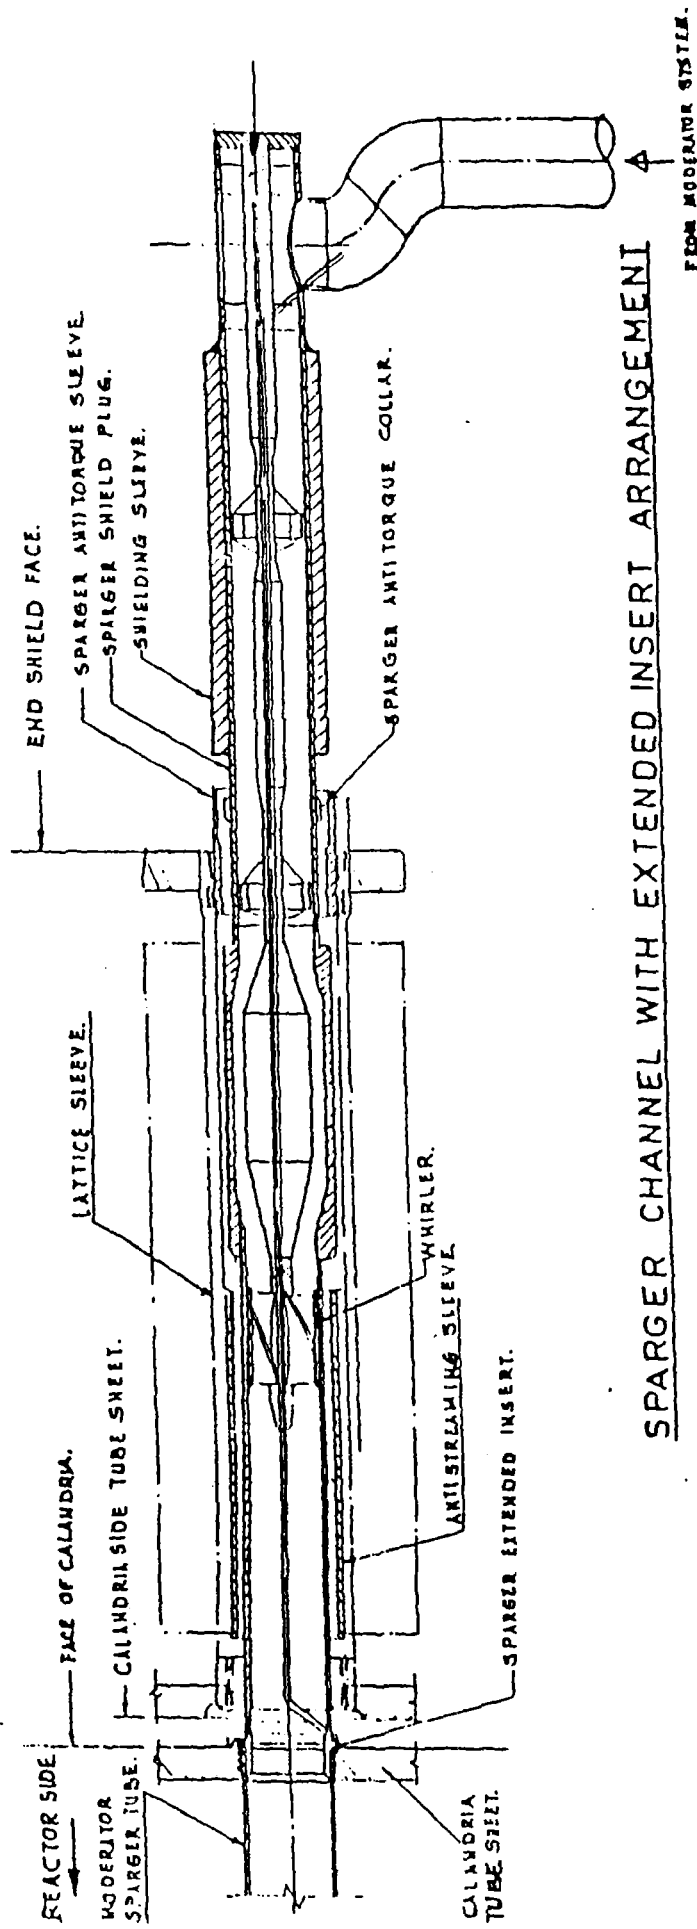
FIG-10

SPARGER CHANNEL WITH EXTENDED INSERT ARRANGEMENT

In order to restore the moderator flow to original configuration and achieve full power, development work was undertaken and it is proposed to cut pressure tubes and calandria tubes at three lattice locations near the bottom of the calandria and install sparger tubes made of Zircalloy. These will be rolled into the calandria tube sheet. Another stainless steel insert extending upto the fuelling machine vaults through the end shield lattice bore openings will be rolled into the calandria tube sheet thus sandwiching the sparger tube between the tube sheet and the insert. Moderator piping which is routed into the fuelling machine vaults will connect to these extended inserts and the layout ensures that this arrangement will not hinder movement of fuelling machine to do refuelling in adjacent channels. Hydraulic studies were made on models and suitable provisions based on these studies have been incorporated to achieve required flow distribution through these spargers. The proposed sparger and the rolled joint are given in Figures 10 and 11. As a parallel measure, provision of a third moderator heat exchanger to bring down the moderator inlet temperature and operate the reactors at higher power in this mode itself are being studied.

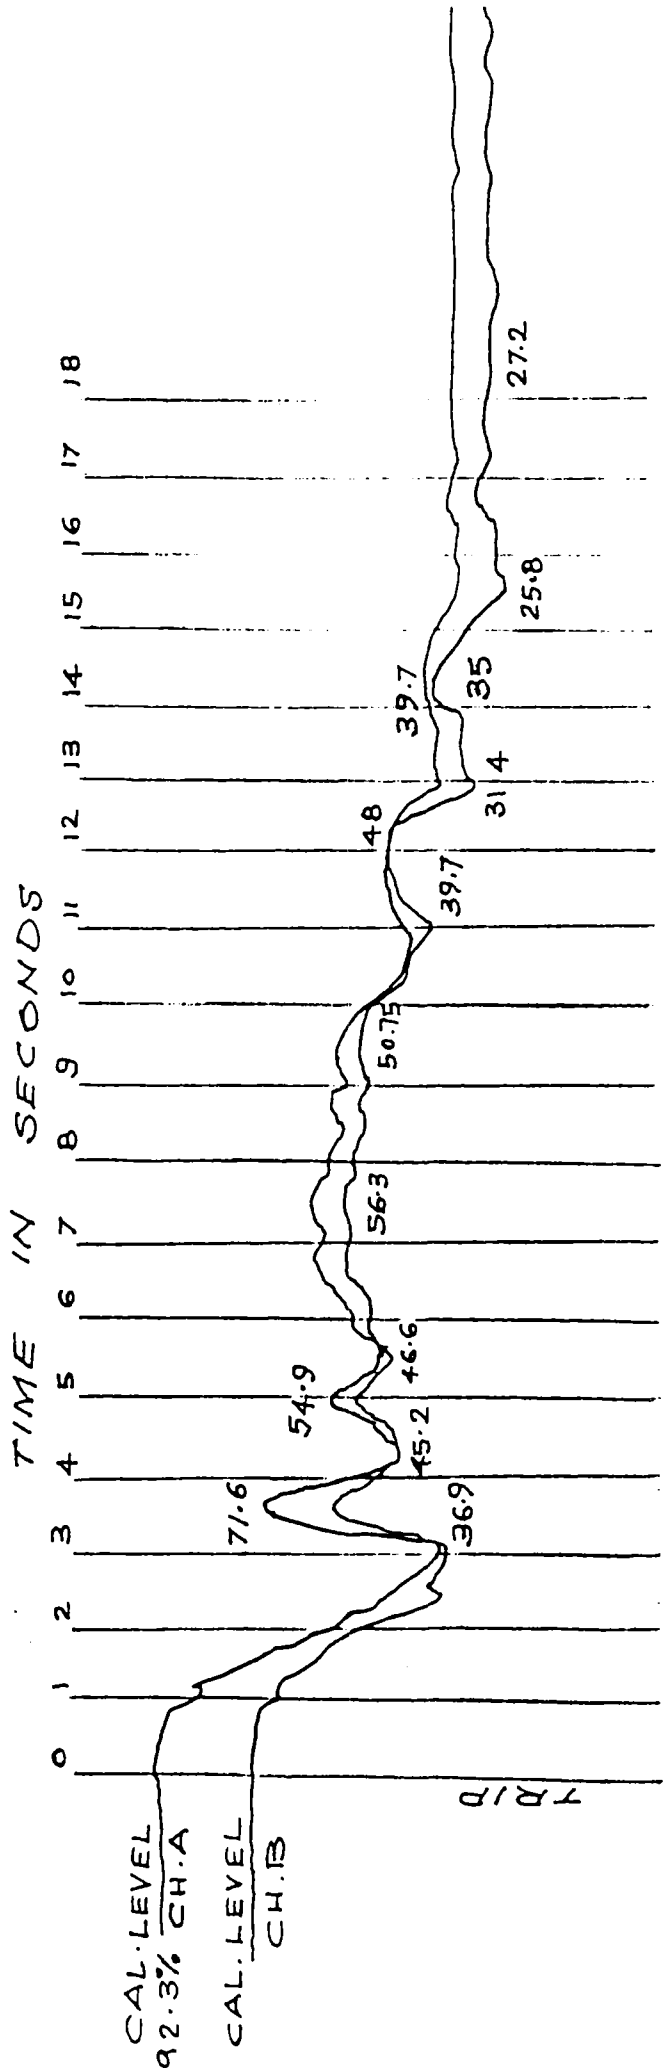
FIG-12

Subsequent to the altered flow path of moderator into the calandria, the calandria spray cooling flow joining the top of the calandria was also increased in order to take advantage of this flow for increased heat removal capability from the moderator in the calandria. Performance tests were being conducted to assess the operation under the altered conditions. While dumping this, tests were conducted with fast recorders to record the calandria moderator level with respect to time, it was found that in Unit-2 there was a significant increase in the time taken for the level to reach 35% from full tank level as compared to the design values. The level measurement was also indicating an oscillatory

pattern as shown in Figure-12.

MAPS-2  
 DUMP TEST  
 12-11-1989

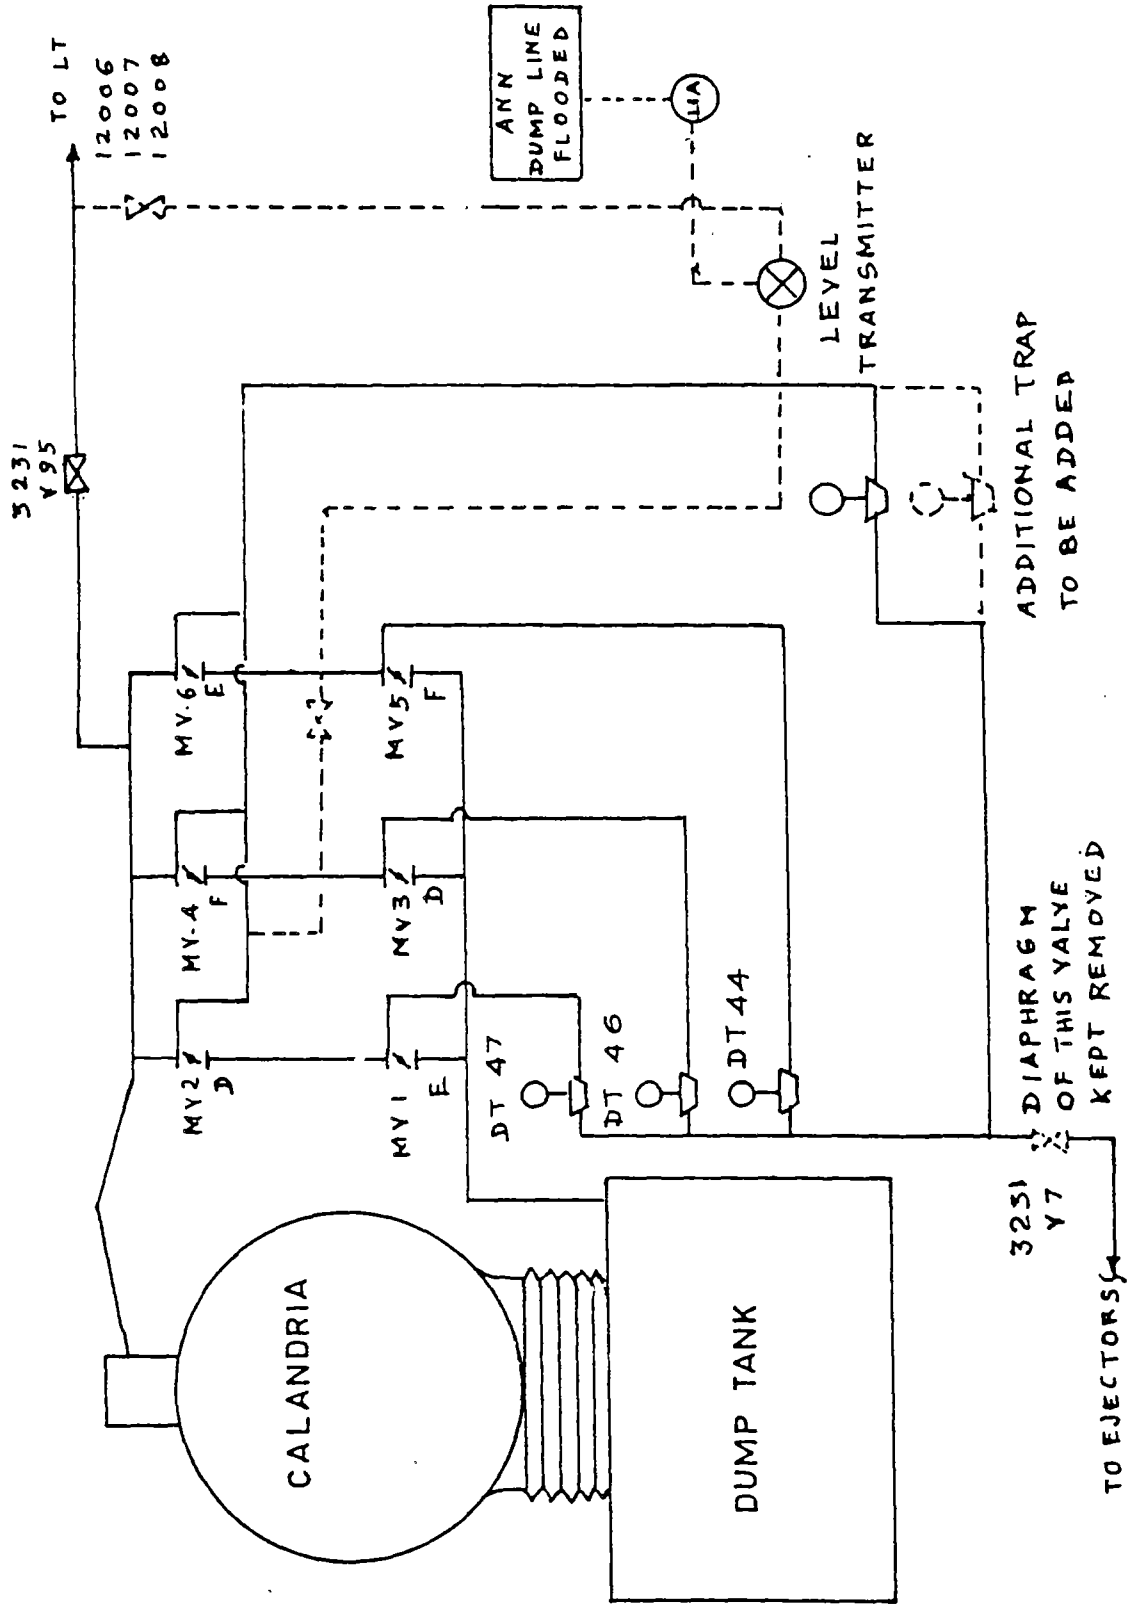
FIG. 13

In order to check for flow blockage in the gas headers access to the calandria side gas header above the dump valves was made through the rupture disc connection. Though no blockage could be found, D2O was found to be present at the bottom portion of the horizontal run of this header. Design had expected that a small amount of heavywater will be present in the line due to condensation from helium. However the quantity present was found to be more than expected. Provision existed in original design to drain off any condensed heavywater on the top of the dump valves, through a float type trap to a low pressure portion of the moderator system. This float had an isolating valve of diaphragm type on the downstream side. The arrangement is shown in Figure-13. Accumulation of significant quantity of heavywater on top of the dump valves was suspected causing an increase in dump timing by impeding quick pressure equalisation. To confirm this, the system was operated with the isolating valve of the trap closed for varying periods ranging from 6 to 14 hours and dump test was repeated at the end of each period. Accumulation of heavywater over dump valves was confirmed by ultrasonic methods. The dump tests revealed that higher the time of accumulation, the slower the dump rate. Examination of the isolating valve of trap revealed that the diaphragm was slightly bulged. This is suspected to have impeded the drain flow. This alongwith increased ingress of heavywater had caused accumulation over the dump valves.

It was felt that improper nozzle orientation in the sprays provided in the gas balance line near the top of the calandria was possible. This combined with increased spray flow would have rendered the slope provided in the gas balance line to drain off the heavywater towards calandria ineffective due to higher reach of the sprays and caused more ingress towards the top of the dump valves.

The calandria spray flows were reduced to original design values. The diaphragm valve in the drain line was eliminated. An additional drain trap was provided in parallel with the existing one to cater to single failure criterion. Level measurement with alarm facility was provided to detect heavywater accumulation in the gas space above the dump valves to alert the operator. These modifications are also shown in Figure-14.

PROPOSED SCHEME OF DRAINING FOR GAS SPACE
