Full scale testing of wind turbine blade to failure - flapwise loading

**Erik R. Jørgensen, Kaj. K. Borum, Malcolm McGugan,
Christian L. Thomsen, Find M. Jensen, Christian P. Debel
og Bent F. Sørensen**

Abstract A 25m wind turbine blade was tested to failure when subjected to a flapwise load. With the test setup, it was possible to test the blade to failure at three different locations.

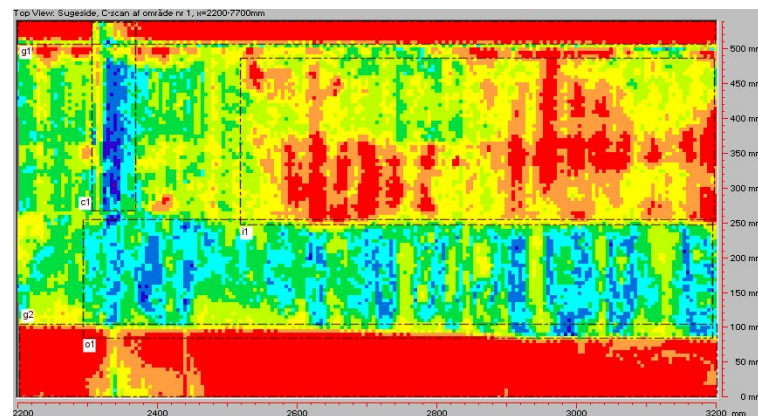
Figure 3 Ultrasonic scan from 2.2m to 3.2m (section 3)

In this scan a good adhesion between the layers is seen, even though there are areas (marked i1, red), which indicates missing adhesion or epoxy. In this scan red "lines" are seen in upper right part of the figure, which indicates how the epoxy is put in lines during manufacturing of the blade. In other areas these lines where much more dominant and larger areas with a bad adhesion/distribution of epoxy was also seen in some areas.

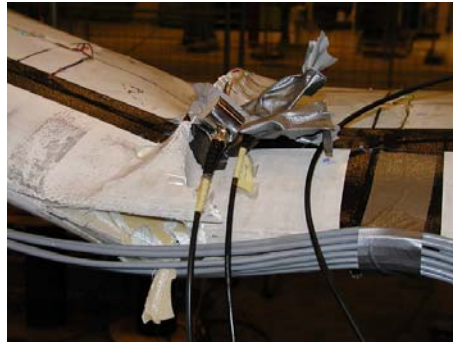
In test of section 1 (19.3m to 23.3m) the blade failed 20.1m from the root, with a load introduction as given in figure 4. In the figures below the large deflection in this test is seen as well as a picture of the failed section of the blade.

Figure 8 The blade failed 20.1m from the root section. AE sensors where mounted very close to the failure

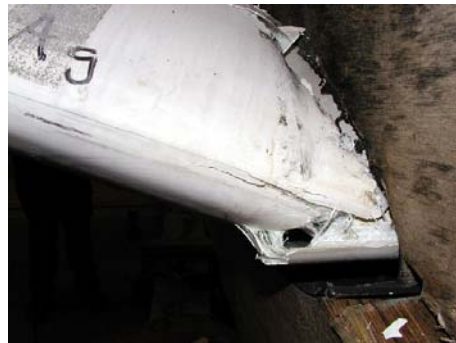
In test of section 2 the blade failed 15.3m from the root (unfortunately at the yoke), with a load introduction as given in figure 5.

Figure 9 In test of section 2 the blade unfortunately failed at the loading yoke at 15.3m from root section

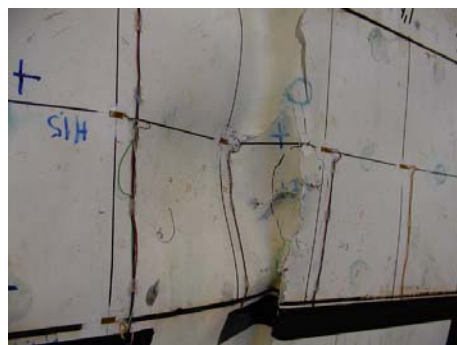
In test of section 3 the blade failed 4.4m from the root, with a load introduction as given in figure 6.

Figure 10 Test of section 3 with load introduction at 11.3m *Figure 11 Failure 4.4m from the root.*

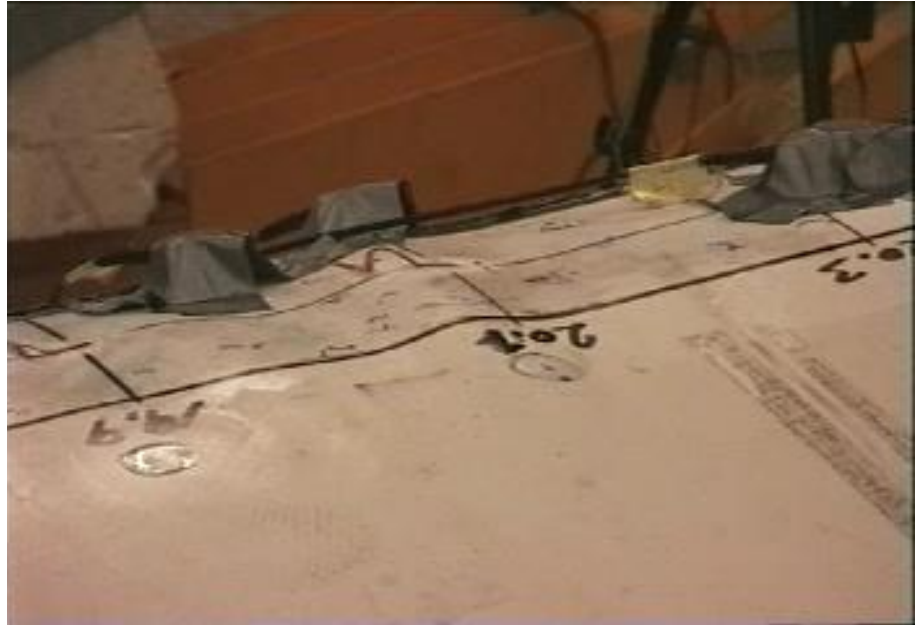
At a specific spot on the blade in test section 1, the skin is visually observed to be buckling. The strain gauges in this area, showed at the same time very high compressive and tension strains. According to figure 27 the strain gauge located on the top of the buckling wave (strain gauge #201.1) showed tension and in the bottom (strain gauge #199.1) showed compression as expected. The area of this debonding of the skin laminate, indicated by the strain gauge measurements as well as seen visually, was corresponding very well with the areas of improper bonding as found in the ultra sonic measurement prior to the test. It should be mentioned that the skin laminate is only a minor part of the load carrying part in a flapwise load situation. The results are shown here for the good correlation between strain gauge measurements, the visual identification and the prediction of the bonding situation based on the ultra sonic test of this area. Even though the skin only contribute as a minor part to the strength of the blade in a flapwise load situation the blade actually failed in this area of delamination (20.1m from the root section).

Figure 27 Photo of skin behavior (skin laminate debond from the main spar)

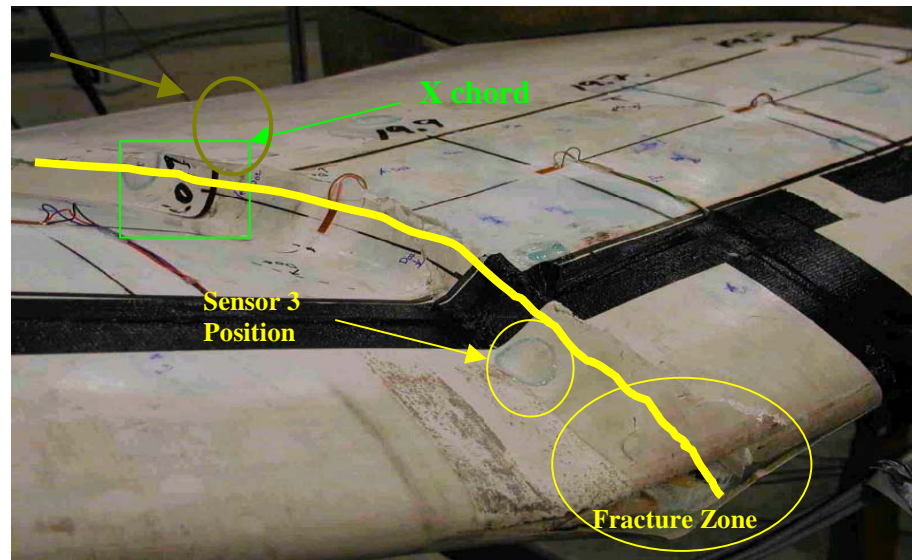
Figure 30 Blade failure at the 20.1m chord. Note position of sensor 3

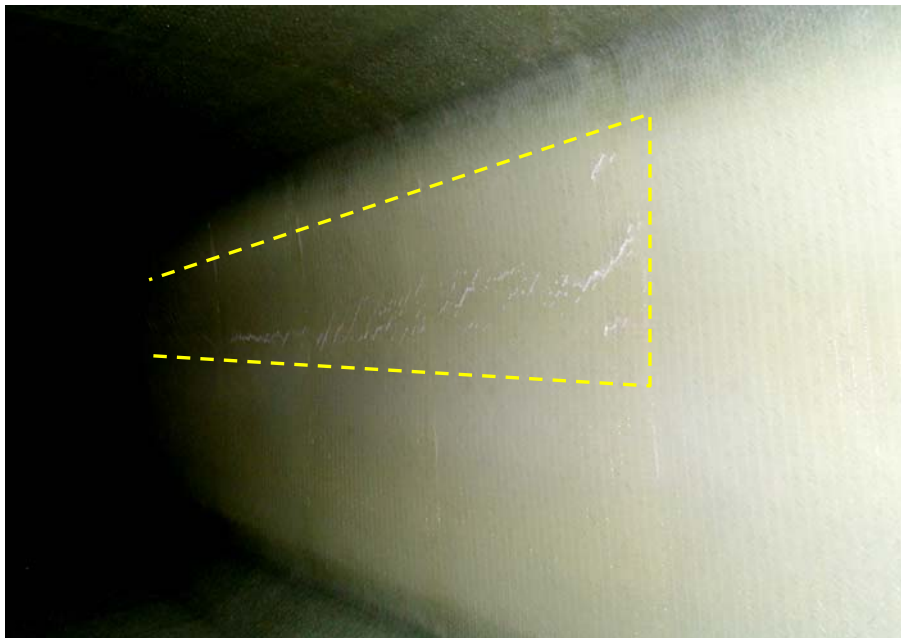
Figure 36 Image taken from inside the central spar showing lateral cracking (enclosed by yellow dashed lines) at approximately 11.3m chord. This damage occurred when the blade “sprang back” against the clamping yoke during section 2 blade failure.

the interior of the blade was reinforced at the 11.3m loading yoke. This successfully prevented the growth of the lateral cracks and permitted load to failure at the 4.5m chord. And once again, the AE activity recorded throughout this loading successfully identified 4.5m as the failure chord in preference to the 7m chord.
