This paper discusses a Failure Analysis after a leak in the spiral weld of a 16" natural gas pipeline, in service since 1974. The leak was the result of the coalescence of two different defects, on each surface of the pipe wall, located in the center of the inner cord of the helical DSAW weld. Fractographic and metallographic studies revealed that the leak was a combination of three conditions. During fabrication of the pipe, segregation in grain boundary grouped in mid weld. During service, these segregations underwent a process of selective galvanic corrosion. One of these volumetric defects coincided with a tubular pore in the outer weld. Pigging of the pipeline in 2005 for cleaning likely contributed to the increase of the leak flow, when eliminating corrosion product plugs. Although these defects are likely to repeat, fracture mechanics shows that a defect of this type is unlikely to cause a blowout.

This study establishes the causes (operative, maintenance, materials, design, construction, etc.) that produced a leak in the spiral weld of a 16" diameter, 6,35 mm thick natural gas pipeline, in service since 1974. The pipe operates at 68 Bar inner pressure. Last hydrostatic tes

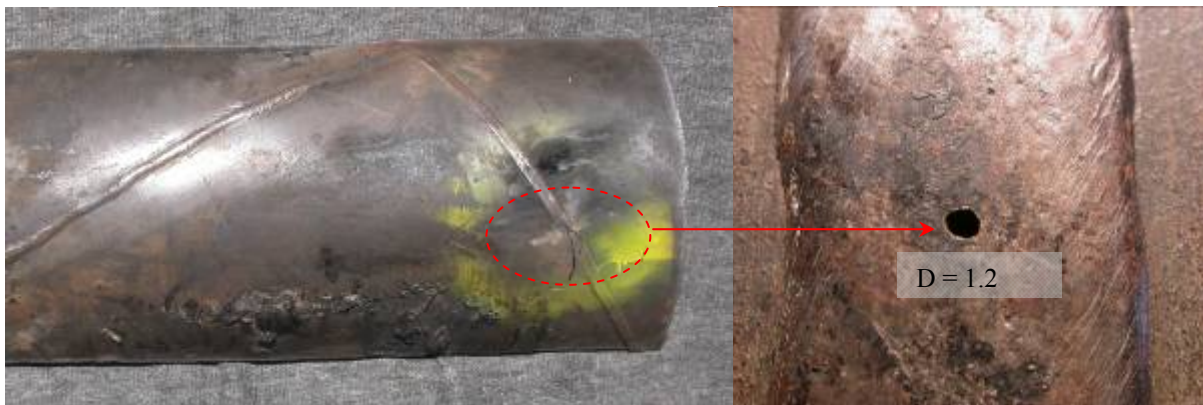
Figure 1: Defect that produced the leak and leak detail, external surface

In a first analysis, apparently a 1.2 mm wide pore at mid weld of the spiral seam weld generated the gas leak, Fig. 1. The determination of the mechanism by which the leak took place is fundamental for the prevention of future failures, since necessary corrective measures can be taken only after root causes are understood. This failure analysis¹ aims to: a) identify operating failure mechanisms; b) determine the causes that created the conditions so that this mechanism generated the failure; c) establish the probability and future failures on similar components d) evaluate possible mitigation actions.

On the outer side, the leak is circular, Fig. 1. Of the inner surface, however, the leak is elliptical, approximately 7 mm long and 1,5 mm wide. **Figure 2** shows its location in the weld and the position of the weld with respect to the gas flow. Longitudinal marks are likely due to passage of an internal tool. Some oxide deposits in the inner surface of the tube were mechanically removed.

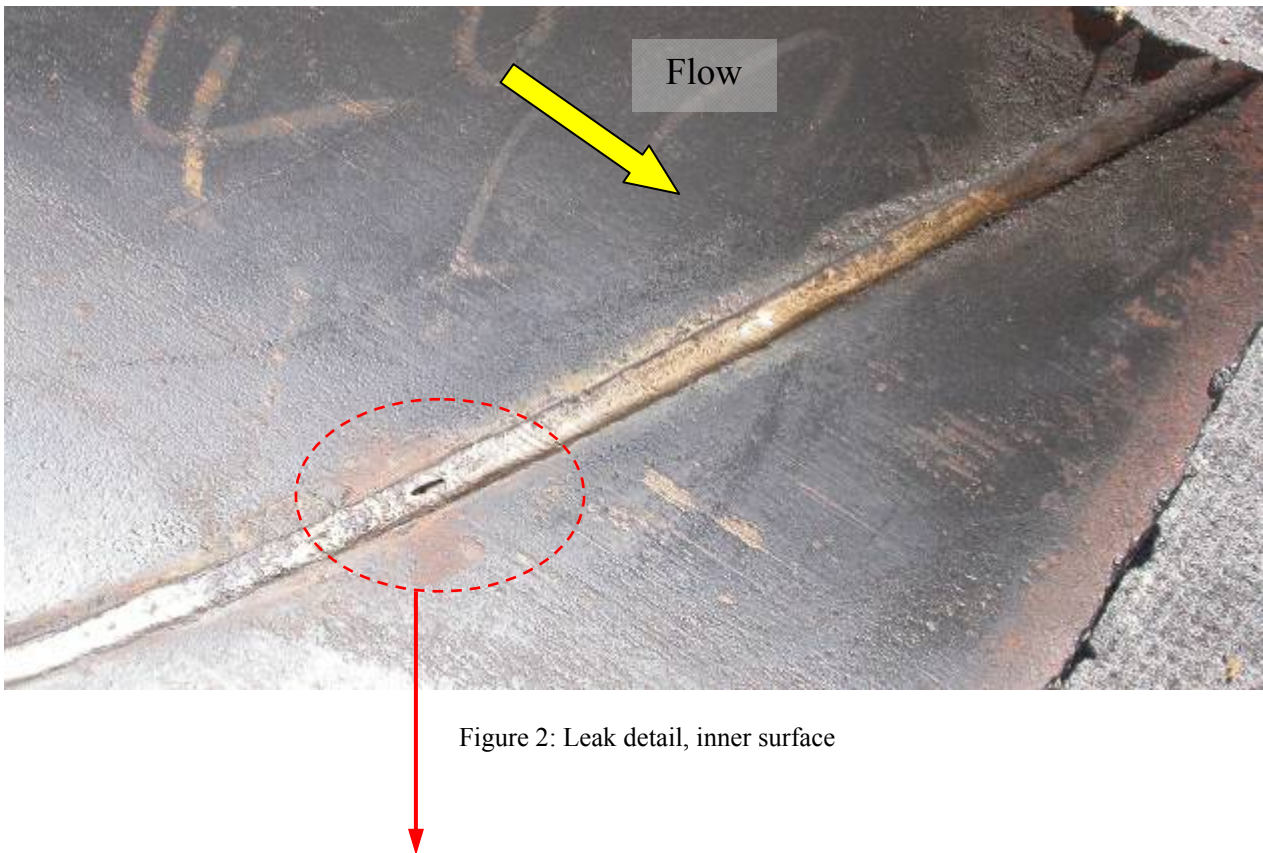
Figure 2: Leak detail, inner surface

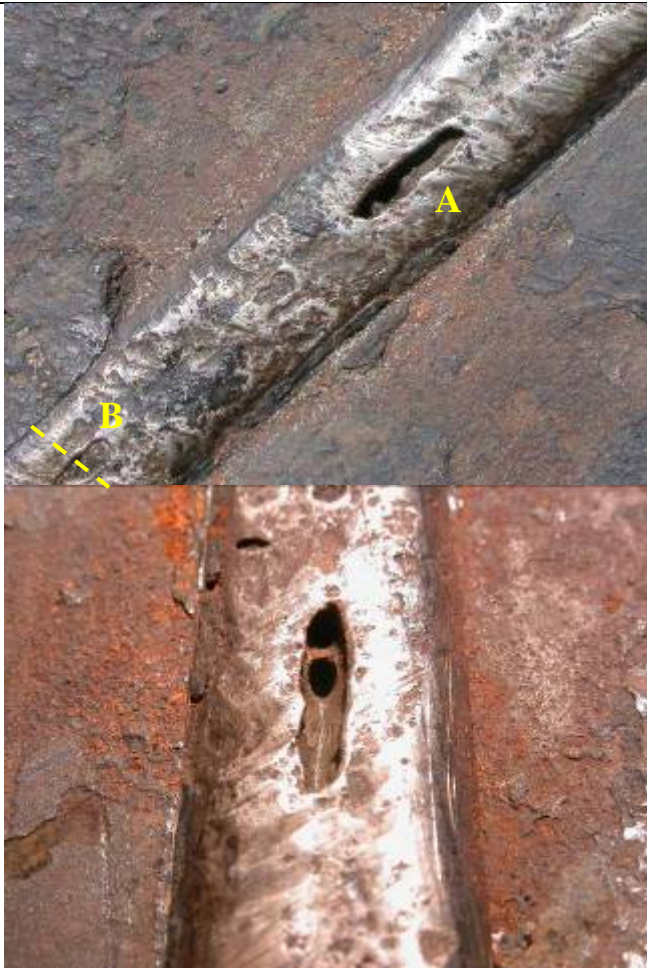
Other defects along this weld were also detected, although smaller, that have similar characteristics (details A, B in **Figure 3**, after surface cleaning), Greater detail of the leak (inner surface) is shown in **Figure 4**. The dotted indicates the cut made for the metallographic sample. Defect characteristics are similar to a cavern, within which a pair of “tunnels” exists. One of those tunnels ends across of the weld, in the orifice indicated in Fig. 1.

Figure 3: Other defects along the weld

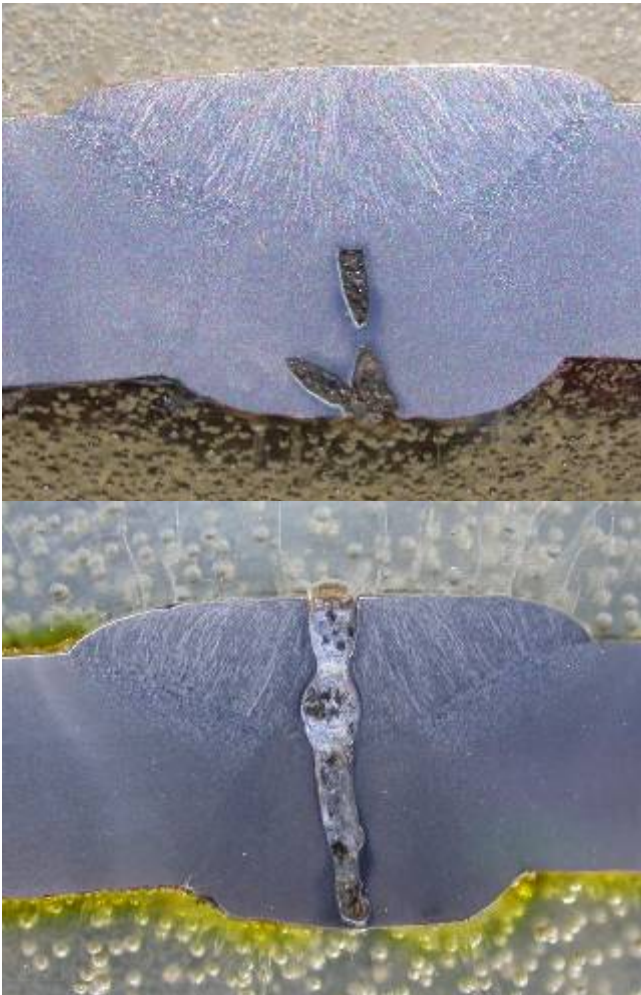
Interaction between defects and microstructural characteristics of the material was analyzed via polished and Nital etched cross sections. **Figure 5** shows a metallography of the section indicated in Fig 4. The weld is a double submerged arc process. The inner bead presents evident discontinuities, probably due to selective corrosion from nonmetallic inclusions or segregations, which were trapped in weld metal. The volume originally occupied by these inclusions eventually became caverns or hollows. Note that one of these segregations stops exactly in the inferior part of the outer weld bead.

The microstructures of both weld beads are different. The outer bead shows a oriented structure with a well defined Heat Affected Zone (HAZ). The inner bead shows a fine microstructure with a smooth, almost imperceptible, transition to base material. This difference is product of the weld sequence. The outer bead was laid after the inner bead, which this way underwent a heat treatment.

Figure 5: metallography of the section indicated in Fig 4

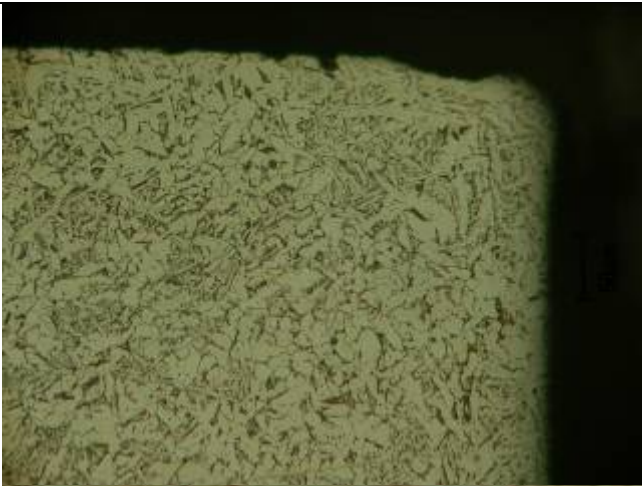
Figure 7 (X500), shows the microstructure at the center of the outer bead and its relation with the through defect. The edges of the defect do not display a clearly identifiable microstructural characteristic. **Figure 8** (X500) on the other hand, shows the characteristics of the edges of the cavern in the inner bead, compatible with an initial slag inclusion. These details allow verifying the existence of a process of selective corrosive, caused by a chemical agent from the inner side of the pipeline.

Figure 7: (X500) microstructure of the outer bead

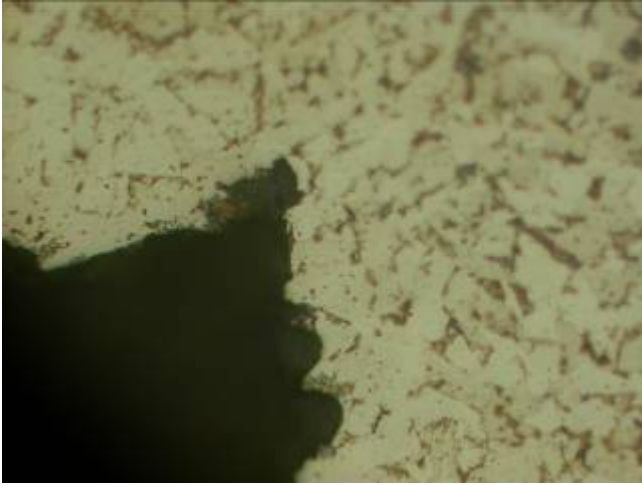
Figure 8: (X500) characteristics of the inner bead

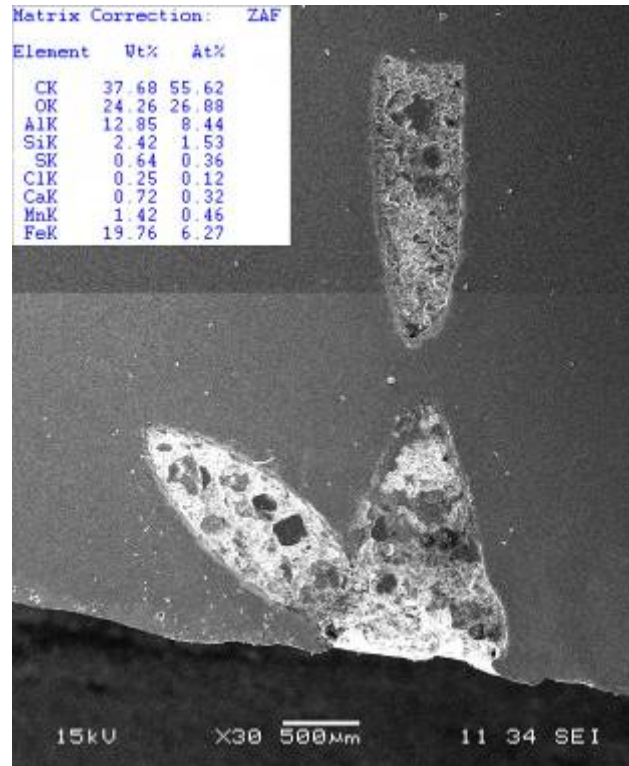
Scanning electron microscopy and EDS analyses of chemical composition were carried out. In the material filling the discontinuity at the inner weld some nonhabitual elements, like Aluminum, Silicon, Sulfur, Chlorine and Calcium are seen in **Figure 9**. Likely, Cl is due to cleaning of samples, the other elements are due to weld metal alloying.

Figure 9: EDS analyses of chemical composition

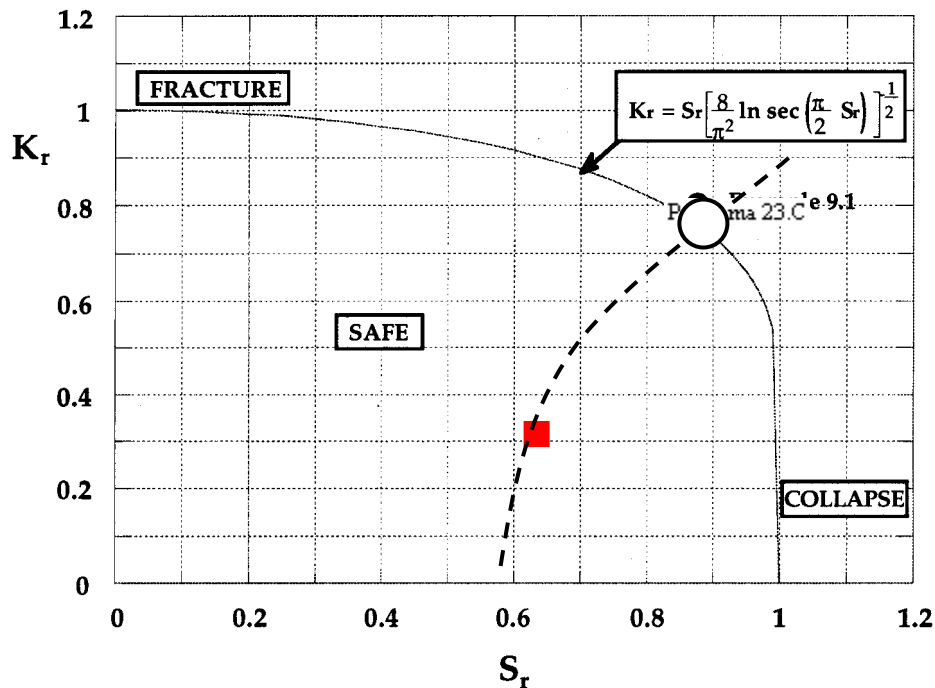
The FAD of **Figure 10** shows the site of predicted failure. All points inside the FAD are considered safe; points outside the diagram are unsafe. The square point ($S_r = 0.65$, $K_r = 0.32$) corresponding to the analyzed defect falls in the safe part of the diagram, far from limits of admissibility.

The round symbol indicates a certain risk of fast fracture or blow out. This condition is reached when $K_r = 0.72$. The length of a through defect for this condition, as calculated with eq. 2, is around 30 mm.

Figure 10: Fad diagram

Many other discontinuities of this type in the pipeline are most probable. The critical length of a surface defect of this type to cause a blow up is more than 30 mm, Fig. 10. No defects this size have been reported by ILI and other exploratory direct inspections. However, these defects will always lead to leaks. Therefore, this study showed that the affected pipes are in a leak before break condition.
