## **Sodium Leak at Monju (I)**

### **- Cause and Consequences -**

H. Mikami, A. Shono and H. Hiroi,  
Reactor and System Engineering Section,  
Monju Construction Office,  
Power Reactor and Nuclear Fuel Development Corp.  
2-1, Shiraki, Tsuruga-shi, Fukui-ken,  
Japan

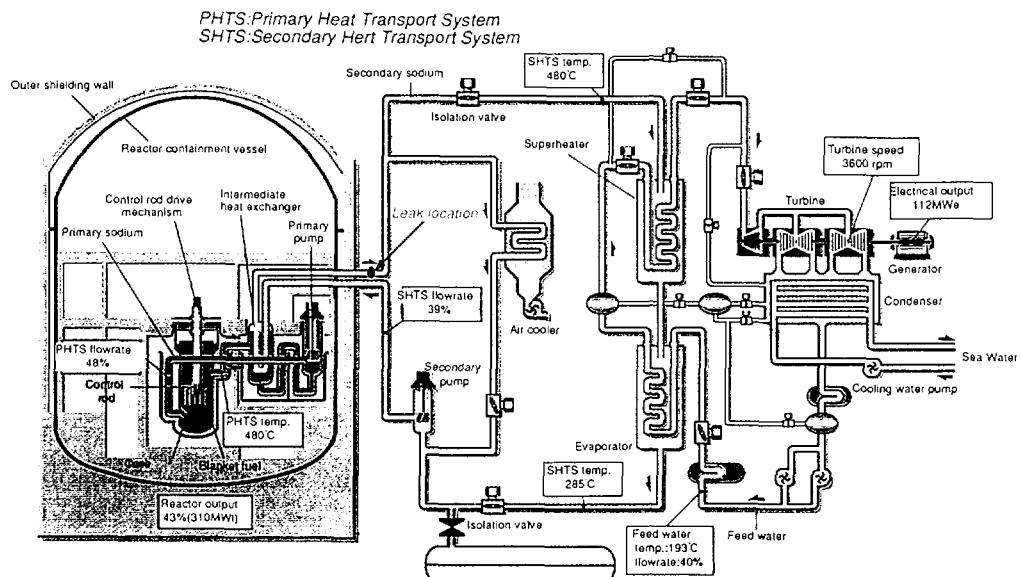
Fig.1 Monju Plant Condition (just before the Sodium Leak)

Following a programmed shutdown, Monju restarted operation on December 6, 1995. On December 8, while power was being raised for a plant trip test as part of the 40% electric power test (thermal power 43%), a high sodium temperature alarm at the outlet of the IHX in SHTS Loop C sounded at 19:47 and at approximately the same time the fire alarms (smoke detector) sounded in the same area. A sodium leak detection alarm followed, indicating that there was a sodium leak in the piping room of SHTS Loop C. The plant conditions at the time of the sodium leak occurrence are shown in Fig.1.

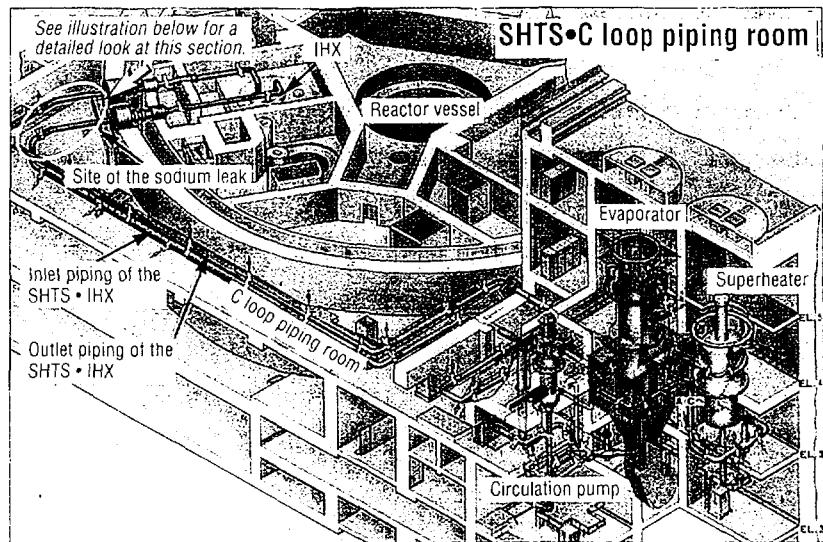
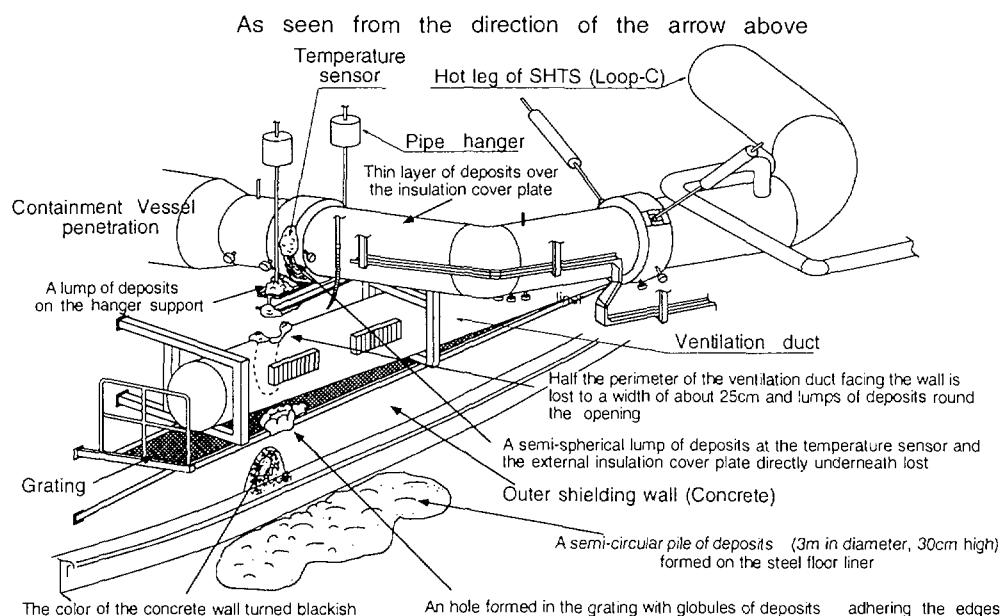
Fig.2 The State of the Piping Room (C) after the Sodium Leak

An inspection of the SHTS Loop C piping room on December 9 confirmed the presence of solidified sodium residue materials in the vicinity of the thermocouple well at the secondary-side outlet of the IHX. It was concluded that the thermocouple well was the probable origin of the leak. The state of the piping room after the sodium leak is shown in Fig.2. On the 6mm thick steel floor liner approximately 1m<sup>3</sup> of sodium compounds formed a semicircular mound, nearly 3m in diameter and 30cm high. Other sodium compounds resulting from the leak were lightly spread over the floor and walls of the room. The only damage observed was to a ventilation duct and an access walkway. The ventilation duct, running directly under the SHTS piping, had a hole extending over half the perimeter facing the wall with lumps of deposits around the opening. On the steel walkway grating under the piping, an opening was formed and globules of deposits stuck around the edges. Sodium compounds from the leak were found over the entire floor of the Steam Generator room of SHTS Loop C connecting to the piping room and in the passages.

From December 14, work began to remove and recover sodium compounds from the floor near the leak site. About 3m length of the ventilation duct which obstructed access to the suspect temperature sensor was removed during January 4~8, in order to make a closer inspection and establish the cause of the leak.

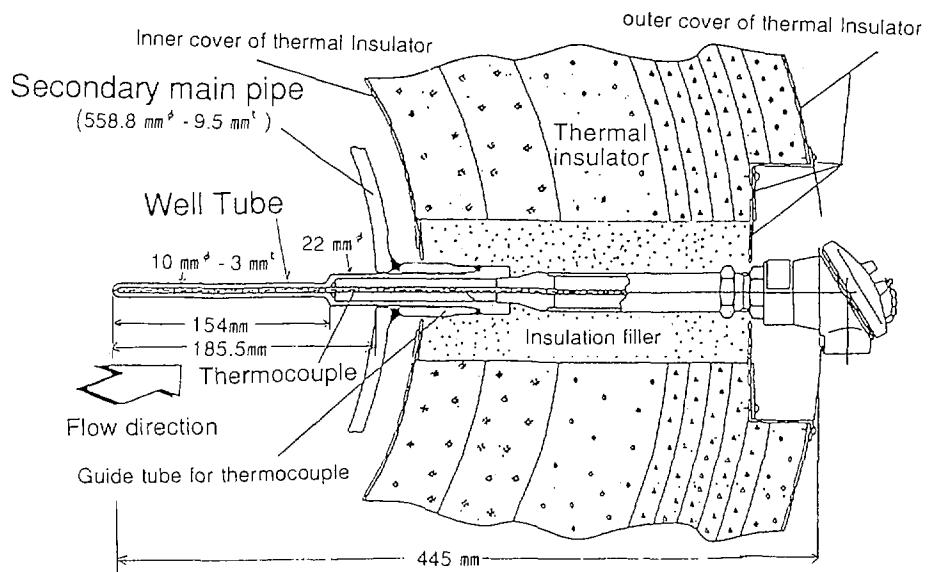
Fig.4 The Thermocouple Well of the Secondary Loop

The thermocouple wires are enclosed in a sheath that is itself housed within the well tube. This well tube extends horizontally toward the center of the pipe. The tip of the well tube (some 15 cm in length) is thinner in diameter than at its root. (Fig.4)

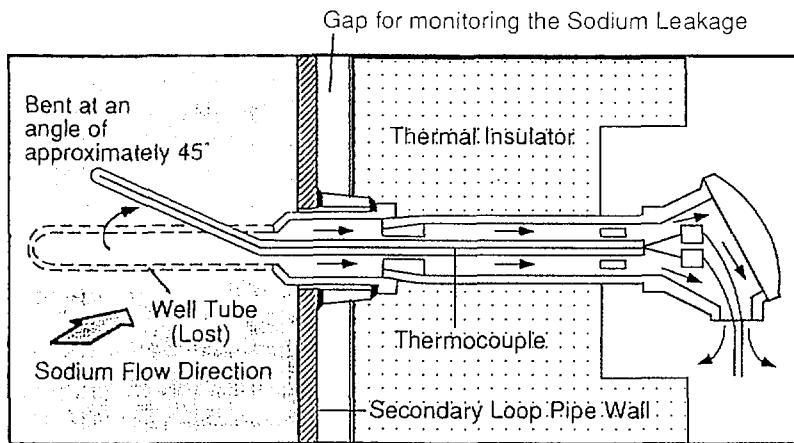
Fig.5 The Sodium Leak Flow Path

around the temperature sensor and to assess its structural condition. It was found that the tip of the well tube had been lost and the thermocouple (3 mm diameter) was bent at an angle of 45 degrees toward the downstream flow direction (Fig.5). The protective body of the thermocouple unit was found to be filled with sodium compounds; but the thermal insulating materials around the thermocouple did not exhibit density shadows typical of the compounds. No other anomalies were observed on the radiographs. These findings confirmed that the failure of the thermocouple well was the direct cause of the sodium leak.

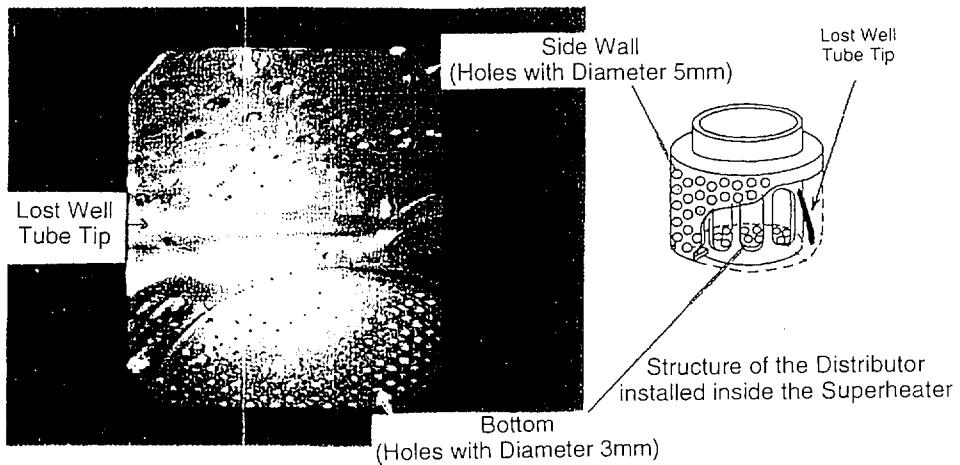
Fig.6 The Lost Well Tube Tip found by CCD Camera in the Distributor inside the Superheater

The search for the lost well tube tip of the thermocouple well began on January 26. Firstly, radiography was carried out along the horizontal pipes downstream of the affected temperature sensor on the secondary main cooling system (hot leg) and the secondary sodium filling-draining system, a total of about 185 m in length, but the well tube tip was not found. On March 28, a CCD camera inserted into the sodium-inlet header of the superheater, showed the lost well tube to be in the distributor at the top of the superheater (Fig.6). The lost well tube tip was recovered using a specially developed gripper on April 24.

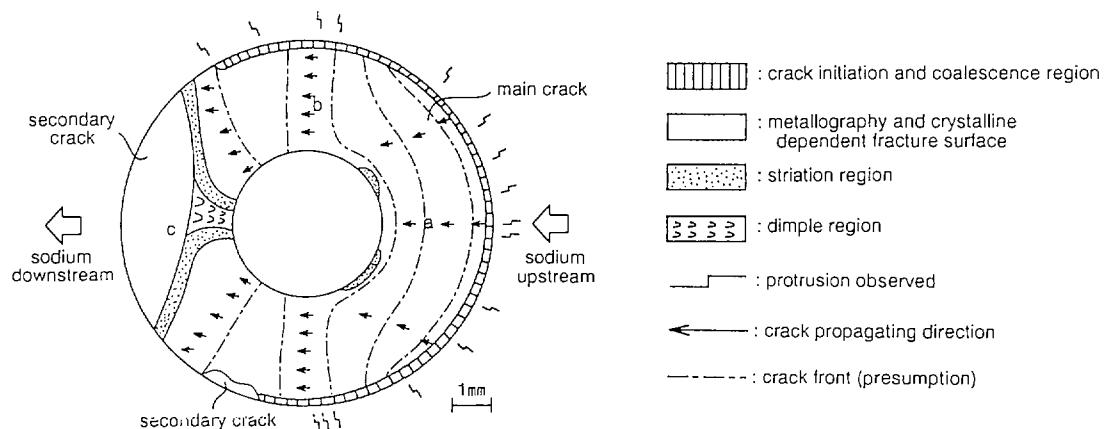
Fig.7 Microscopic Inspection of the Fracture Surface of the Thermocouple Well

Detailed microscopic and metallographical examinations of the well tube and the fractured surface, examination of welded parts of the well, and the thermocouple sheath were carried out at JAERI (from February 13) and the National Research Institute of Metals (NRIM) (from February 16). The results of the microscopic inspection of the fractured surface of the thermocouple well are shown in Fig.7.

Flow induced vibration analysis and mock-up tests have been conducted to identify the direct cause of the failure. On the basis of these investigations, it was concluded that the breakage of the thermocouple well was caused by high cycle fatigue due to flow induced vibration in the direction of sodium flow. The results of the analysis of flow induced vibration are shown in Fig.8, where the stream line oscillations of the well tube were observed with symmetric vortex shedding from both sides of the tube.

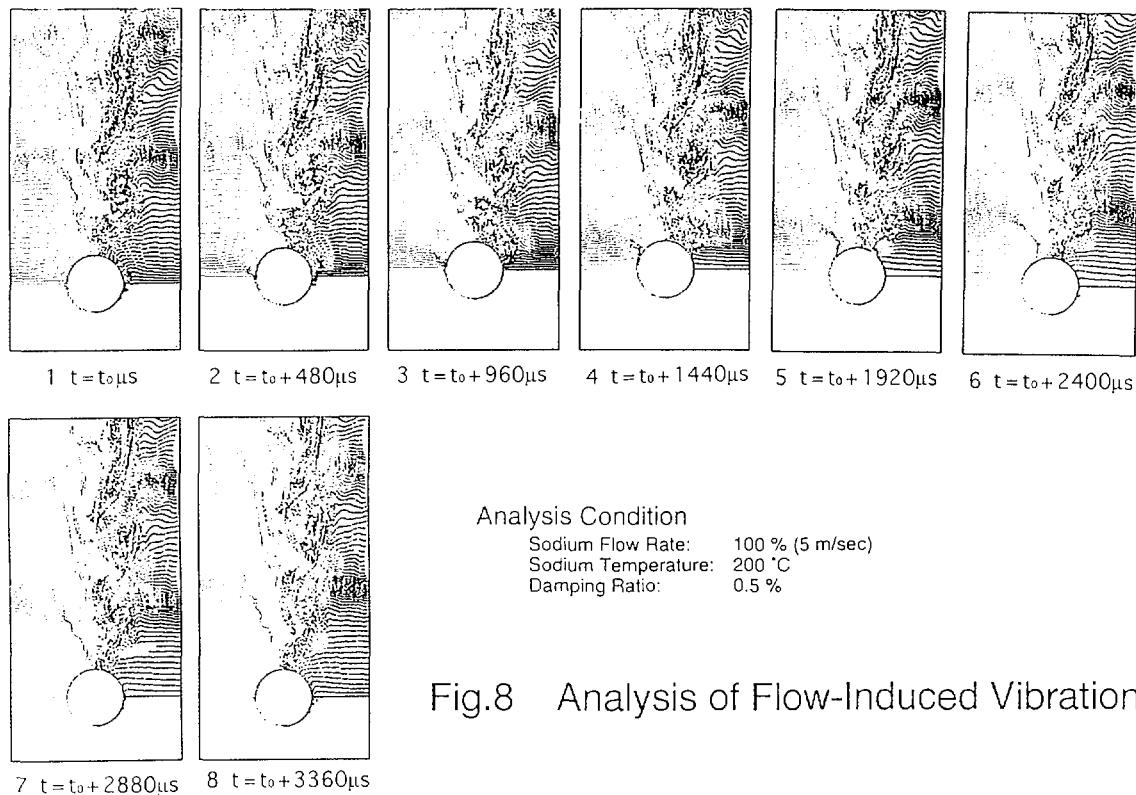
Fig.8 Analysis of Flow-Induced Vibration

According to fatigue crack analysis, on the basis of the operational history, it was deduced that the cracks initiated at an early stage of the 100% flow operation, propagated in the subsequent operation, and finally led to the failure of the well tube in the last period of 40% flow operation. This failure mode agreed with the results of the examination of the rupture surface and a full scale in-water hydraulic vibration experiment.

The problems were in the design of thermocouple well tube. The designers applied the ASME (American Society of Mechanical Engineers) Performance Test Code, PTC 19.3, where the design rules are provided only for the recommended tapered well tube to prevent resonant vibrations of the well tube due to vortex shedding. These were inappropriate for the Monju well tube having a local sharp taper (at an angle of 120 degrees). As a result, the vortex induced vibration in the drag direction could not be prevented. Another point was that PNC and fabricators involved did not take account of the issue of the 1991 addenda to the ASME Boiler and Pressure Vessel Code, Section III, Appendix N, the newly published non-mandatory design rules, which includes the prevention of vortex-induced vibrations in both lift and drag direction. An opportunity to make a re-evaluation of the design of thermocouple well tube in the light of this code revision was.
