An Overview of Stress Corrosion in Nuclear Reactors from the Late 1950s to the 1990s

Spencer H. Bush
Alan D. Chockie

February 1996

STATENS KÄRNKRAFTINSPEKTION
Swedish Nuclear Power Inspectorate

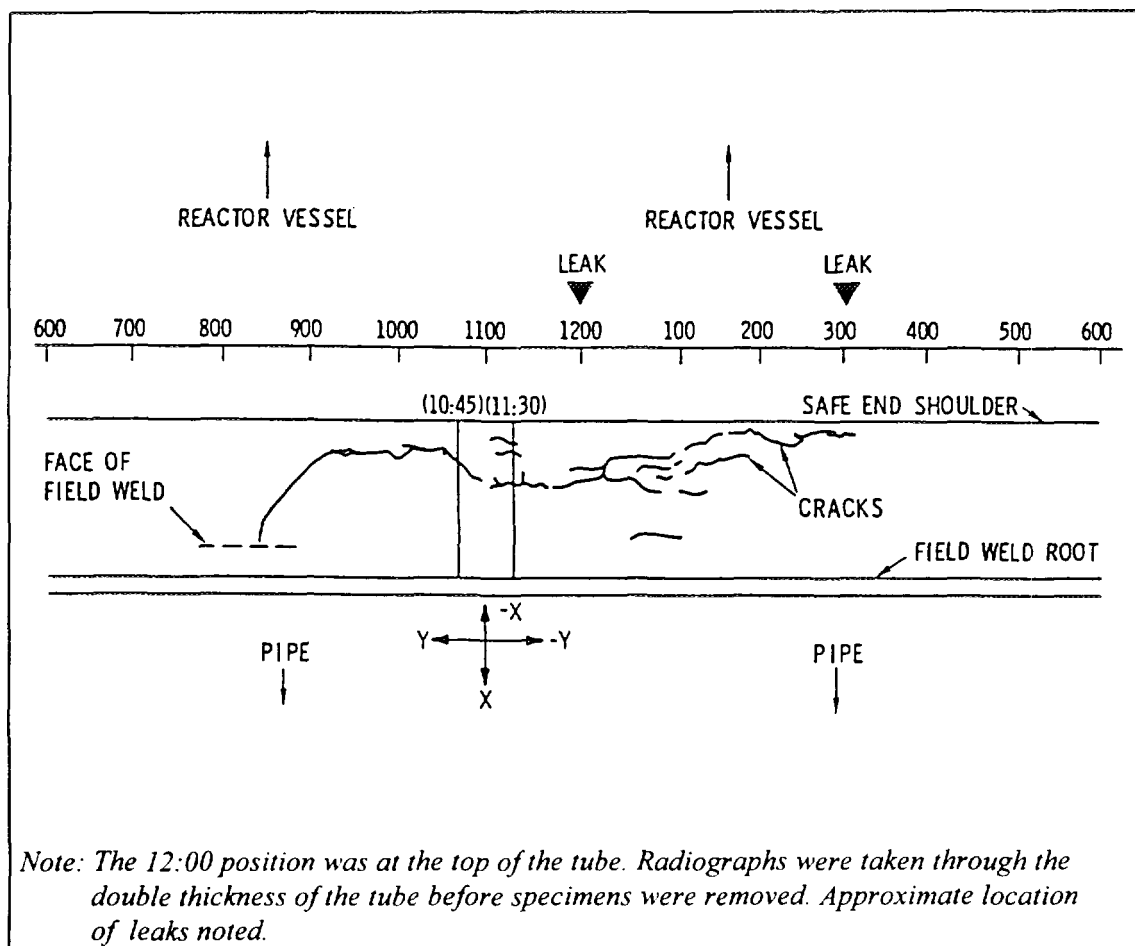
The stress relief temperature of 6200°C (11500°F) led to severe sensitization of the 304 stainless steel. Table 4 presents this phenomenon. As can be seen, 13 reactors representing almost all the older domestic BWRs operating had a total of 244 sensitized safe ends. The calculated failure rate is quite high; however, most sensitized safe ends were removed or weld clad on the inside. Nine Mile Point 1 nearly suffered a double ended guillotine break (DEGB) after three months of commercial operation. A design error placed supports on the 10-inch core spray line without accounting for the change in height of the vessel due to heat-up. As a result very high bending stresses, combined with the severe sensitization, led to extensive cracking. The crack was detected during an outage because of water leaking through the IGSCC cracks. Figures 1 and 2 illustrate the geometry of safe end and crack size, and the micrograph in Figure 3 illustrates a through-wall crack.

Figure 2: Schematic description of radiographic indications from safe end showing location of cracks.

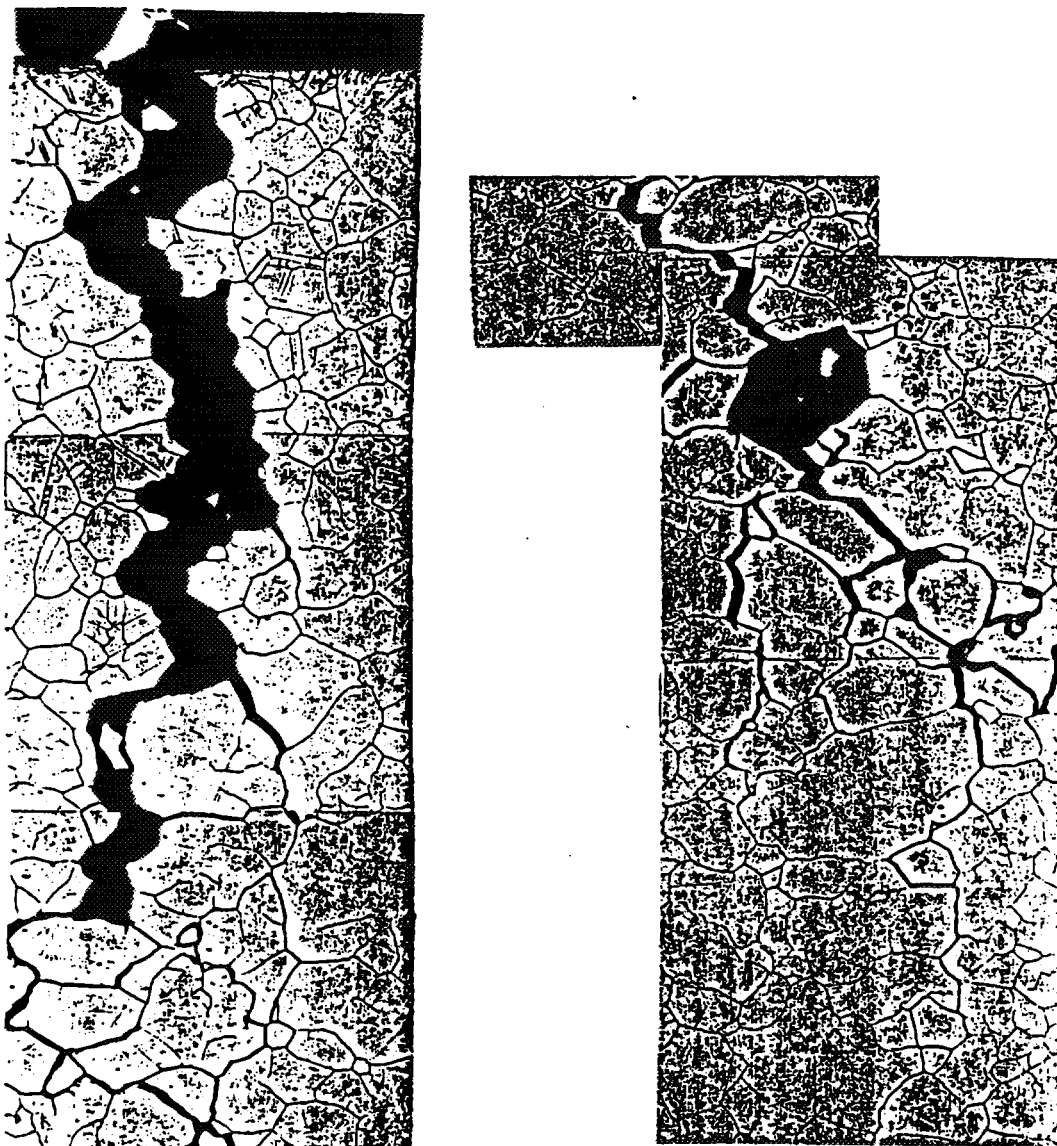
Note: Face being examined is parallel to pipe axis. Left figure is initial portion of crack, right figure is bottom. The bottom of the left figure and top of right are exactly contiguous.

Figure 3: *Optical micrograph of crack starting at inside surface and extending toward the outer surface.*

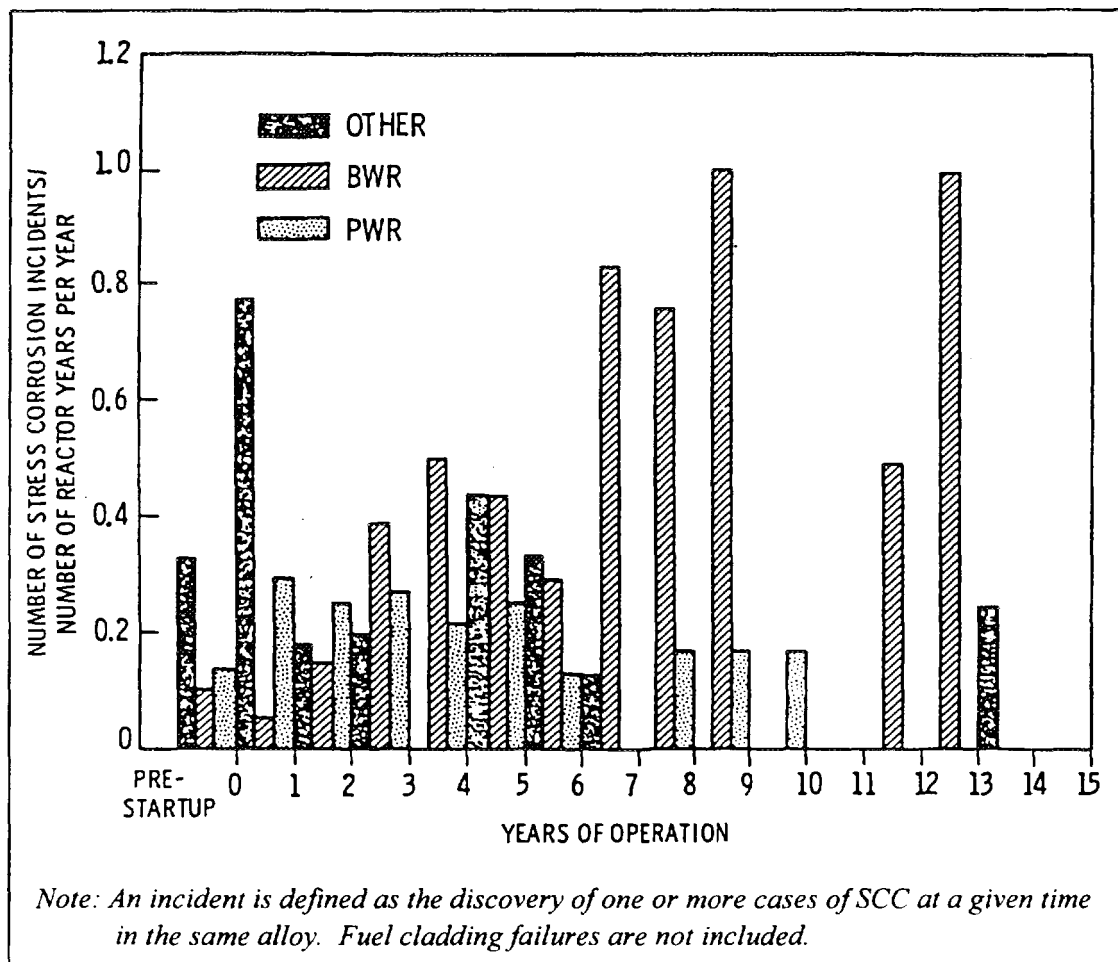
Figure 4: Stress corrosion cracking incidents (limited to US data).

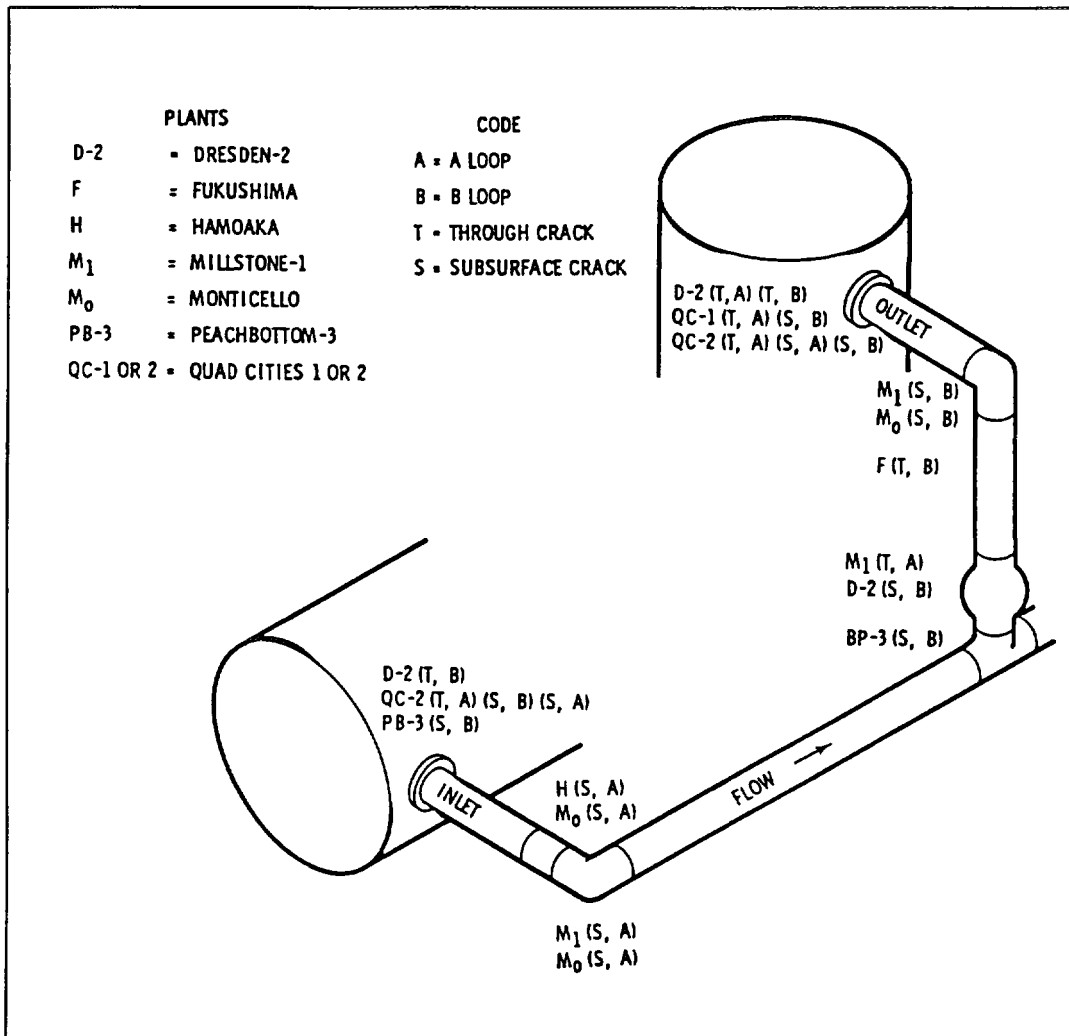
Figure 5: *Record of recirculation bypass cracks.*

Non-flowing or low-flow branch runs of austenitic stainless steel piping are more susceptible to SCC and therefore require more frequent examination than those pipes where the coolant continuously flows during the plant operation.

- Investigate revision of operating procedures to improve flushing of non-flow or low-flow branch lines in order to minimize any potential for oxygen concentration.
- Eliminate, where feasible, non-flow conditions in branch lines by operating with shutoff valves in open mode (e.g., valve in by-pass lines).

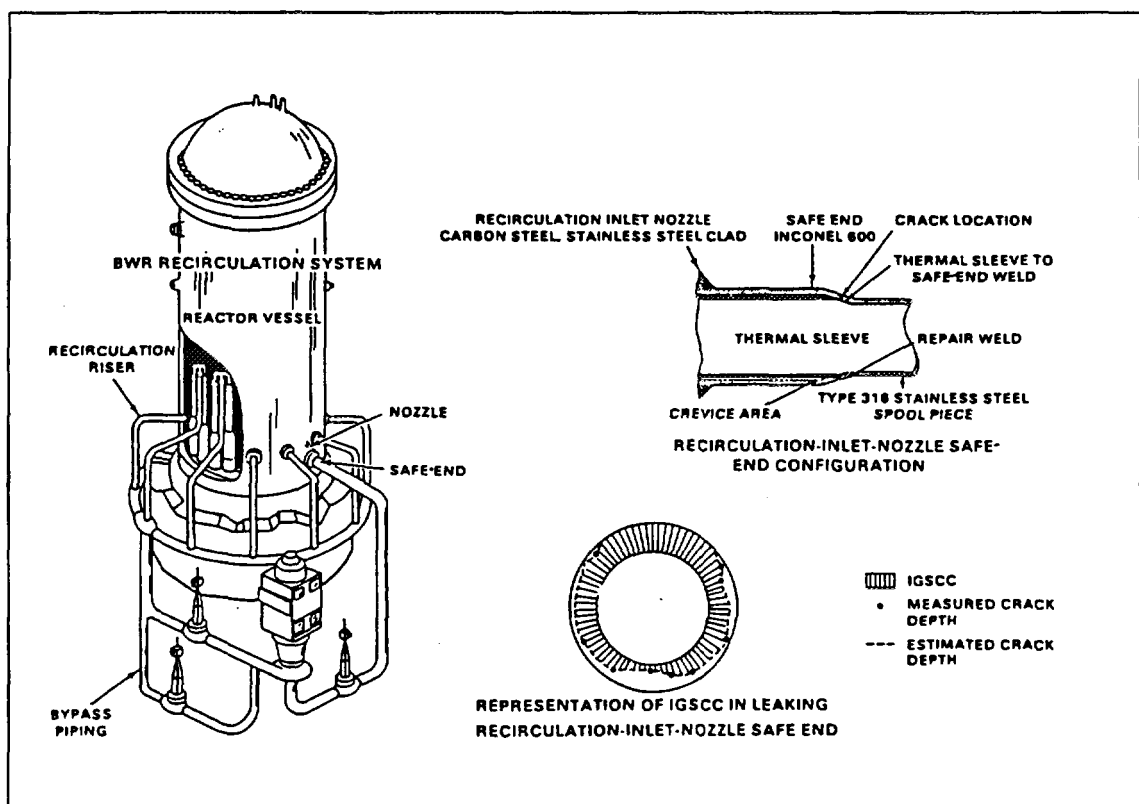
The significance of cracking in the Inconel-600 safe ends at Duane Arnold merits an in-depth review. The cracking could be classified as a near miss double-ended pipe break for one or more of the safe ends. Figure 6 illustrates a typical BWR recirculation system, i.e., the configuration of the Duane Arnold Recirculation-Inlet Nozzle Safe End including location of a repair weld and a representation of IGSCC in the leaking recirculation inlet-nozzle safe end. The nozzle is approximately 10 inches in diameter. The repair weld occurred because of an error in the fabrication drawing that resulted in the machining of a groove in the outer surface of all eight safe ends. Repair consisted of filling with weld metal. Since the safe ends were attached to the vessel nozzles prior to stress relief, they underwent two $1100 \pm 25^\circ\text{F}$ ($595 \pm 15^\circ\text{C}$) stress relief treatments. Note the thermal sleeve that was installed to direct coolant flow into the vessel. It also resulted in a long, narrow crevice ending at the tip of the attachment weld. This crevice led to a stagnant chemical environment conducive to IGSCC. A severe resin spill produced an acid sulfate that was trapped in the crevice as confirmed by the presence of sulfur and low pH.

A combination of the chemical environment, oxygen, high residual and operating stresses, and sensitization led to severe IGSCC. Figure 6 represents the one leaking

safe end. Note the 360° circumferential crack that is through-wall in one section and 50-75% through-wall over most of the remaining circumference. While Figure 6 illustrates the leaker, the other seven safe ends were cracked almost completely around the circumference. Duane Arnold and Nine Mile Point represent the two cases of SCC in nuclear power plants that could have led to a DEGB. Therefore, the lesson learned is to avoid crevices (probably by not installing thermal sleeves) and conduct inservice inspection (ISI) in conformance with NUREG-0313.

Figure 6: *Example of severe intergranular stress corrosion cracking in Inconel-600 safe end.*
