Kvitebjørn gas pipeline repair – UTC-Bergen 22-23 Sept 2010

Erling Gjertveit,
Senior Advisor Pipeline technology
Statoil ASA

Kvitebjørn gas pipeline damage

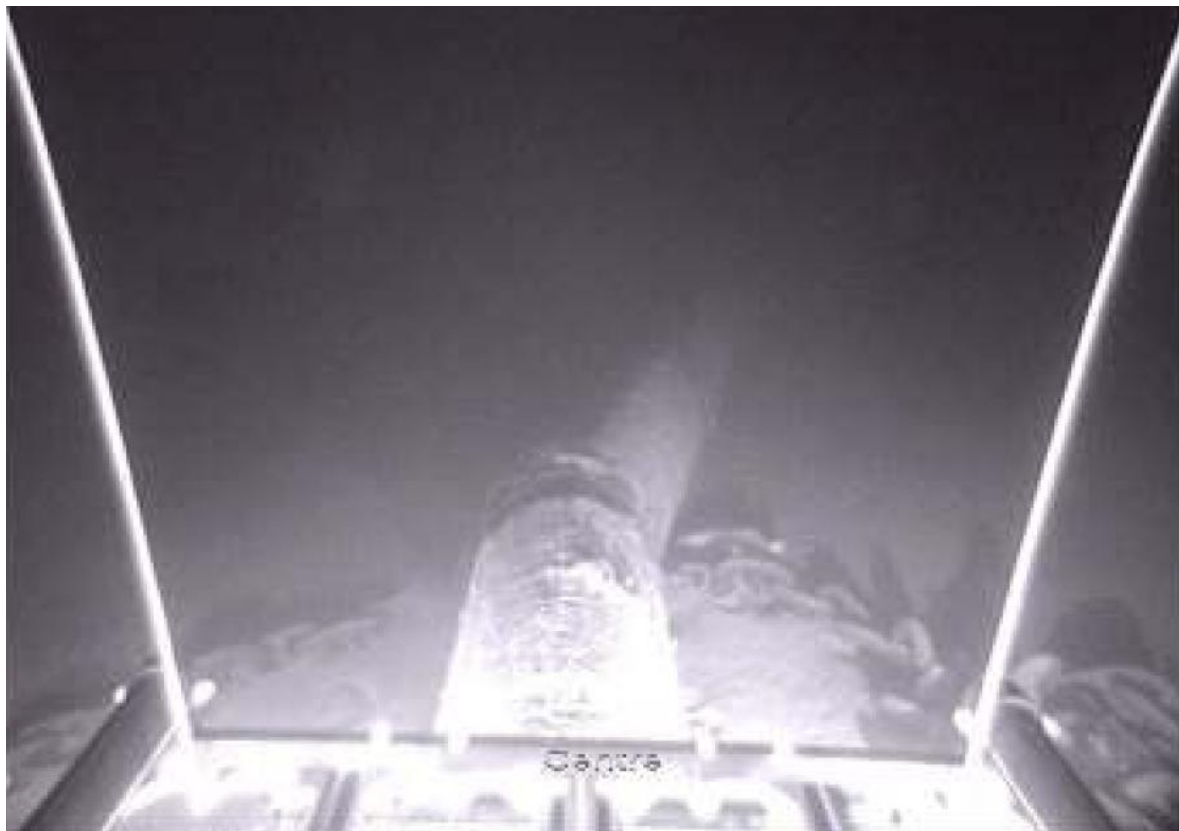
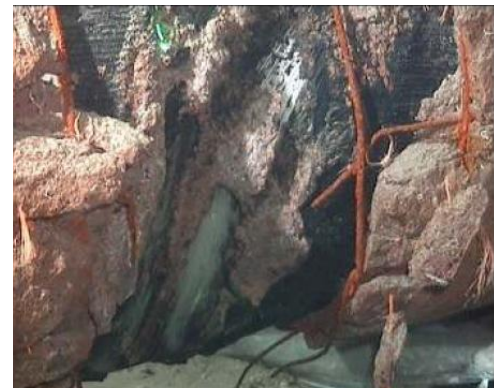
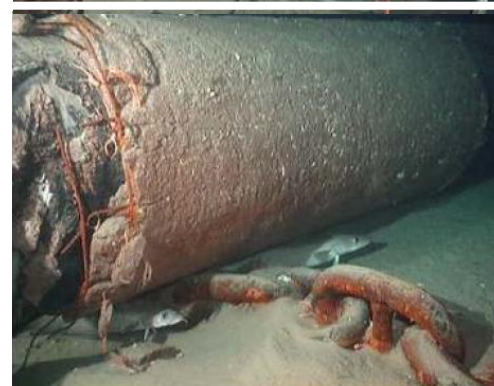
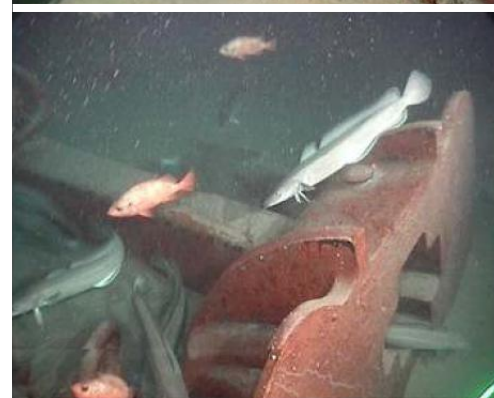
Damage survey 1. November 2007

Kvitebjørn pipeline damage

Purpose of the damage survey:

- exact measurements of the external geometry (ovality and deformations)
- detect and measure possible cracks
