OPERATION CASTLE

Project 3.5 *107*

BLAST EFFECTS ON MISCELLANEOUS STRUCTURES

REPORT TO THE SCIENTIFIC DIRECTOR

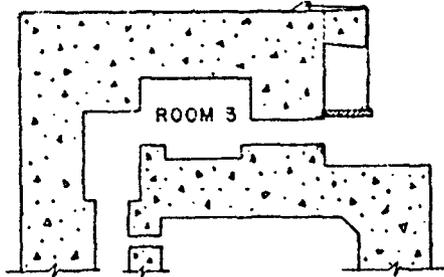
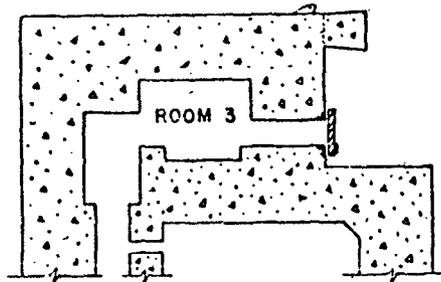
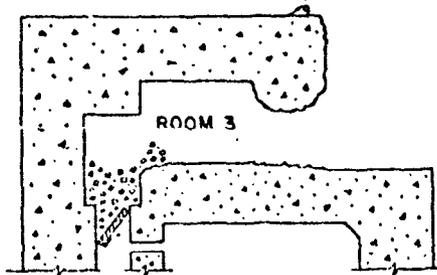
Fig. 3.42 Position of Shutter Door, Station 1341, Able Island,
7500 ft from GZ

Due to the failure of the wall supporting the shutter door, the blast wave entered the building. The shutter door was hurled inward and dropped part way down the chimney, lodging in a position No. 3 as shown in Fig. 3.42. The forces from the blast also broke the latches and hinges from three other doors, namely, the lead door entering the equipment room on the first floor, the light weight steel door between rooms No. 1 and No. 4 on the first floor, and the main personnel door on the second floor. This door is shown in Fig. 3.45. The following doors did not fail: two exterior lead doors on the side of room No. 4, and three steel doors on the outside of the back wall of the equipment room.
