JOINT TASK FORCE SEVEN
TASK GROUP 7.3
APO 187, c/o Postmaster
San Francisco, California

22 March 1954

From: Commander, Task Group 7.3
To: Chief of Naval Operations
Via: (1) Commander Joint Task Force SEVEN.
(2) Commander in Chief, U.S. Pacific Fleet

Subj: Radioactive Contamination of Ships and Radiological Exposure of Personnel of Task Group 7.3 due to BRAVO, the First Nuclear Explosion of CASTLE

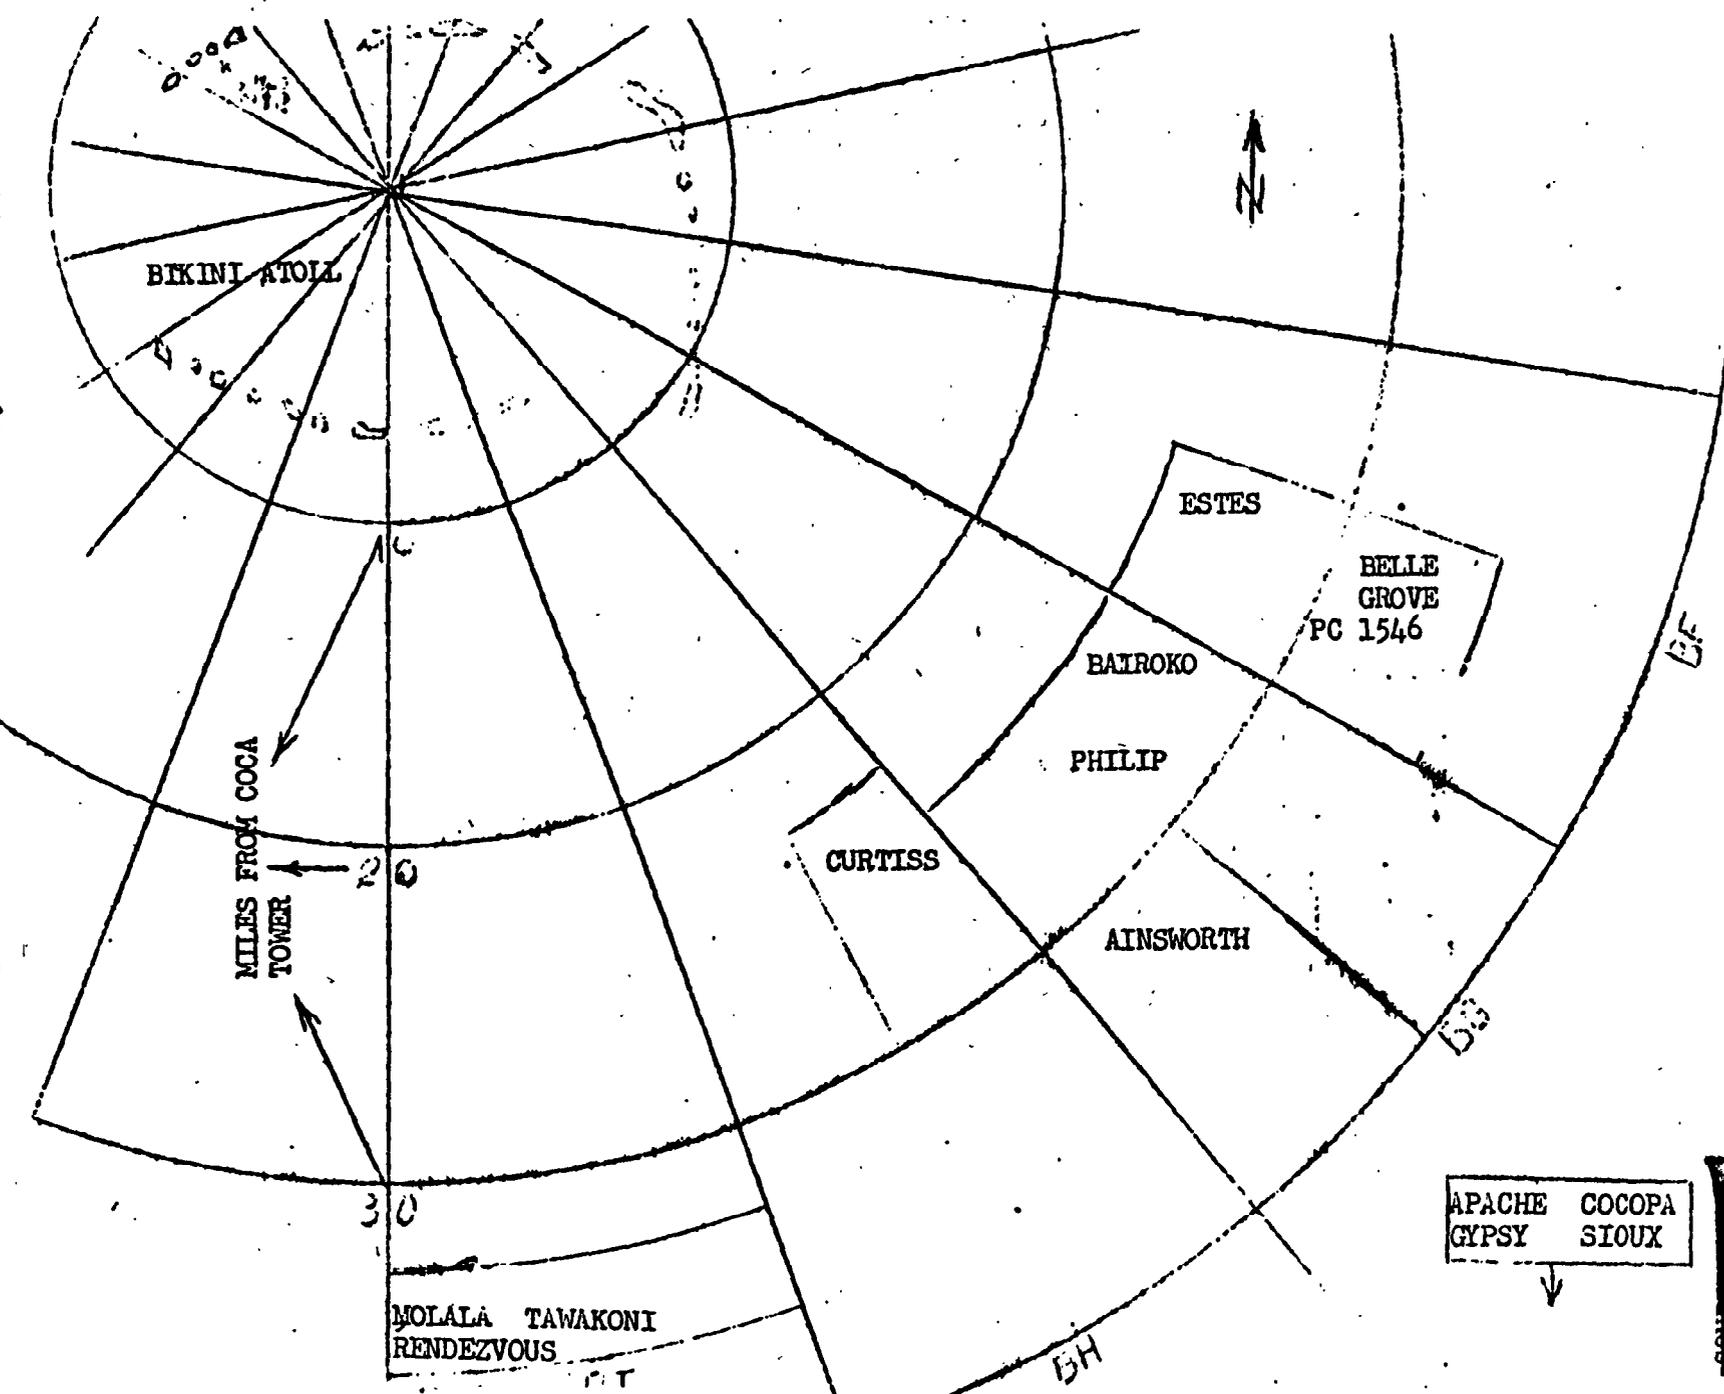
Positions of TG 7.3 ships from BRAVO Hour until about 0815, 1 March 1954

1. On 1 March 1954, at 0645M, the first nuclear explosion (BRAVO) of Operation CASTLE was detonated. Prior to the detonation, ships of Task Group 7.3 had been deployed at sea generally in the southeast quadrant from ground zero as indicated in enclosure (1). This disposition and its location were based on four principal factors, (a) the latest CJTF SEVEN radex, (b) the requirements of the Commander Scientific Task Group (CTG 7.1) that ESTES (AGC 12) and CURTISS (AV 4) be positioned about 12 miles from ENYU Island for reliable UHF communications and Raydist purposes, (c) the requirement that ships be disposed at safe distances (at least 30 miles) from ground zero to avoid harmful heat, and blast effects, and (d) the requirement of reasonable concentration for communications and control purposes. Prior to the detonation and because later wind data began to indicate an easterly component, some of the smaller and slower units were directed to move to the south, but the larger ships were retained in the localities indicated in view of the foregoing requirements (b) and (d) and the expressed desire of the JTF Commander that they not be moved. Because of the additional requirements for early helicopter survey trips and the early dispatch by helicopter of an emergency airfield crew for the airfield on ENINMAN Island, the large ships were retained generally in their pre-shot positions after the detonation until about 0800M, when sudden and rapidly increasing radioactive fallout was detected on some ships. At this time, all ships were ordered to take all possible radiological defense damage control measures, including the employment of washdown systems, and to proceed to the south at best speed.
