File No: W-30, 3-2
 I-No: 17367
 Date Completed: 2-20-61

Re: Climatic Tests of a W-30 With a Dow 17 Primer

Summary of Test

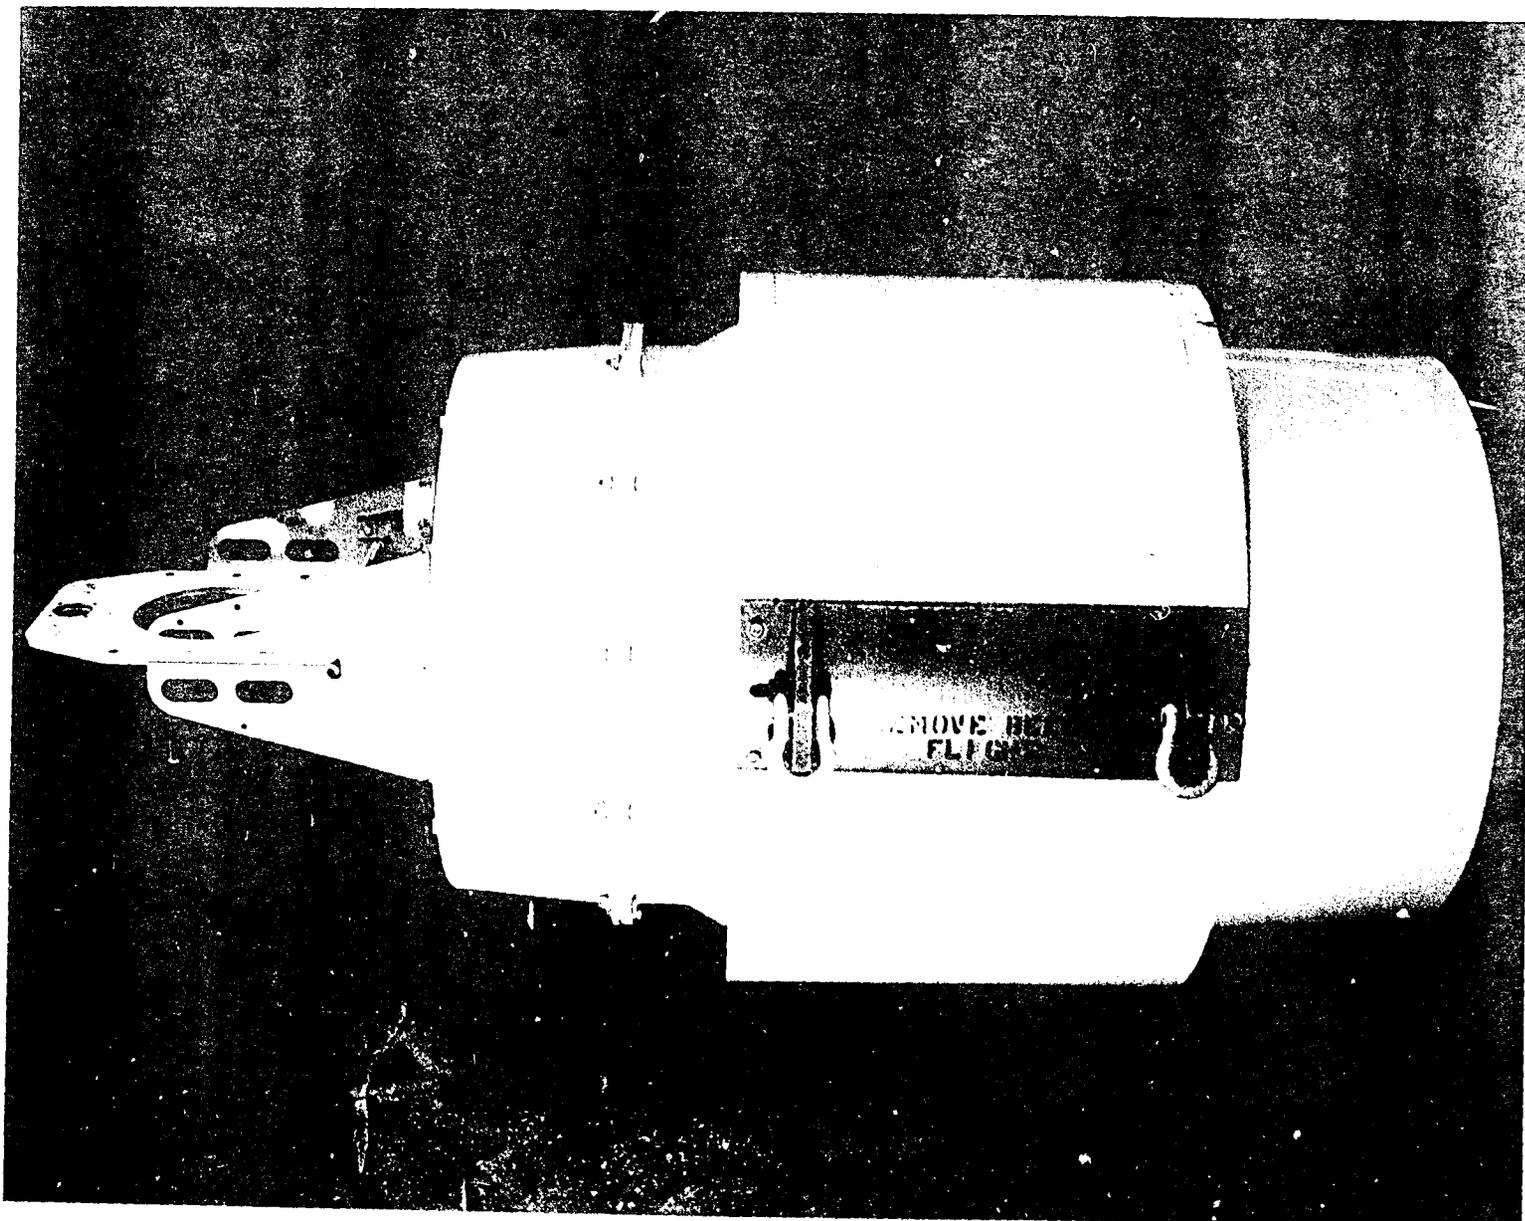
Figures 1, 2, and 3 are photographs taken after the 20 day humidity test. The finish sustained little degradation during the complete series of environmental tests and appeared to be highly satisfactory.

FIGURE 1 - 30 AFTER HUMIDITY TEST

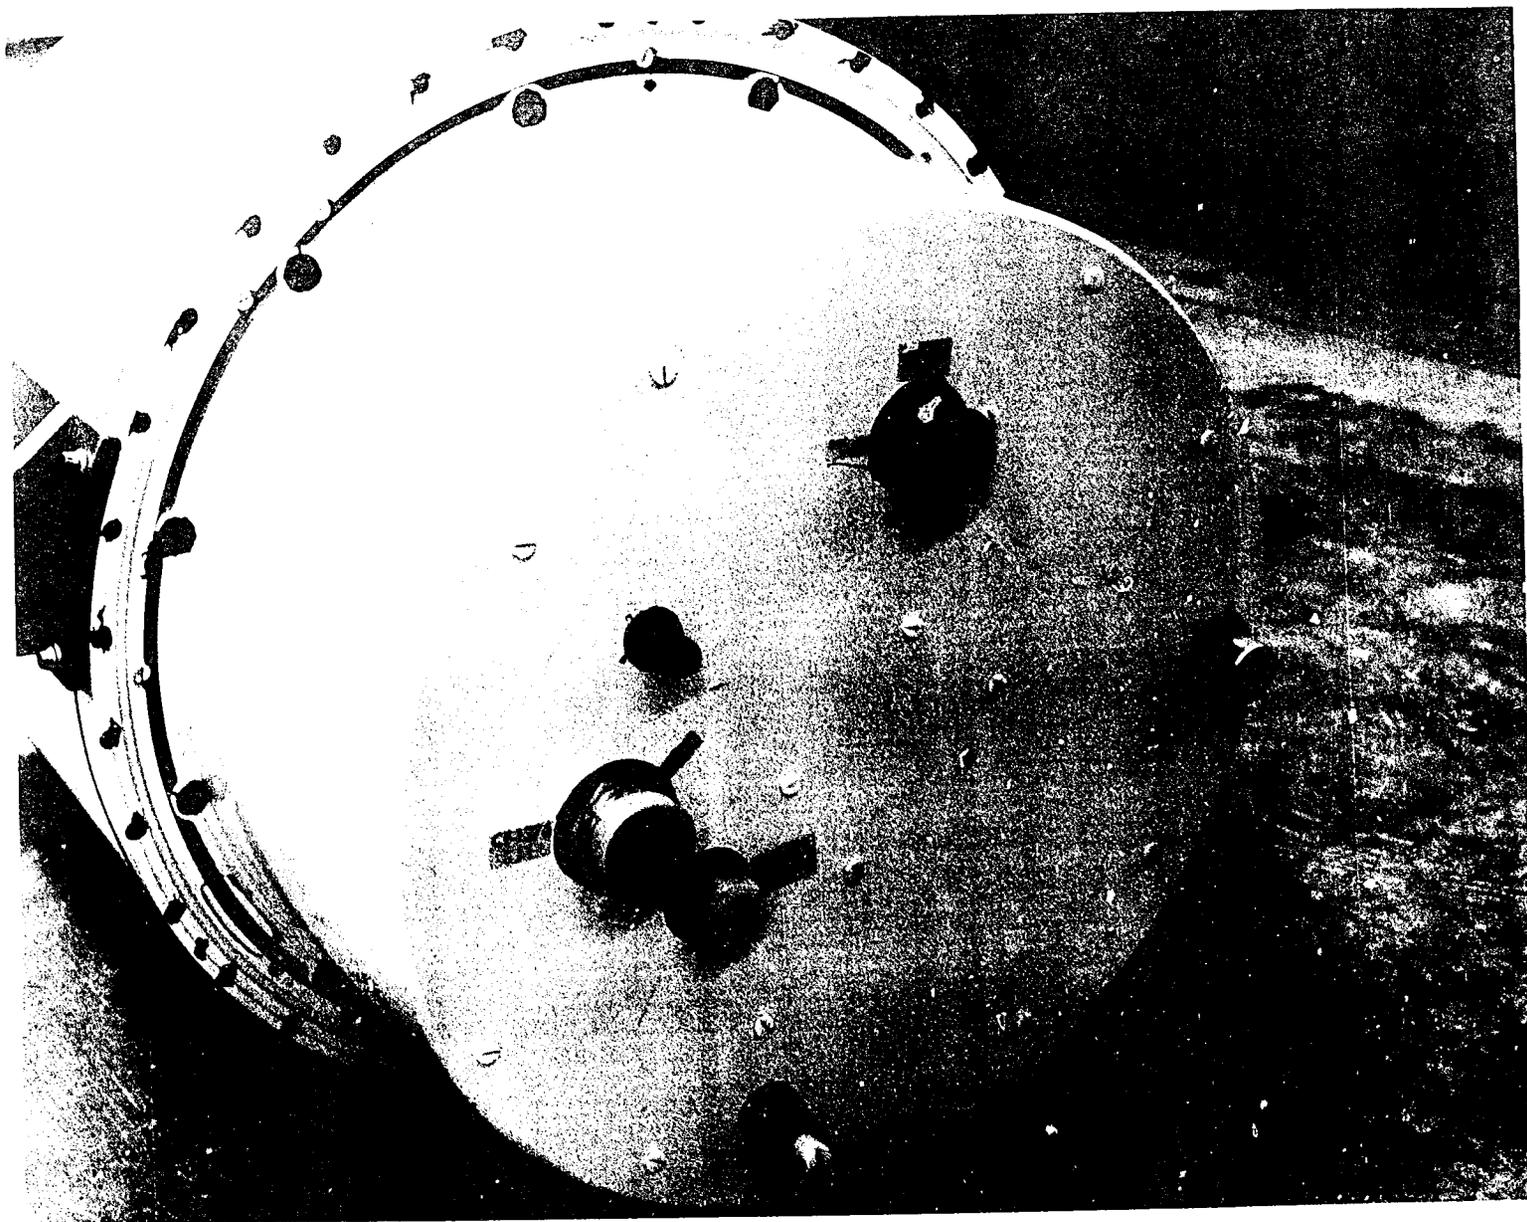
DI-2070
FIGURE 2 - W 30 AFTER HUMIDITY TEST

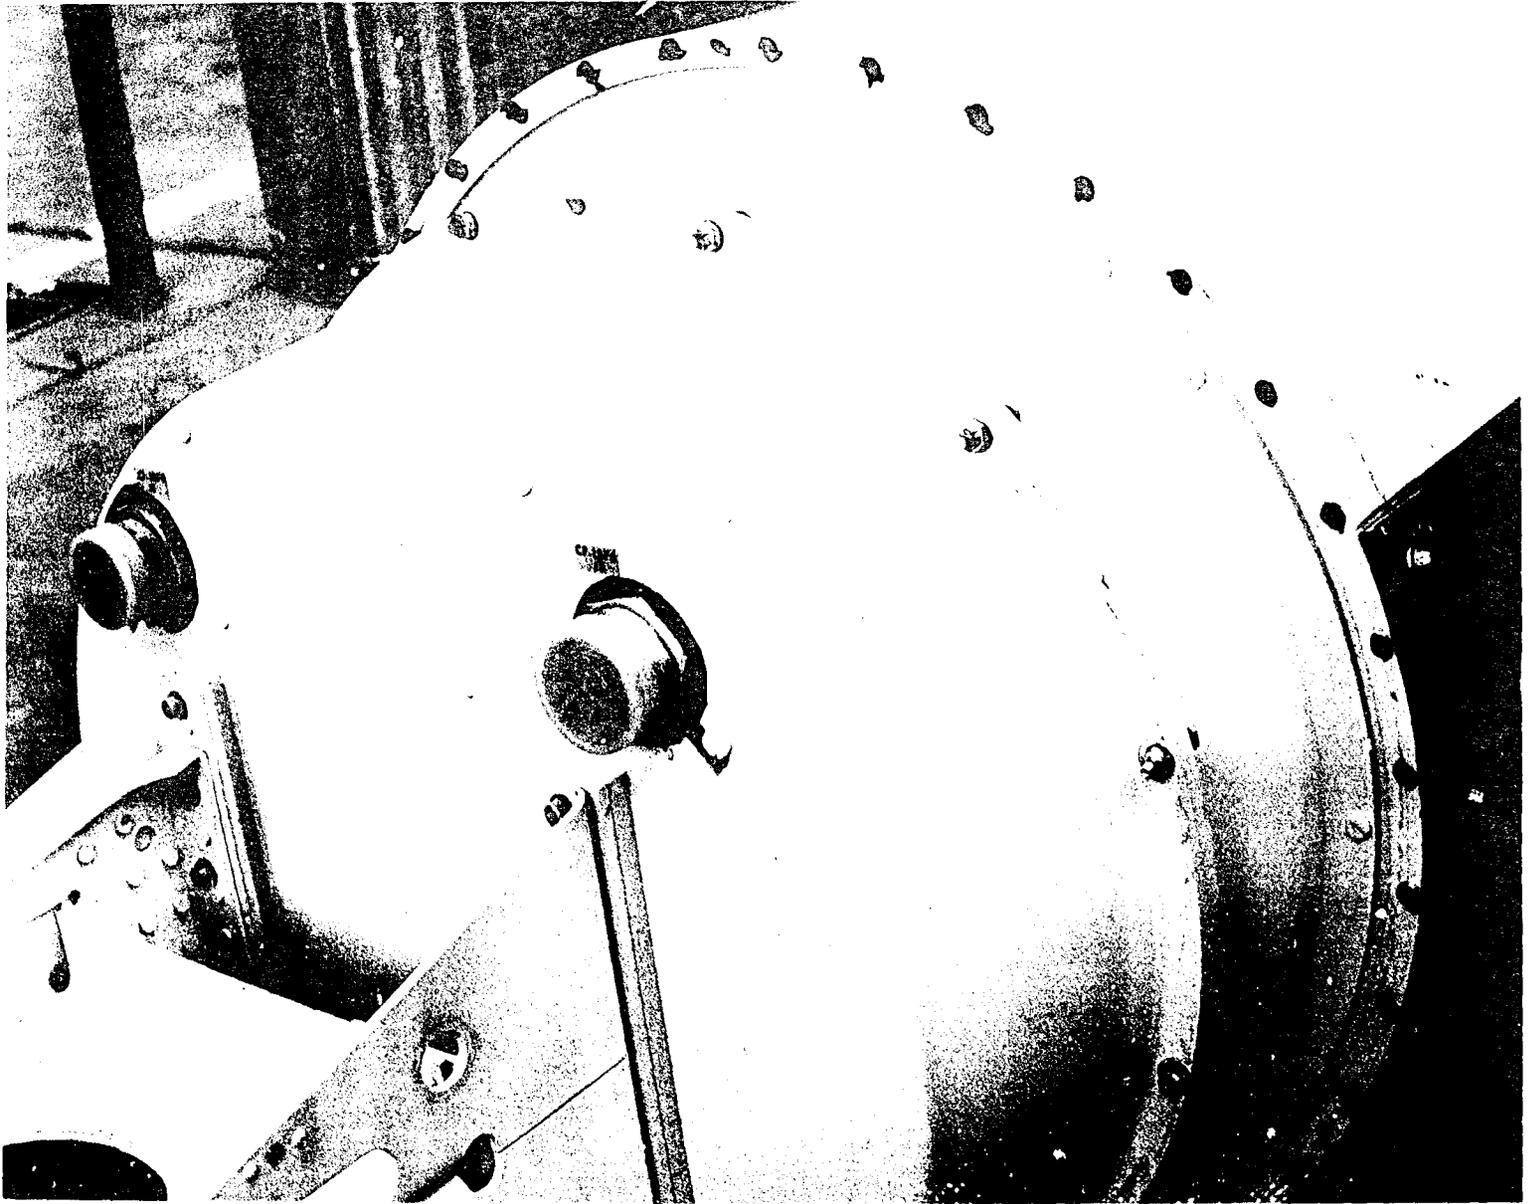
FIGURE 3 - 30 AFTER HUMIDITY TEST
