XW-49, 3-2
 Project No. T-16708
 Case No. 784.10
 Ref. Sym: 1613(130)

Re: Rain and Salt Spray Test of MK-3/XW-49-X1, Unit "B"

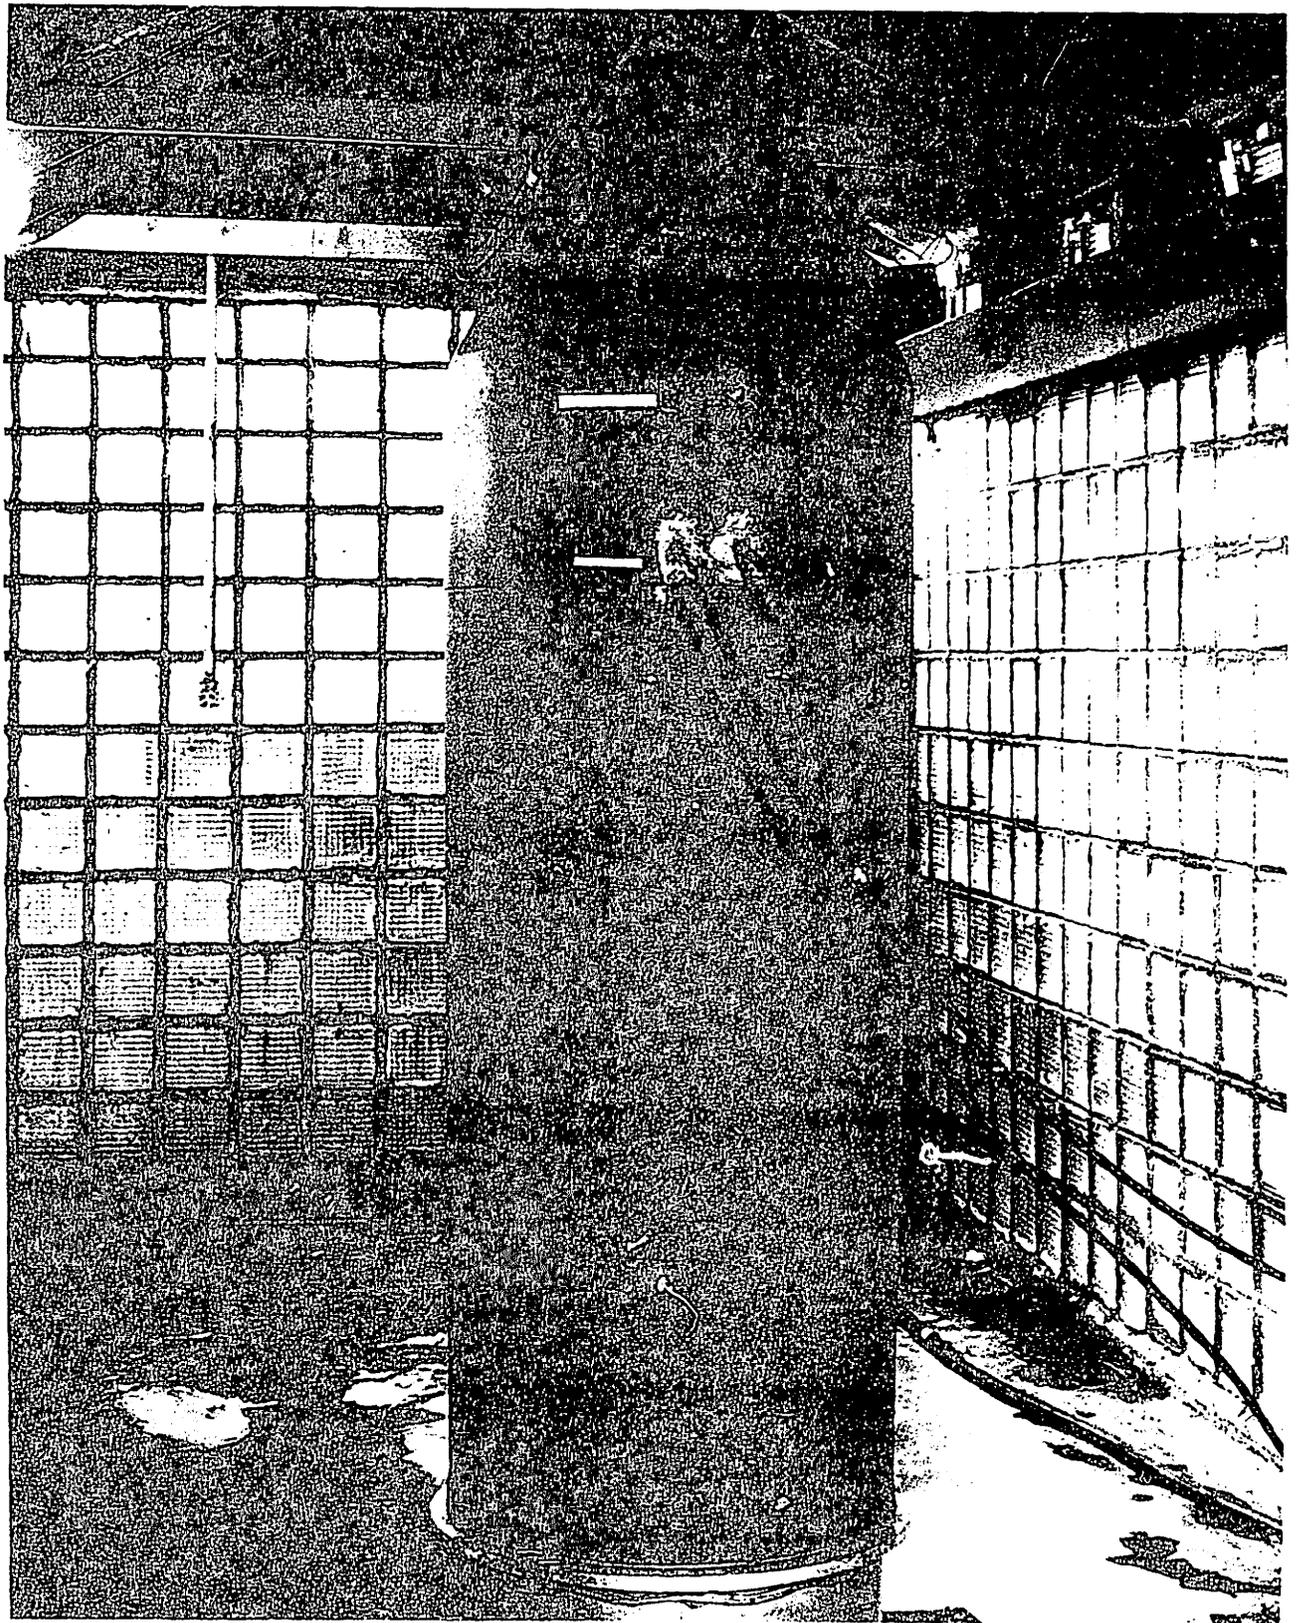
The re-entry vehicle, complete except for its flared skirt, was placed in a vertical position within the rain chamber (Fig. 1). A simulated skirt was used to support the unit, since vertical clearance within the chamber was inadequate to accommodate the complete re-entry vehicle.

FIGURE 1 - MK-3 RE-ENTRY VEHICLE/ XW-49-X1 UNIT "B" IN THE RAIN CHAMBER FOR RAIN AND SALT SPRAY TESTS
