MR. L. A. DUNN - 1284

Ref. Symbol: 1611
Project No. ET-886Results

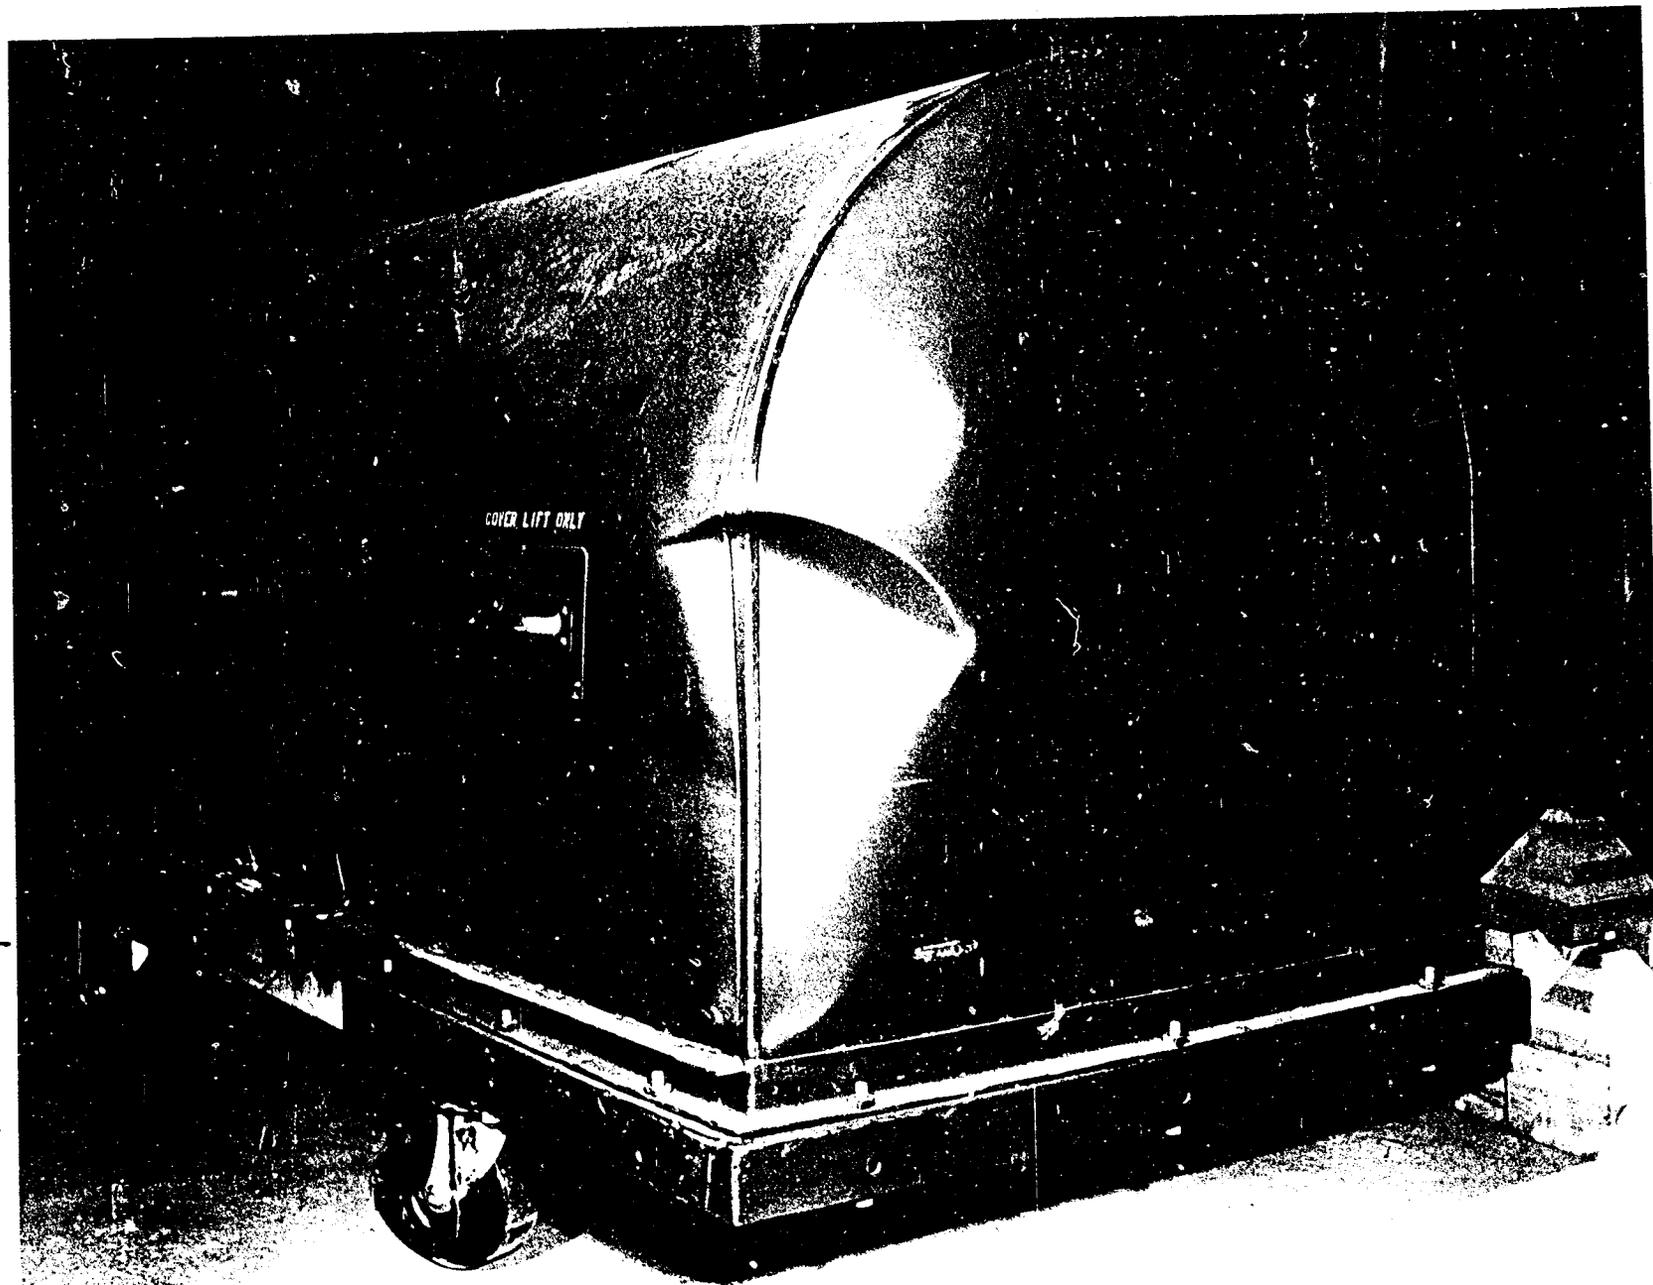
When one psi gauge of air pressure was applied internally to the container, the rear face bowed and air leaked audibly from around the gasket. A second container was then supplied. This container buckled at two diagonally opposite corners when the internal pressure reached 4.1 psi gauge (Fig. 1). However, because the container did not seem to leak around the buckled places, three runs of pressure versus time were made, with an initial pressure of 3 psi gauge. The soap-bubble tests failed to reveal any leaks, but a final check using Freon 12 gas and the General Electric Freon detector revealed numerous leaks. These leaks were not around the gasket but at the spot welds which hold the wheel plates and the angle-iron reinforcements. These leaks were of the order of 4 cc of Hg per hour.

FIG 1 - DAMAGE RESULTING FROM PRESSURE TEST
