Re: Ramp Test of H-194 Containing FSI-1

Summary of Results

Project No. TM-448

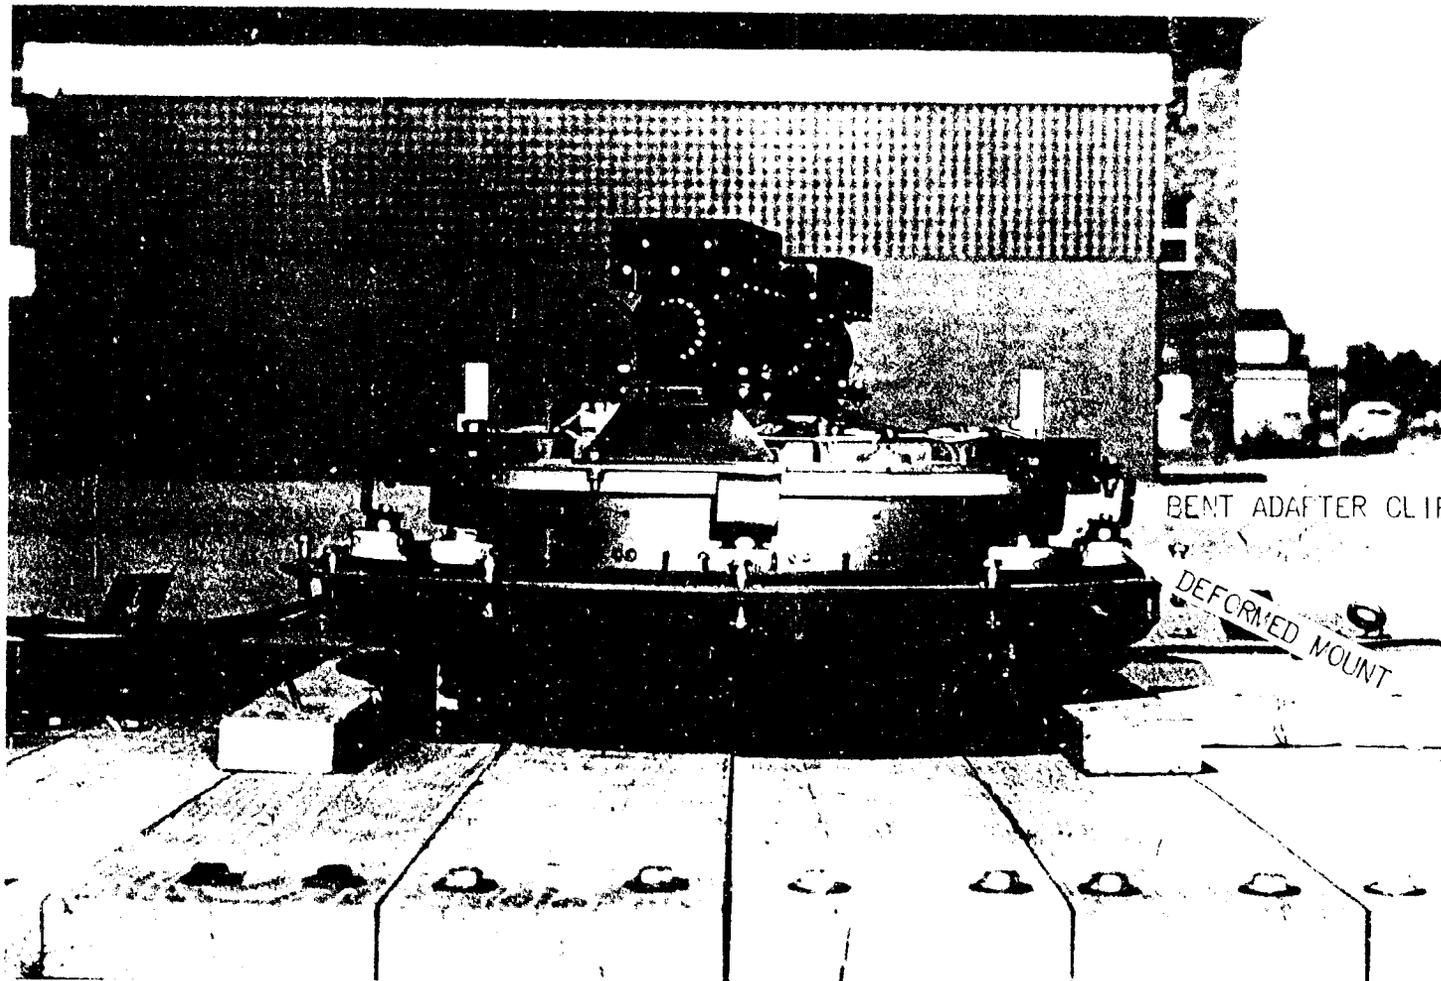
FIG. 3 -- FSI-1 DAMAGED FROM IMPACT -- RAMF TEST OF H-194 CONTAINING FSI-1

By changing to rubber bumpers, a total velocity change of 12.46 mph on the ramp dolly was effected by an 8.94 mph impact velocity. This impact produced considerable bending of the adapter clips and the flanges of the X-unit (Figs. 3, 4, and 5). Bending of the front of the X-unit from contact with the container was increased (Fig. 6). The Met-L-Flex mounts were permanently deformed (Fig. 7). Figure 8 shows typical load-deflection curves of new unused mounts compared to those of mounts that were tested on the engineering test ramp.

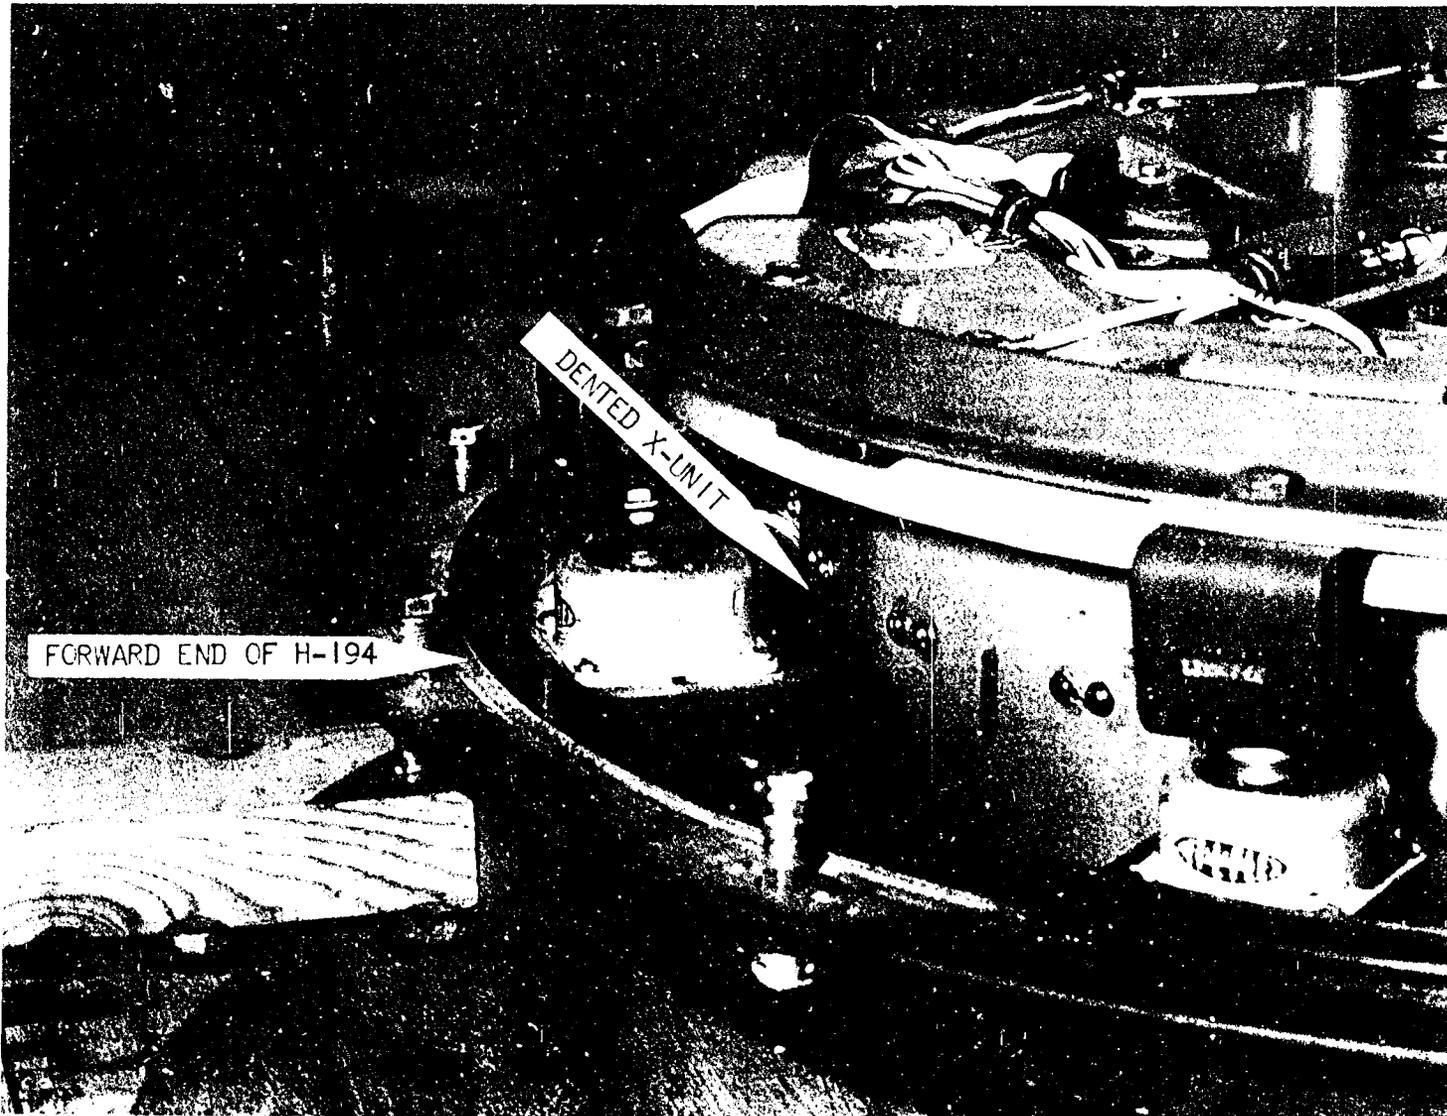
FIG. 6 -- X-UNIT DENTED FROM CONTACT WITH THE H-194 -- RAMP TEST OF H-194 CONTAINING FSI-1

the forward adapter clip, and the front of the X-unit was slightly dented from contact with the H-194 container. No further noticeable damage resulted from increasing the impact velocity to 9.65 mph (15.1 mph velocity change), using wood bumpers.

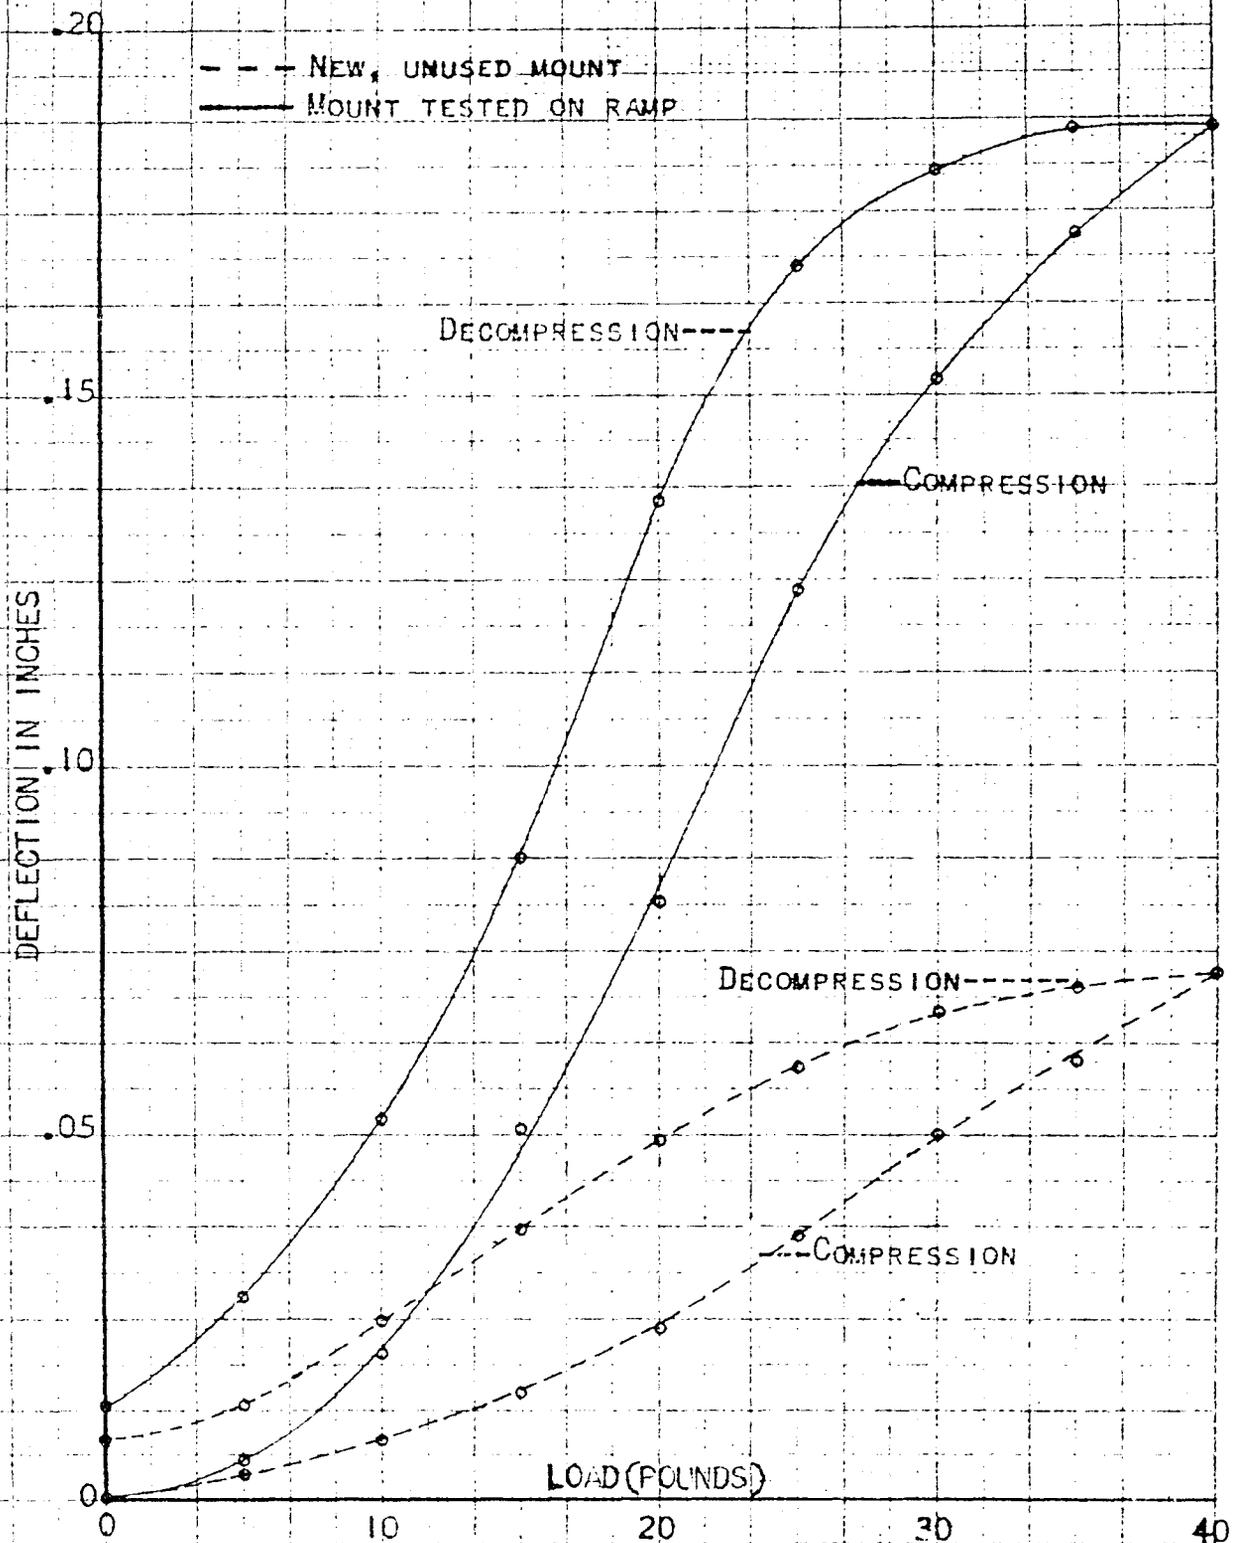
FIG. 8 LOAD-DEFLECTION CURVES FOR ROBINSON MET-L-FLEX MOUNTS NO. 1202-4A---RAMP TEST OF H-194 CONTAINING FSI-1

After completion of the test, a compression vs. deflection test was performed on several damaged Met-L-Flex shock mounts, and comparison made with new mounts.
