# Effect of Hurricane Andrew on the Turkey Point Nuclear Generating Station from August 20-30, 1992

Jointly sponsored by the Institute of Nuclear Power Operations and the  
U.S. Nuclear Regulatory Commission

March 1993

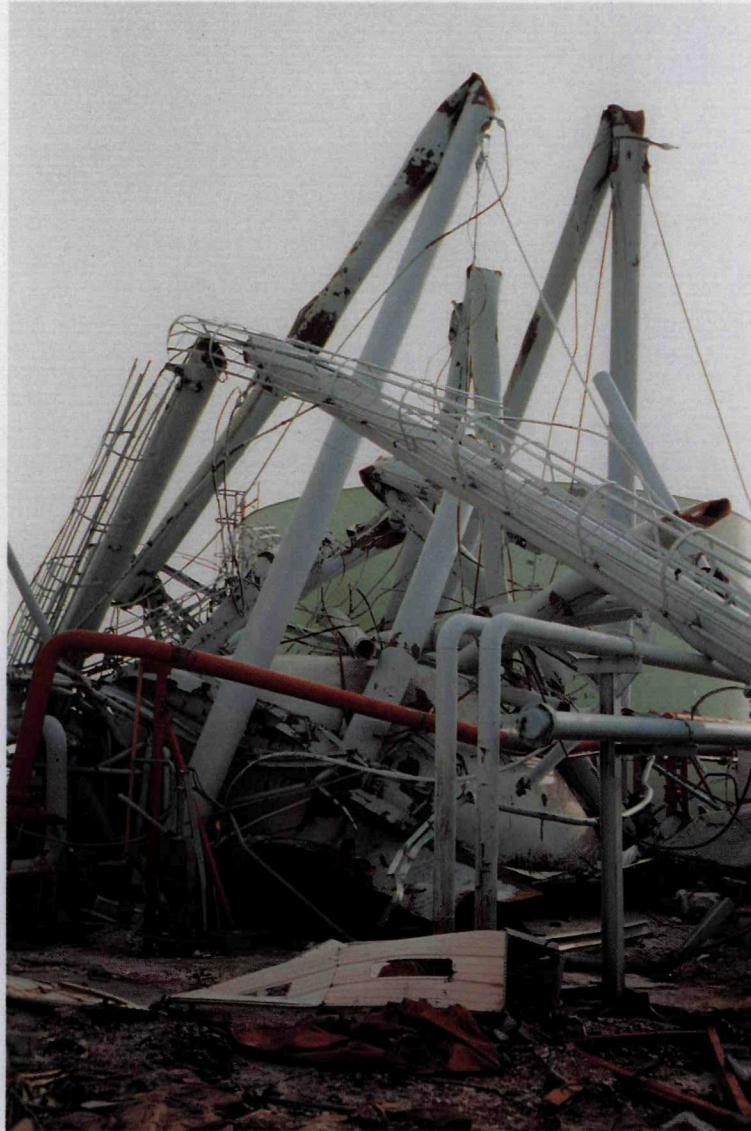
Figure 3.2 Water Tower

One of the earliest and most significant findings of the teams sent to survey the damage to the remainder of the site was that the fire water system had been damaged and was inoperable (see Figure 3.2). Several teams were immediately assigned to establish an emergency fire water system.

There are three probable causes for the failure of the high water tank: hurricane winds, a tornado, or a wind-generated missile. The most likely cause of the failure was a wind-generated missile. A missile probably impacted one or more compression struts or tension rods, causing them to fail. This caused the tank support columns to fail, which caused the tank to collapse.

When the high water tower fell, it impacted raw water tank number 1 and caused it to fail. The tower also tore a feeder header for the main water line from raw water tank number 2. This caused raw water tank number 2 to drain. The fire protection electric pump was damaged beyond repair, and the fire pump controller was damaged, rendering the diesel-powered pump inoperable. The two jockey pumps that continuously pressurize the header were also damaged and could not function. These failures caused the fire suppression system to be declared inoperable. This condition and the overall level of damage prompted an Alert to be declared at 9:16 a.m., August 24. At 3:56 p.m., after establishing communications, the utility notified the offsite agencies that an Alert had been declared. Because of the inability to staff continuous fire watches in selected areas after the Alert declaration, continuous roving watches were used.

A special team was formed to temporarily repair the system. The pumps that were staged before the storm for dewatering were used as portable fire pumps, providing an emergency fire water system.

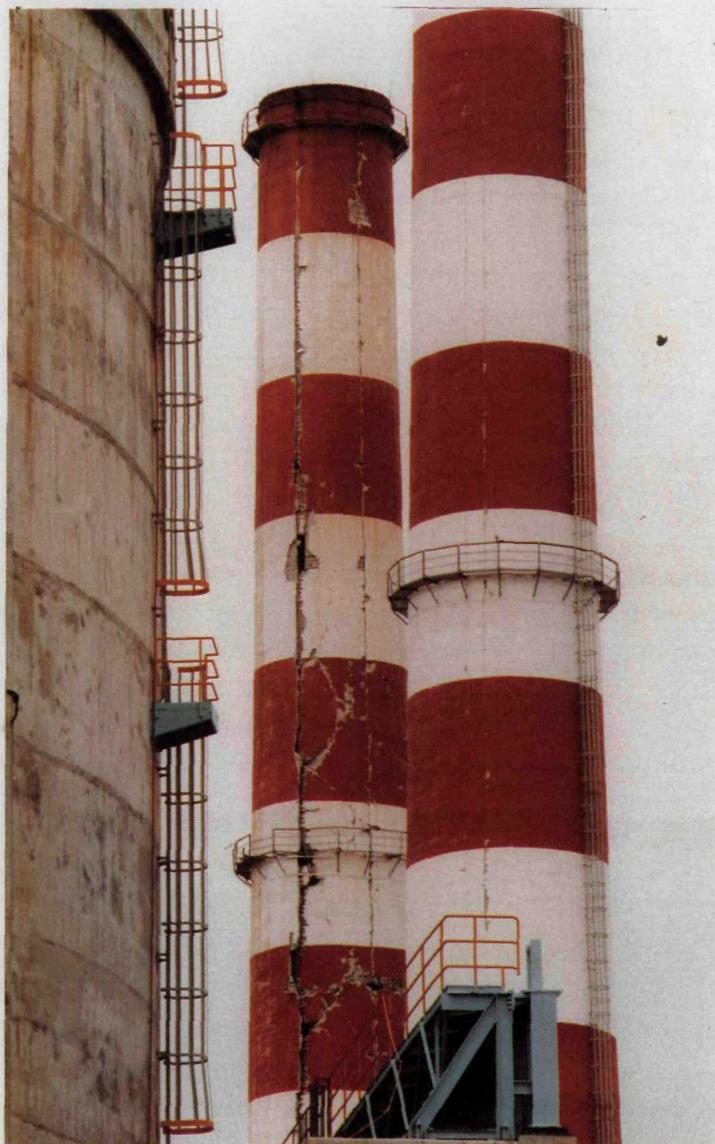
Figure 3.3 Chimneys for Units 1 and 2

During the hurricane, the TSC and OSC buildings were evacuated since they are not Class I structures and not strategically located. The TSC building sustained severe damage and was near the damaged Unit 2 chimney (see Figure 3.3). Therefore, the TSC was moved from the cable spreading room to the Entrance Building, which had lighting from an emergency generator and had sustained relatively minor damage. The OSC was moved to the administration building, and later the TSC was also moved to the administration building when lighting was restored.

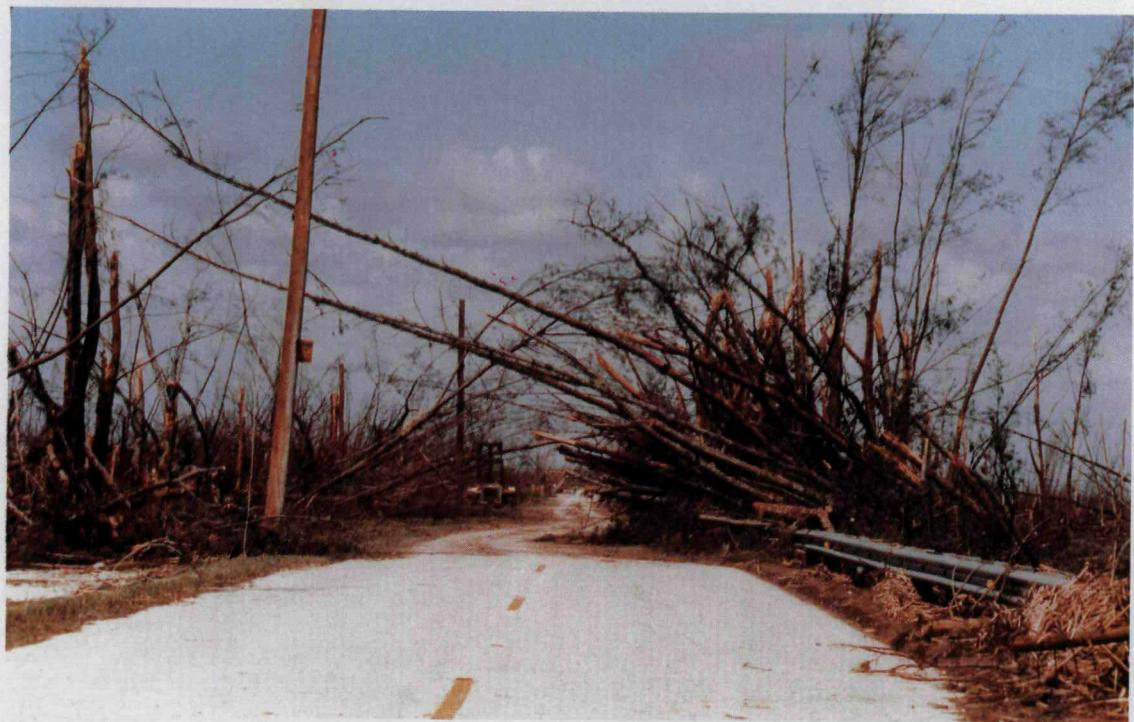
Figure 3.4 Site Access Road (Palm Drive) After Opening

Although tree removal equipment on site was inadequate, site personnel opened a path through the levee road by Tuesday morning (day 2). By 6:15 p.m., Palm Drive was opened from U.S. Highway 1 to the site (see Figure 3.4). Site personnel overcame many challenges in clearing debris from the road. For example, the site could not locate a high-voltage detector and had to throw a length of chain over downed electrical cables to determine if they were still energized before continuing to clear and clean the roadway.

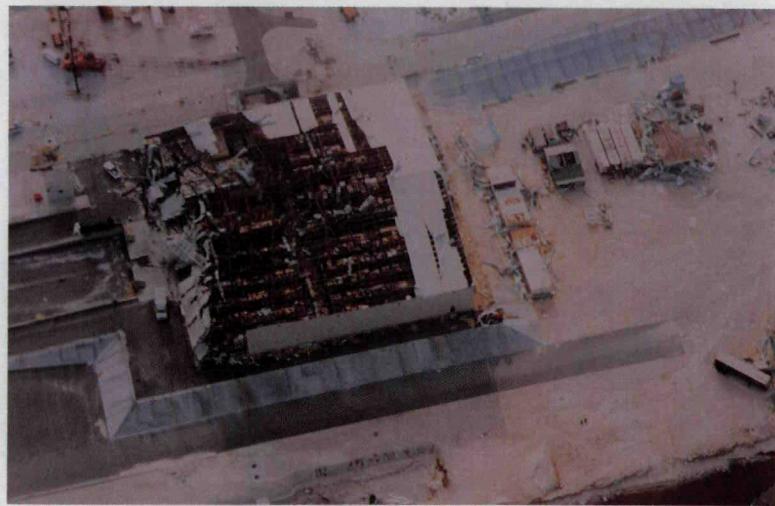
Figure 3.6 Materials Warehouse

The spare parts warehouse was extensively damaged (see Figure 3.6), and most of the spare parts were damaged or scattered. Parts that were found in apparently satisfactory condition had to be evaluated and perhaps tested before use. The hurricane also disabled the normal Turkey Point onsite procurement process because the process requires the use of a computer, and these computer systems were without power for several days.

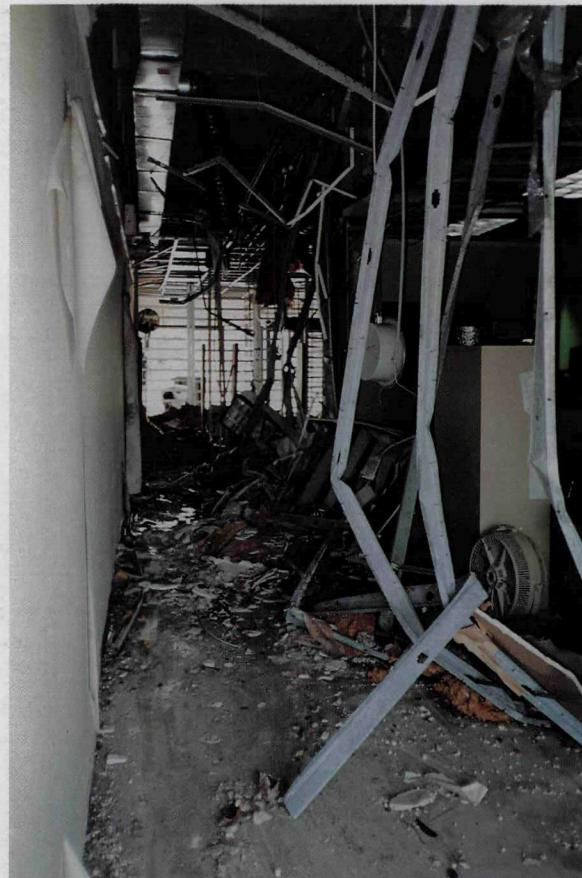
Figure 3.7 Nuclear Entrance Building

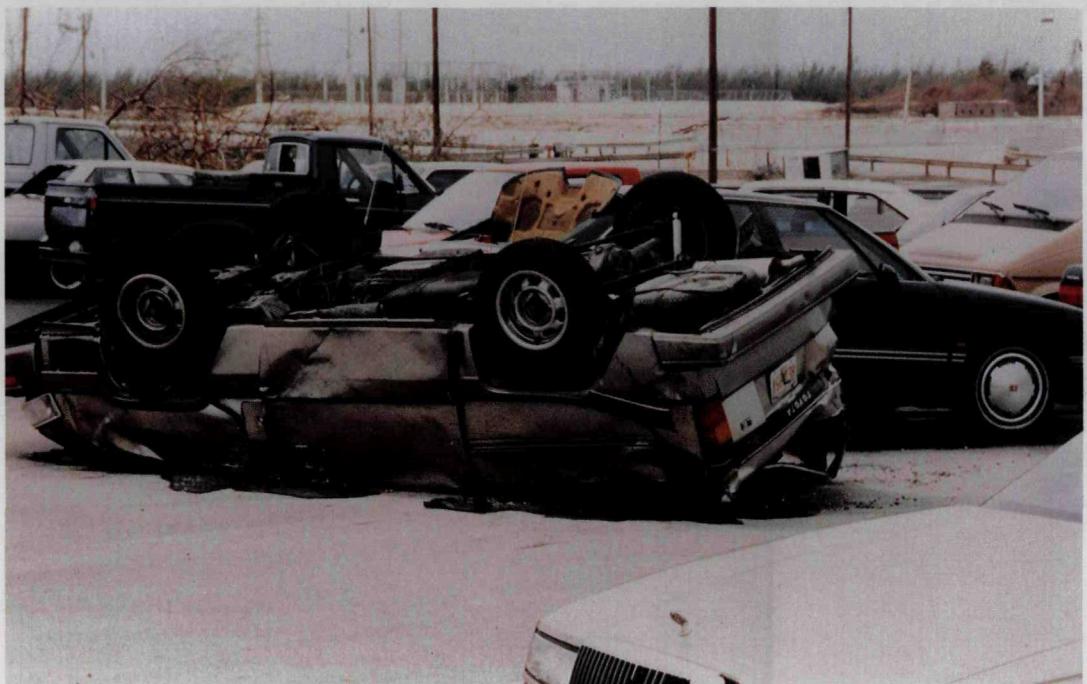
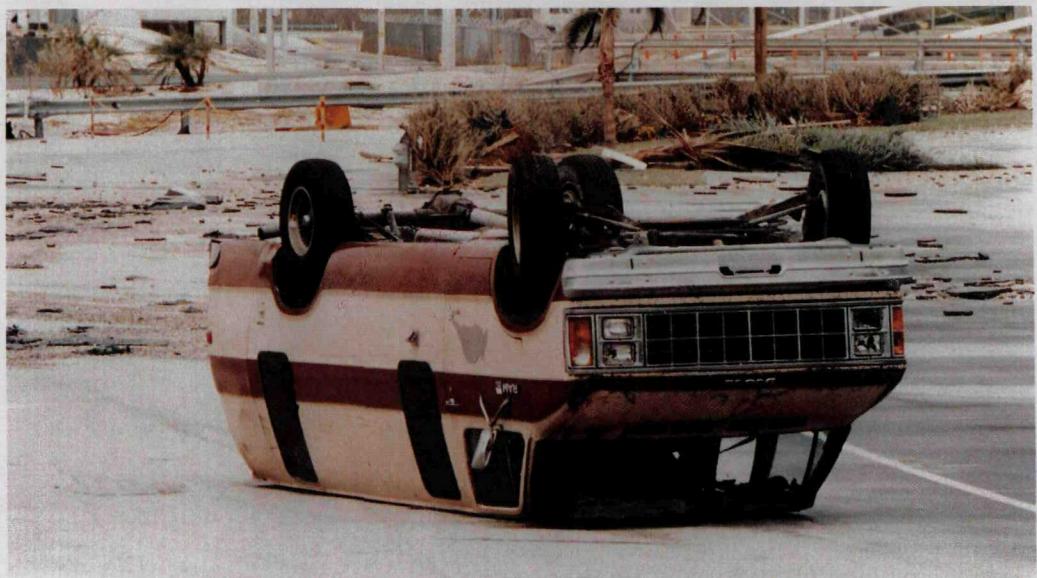
Figure 3.8 Employees' Automobiles

Figure 3.9 Employee Parking Lot

Most people obeyed the order to evacuate Homestead, Florida City, and the nearby coastal areas. Spouses and children of the site staff were sent north to safe sanctuary. After the winds subsided and daylight came, the effect of Hurricane Andrew was learned. Damage was evident everywhere at the plant. Some Class III buildings and office trailers were destroyed or severely damaged, many windows were broken, and most trees were down or stripped of any foliage (see Figure 3.5). Buildings were damaged (see Figures 3.6 and 3.7) and cars were smashed against one another in the parking lot, some upside down (see Figures 3.8 and 3.9).

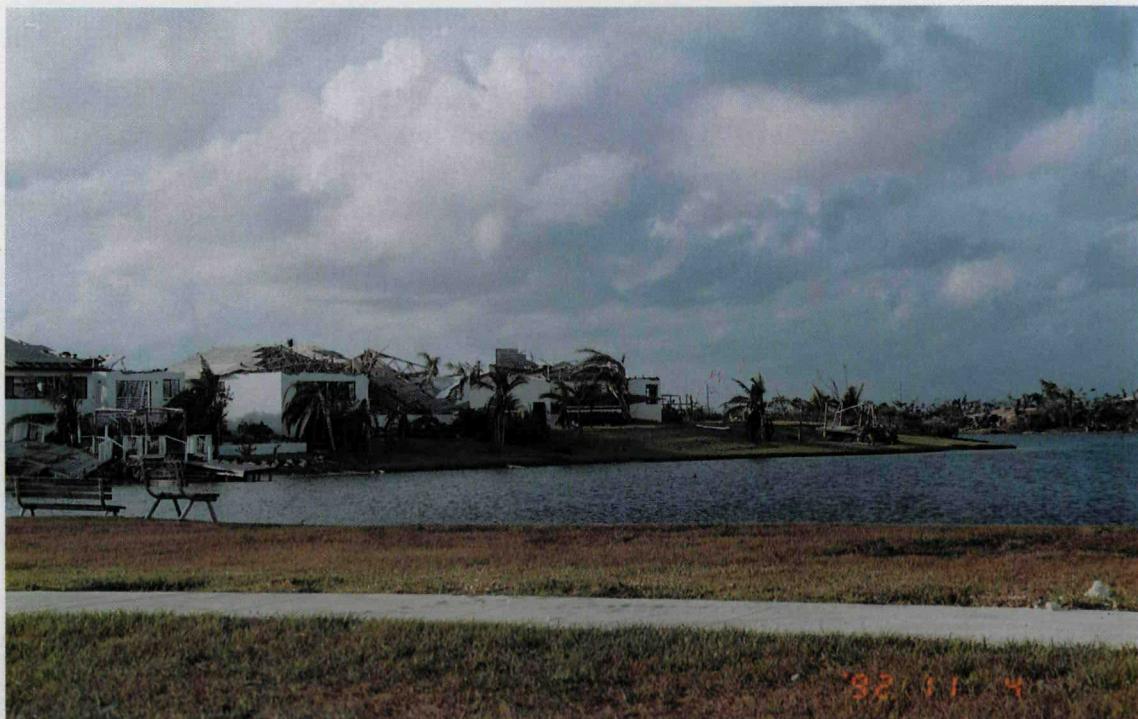
Figure 3.10 Houses in Homestead

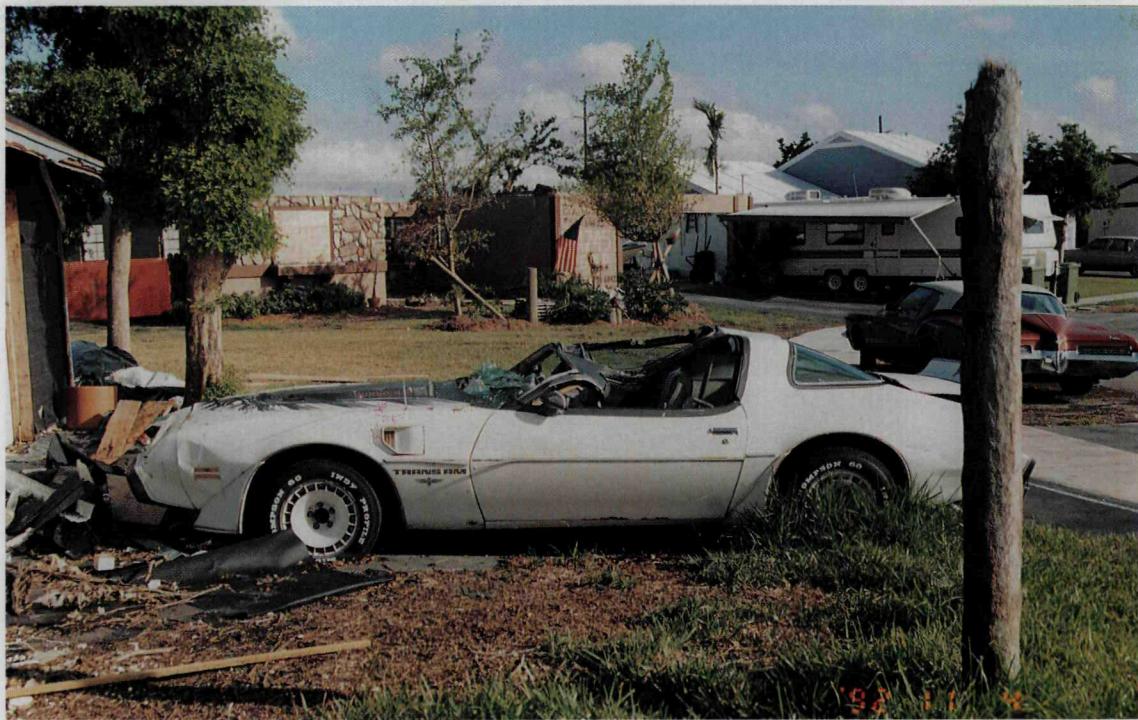
Figure 3.11 Damage in Homestead Area

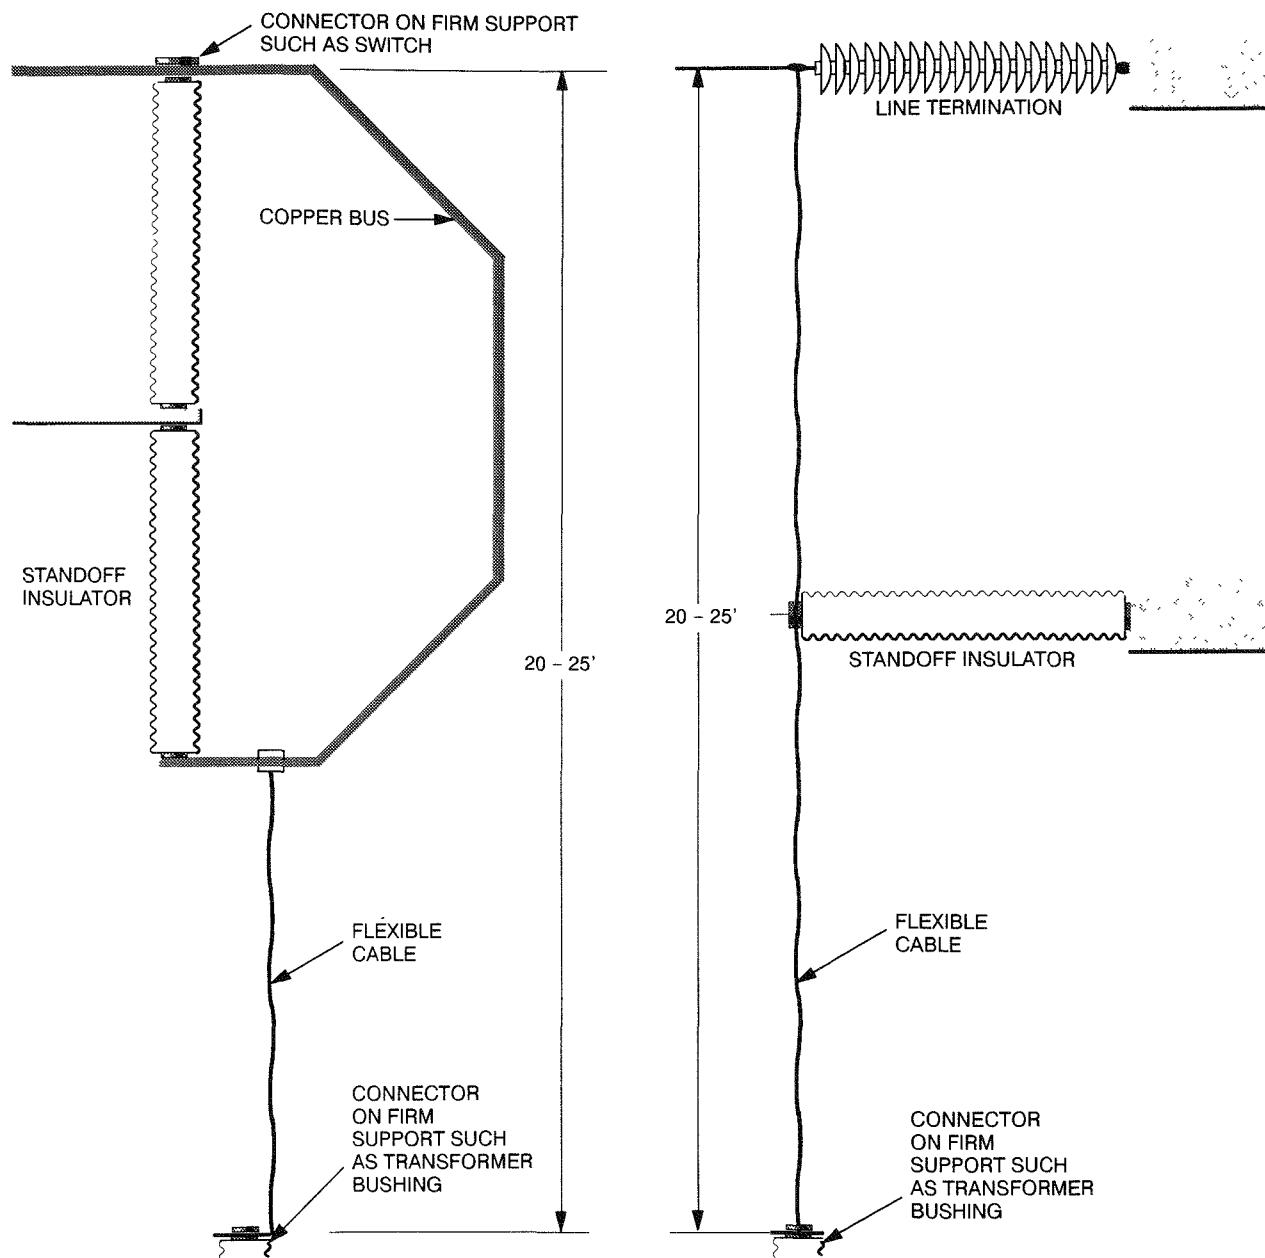
Figure K.2 Examples of Switchyard Connection Arrangements Where Standoff Insulators Failed

Although there was no damage to major equipment, the hurricane did reveal a lesser but apparently generic failure mechanism. At many locations in the switchyard, a standoff insulator is used for mid-length support of flexible cable or copper bus tubing spans (see Figure K.2). These spans connect one piece of equipment, such as a 240-kV disconnect switch, to another, such as a circuit breaker or transformer bushing. These insulators are 7.5 feet (2.23 m) long and about 1 foot (0.3 m) in diameter. The total distance between the equipment connectors is typically 20-25 feet (6.1-7.6 m) with the standoff insulator providing support at about the midpoint. Figure K.3 is a photograph of a failed standoff insulator. Eighteen of these porcelain standoff insulators failed. Three insulators failed in the 240-kV connections to each of the Unit 3 and Unit 4 main transformers. Two insulators failed in the 240-kV connections to each of the startup transformers, and eight insulators in the switchyard also failed.

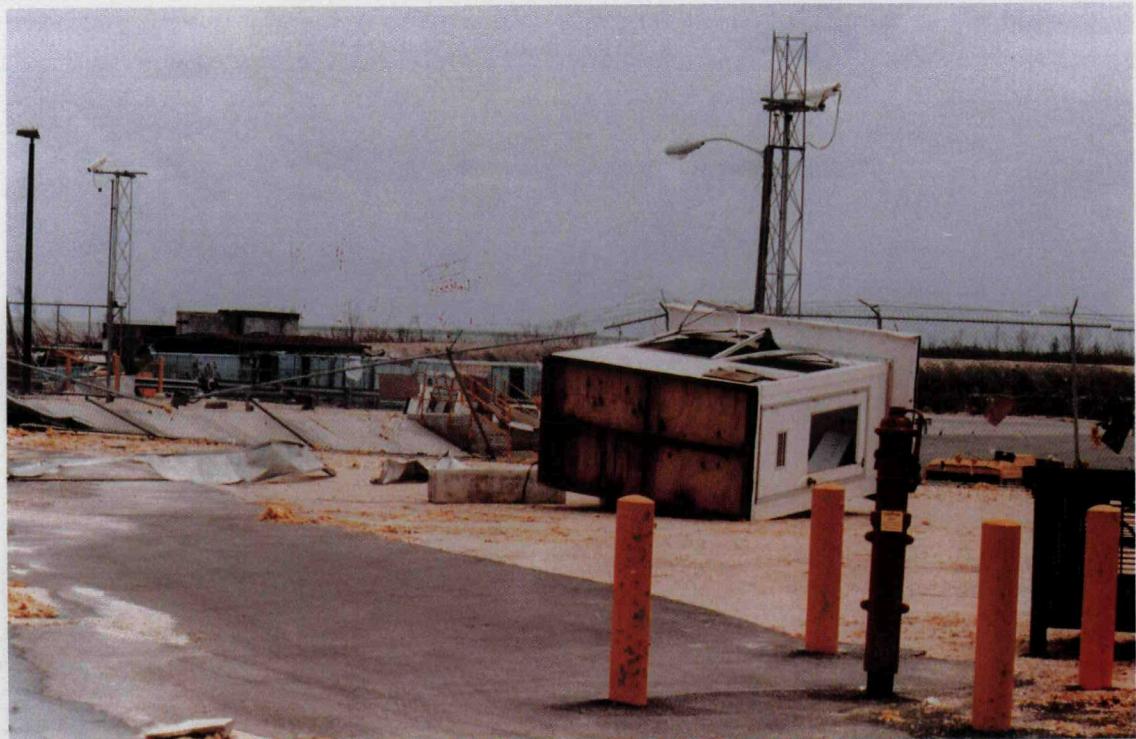
Figure L.1 Damaged Security Building and Fence

The security system sustained extensive damage to equipment such as lighting, cameras, intrusion detection equipment, protective area fencing, and the entrance building.

By August 29, fences were restored in most areas. Security officers continuously staffed the posts in areas that could not be immediately repaired to compensate for the lack of a physical barrier. Other areas were patrolled or were monitored by security cameras. High priority was given to restoring lighting. Diesel-powered lighting units were used to compensate for lights that had been destroyed.

Compensatory actions were taken immediately to reestablish security conditions after the hurricane force winds subsided. Roving patrols were established to compensate for fences that were damaged. Within 48 hours after the storm, all fence fabric had been repaired except for the fences in the water treatment area. At 12:20 p.m. on September 22, full safeguards were restored.

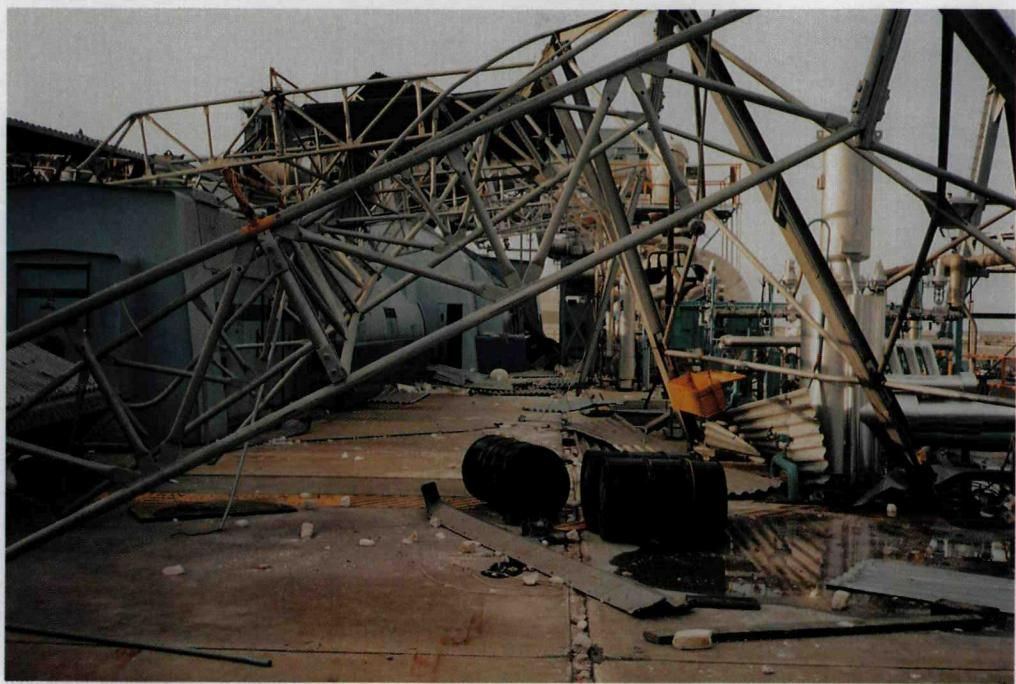
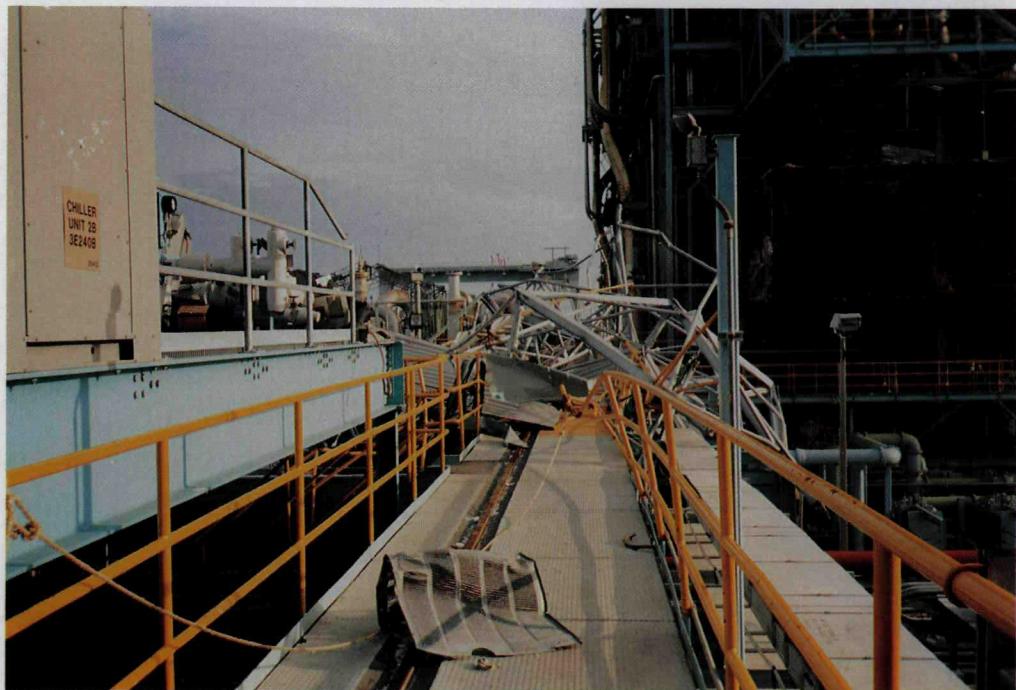
Wind loads on the roof and frame caused each of the six turbine canopies to fail (see Figures O.1 and O.2). The structures tipped over and were further destroyed as they impacted other objects in the area. The wind loads caused the anchorages to fail by pulling the threaded inserts from the concrete or destroying the frame at attachment points. One of the anchors in the turbine deck was pulled from the concrete, and the concrete around another was severely cracked.

The canopy roofs became detached from the frames and became missiles that may have struck other canopies, structures, or equipment; however, the safety function of the nuclear plant was not effected.
