Nevada
Environmental
Restoration
Project

Post-Closure Inspection Report for the Tonopah Test Range, Nevada

For Calendar Year 2010

U.S. Department of Energy
National Nuclear Security Administration
Nevada Site Office

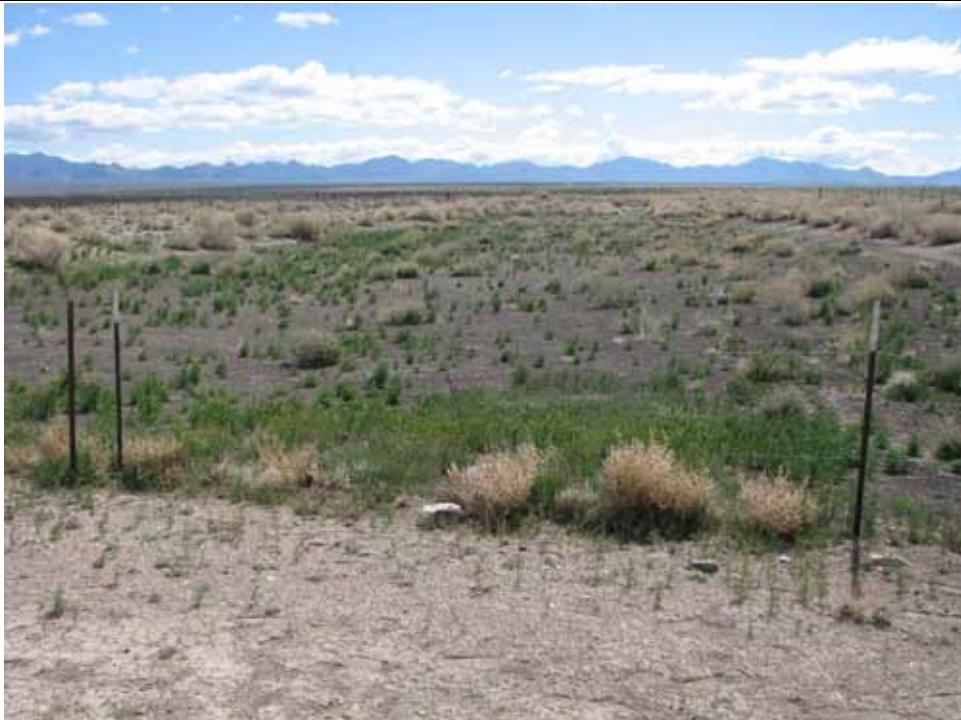
Photograph 1: CAU 400 Five Points Landfill, looking west, 05/12/2010

The Five Points Landfill is shown in Figure 2 of Attachment A. The annual inspection was conducted on May 12, 2010. Fencing was in good condition, and the vegetation appeared healthy. No issues or concerns were noted.

The site was in good condition. Inspections at the Five Points Landfill should continue as scheduled. Vegetation at the Five Points Landfill is stable and meets revegetation standards in the area that was not flooded; however, the potential for flooding persists and may result in additional plant death; therefore, vegetation monitoring of this site should continue.

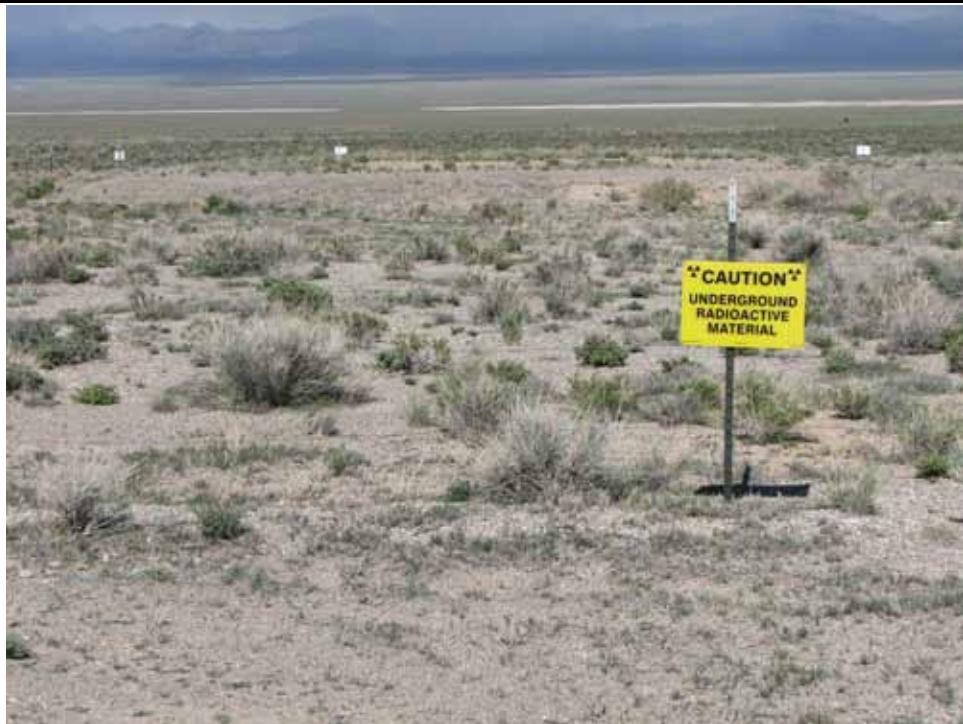
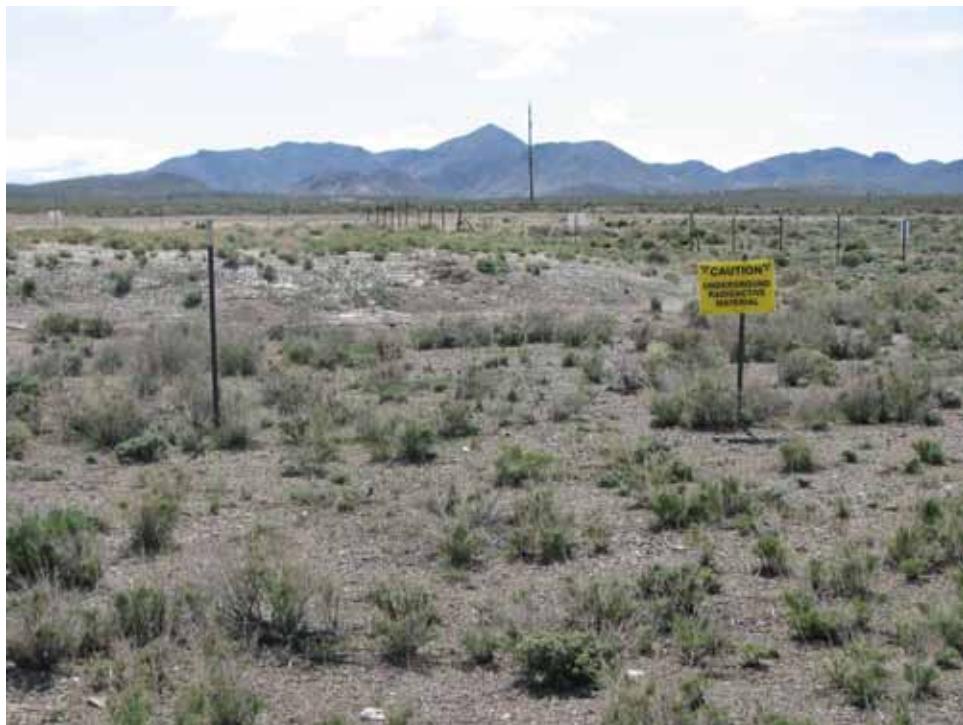
The annual inspection was conducted on May 11, 2010. The signs, fencing, and cover were in good condition, and the vegetation appeared healthy. No issues or concerns were noted.

Photograph 3: CAU 407, looking east, 05/11/2010

Photograph 4: CAU 407, looking west, 05/11/2010

The site was in good condition. Vegetation is healthy and exceeds revegetation standards; however, future monitoring should focus on the re-establishment of perennial grasses and the potential dominance of invasive weeds, and remedial action may be recommended in the future. Inspections should continue as scheduled, and vegetation monitoring should continue.

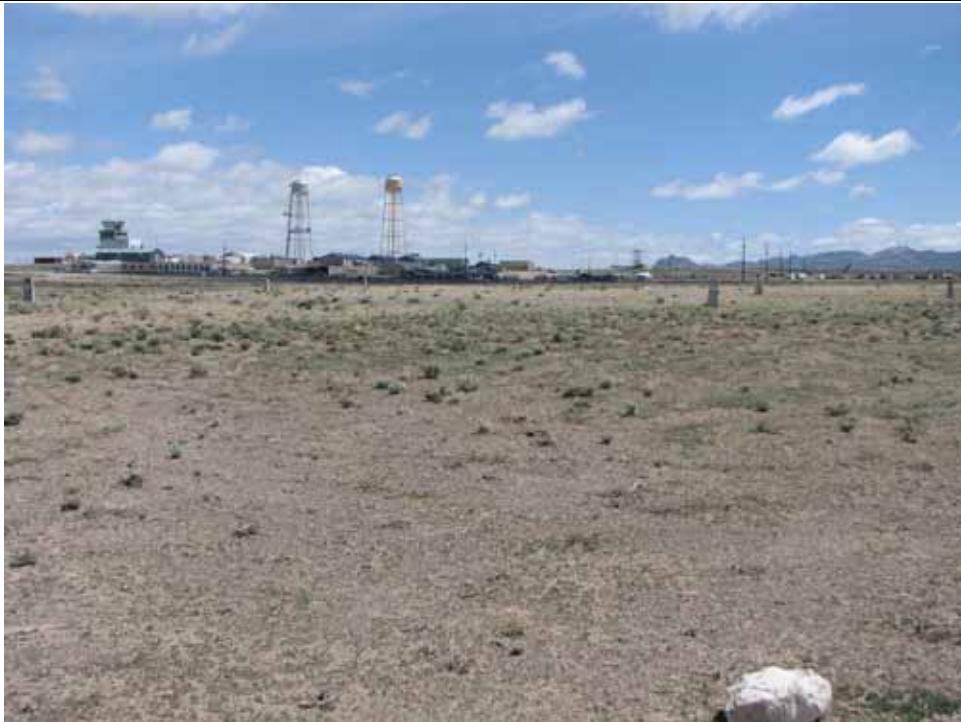
Photograph 5: CAU 424, Landfill Cell A3-1, looking southeast, 05/11/2010

Landfill Cell A3-1 (CAS 03-08-001-A301): The signs, survey markers, monuments, and cover were in good condition. No issues or concerns were noted.

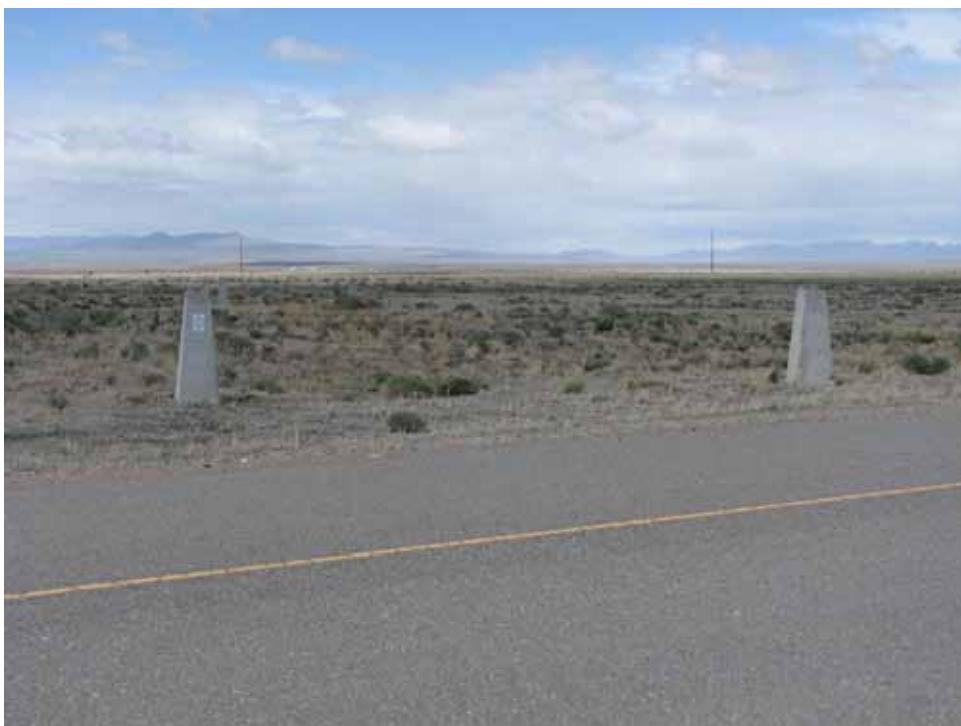
Photograph 6: CAU 424, Landfill Cell A3-2, looking north, 05/11/2010

Landfill Cell A3-2 (CAS 03-08-002-A302): The signs, brass survey markers, concrete monuments, and landfill cover were in good condition. No issues or concerns were noted.

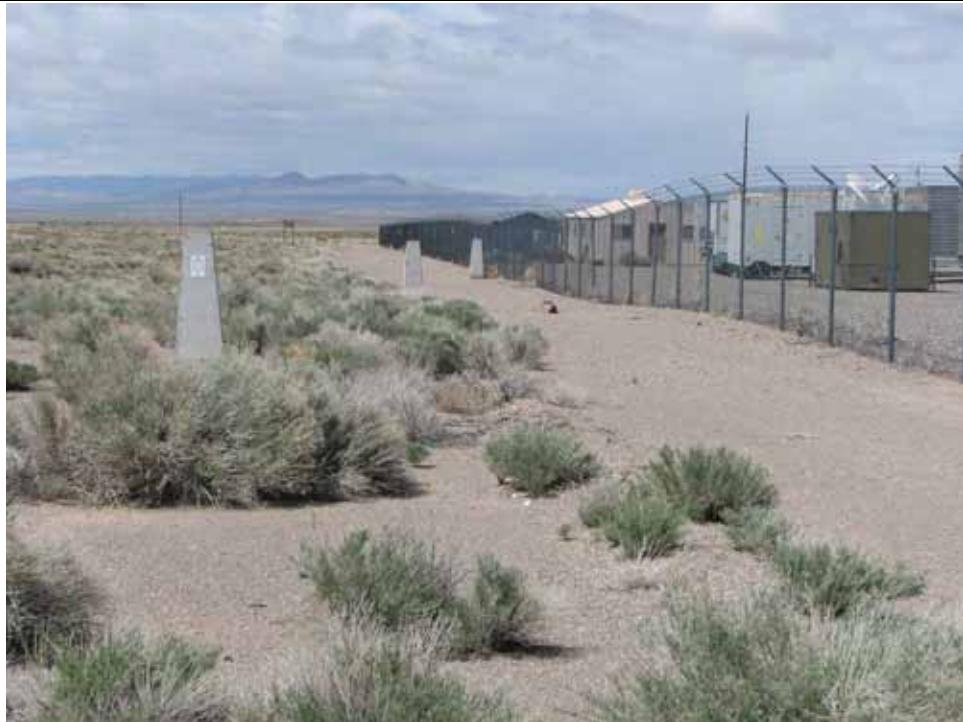
Photograph 7: CAU 424, Landfill Cell A3-3, looking northwest, 05/11/2010

Landfill Cell A3-3 (CAS 03-08-002-A303): The monuments, brass survey markers, signs, and cover were in good condition. No issues or concerns were noted.

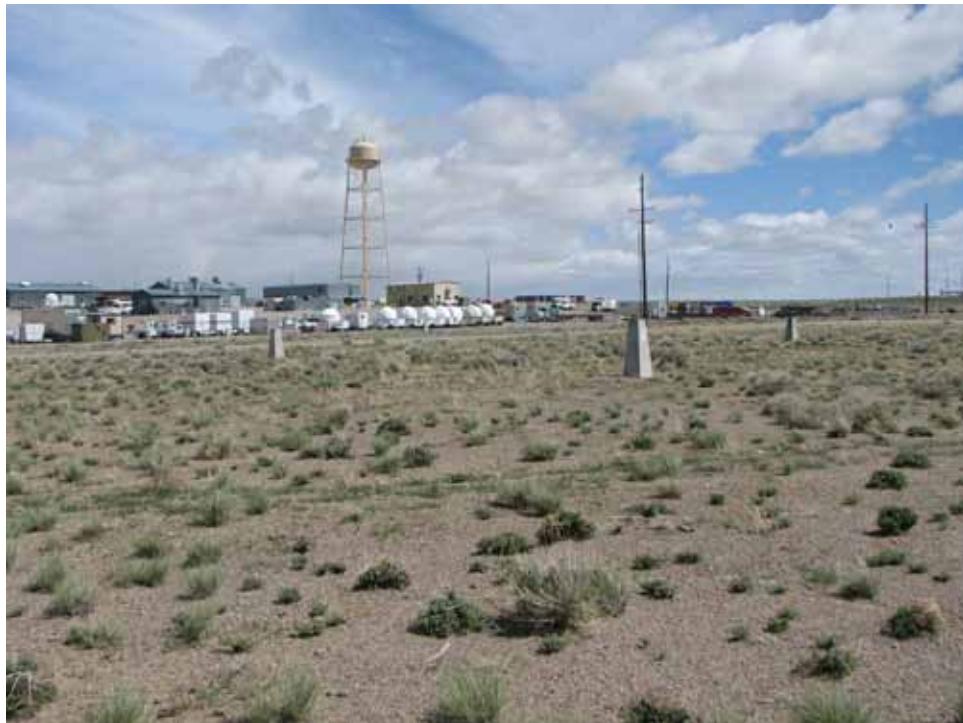
Photograph 8: CAU 424, Landfill Cell A3-4, looking north, 05/11/2010

Landfill Cell A3-4 (CAS 03-08-002-A304): The monuments, brass survey marker, and signs were in good condition. No issues or concerns were noted.

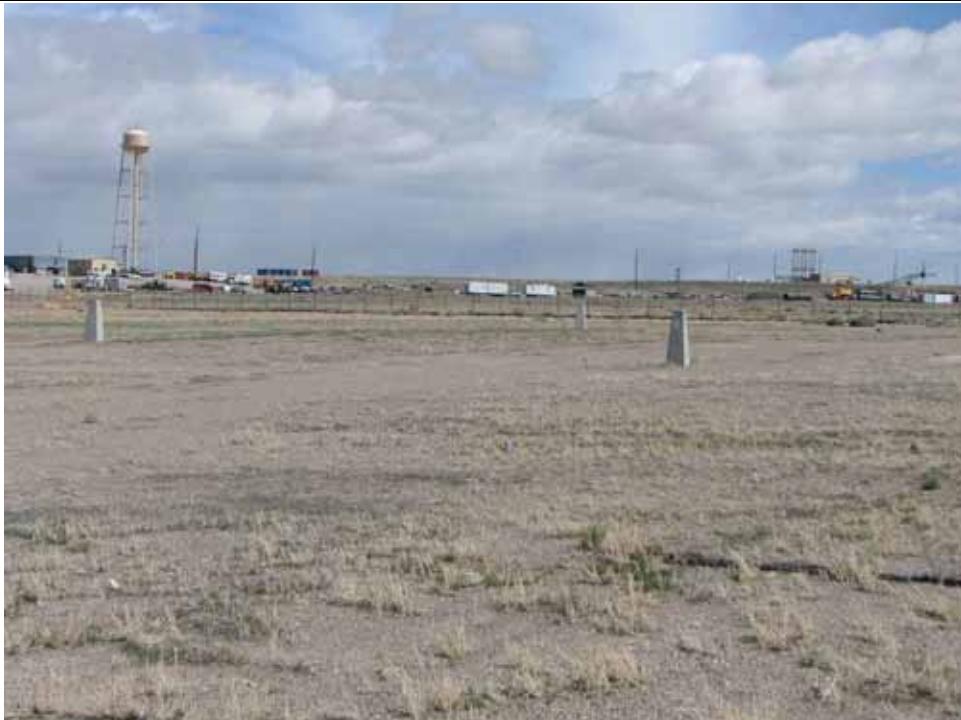
Photograph 9: CAU 424, Landfill Cell A3-5, looking southeast, 05/11/2010

Landfill Cell A3-5 (CAS 03-08-002-A305): The monuments and attached signs, brass survey markers, and cover were in good condition. No issues or concerns were noted.

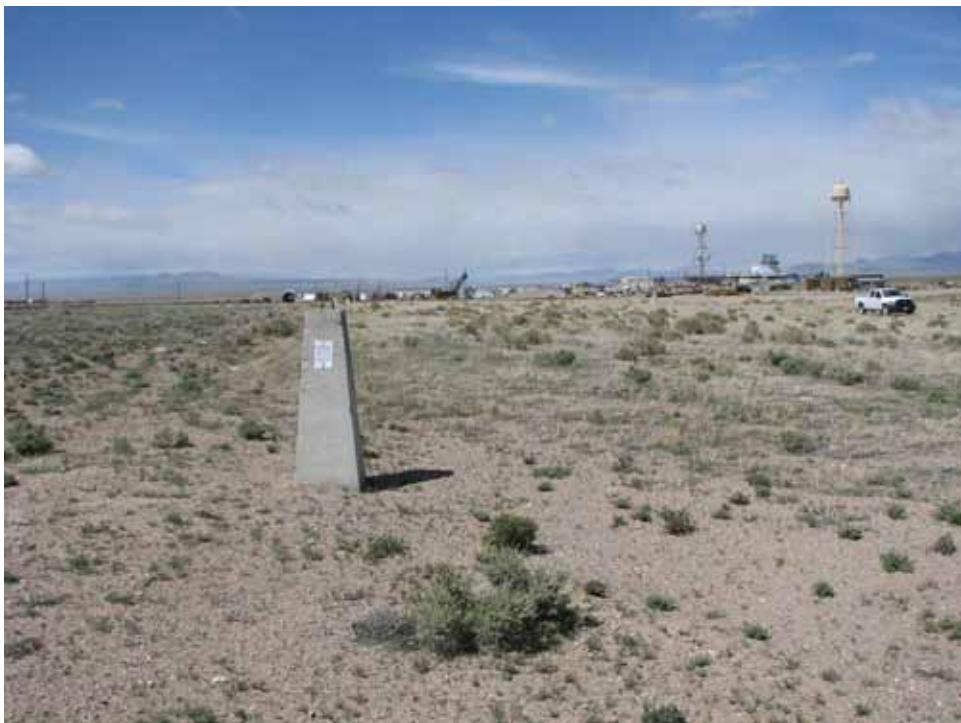
Photograph 10: CAU 424, Landfill Cell A3-6, looking east, 05/11/2010

Landfill Cell A3-6 (CAS 03-08-002-A306): The monuments and attached signs, brass survey markers, and cover were in good condition. No issues or concerns were noted.

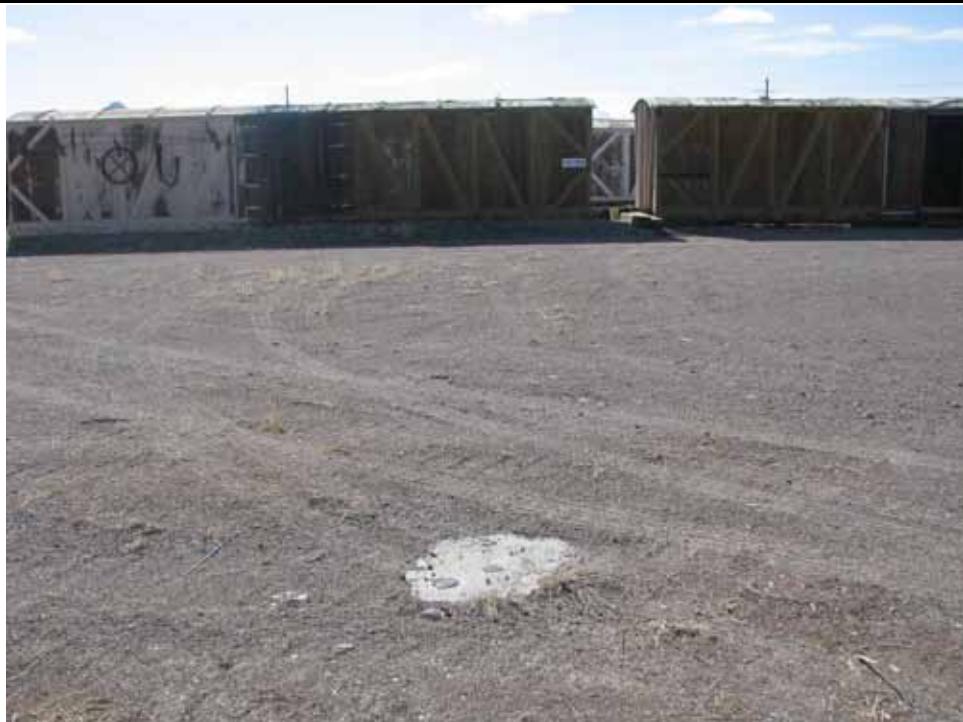
Photograph 11: CAU 424, Landfill Cell A3-8, looking west, 05/11/2010

Landfill Cell A3-8 (CAS 03-08-002-A308): The brass markers and cover were in good condition. No issues or concerns were noted.

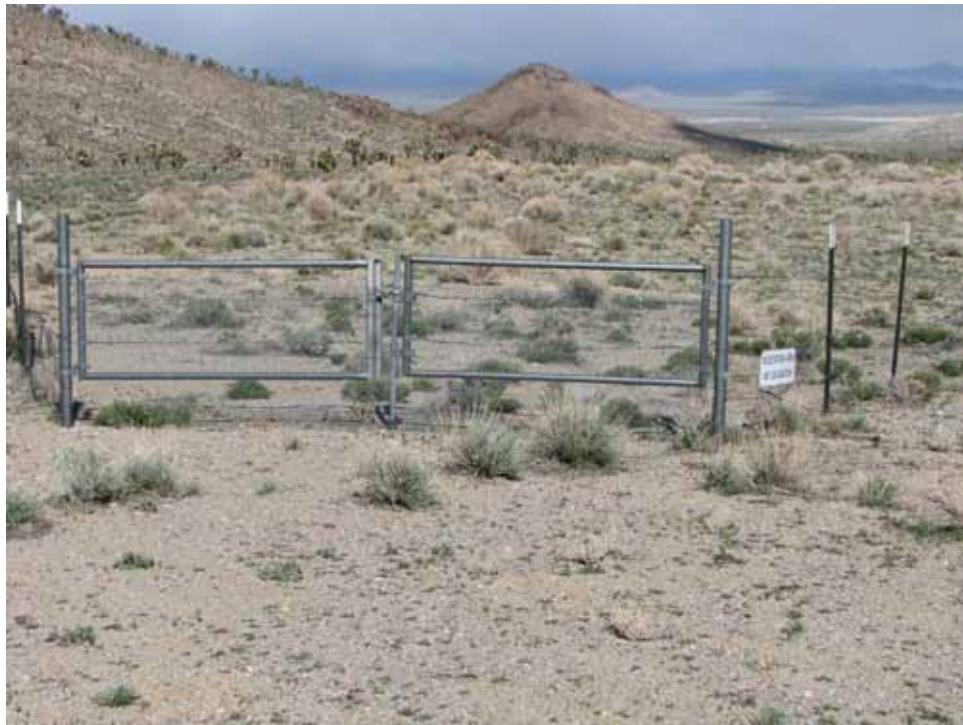
Photograph 12: CAU 426, looking east, 05/11/2010

The annual inspection was conducted on May 11, 2010. The signs, fencing, and cover were in good condition, and the vegetation appeared healthy. No issues or concerns were noted.

Vegetation monitoring has been performed since 1998, and maintenance has not been required since 2006, when the fencing adjacent to the gate was tightened. Remedial revegetation has not been required at this site. Discontinuation of vegetation monitoring was recommended in the post-closure report for calendar year 2009, and NDEP approved this request. Therefore, removal of the fencing and discontinuation of annual visual inspections is recommended at this site.

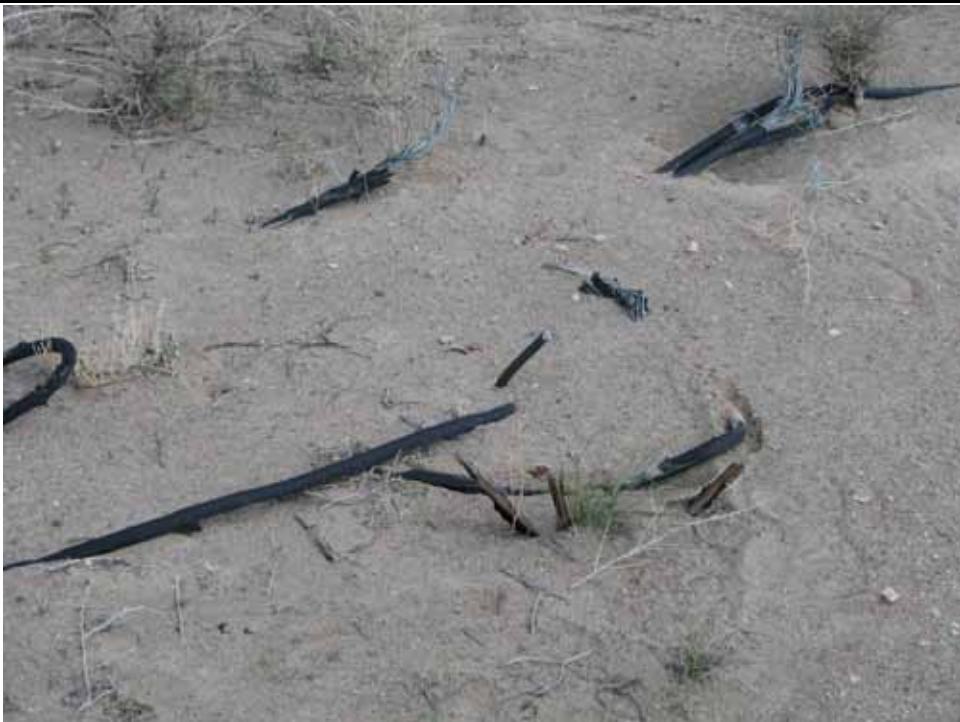
Photograph 13: CAU 453, Surface Debris, 05/12/2010

The annual inspection was conducted on May 12, 2010. The fence, signs, and monuments were in good condition. There was evidence of animal burrowing, and debris was present on the cover.

Animal burrows observed during the annual inspection were backfilled, and debris was removed for disposal as sanitary waste on July 14, 2010.

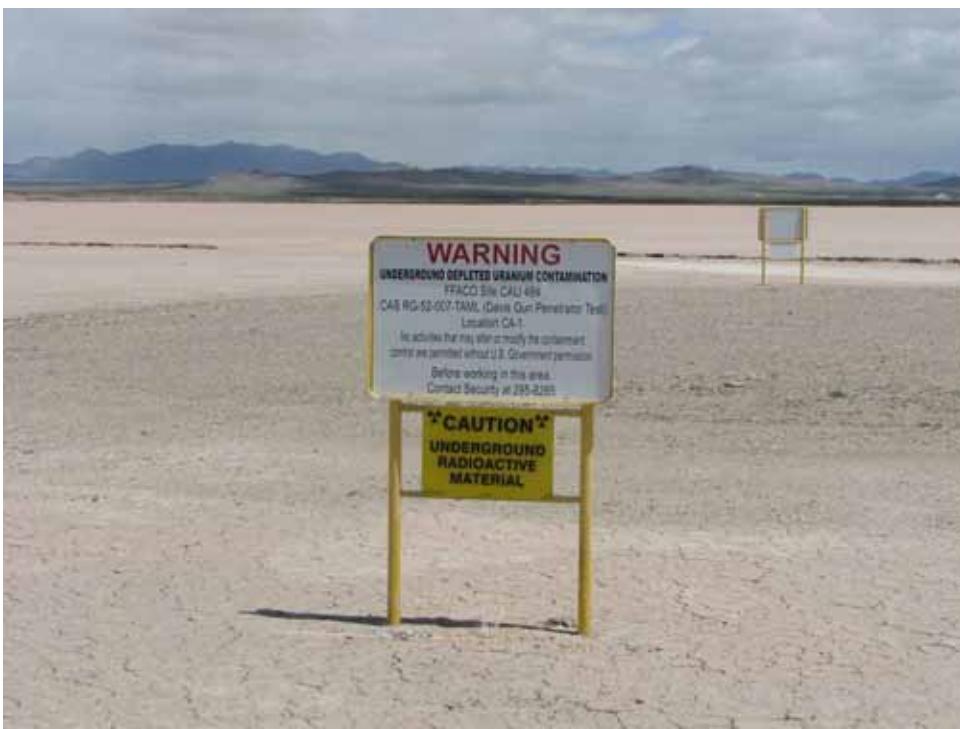
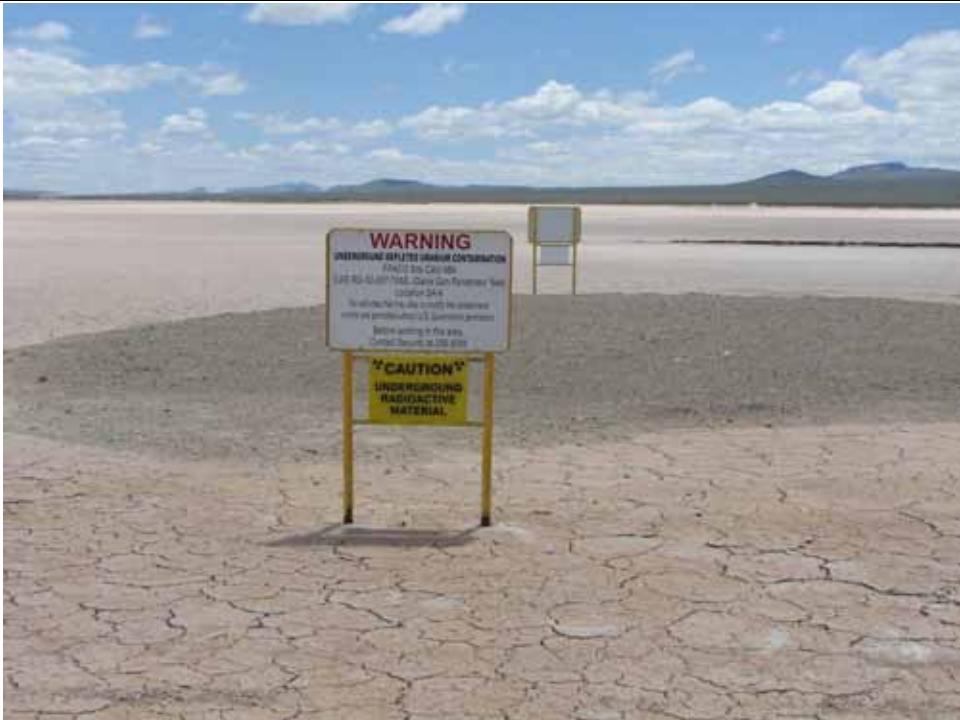
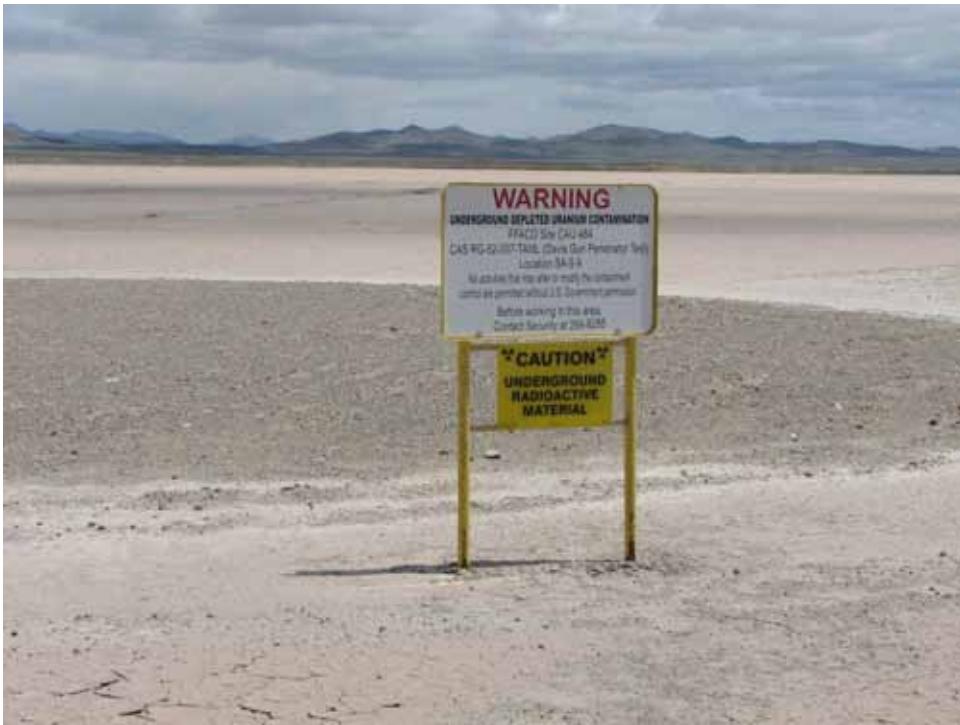
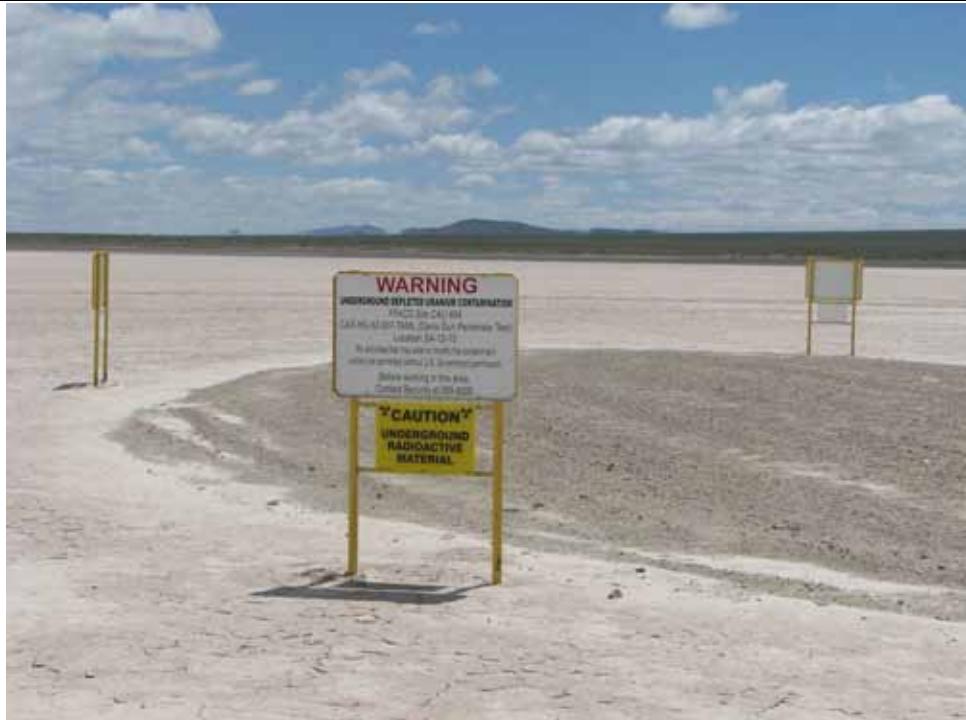
The annual inspection was conducted on May 11, 2010. The signs and covers were in good condition. No issues or concerns were noted.

Photograph 14: CAU 484, CA1 anomaly, looking east, 05/11/2010

Photograph 15: CAU 484, SA4 anomaly, looking southwest, 05/11/2010

Photograph 16: CAU 484, SA5-9 anomaly, looking east, 05/11/2010

Photograph 17: CAU 484, SA12-15 anomaly, looking southwest, 05/11/2010

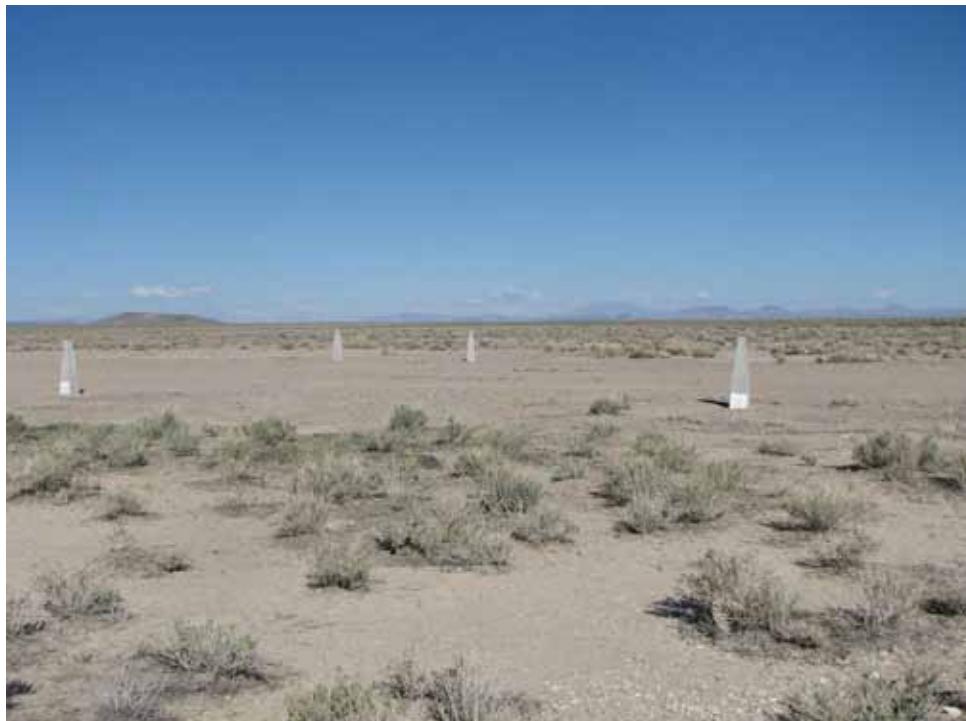
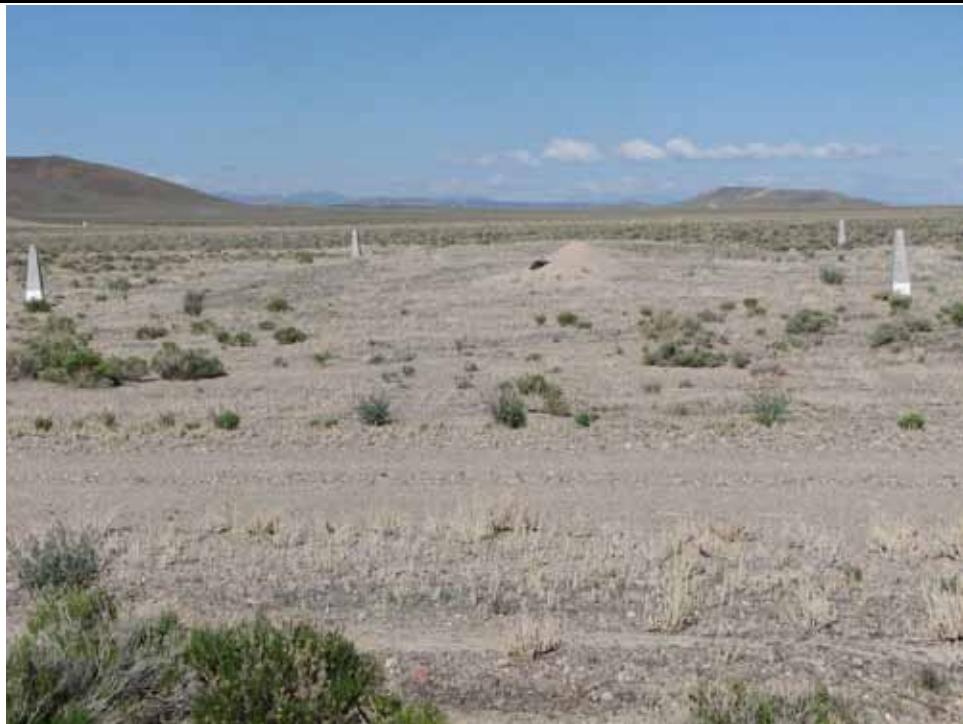
The annual inspection was conducted on May 12, 2010. The signs and monuments were in good condition. No issues or concerns were noted.

Photograph 18: CAU 487, A-8 anomaly, looking north, 05/12/2010

Photograph 19: CAU 487, A-17 anomaly, looking west, 05/12/2010
