Metallography of Pitted-Aluminum Clad, Depleted Uranium Fuel

A document prepared for CORROSION 95-THE NACE INTERNATIONAL ANNUAL CONFERENCE AND CORROSION SHOW at Orlando from 03/26/95 - 03/31/95.

**METALLOGRAPHY
OF
PITTED ALUMINUM-CLAD, DEPLETED URANIUM FUEL**

D.Z Nelson and J.P. Howell
Westinghouse Savannah River Company
Savannah River Technology
P.O. Box 616
Aiken, S.C. 29803

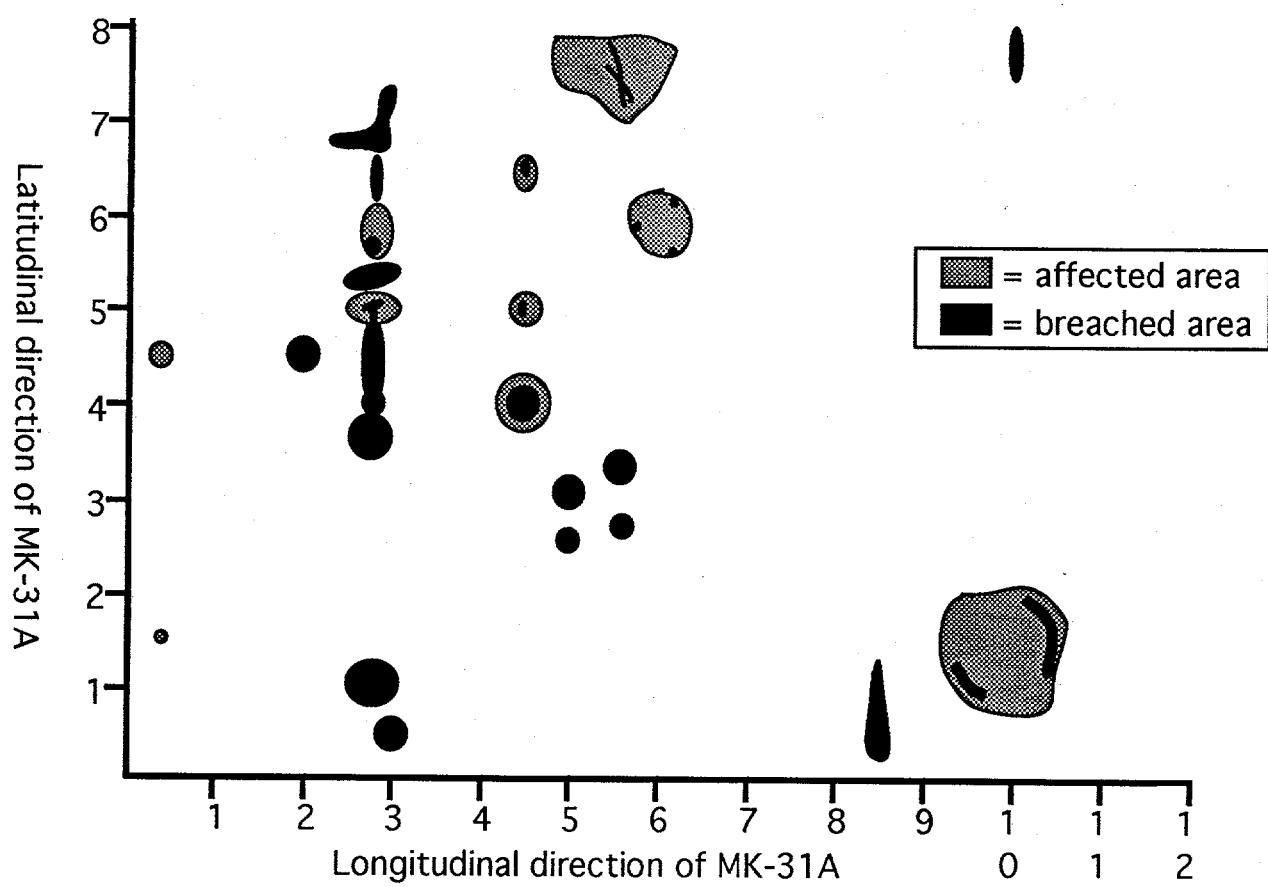
The one inch grid marked on the slugs was used to provide accurate measurements of location and size of the pits covering the surface of the outer slug. The measurement of pit locations and sizes were performed and are shown in Figure 4. This planar map shows the relative location of all pits on the outer surface of the slug and shows the linear positions of the pits in scratches. Representative pits were plotted on the map using coordinates from the grid on the sample. Sizes of the pits were measured and the breached areas of the aluminum clad were calculated. In many cases, the total area of the uranium corrosion was significantly greater than the area of the aluminum opening. This was visually obvious and usually resulted in a blistered or raised area surrounding the hole in the aluminum. The size of the aluminum pits and the total effected area of the uranium corrosion is shown in Table 1. The total breached area of the aluminum was found to be about 3.2 in^2 (20.65 cm^2) with a corresponding area of uranium affected of 7.7 in^2 (49.68 cm^2). With a total cladding surface area of over 172 in^2 (11 cm^2) for the outer slug, the percentage of the uranium surface affected by corrosion is calculated to be about 4.5%.

FIGURE 4 - Mapping of corrosion sites on outer target

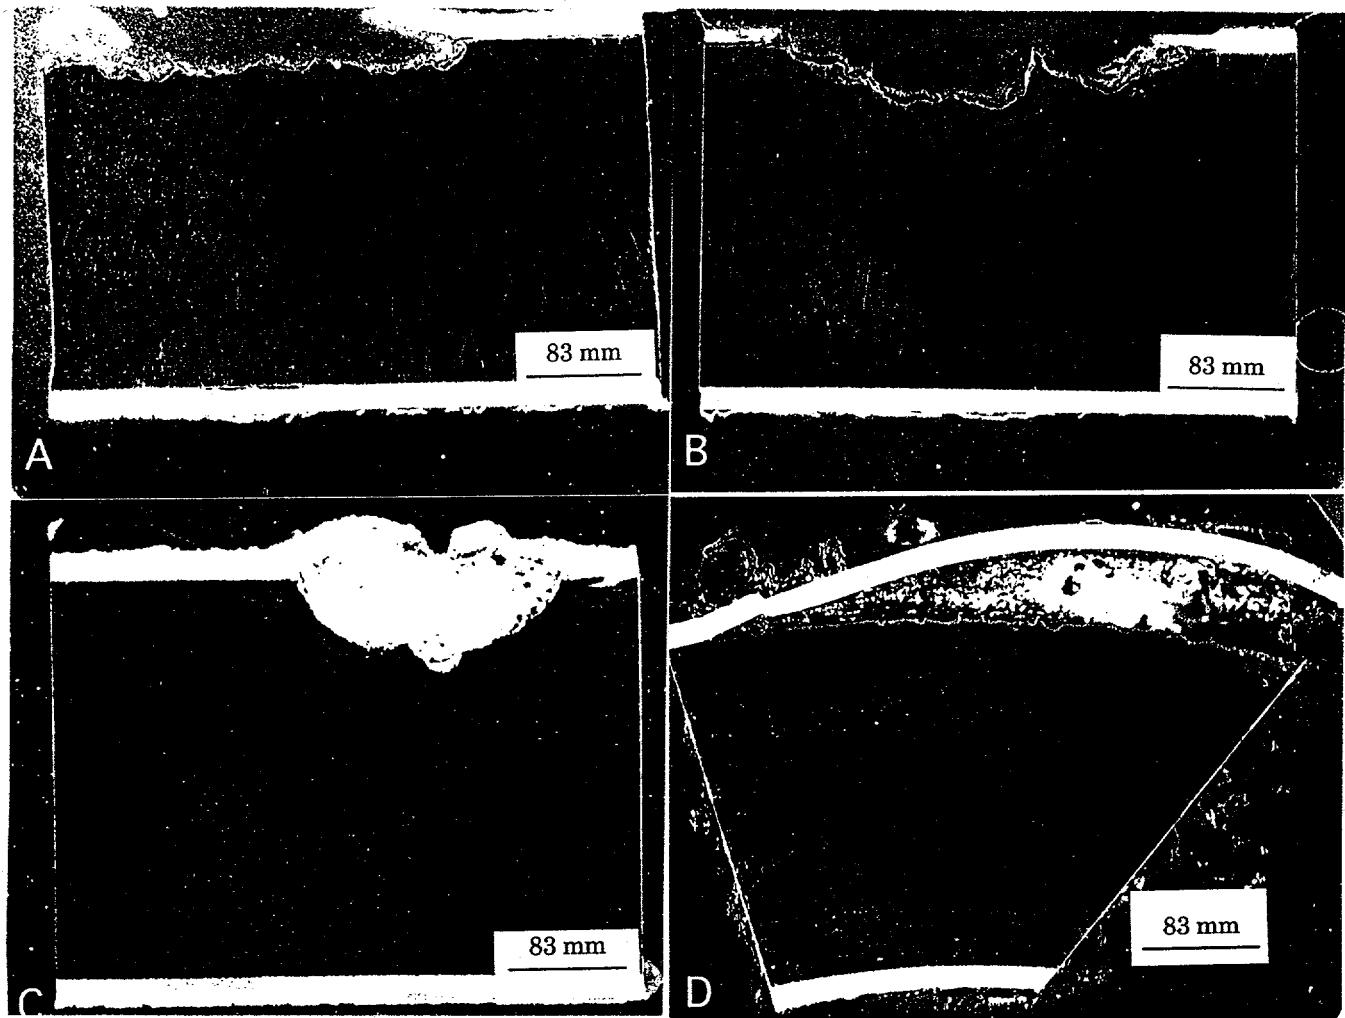
Pits on the outer surface of the target slugs were generally classical in nature and most appear to follow the explanation provided in the previous corrosion discussion. Although the proof of hydride attack was not absolute, the location of blisters at some distance from any breached areas indicate a strong possibility that this mechanism, as well as, water attack on the uranium is responsible for the pits that are readily visible. Metallography on sections taken from the slug revealed four types of pits present in the slug. Although, some may look slightly different, most of the pits examined in this investigation looked like those shown in Figure 5. The pit shown in Figure 5(a) is a shallow pit than runs horizontally beneath the clad. The aluminum cladding has been completely corroded away to a size slightly smaller than the affected uranium core. The uranium core has superficial corrosion on the surface and only extends to a depth of 0.04 in. (1.02 mm). The uranium oxide has been dissolved away and no longer is present in this pit except for a very thin layer. The shallow corrosion of the surface of the uranium core may be due to a weak cladding bond to the core in this region allowing some undercutting of the aluminum by the uranium corrosion.

The second type pit is shown by Figure 5(b). This pit is similar to 5(a), but the uranium corrosion has penetrated to a depth of 0.09 in. (2.29 mm). The aluminum cladding has been completely corroded away and the uranium core is completely exposed in this region. Due to the loss of the aluminum cladding, the corrosion product has been washed away and is no longer present. Penetration of the uranium core is deeper in this area because of a strong bonding in the region forcing it's direction downward. Whenever the oxide growth is not strong enough to break the bond of the aluminum /nickel /uranium layer, corrosion appears to continue vertically into the uranium.

Figure 5(c) shows a breach in the aluminum cladding smaller than the affected area of uranium corrosion. Generally, the increased corrosion of the uranium with the aluminum cladding still present will cause a bubble to form around the breach from the expansion of the oxide product. The uranium corrosion has a "V" shaped appearance and the depth of penetration of this pit was found to be 0.12 inches (3.05 mm), the deepest pit found on this slug. Because the aluminum cladding is still present except for the smaller breached area, the corrosion product is still present. Again, the growth of the pit in a vertical position may occur because of a better bond of the aluminum cladding to the uranium in this region. In other regions where the aluminum bonding is not as strong a larger bubble occurs and the corrosion runs in a lateral position like that shown by the pit in Figure 5(d).

Figure 5(d) shows a bubbled area where most of the aluminum cladding is still present. This may have been caused by hydride attack, or could have occurred by a small pinhole breach in the aluminum allowing exposure to water. However, the breach was not large enough to allow the uranium oxide to escape. The uranium oxide caused a 0.09 inch (2.29 mm) bulging of the aluminum cladding with little penetration of the uranium metal. All of the oxide is deposited directly under the aluminum cladding. The corrosion of the uranium continues horizontally with very little penetration into the uranium metal because of a weaker bond in this region.

FIGURE 5 - Four typical pit types found on target: (a) shallow corrosion penetration of uranium core, (b) deeper penetration of uranium core, (c) vertical penetration of uranium core, (d) bubble formed under aluminum cladding

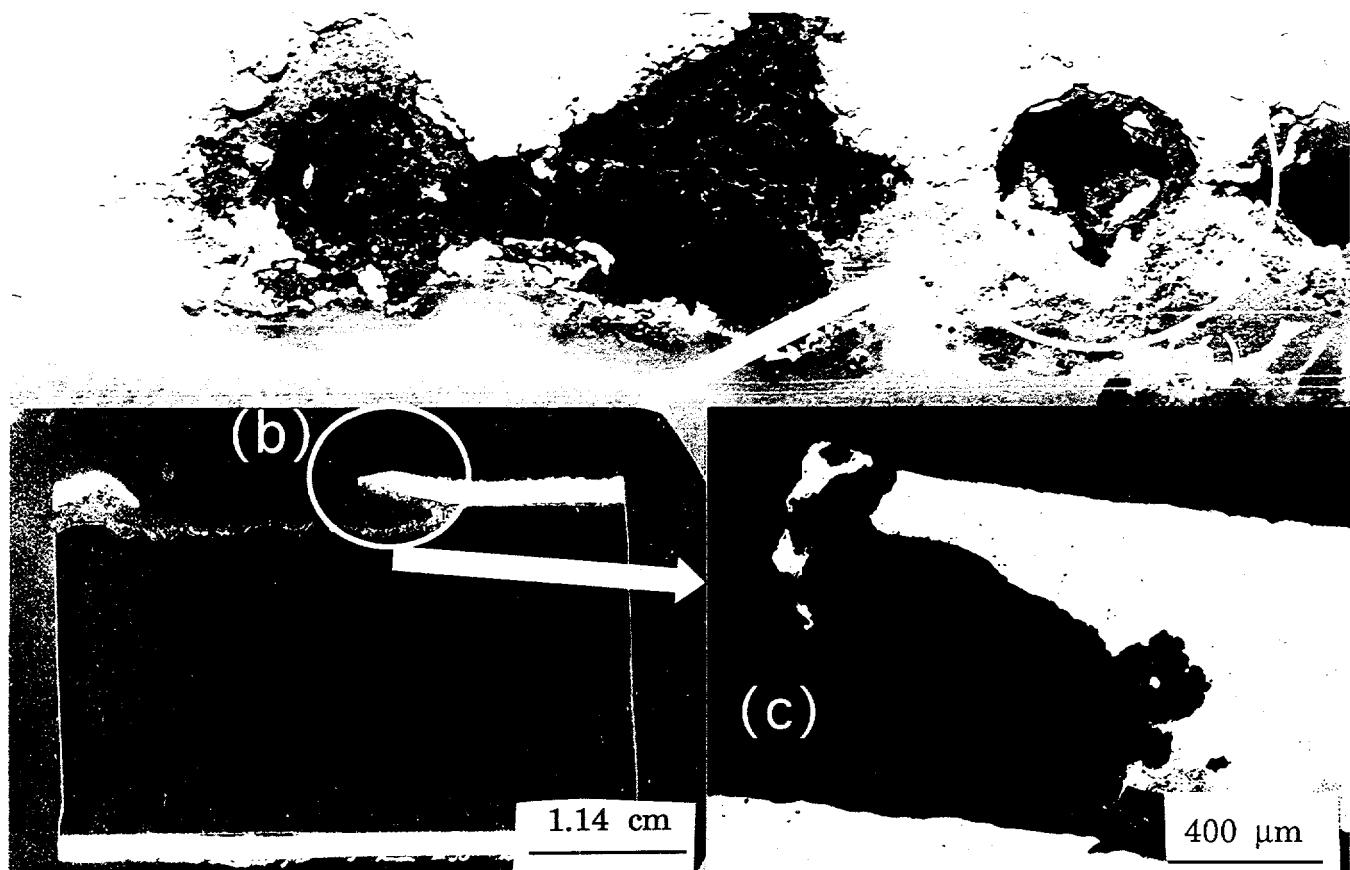
Figure 6 examines a series of pits which originated in a scratched area of the outer slug surface. This pit has a large opening in the aluminum cladding. As shown by Figure 6(b), there is a large area of uranium exposed, as well as the underside of the aluminum. Because the aluminum cladding is exposed to the basin water on both sides, corrosion occurs on the underside that was bonded to the uranium, as well as the outer surface as shown by Figure 6(c).

FIGURE 6 - Corrosion morphology of shallow pit

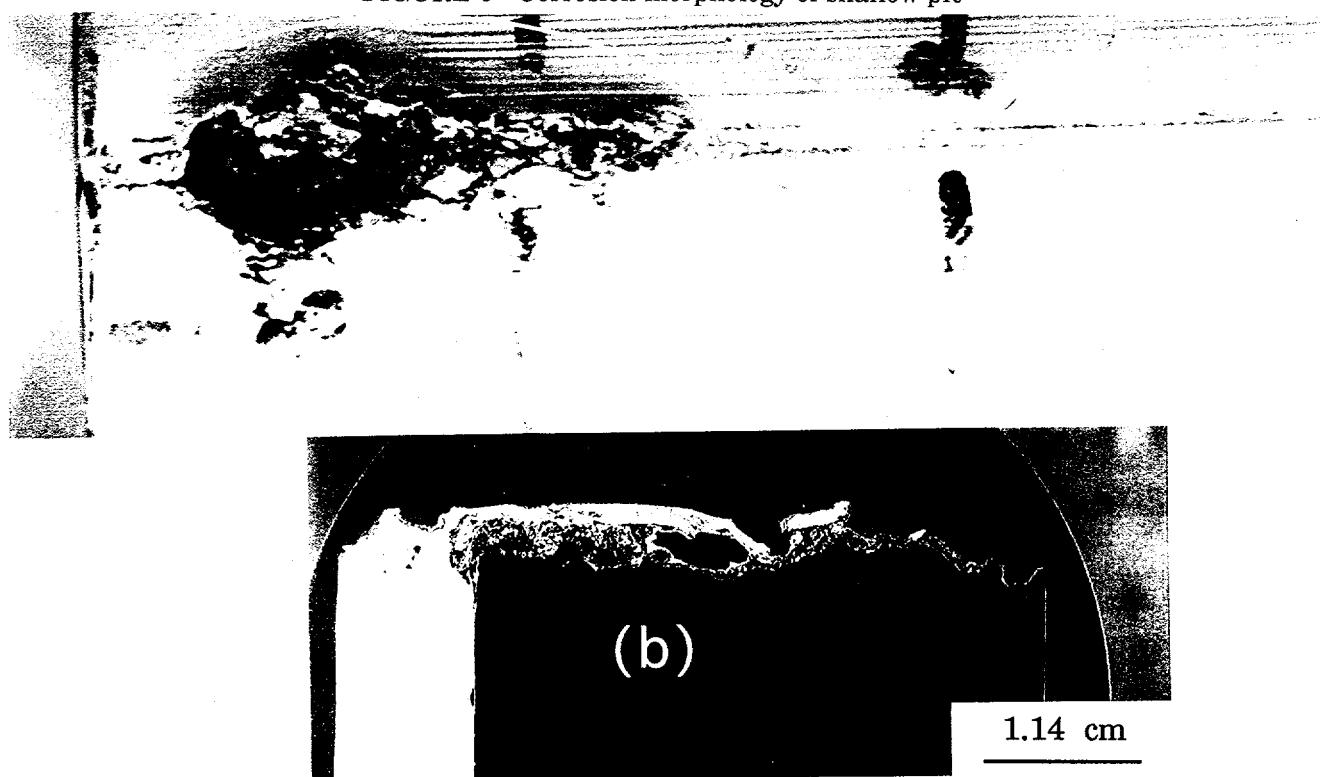
Figure 7 shows a large pit located near the end of the slug. Not only was the cladding affected, but also corrosion of the end cap was present. General corrosion of the uranium is present. Corrosion of the aluminum cap is taking place on the outer edge as well as in the region

of the cap that is in contact with the uranium core as can be seen in 7(b). Due to a crevice that is in this region, accelerated corrosion may be due to crevice corrosion attack in this area.

FIGURE 7 - Corrosion pit affecting aluminum end cap

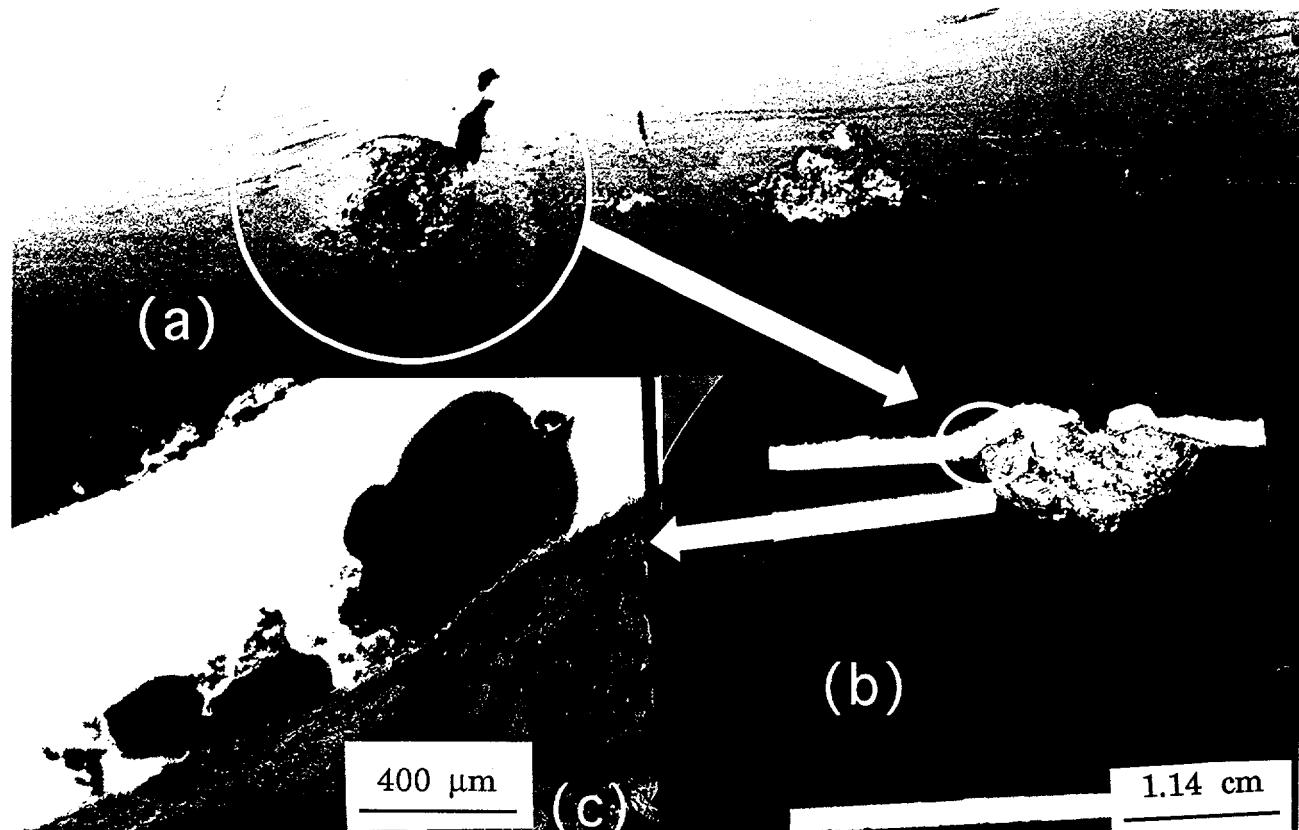
Figure 8(a) shows a large pit on the outer surface of the slug. The pit in this area is shown penetrating deeper into the core than most of the pits examined. The depth of this pit may have been influenced by the strength of the cladding bond. A strong bond outside the bubbled region could cause the corrosion of the uranium to penetrate the core instead of extending along the surface between the cladding. When the aluminum cladding is breached and oxide is formed, the uranium oxide holds aggressive ions in this region close to the underside of the aluminum cladding. This may be responsible for the aluminum corrosion on the outer, as well as, the inner surface of the aluminum cladding.

FIGURE 8 - Pit showing bubble and corrosion product still present
