**Dual-Band Infrared Imaging
for
Quantitative Corrosion Detection in Aging Aircraft**

N. K. Del Grande

**This paper was prepared for submittal to the
ASNT (American Society for Nondestructive Testing)
Fall Conference, Long Beach, California
November 9-11, 1993**

November 1993

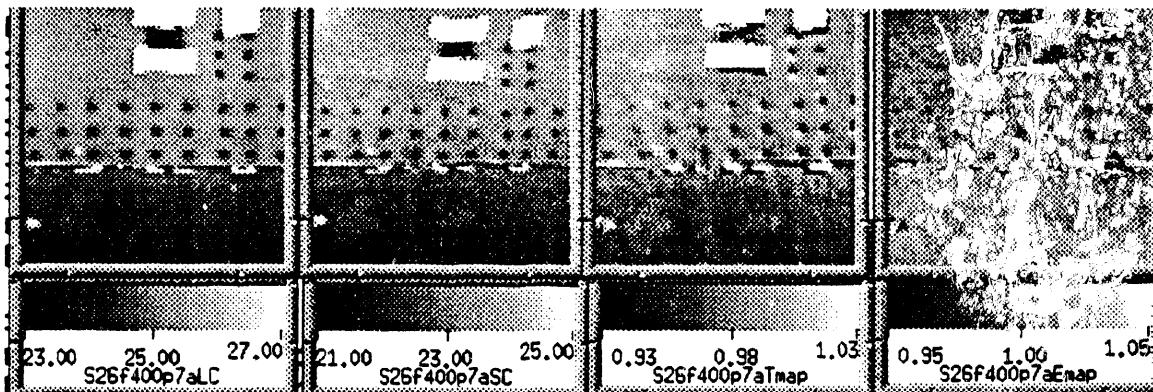
where S is the short-wavelength intensity (e.g., I_5), S_{av} is the average value of the pixels in S , L is the long wavelength intensity (e.g., I_{10}) and L_{av} is the average value of the pixels in L . See Figure 1 for the Boeing 737 images of the above temperature and emissivity-ratio maps which allowed us to distinguish corrosion-related thickness loss effects and surface emissivity clutter (from dirt, dents, tape, markings, ink, sealants, uneven paint, paint stripper, exposed metal and roughness variations).

Figure 1. Maps (left to right) of Boeing 737 lap splice structure with hidden defects showing 10 μm and 5 μm apparent temperatures ($^{\circ}\text{C}$), dual-band infrared (DBIR) enhanced temperatures (relative scale) and emissivity differences from clutter.

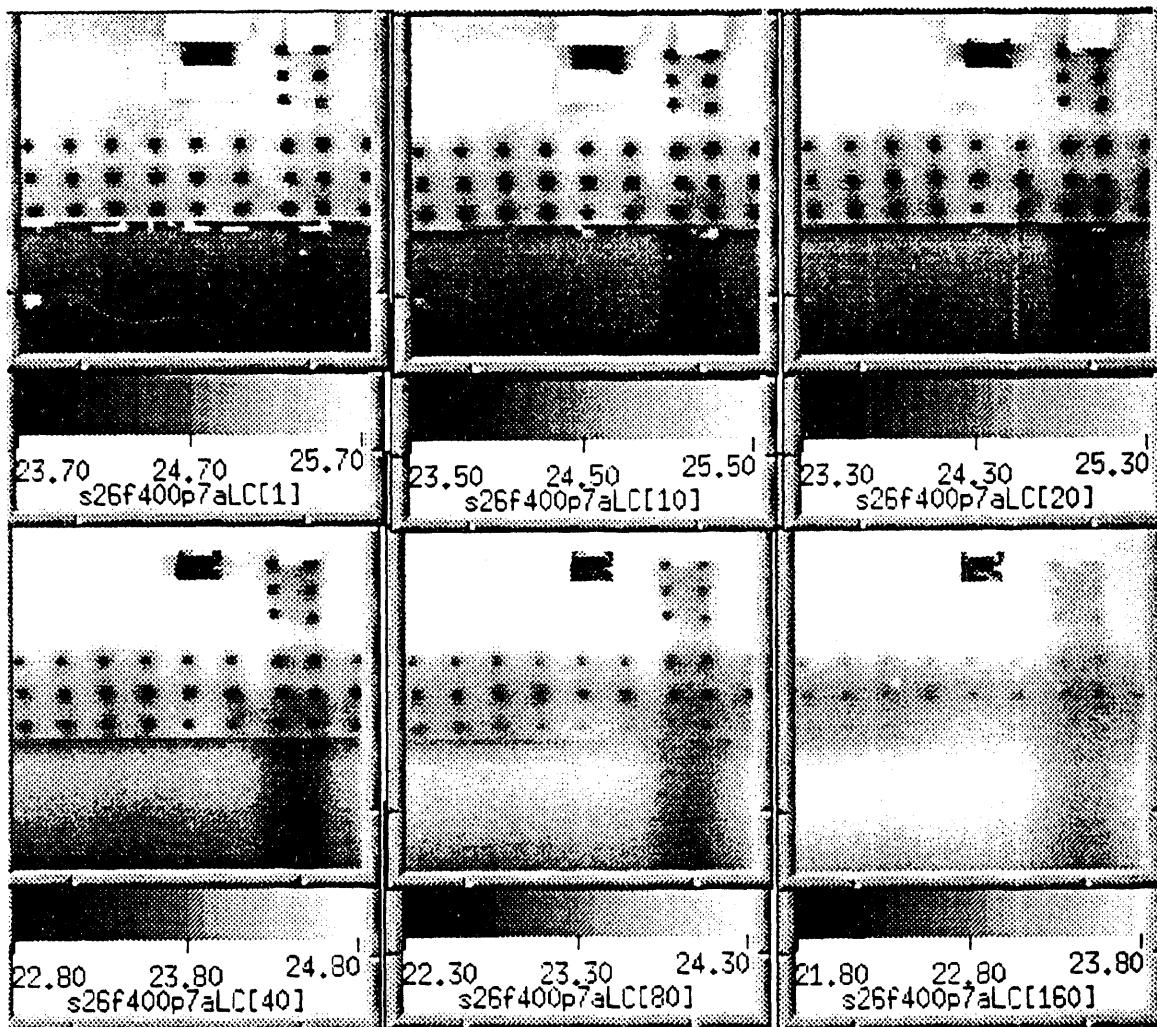
Corrosion within the Boeing 737 (epoxy-bonded) lap splice causes disbonding. Trapped by-products act as an insulator, delaying heat transfer by conduction from the front to the back surface. This effect is shown in Figure 2 by the near-constant temperature contrast from 0.4 to 3.2 s which is based on our measurements of the FAA owned Boeing 737 which was inspected at the Aging Aircraft NDI Center (AANC), at a Sandia hangar in Albuquerque, New Mexico.

Corrosion-related material loss effects are best measured at 0.4 seconds after the heat flash. Temperatures at 0.4 s are sensitive to material loss effects within a lap splice and insensitive to timing uncertainties. The timing is early enough to provide a good temperature contrast for sites with and without material loss from corrosion. At later times, trapped materials mask the temperature-time history which characterizes material-loss effects for corrosion sites.

Figure 2. The dynamic temperature variations for the Boeing 737 lap splice images at 0.04 s, 0.4 s and 0.8 s (top left to right) and at 1.6 s, 3.2 s and 6.4 s (bottom left to right) based on the 10 μm apparent temperature maps.

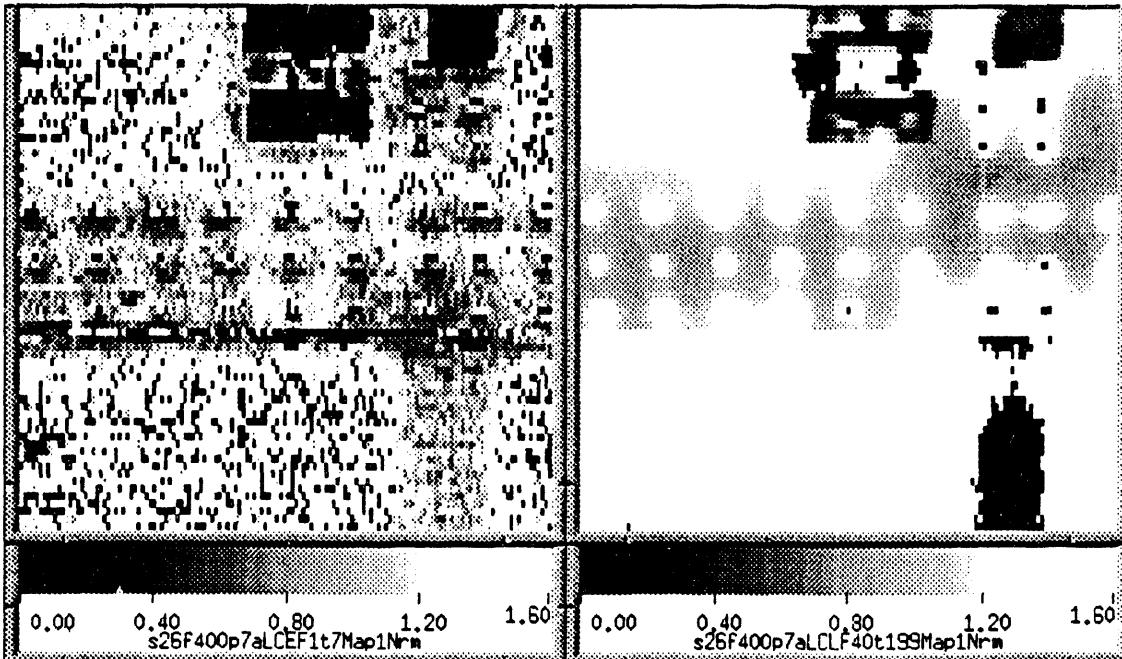
We note in Figure 3 (right side) a butterfly-like pattern at the upper right side. This is where the corrosive activity invaded the inside (upper lap edge) of the Boeing 737 lap splice on Stringer 26, near station F400.7, beneath the galley and the latrine. Typical visible signs of corrosion were also evident (e.g., pillowing) resulting from the increased volume of corrosion by-products within the lap splice, between the rivet heads.

Figure 3. Seven early-time (less than 0.28 s, on the left) and 159 late-time (1.6 s to 8.0 s, on the right) images were used to produce composite thermal inertia maps of the Boeing 737 aircraft fuselage lap splice shown above. Note the relatively low thermal inertia for the front-surface cloth tape and masking tape markers (top center and right corner) and the back surface tear strap (bottom right corner).
