## Dual-Band Infrared (DBIR) Imaging Inspections of Boeing 737 and KC-135 Aircraft Panels

P. K. Bhagat  
Manager, Nondestructive Inspection R&D  
Aging Aircraft Program  
FAA Technical Center  
Atlantic City Airport, NJ 08505

N. K. Del Grande, K. W. Dolan, P. F. Durbin  
Nondestructive Evaluation Section  
Engineering Sciences Division

27 August 1993

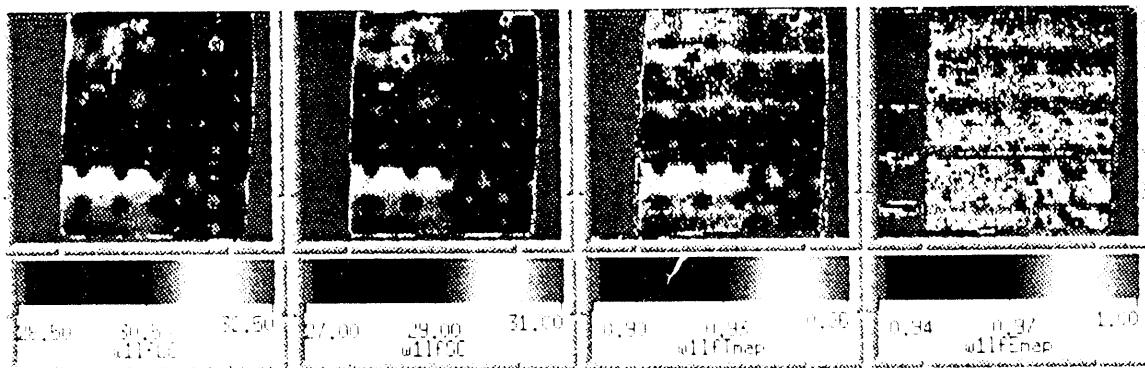
Figure 4. End panel H1 from the Tinker AFB Boeing KC-135 panels inspected at LLNL showing (from left to right) two apparent temperature 10  $\mu\text{m}$  and 5  $\mu\text{m}$  maps, the DBIR enhanced contrast temperature map and an emissivity-ratio map. Note red, hot arrow near the top left corner from wax pencil markings under the black paint that absorbed more heat beneath the paint than surrounding areas. See Appendix A for photograph of this left end piece of Inspection Panel No. 1.

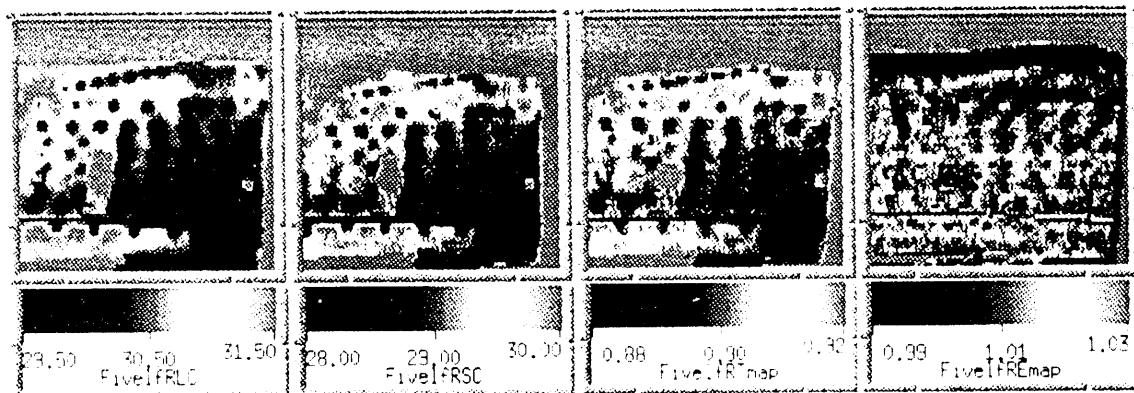
Figure 5. End panel 5IR from the Tinker AFB Boeing KC-135 panels inspected at LLNL showing (from left to right) two apparent temperature 10  $\mu\text{m}$  and 5  $\mu\text{m}$  maps, the DBIR enhanced contrast temperature map and an emissivity-ratio map. Note "bandaid-like" hot area left of center, within the lap splice, where there was a repair patch over a known area of corrosion. The masking tape marker for this area had a different emissivity ratio than the nearby surroundings from surface roughness effects.

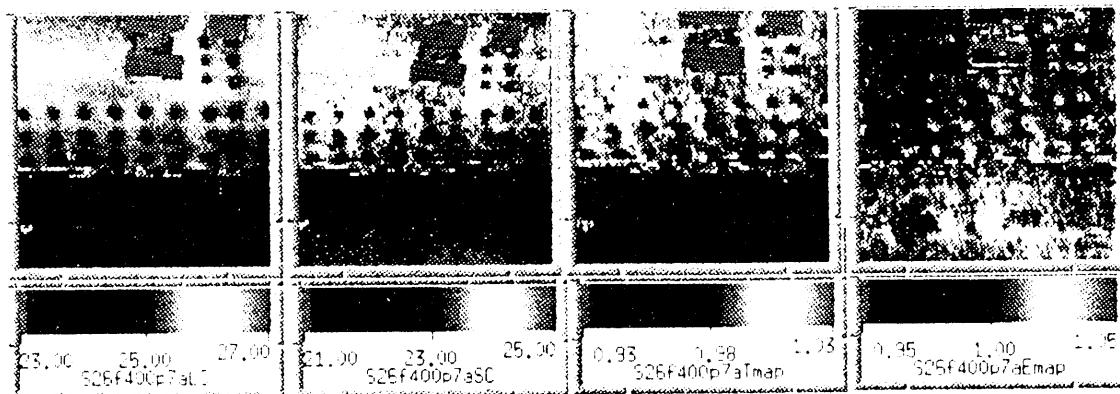
Figure 6. The Boeing 737 aircraft fuselage, Stringer 26 (s26f400p7a) showing (from left to right) two apparent temperature 10  $\mu\text{m}$  and 5  $\mu\text{m}$  maps, the DBIR enhanced contrast temperature map and an emissivity-ratio map. Note temperature and emissivity-ratio differences for various black cloth (red, hot) and metal (purple, cold) tape markers at top, right of center and masking tape marker (painted black) at top right corner. Also, note non-uniform paint applied below lap splice at the bottom.

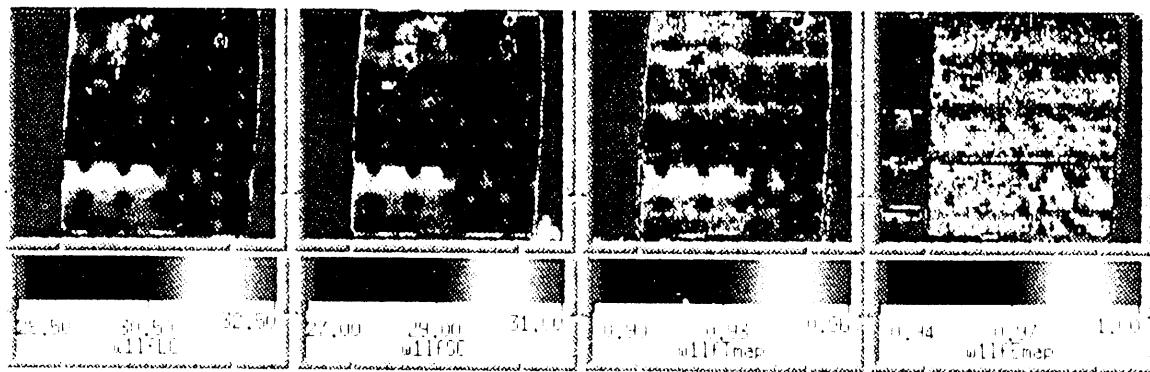
Figure 4. End panel 11E from the Tinker AFB Boeing KC-135 panels inspected at LLNL showing (from left to right) two apparent temperature 10  $\mu\text{m}$  and 5  $\mu\text{m}$  maps, the DBIR enhanced contrast temperature map and an emissivity-ratio map. Note red, hot arrow near the top left corner from wax pencil markings under the black paint that absorbed more heat beneath the paint than surrounding areas. See Appendix A for photograph of this left end piece of Inspection Panel No. 1.

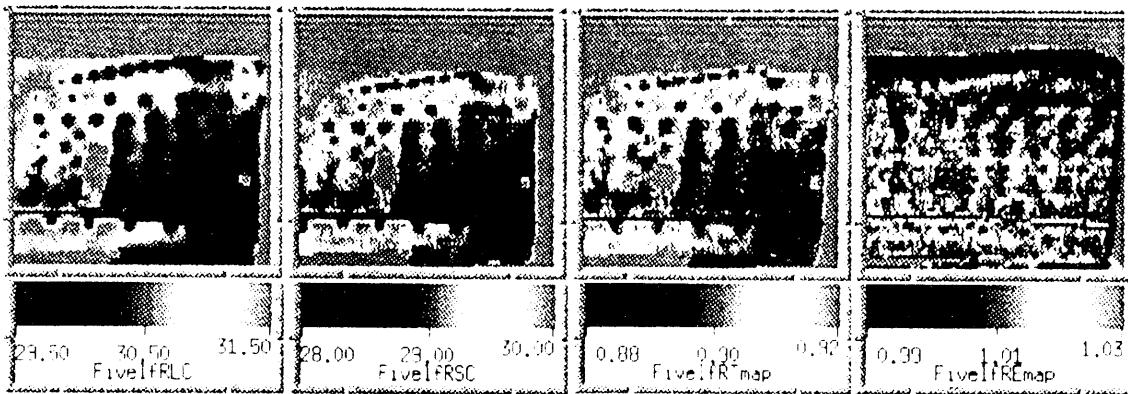
Figure 5. End panel 5HR from the Tinker AFB Boeing KC-135 panels inspected at LLNL showing (from left to right) two apparent temperature 10  $\mu\text{m}$  and 5  $\mu\text{m}$  maps, the DBIR enhanced contrast temperature map and an emissivity-ratio map. Note "bandaid-like" hot area left of center, within the lap splice, where there was a repair patch over a known area of corrosion. The masking tape marker for this area had a different emissivity ratio than the nearby surroundings from surface roughness effects.

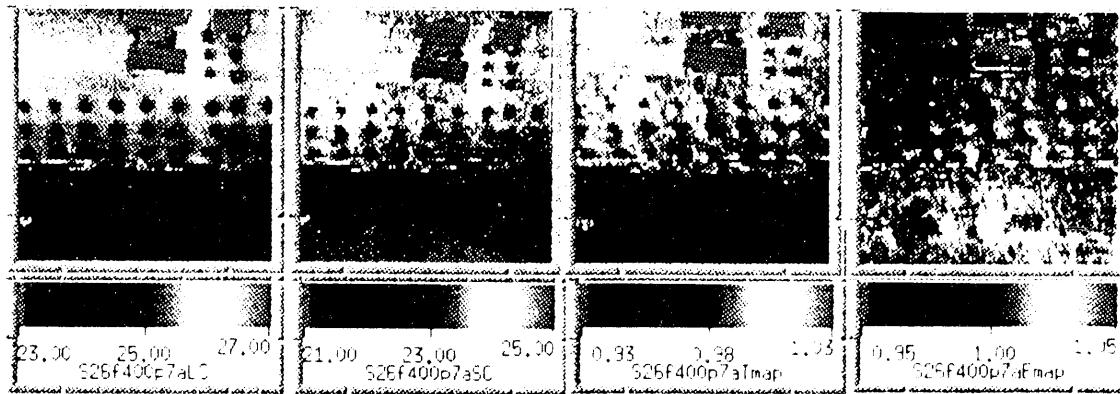
Figure 6. The Boeing 737 aircraft fuselage, Stringer 26 (S26f400p7a) showing (from left to right) two apparent temperature 10  $\mu\text{m}$  and 5  $\mu\text{m}$  maps, the DBIR enhanced contrast temperature map and an emissivity-ratio map. Note temperature and emissivity-ratio differences for various black cloth (red, hot) and metal (purple, cold) tape markers at top, right of center and masking tape marker (painted black) at top right corner. Also, note non-uniform paint applied below lap splice at the bottom.

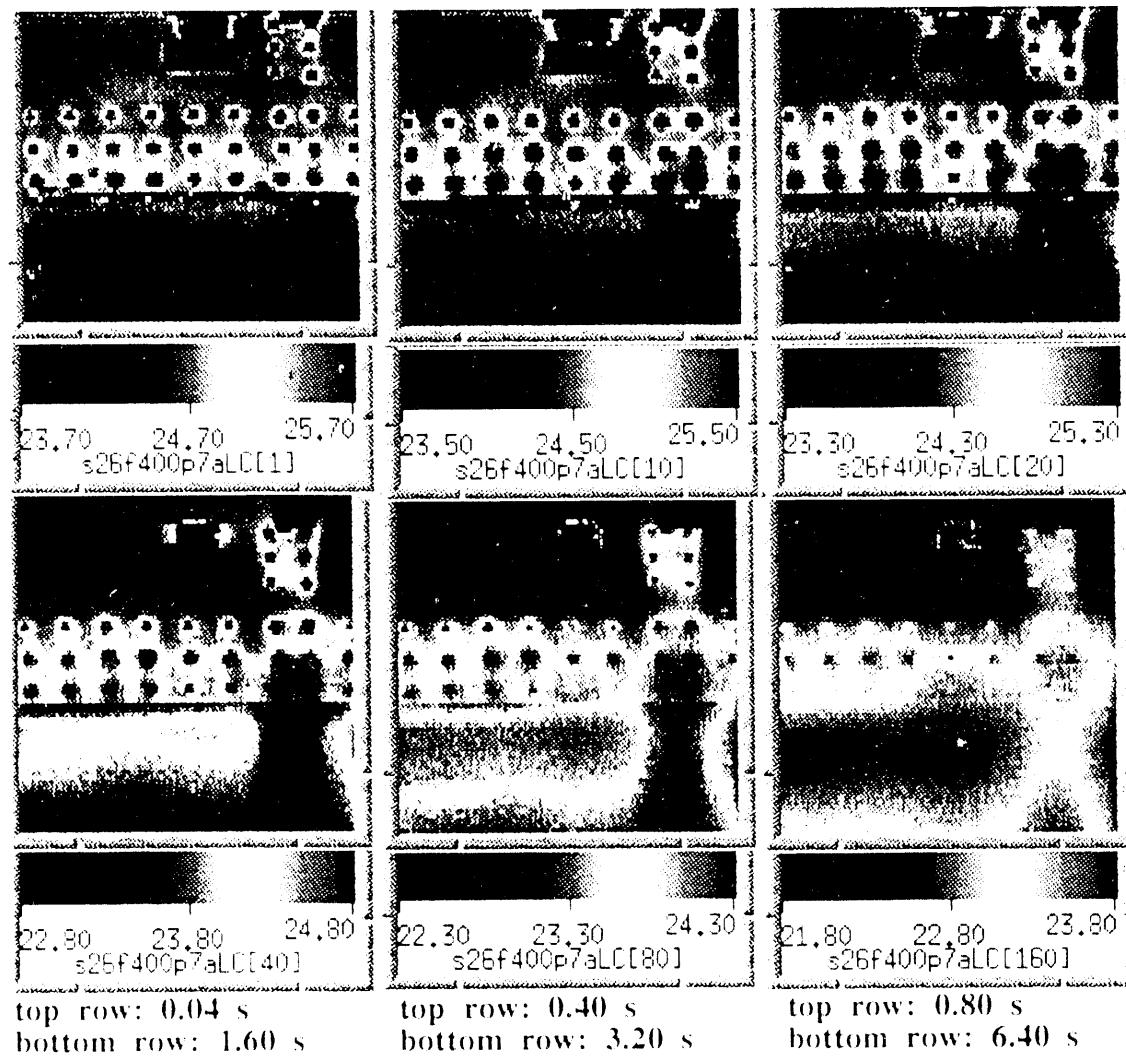
Figure 10. The dynamic temperature ( $^{\circ}\text{C}$ ) variations for the Boeing 737 aircraft fuselage, Stringer 26, Station 400, centered 0.7 of the way toward the next larger station (s26f400.7) at 0.04 s, 0.40 s, 0.80 s (top left to right) and at 1.60 s, 3.20 s and 6.40 s (bottom left to right) based on the apparent temperature maps recorded at 10  $\mu\text{m}$ . Note minimal change in lap splice above-ambient temperature contrast at (corrosion-related) disbond site (beneath blue, cold, tape marker) from 0.4 s to 3.2 s.

Whereas the Boeing KC-135 aircraft lap splices are held together with rivets, they have no adhesive bonds. The Boeing KC-135 Panel 2 (2FR, at the right edge) lap splice sites have significant material loss (35%–45%) from corrosion at center right of images in Figure 11. These sites have above-ambient (1.5–1.9  $^{\circ}\text{C}$ ) temperature rises which remain constant from 0.4 s to 0.8 s, unlike the above-ambient (0.20–0.6  $^{\circ}\text{C}$ ) Boeing 737 (s26f400.7) corroded lap splice sites which remain constant from 0.4 s to 3.2 s.

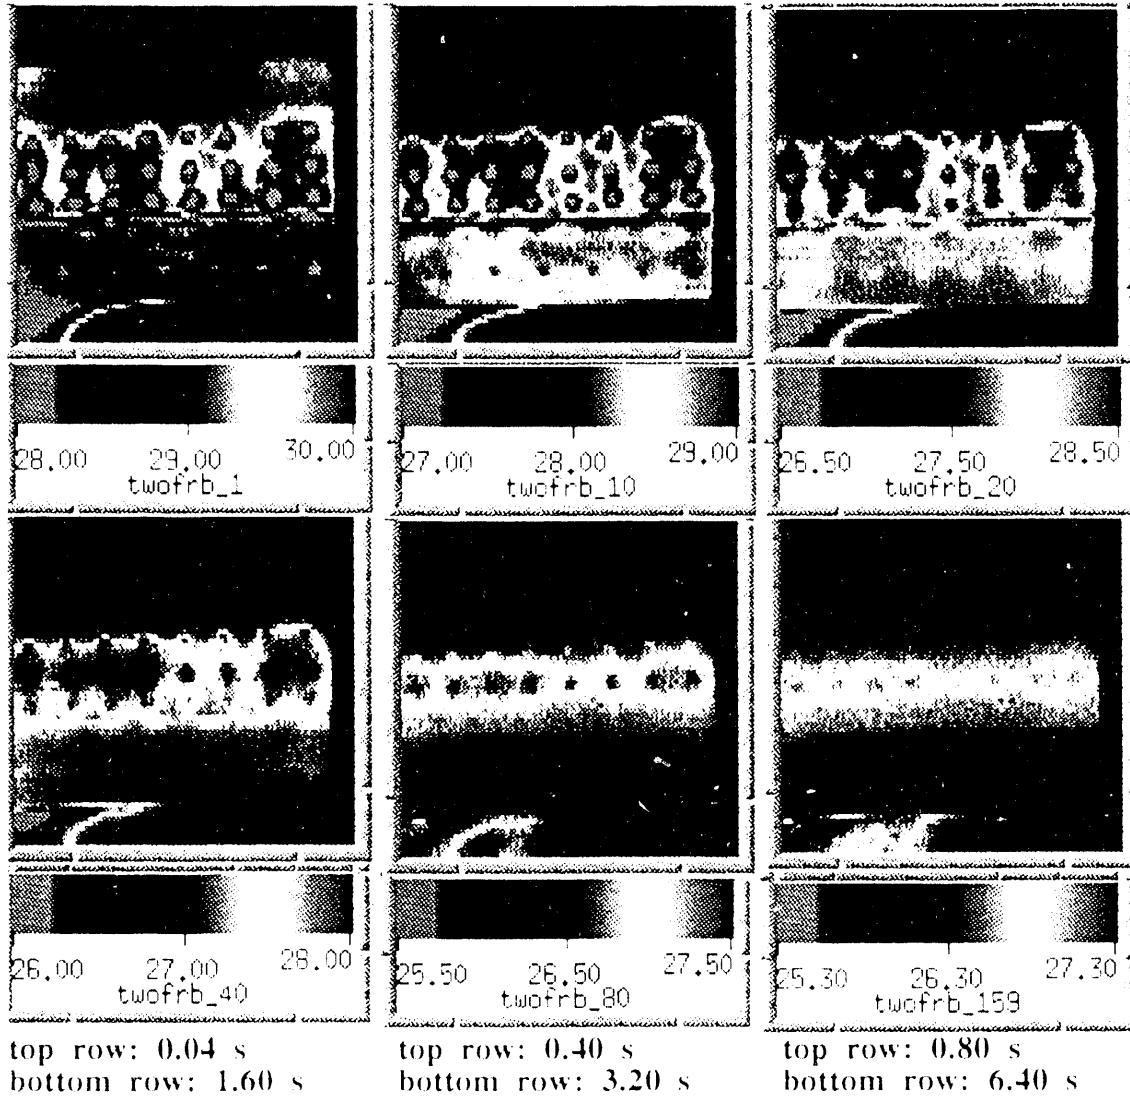
Figure 11. The dynamic temperature variations for the Boeing KC-135 Panel 2 (2FR, at the right edge) at 0.04 ms, 0.40 s, 0.80 s (top left to right) and at 1.60 s, 3.20 s and 6.40 s (bottom left to right) based on the apparent temperature maps recorded at 10  $\mu$ m.

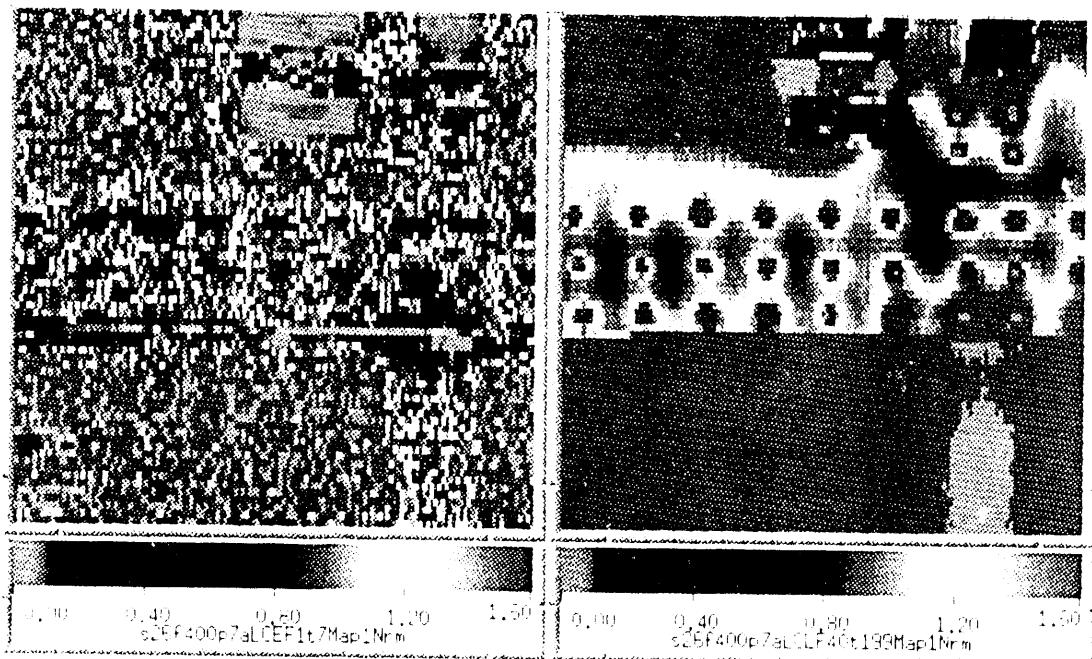
Early-time (less than 0.3 s, on the left) and late-time (more than 0.4 s, on the right) composite thermal inertia maps in Figures 12 and 13 are based on the (inverse) slope of the temperature versus inverse square root of time responses. Heavily corroded areas with the most material loss are red, hot in Figures 10-11. Corroded lap splices have low (green) composite thermal inertias and change temperature more readily than their thicker (uncorroded) surroundings.

Figure 12. Seven early-time (less than 0.28 s, on the left) and 159 late-time (1.6 s to 8.0 s, on the right) images were used to produce composite thermal inertia maps of the Boeing 737 aircraft fuselage. Stringer 26 (s26f400.7) shown above. Note the green "butcher-like" site on the late-time thermal inertia map where corrosion entered the lap splice from inside the aircraft. This site was beneath the galley and the latrine. Also, note the relatively low thermal inertia for front-surface cloth and masking tape markers and back surface tear straps (bottom right corner).

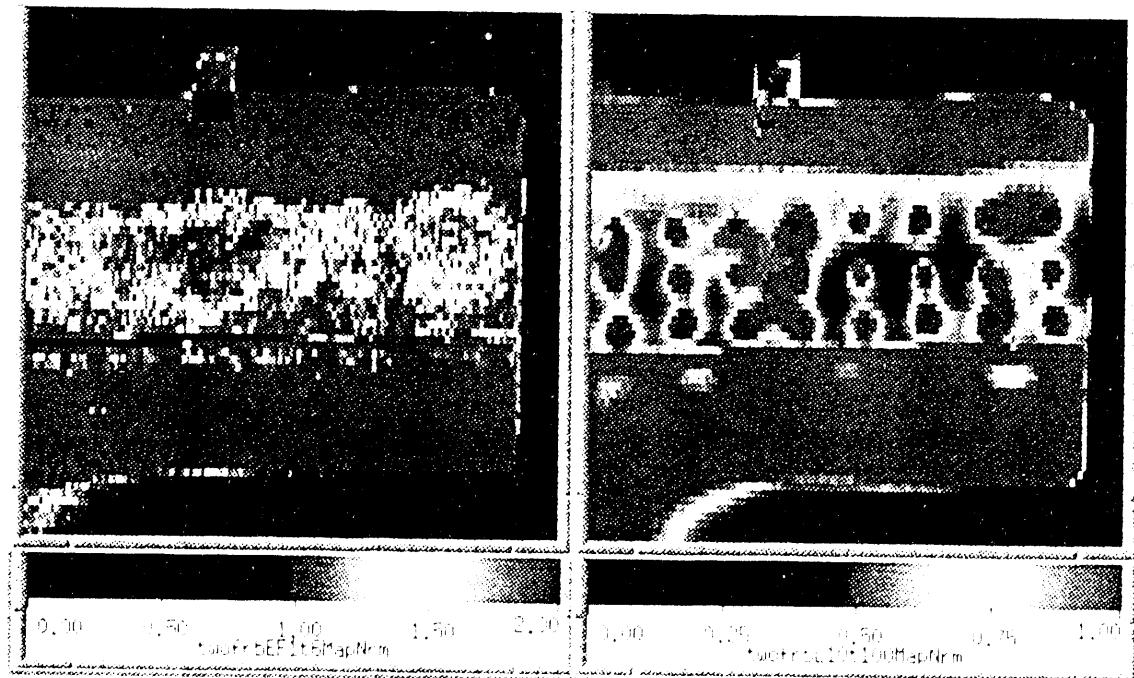
Figure 13. Six early time (less than 0.24 s, on the left) and 90 late time (0.40 s to 4.0 s, on the right) images were used to produce composite thermal inertia maps of Panel 2 (2FR, at the right edge) shown above. Low thermal inertia sites (with the most material loss from corrosion and the least resistance to temperature change) appear green, whereas high thermal inertia sites (with the smallest percentage of material loss from corrosion and the most resistance to temperature change) appear red.

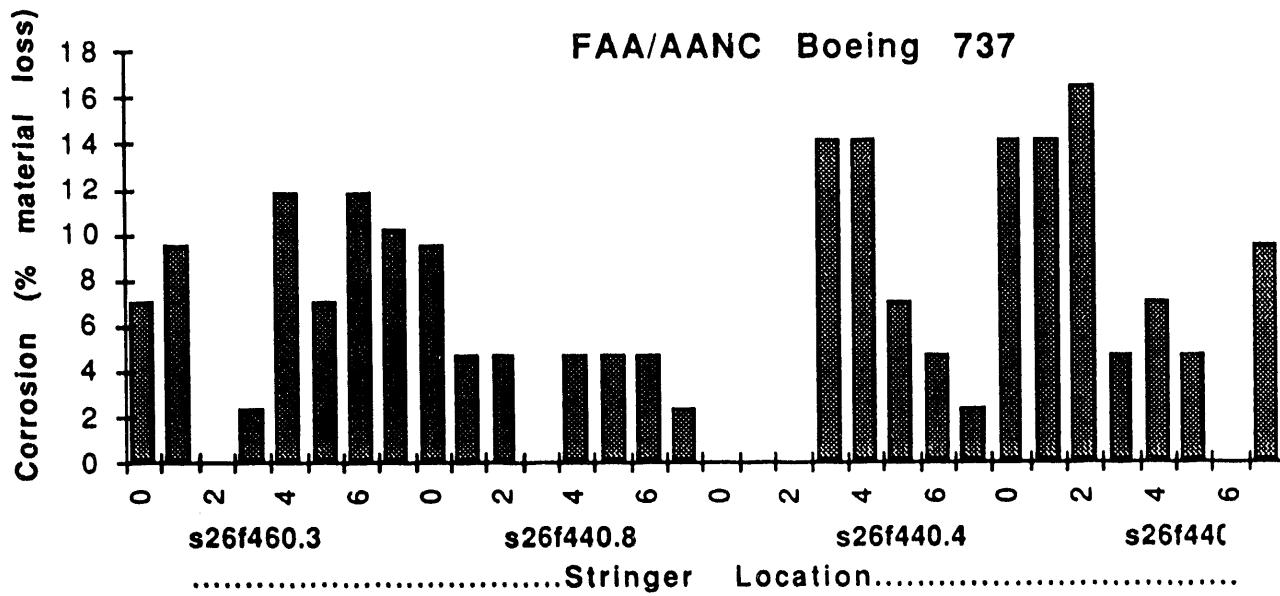
Figure 17. Percent material loss from corrosion, left to right of Stringer 26 images (centered from 30% aft of Station f460 to Station f440) relative to a cooler area with less material loss from corrosion. See Table 2 and Appendix B for spot locations where surface temperature differences were measured.

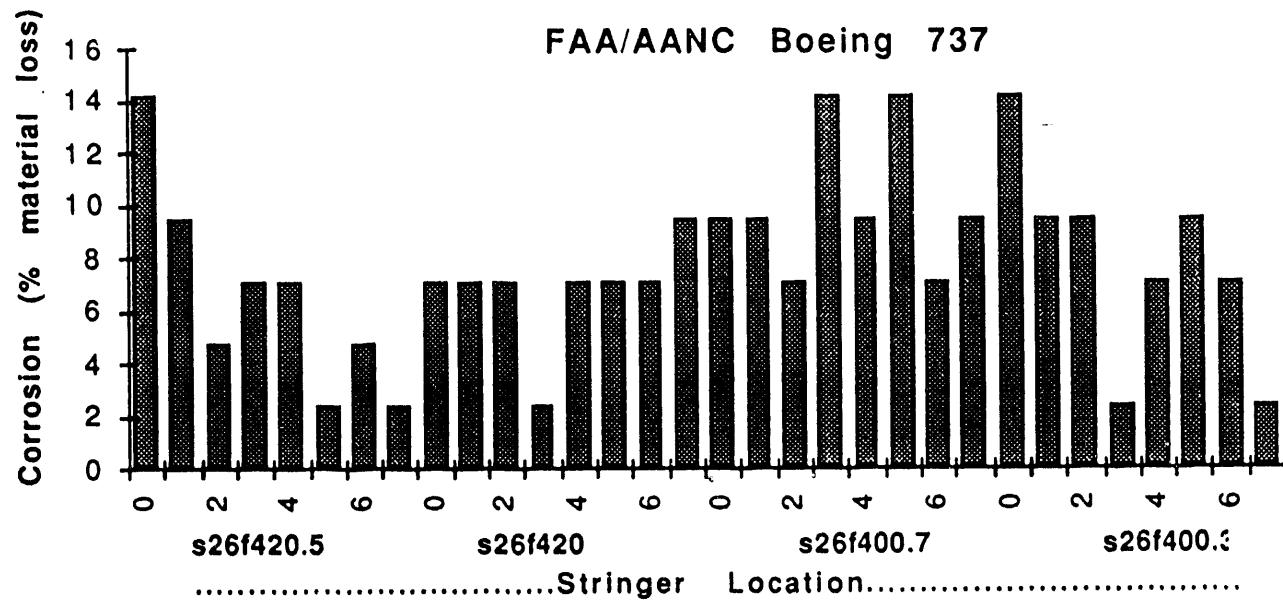
Figure 18. Percent material loss from corrosion, left to right of Stringer 26 images (centered from 50% aft of Station f420 to 30% aft of Station f400) relative to a cooler area with less material loss from corrosion. See Table 2 and Appendix B for spot locations where surface temperature differences were measured.

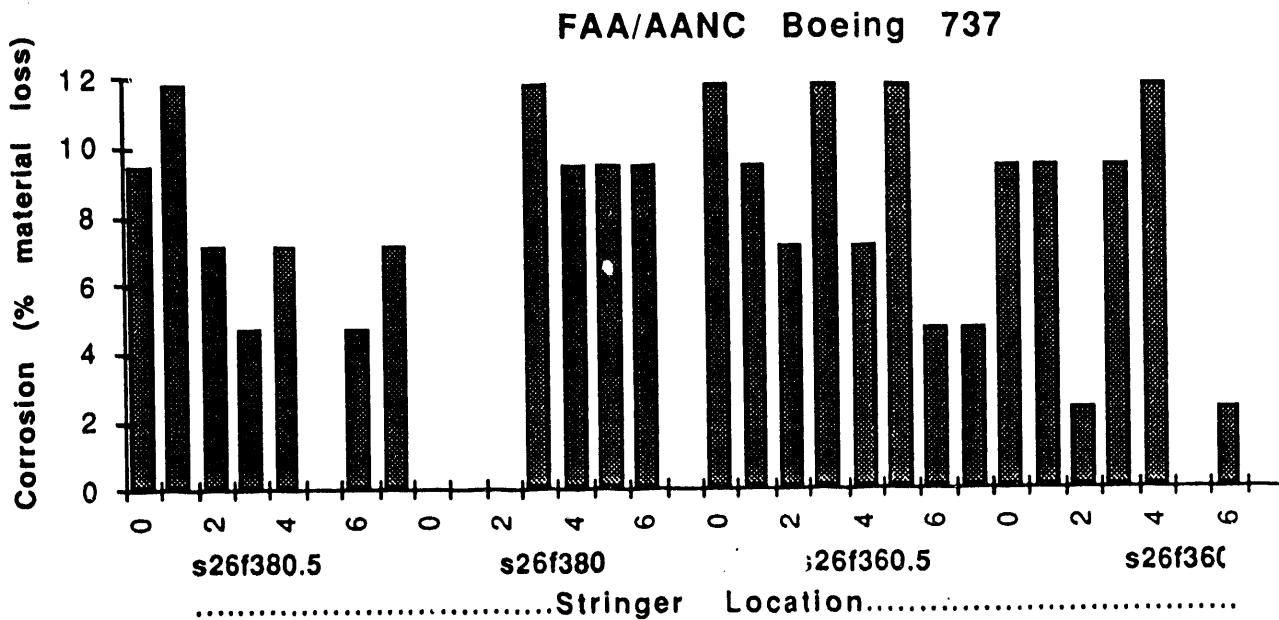
Figure 19. Percent material loss from corrosion, left to right of Stringer 26 images (centered from 50% aft of Station f380 to Station f360) relative to a cooler area with less material loss from corrosion. See Table 2 and Appendix B for spot locations where surface temperature differences were measured.

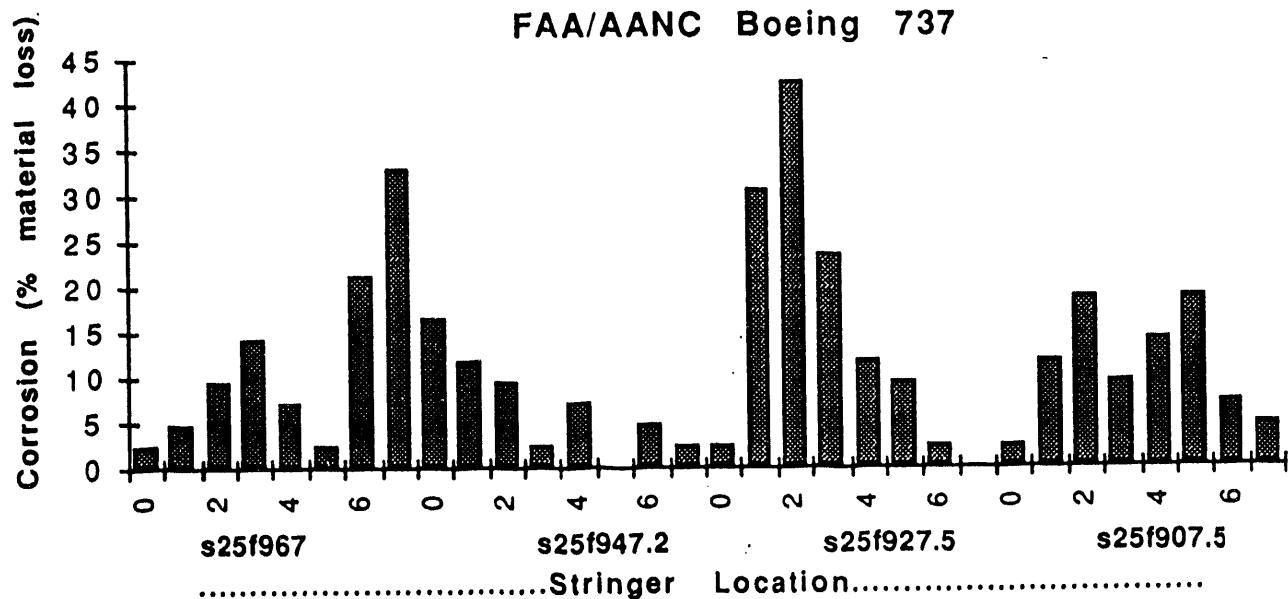
Figure 20. Percent material loss from corrosion, left to right of Stringer 25 images (centered from Station f967, near the tail section, to 50% aft of Station f360) relative to a cooler area with less material loss from corrosion. See Table 3 and Appendix B for spot locations where surface temperature differences were measured.

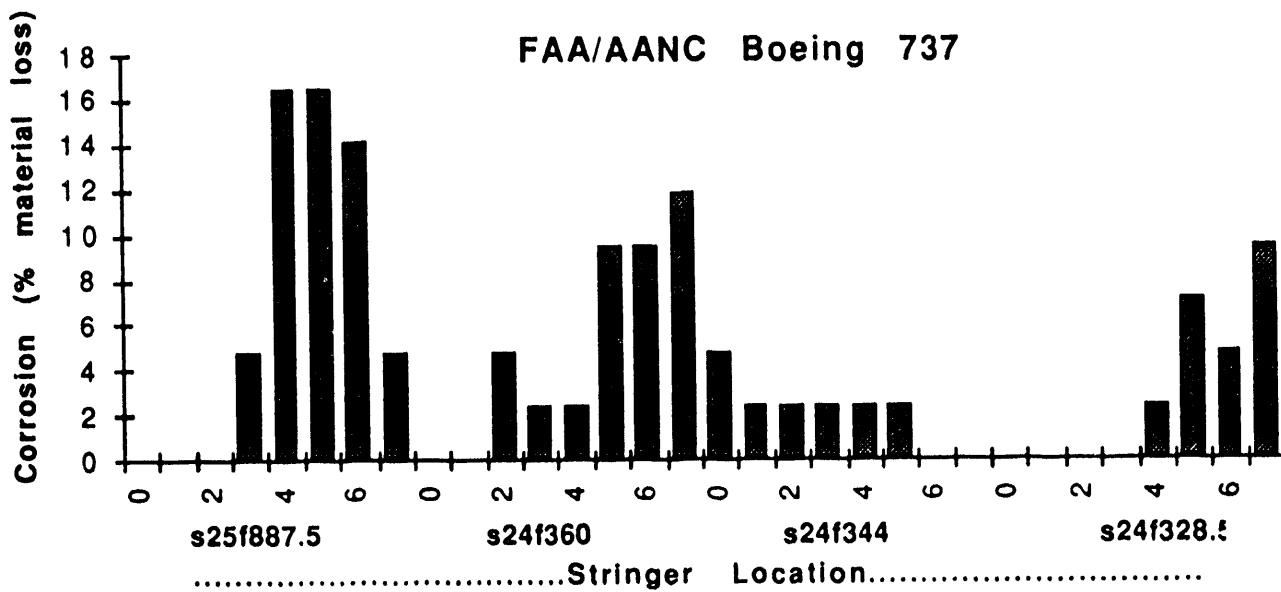
Figure 21. Percent material loss from corrosion, left to right of Stringer 25 images (centered 50% aft of Station f887, near the tail section) and Stringer 24 (centered from Station f360 to 50% aft of Station f328, near the nose section) relative to a cooler area with less material loss from corrosion. See Table 3 and Appendix B for spot locations on color-coded temperature maps.

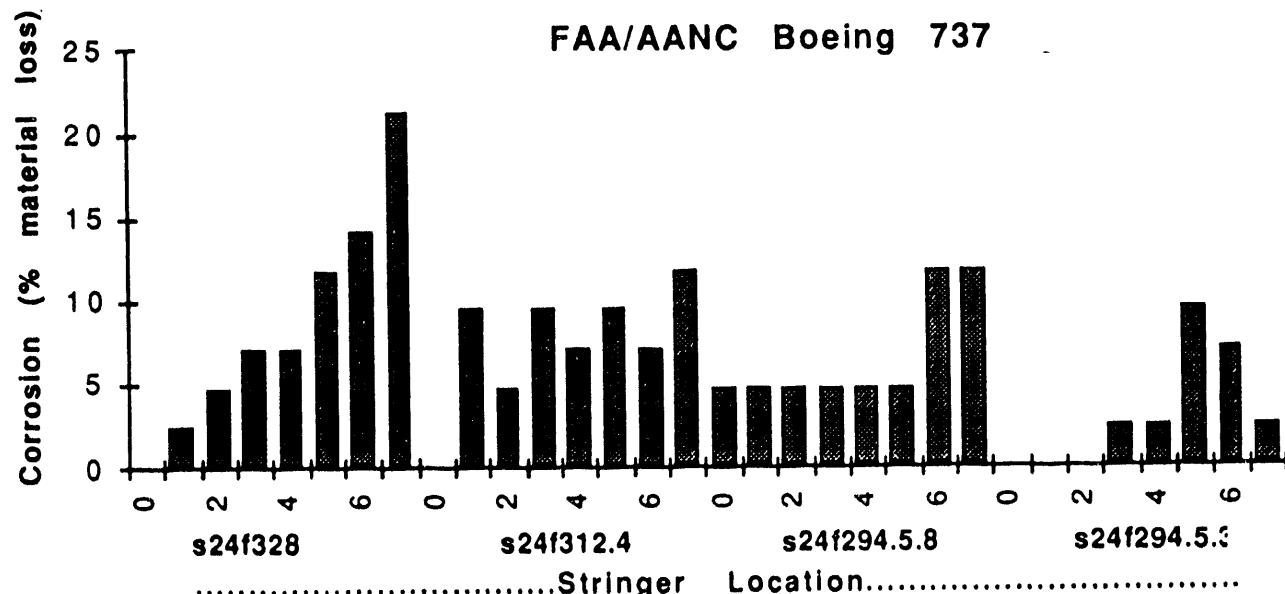
Figure 22. Percent material loss from corrosion, left to right of Stringer 24 images (centered from Station f328 to 30% aft of Station f294.5, near the nose section) relative to a cooler area with less material loss from corrosion. See Table 3 and Appendix B for spot locations on color-coded temperature maps.

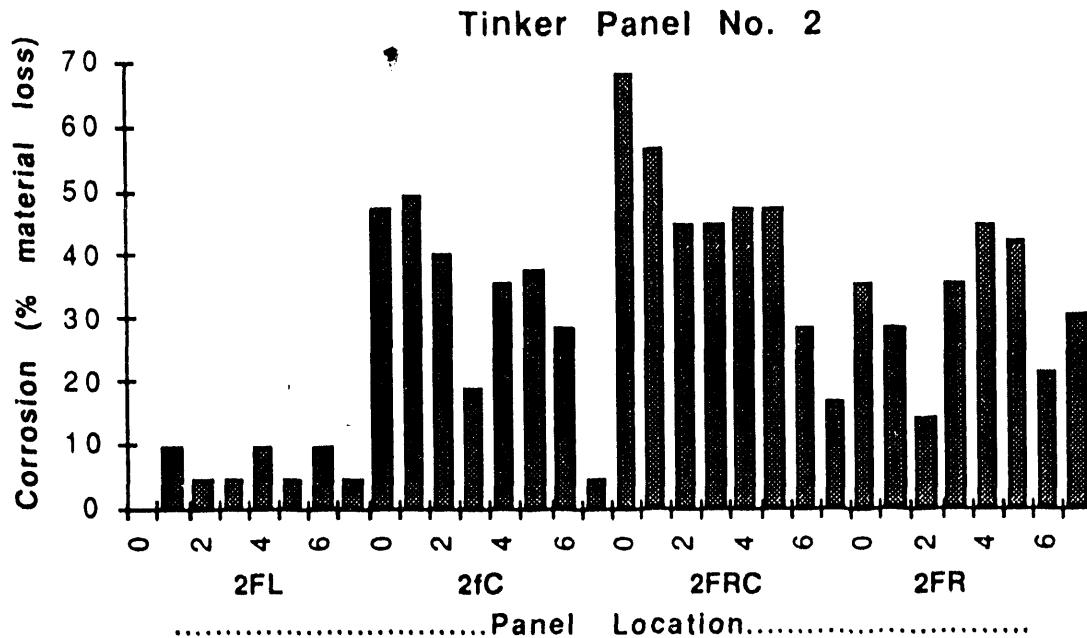
Figure 23. Percent material loss from corrosion, left to right of Panel 2, relative to a cooler area with less material loss from corrosion. See Appendix C for spot locations where surface temperature differences were measured.

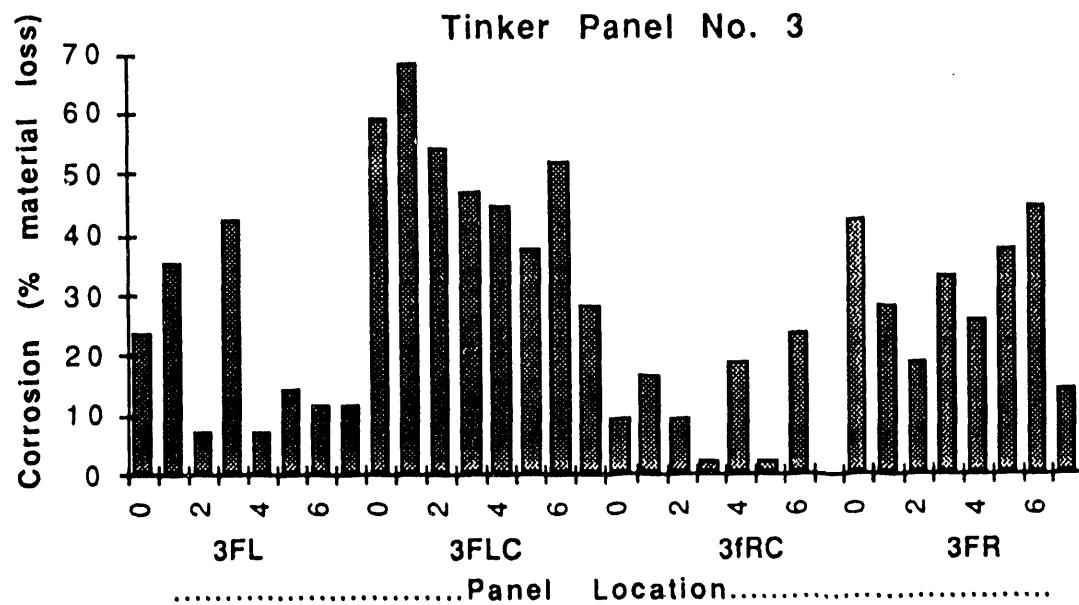
Figure 24. Percent material loss from corrosion, left to right of Panel 3, relative to a cooler area with less material loss from corrosion. See Appendix C for spot locations where surface temperature differences were measured.

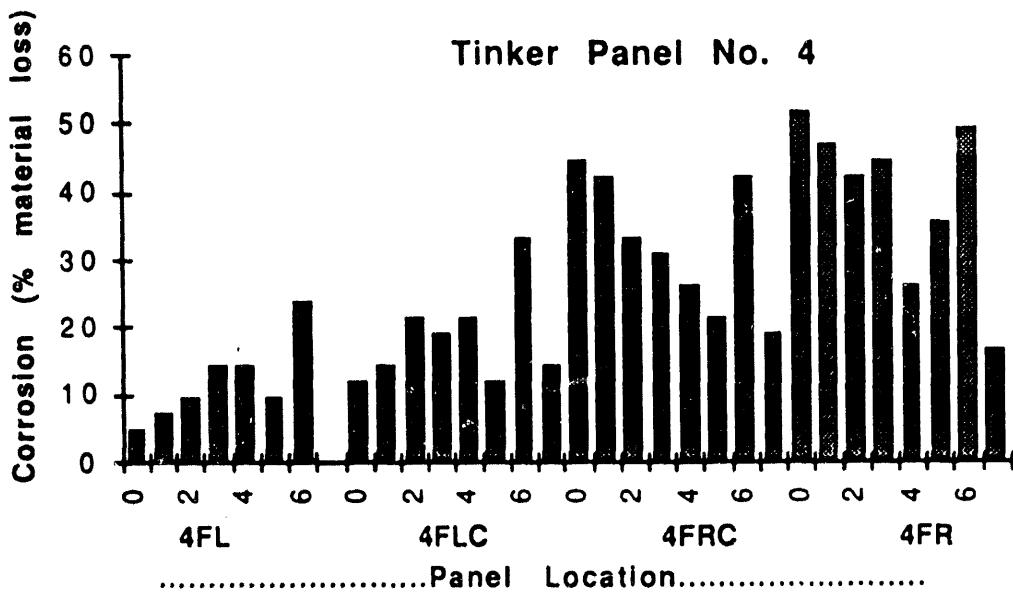
Figure 25. Percent material loss from corrosion, left to right of Panel 4, relative to a cooler area with less material loss from corrosion. See Appendix C for spot locations where surface temperature differences were measured.

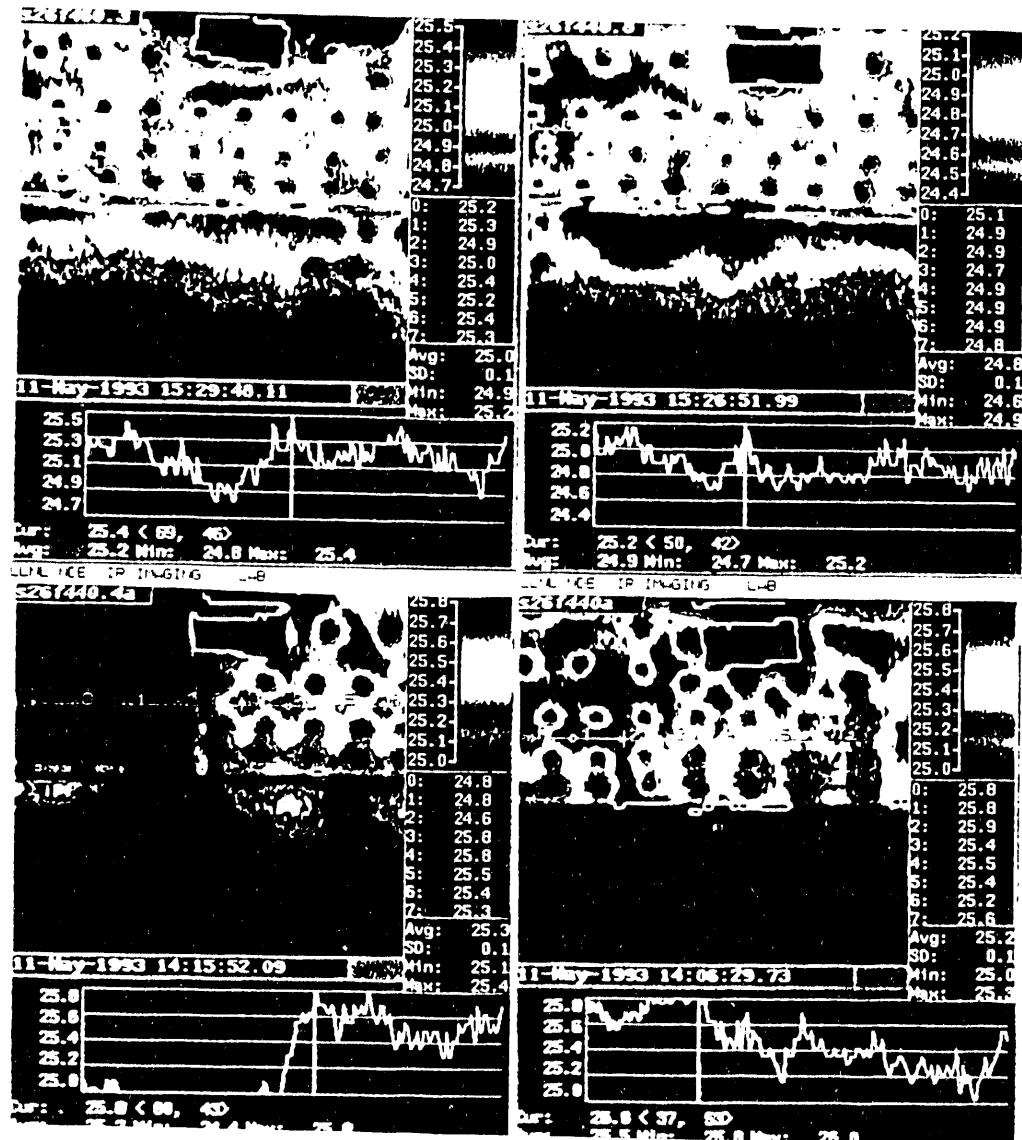
Figure B-7. Boeing 737, Stringer 26 Agema 880 DBIR System long wavelength (10  $\mu$ m) color-coded temperatures in  $^{\circ}$ C at 0.4 s after flash, as shown in four images from top row, left to right, Station f460.3 (30% aft, toward next station) and Station f440.4 (40% aft, toward next station) and bottom row, left to right, Station f440.3 (80% aft, toward next station) and Station f440.4 (40% aft, toward next station). See Table 2, Figure 17.

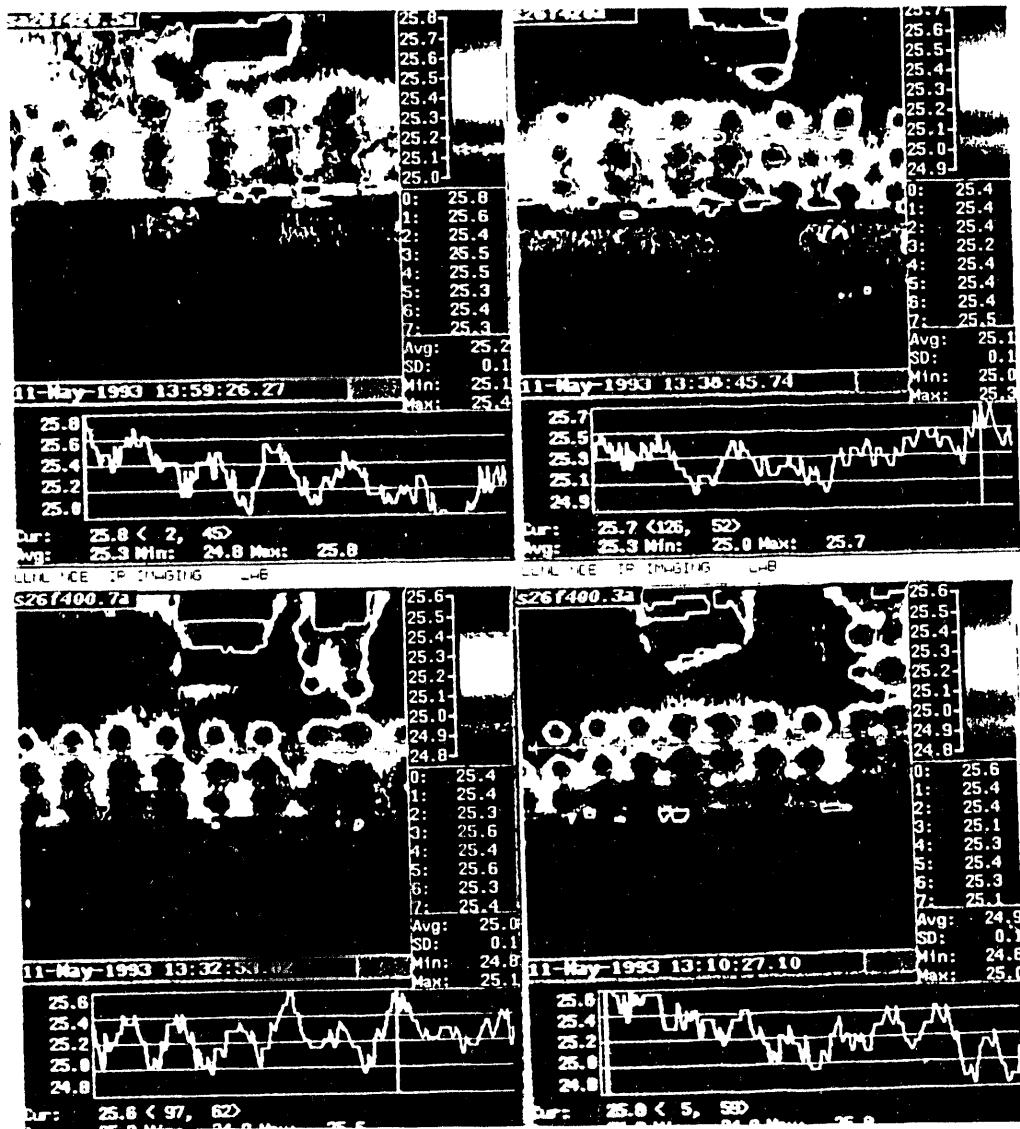
Figure B-8. Boeing 737, Stringer 26 Agema 880 DBIR System long wavelength (10  $\mu$ m) color-coded temperatures in  $^{\circ}$ C at 0.4 s after flash, as shown in four images from top row, left to right, Station f420.5 (50% aft, toward next station) and Station f420 and bottom row, left to right, Station f400.7 (70% aft, toward next station) and Station f400.3 (30% aft, toward next station). See Table 2, Figure 18.

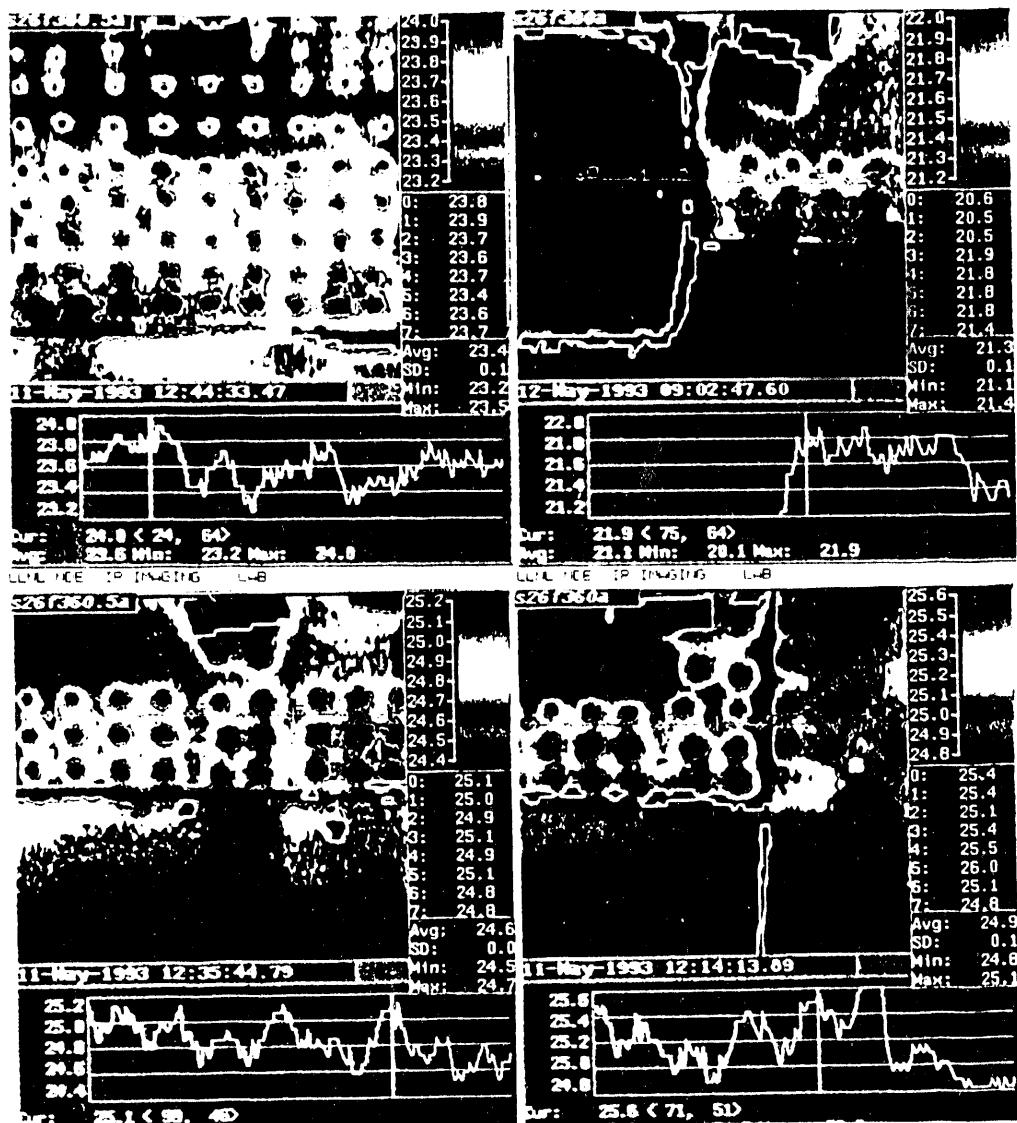
Figure B-9. Boeing 737, Stringer 26 Agema 880 DBIR System long wavelength (10 μm) color-coded temperatures in °C at 0.4 s after flash, as shown in four images from top row, left to right, Station f380.5 (50% aft, toward next station) and Station f380 and bottom row, left to right, Station f380.5 (50% aft, toward next station) and Station f380. See Table 2, Figure 19.

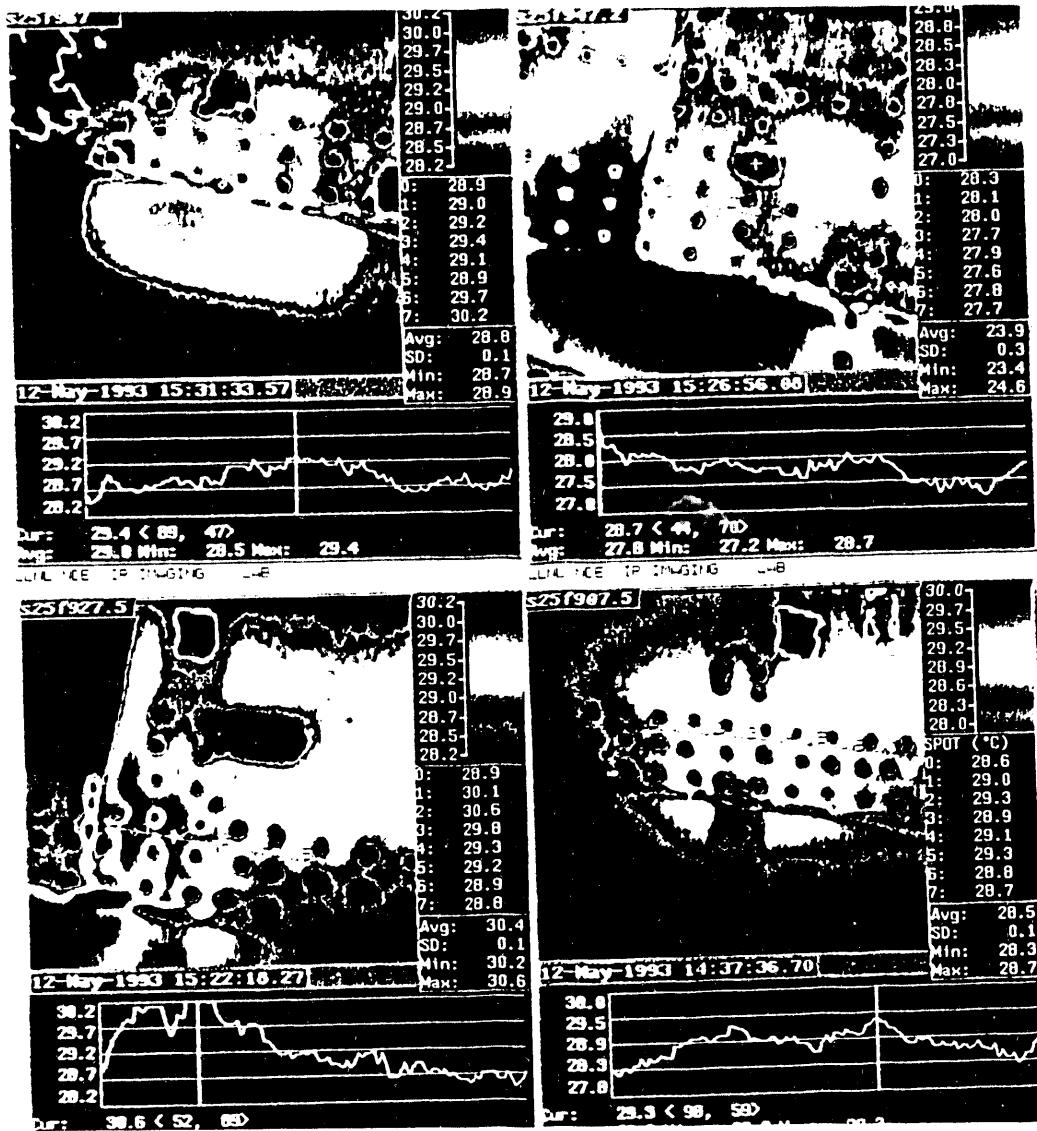
Figure B-10. Boeing 737, Stringer 25 Agema 880 DBIR System long wavelength (10  $\mu$ m) color-coded temperatures in  $^{\circ}$ C at 0.4 s after flash, as shown in four images from top row, left to right, Station f967 and Station f947.2 (20% aft, toward next station) and bottom row, left to right, Station f927.5 (50% aft, toward next station) and Station f907.5 (50% aft, toward next station). See Table 3, Figure 20.

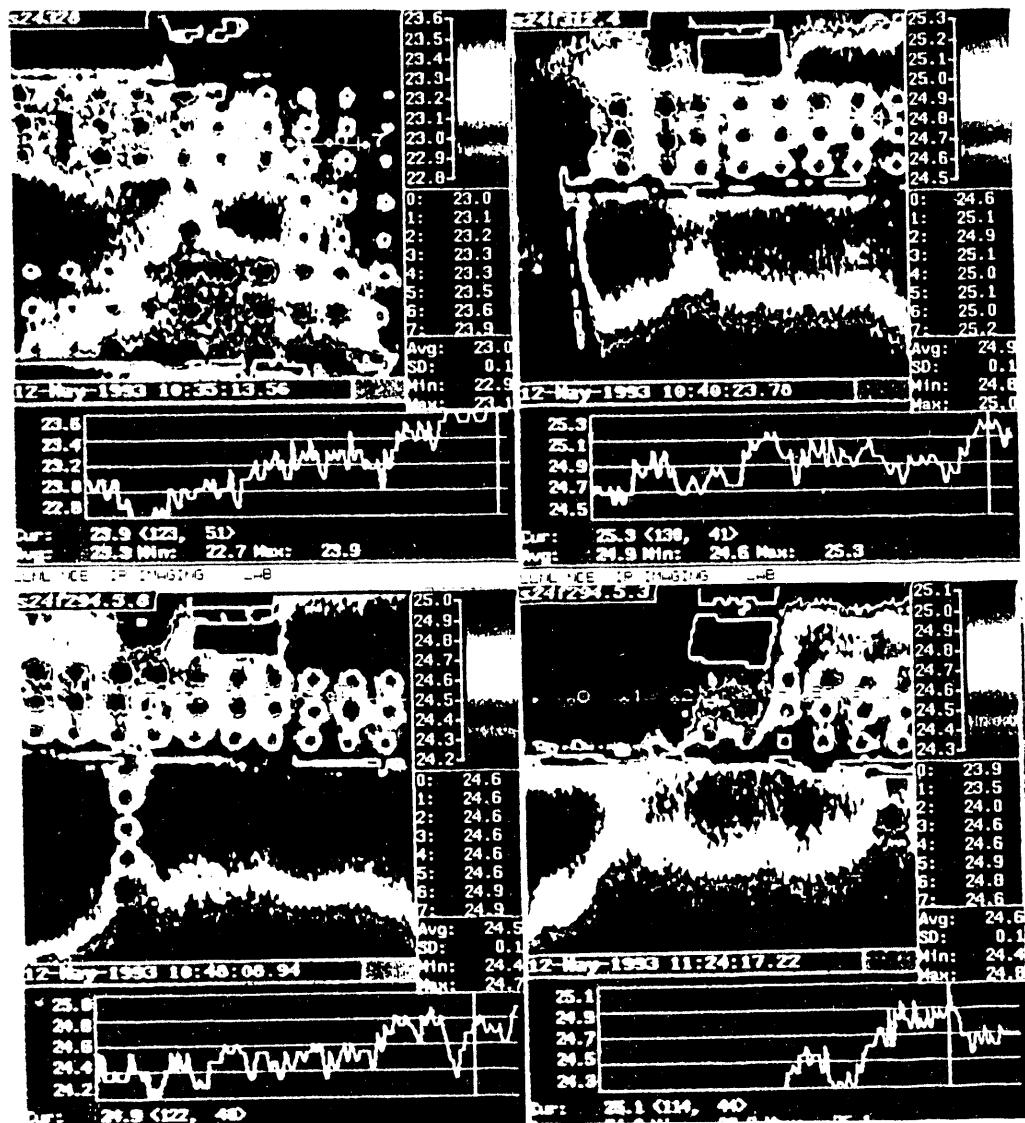
Figure B-12. Boeing 737, Stringer 24 Agema 880 DBIR System long wavelength (10  $\mu$ m) color-coded temperatures in  $^{\circ}$ C at 0.4 s after flash, as shown in four images from top row, left to right, Station f328 and Station f312.4 (40% aft, toward next station) and bottom row, left to right, Station f294.5.8 (80% aft of Station f294.5) and Station f294.5.3 (30% aft of Station f294.5). See Table 3, Figure 22.
