## Dual-Band Infrared (DBIR) Imaging Inspections of Boeing 737 and KC-135 Aircraft Panels

P. K. Bhagat  
Manager, Nondestructive Inspection R&D  
Aging Aircraft Program  
FAA Technical Center  
Atlantic City Airport, NJ 08505

N. K. Del Grande, K. W. Dolan, P. F. Durbin  
Nondestructive Evaluation Section  
Engineering Sciences Division

27 August 1993

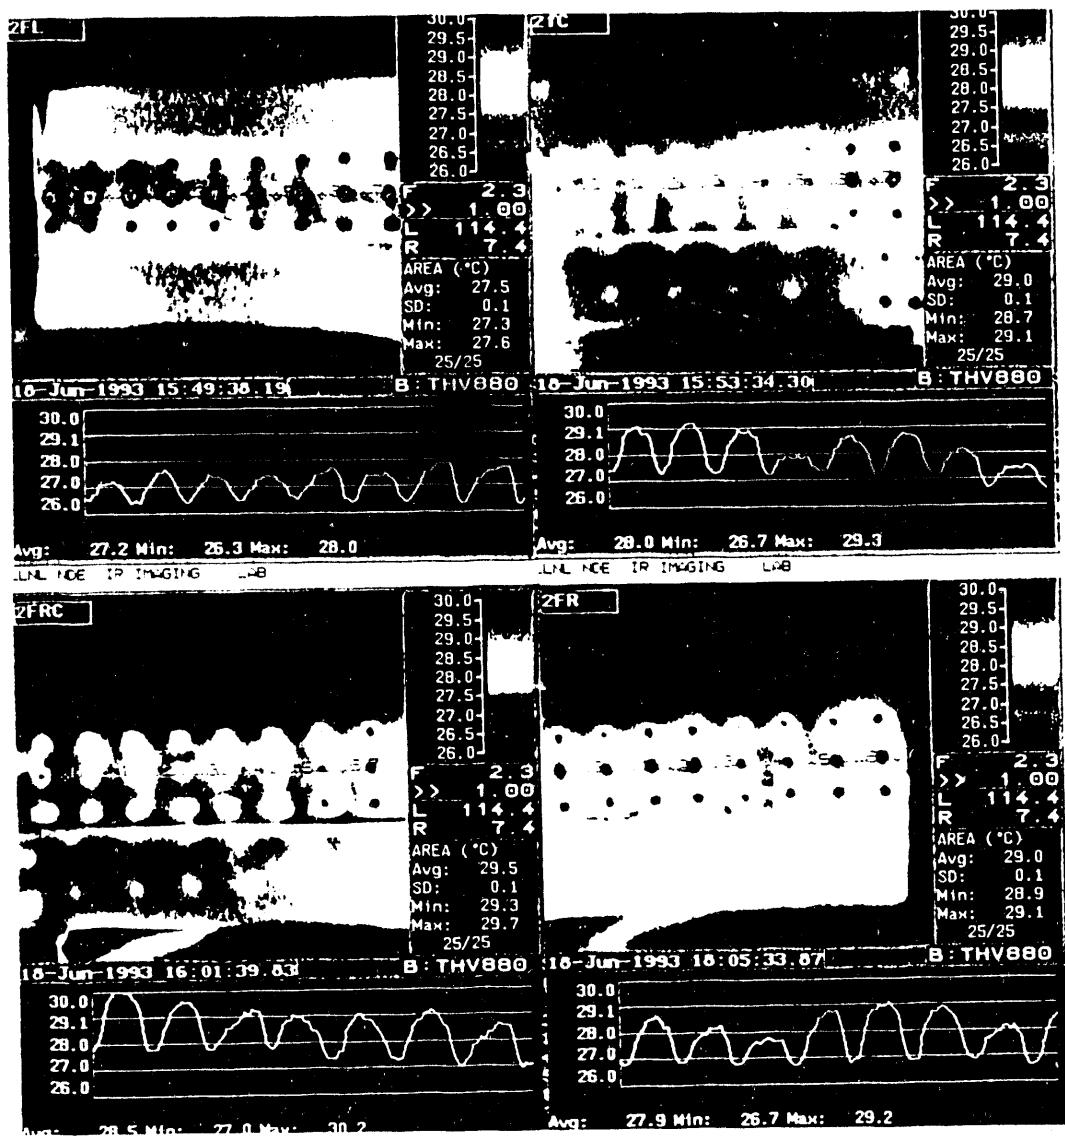
Figure C-1. Panel 2 Agema 880 DBIR System long wavelength (10  $\mu$ m) color-coded temperatures in  $^{\circ}$ C at 0.4 s after flash, as shown in four images from top row, left to right (left edge to center) and bottom row, left to right (center to right edge). Note temperature profile across line through center of lap splice with average temperature for area box near spot 4. Temperature data at spots 0 through 7 are included in Table 4.

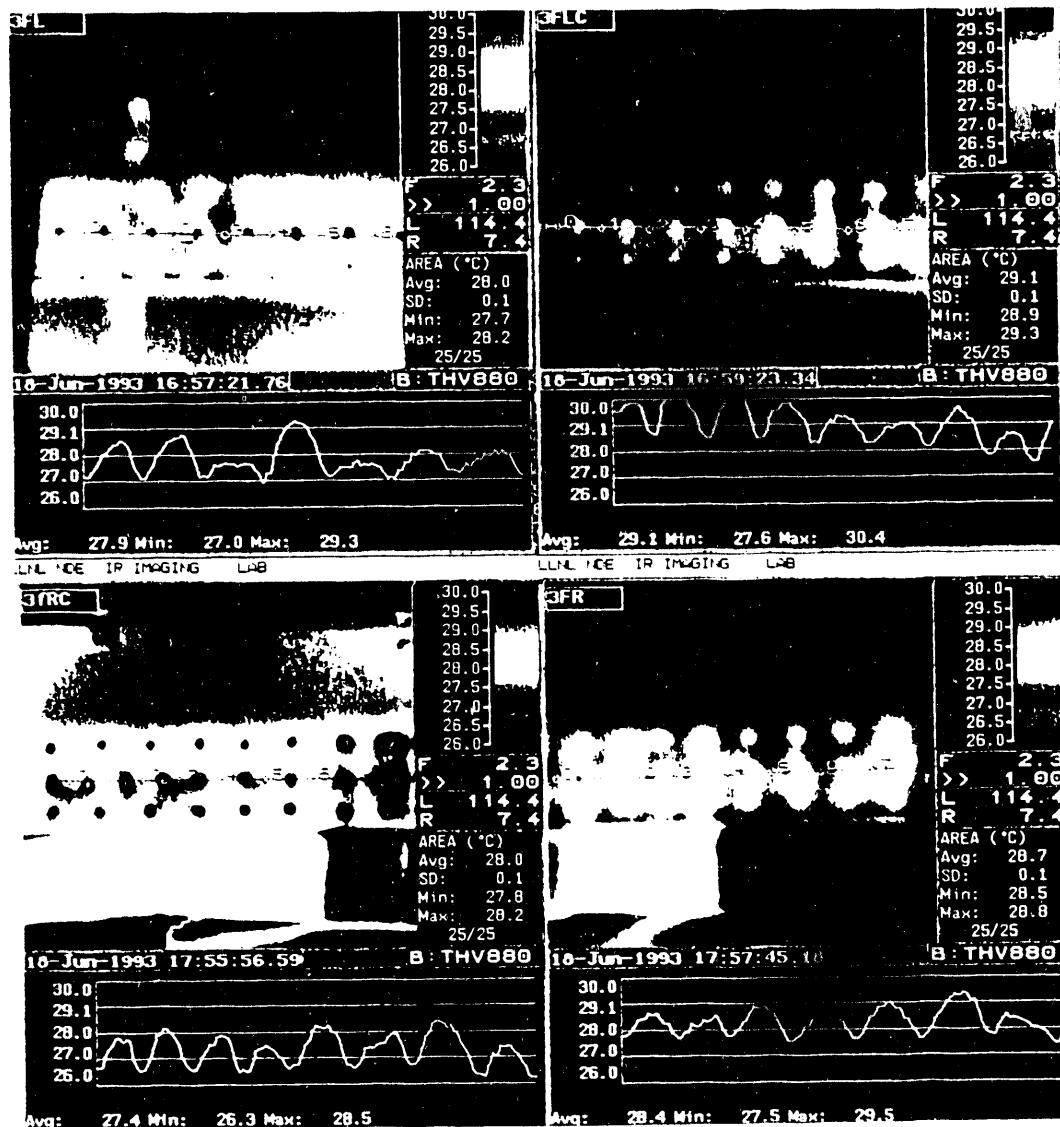
Figure C-2. Panel 3 Agema 880 DBIR System long wavelength (10  $\mu$ m) color-coded temperatures in  $^{\circ}$ C at 0.4 s after flash, as shown in four images from top row, left to right (left edge to center) and bottom row, left to right (center to right edge). Note temperature profile across line through center of lap splice with average temperature for area box near spot 4. Temperature data at spots 0 through 7 are included in Table 4.

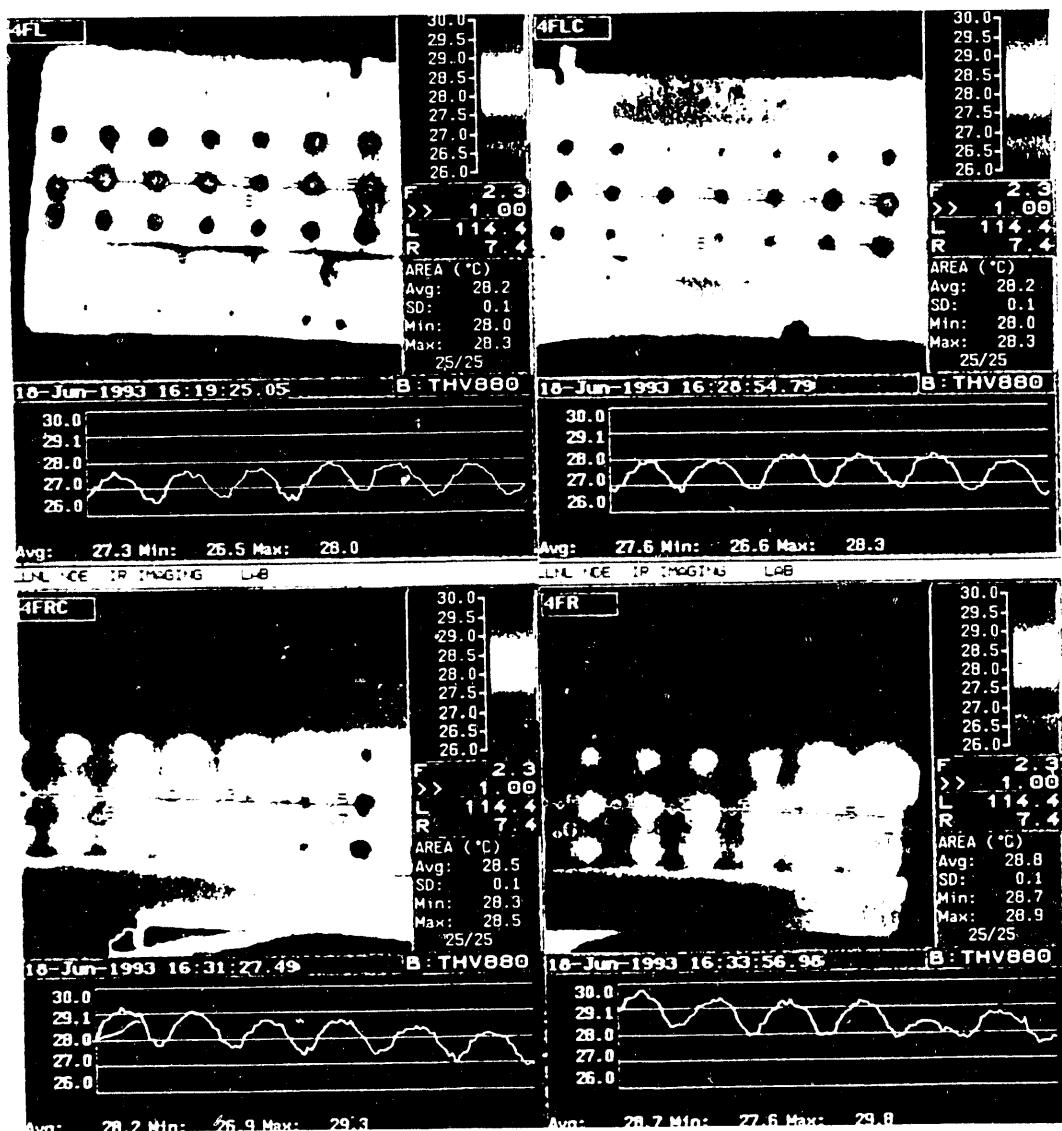
Figure C-3. Panel 4 Agema 880 DBIR System long wavelength (10  $\mu\text{m}$ ) color-coded temperatures in  $^{\circ}\text{C}$  at 0.4 s after flash, as shown in four images from top row, left to right (left edge to center) and bottom row, left to right (center to right edge). Note temperature profile across line through center of lap splice with average temperature for area box near spot 4. Temperature data at spots 0 through 7 are included in Table 4.

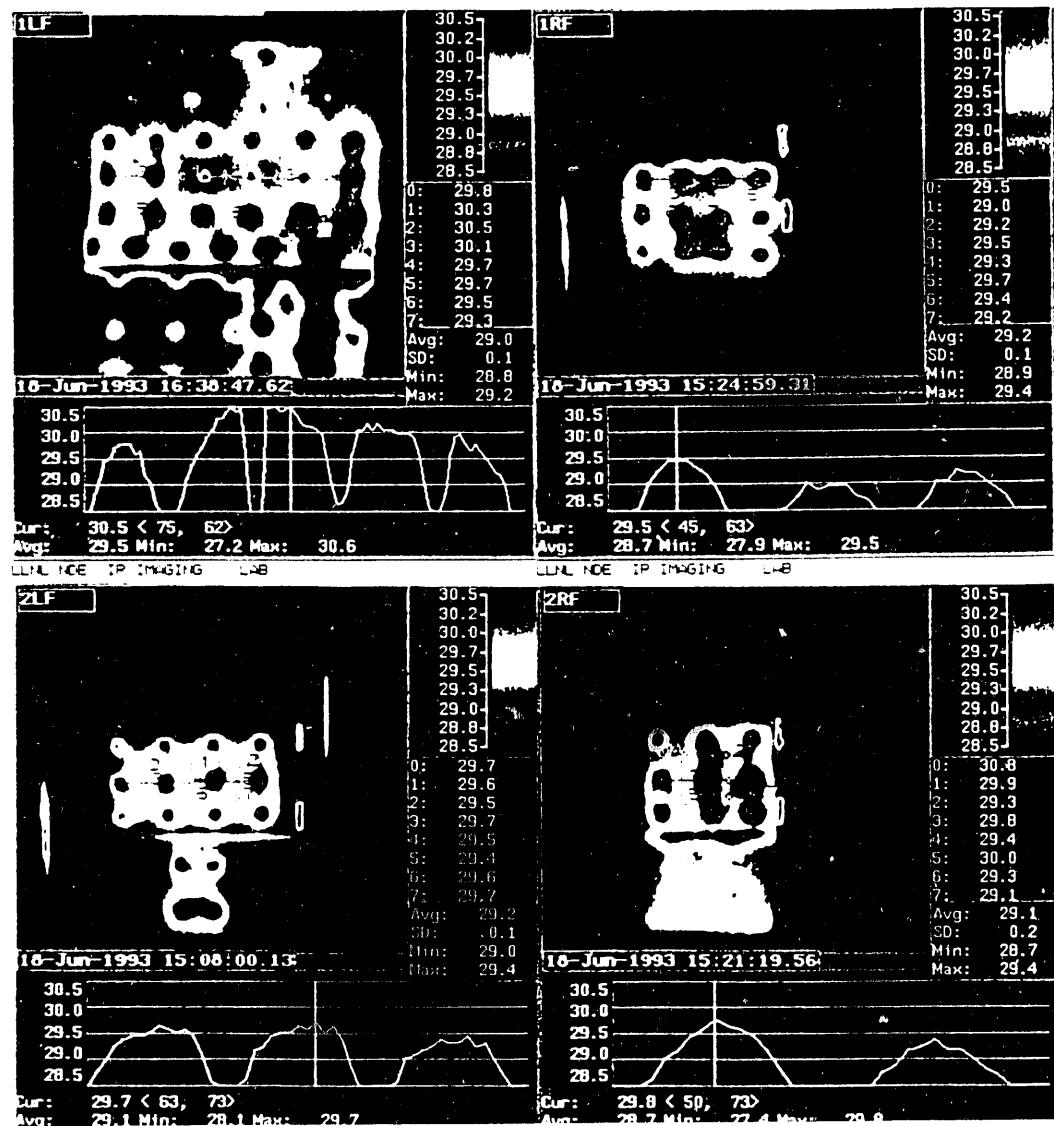
Figure C-4. Top row, left to right: Panel 1 left and right end piece images of Agema 880 DBIR System long wavelength (10  $\mu\text{m}$ ) color-coded temperatures in  $^{\circ}\text{C}$  at 0.4 s after flash. Bottom row left to right: Panel 2 left and right end piece images of Agema 880 DBIR System long wavelength (10  $\mu\text{m}$ ) color-coded temperatures in  $^{\circ}\text{C}$  at 0.4 s after flash. Temperature data at spots 0 through 7 are included in Table 5.

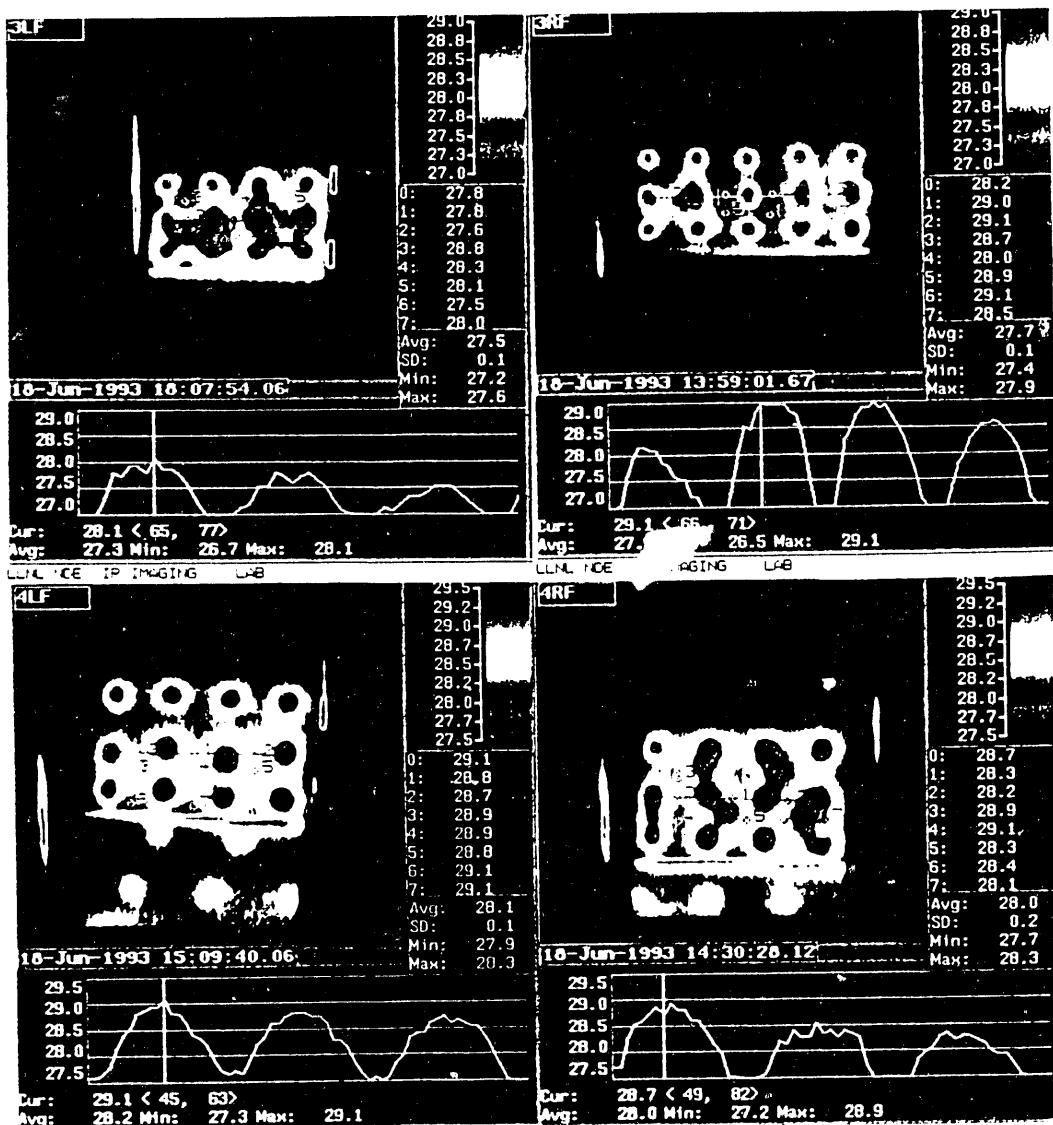
Figure C-5. Top row, left to right: Panel 3 left and right end piece images of Agema 880 DBIR System long wavelength (10  $\mu\text{m}$ ) color-coded temperatures in  $^{\circ}\text{C}$  at 0.4 s after flash. Bottom row, left to right: Panel 4 left and right end piece images of Agema 880 DBIR System long wavelength (10  $\mu\text{m}$ ) color-coded temperatures in  $^{\circ}\text{C}$  at 0.4 s after flash. Temperature data at spots 0 through 7 are included in Table 5.

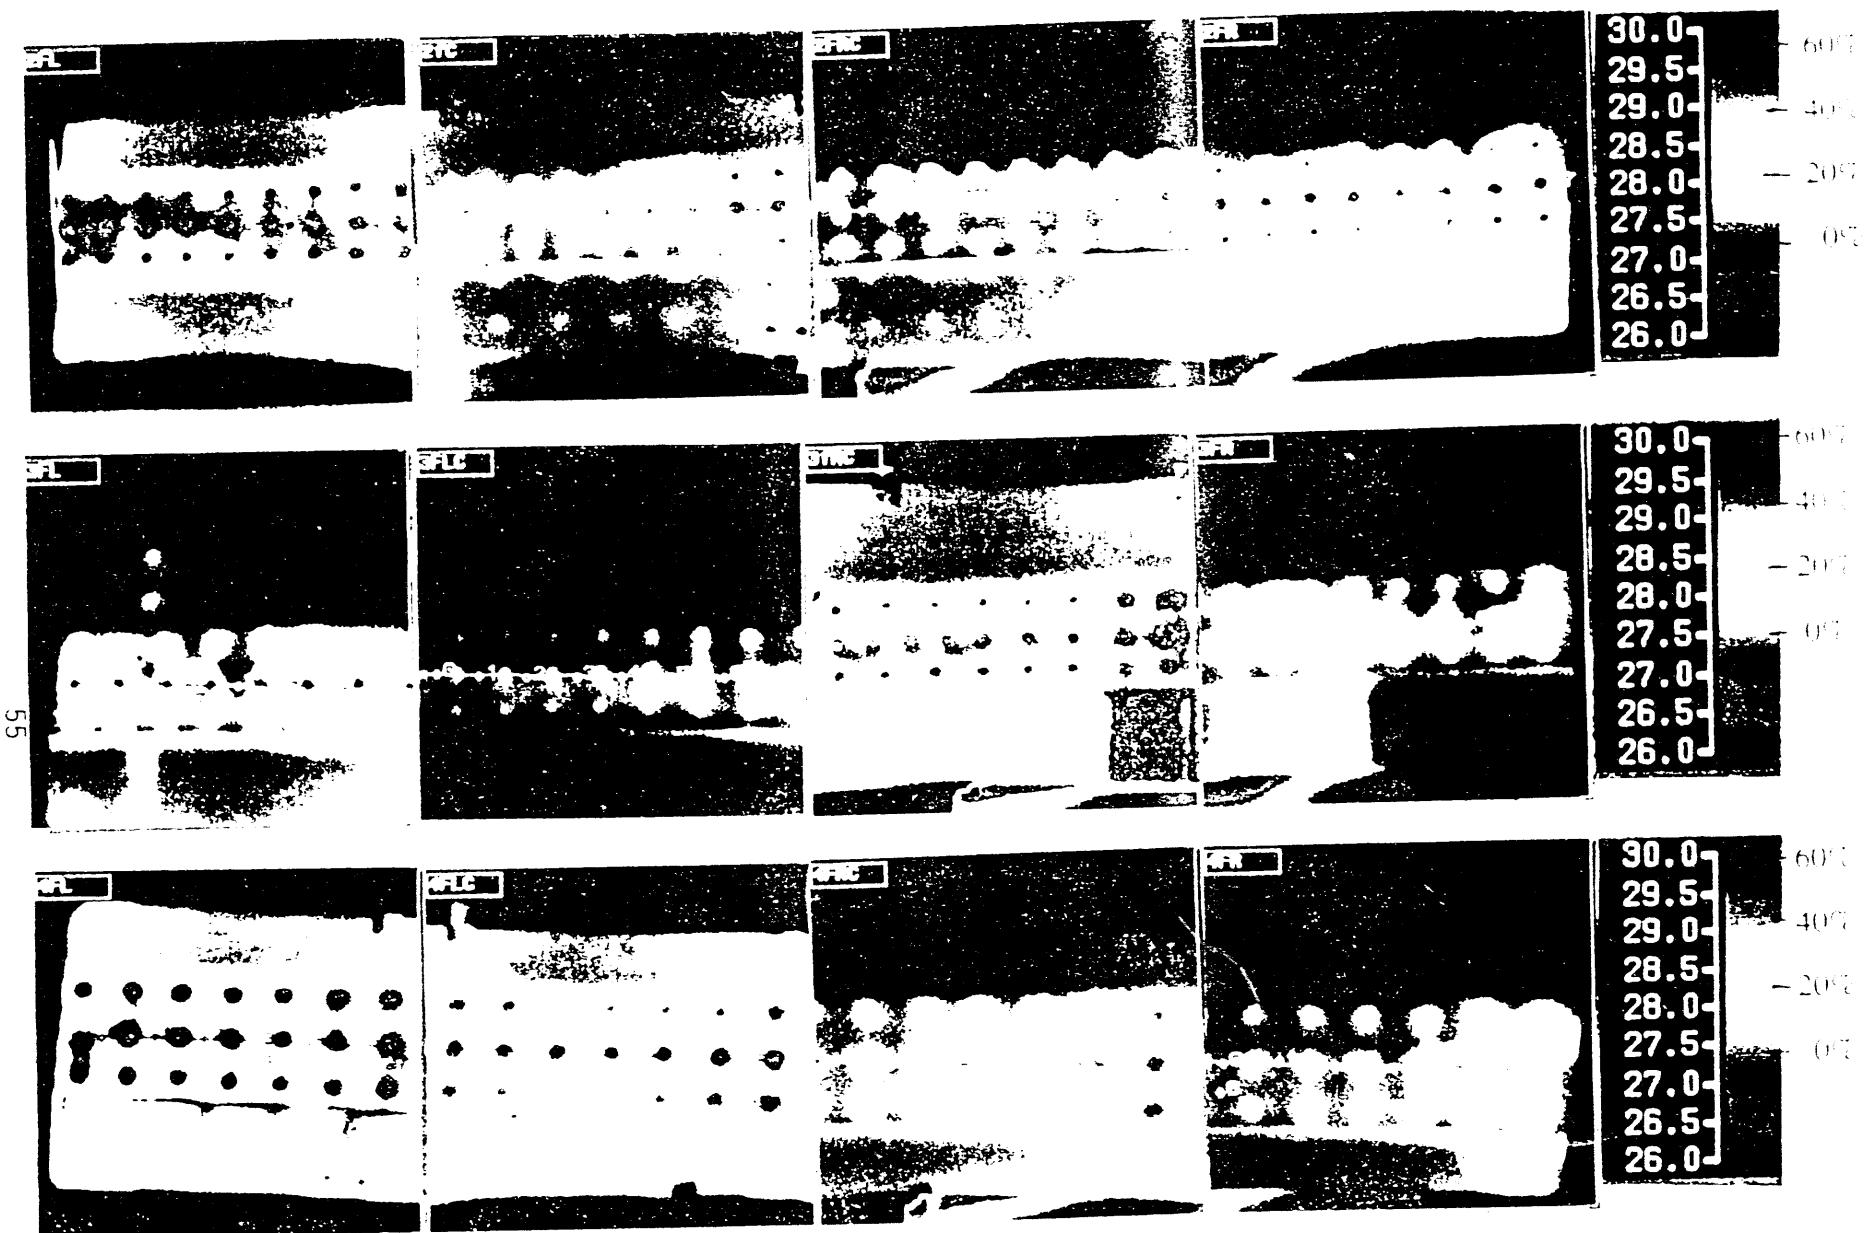
Figure C-7. Summary of color coded temperatures in °C at 0.4 s after flash with corresponding percent material loss from corrosion for the lap splice region of Boeing KC-135 Inspection Panels 2 (top row), 3 (middle row) and 4 (bottom row).
