HW-32800

R. O. Mehann
Superintendent - Process
REACTOR SECTION

Tube 1794-C was removed from the pile as a leaker on July 15, 1954. The tube had been in-pile since startup and had contained a charge of 32 "C" metal slugs just prior to discharge. The tube was slit and examined at the 105-DR underwater viewing facility by Pile Coolant Studies tube examination personnel.

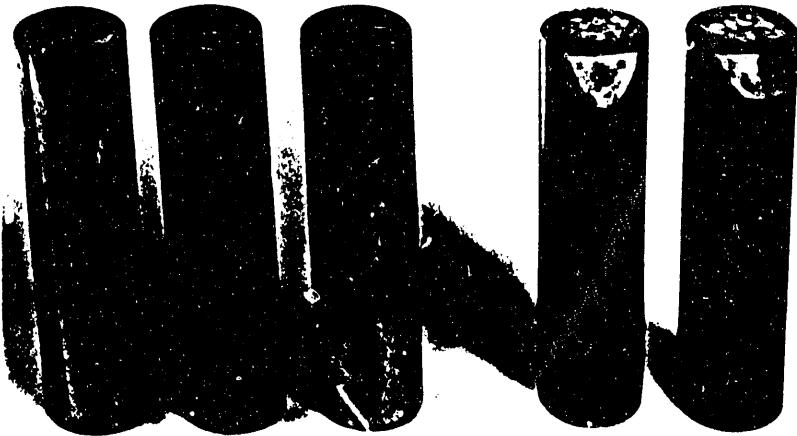
Figure 4. Aluminum minislugs exposed in high velocity water stream. Note bullet-shaped marks where slugs touched tube walls. Slugs on right were not cleaned.

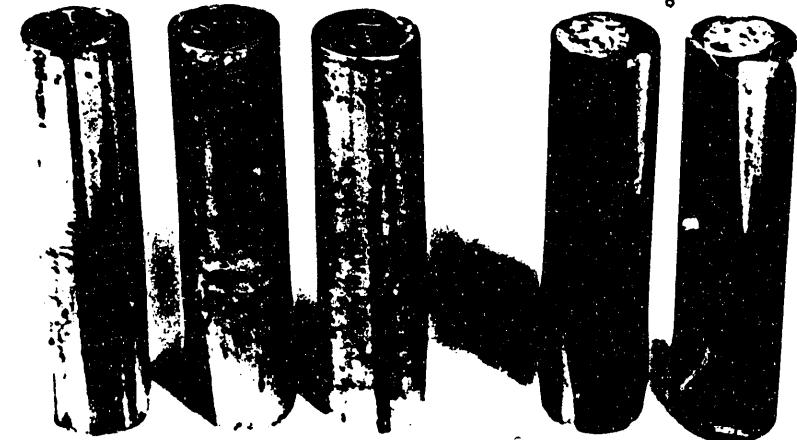
Figure 5. Opposite side of slugs shown in Figure 4. Note rib grooves occurring predominantly at downstream ends.
