WSRC-TR--91-378

SUMMARY REPORT FOR 1990 INSERVICE INSPECTION (ISI) OF SRS 100-L REACTOR TANK (U)

Westinghouse Savannah River Company
Savannah River Site
Aiken, South Carolina 29808

Publication Date: July 12, 1991

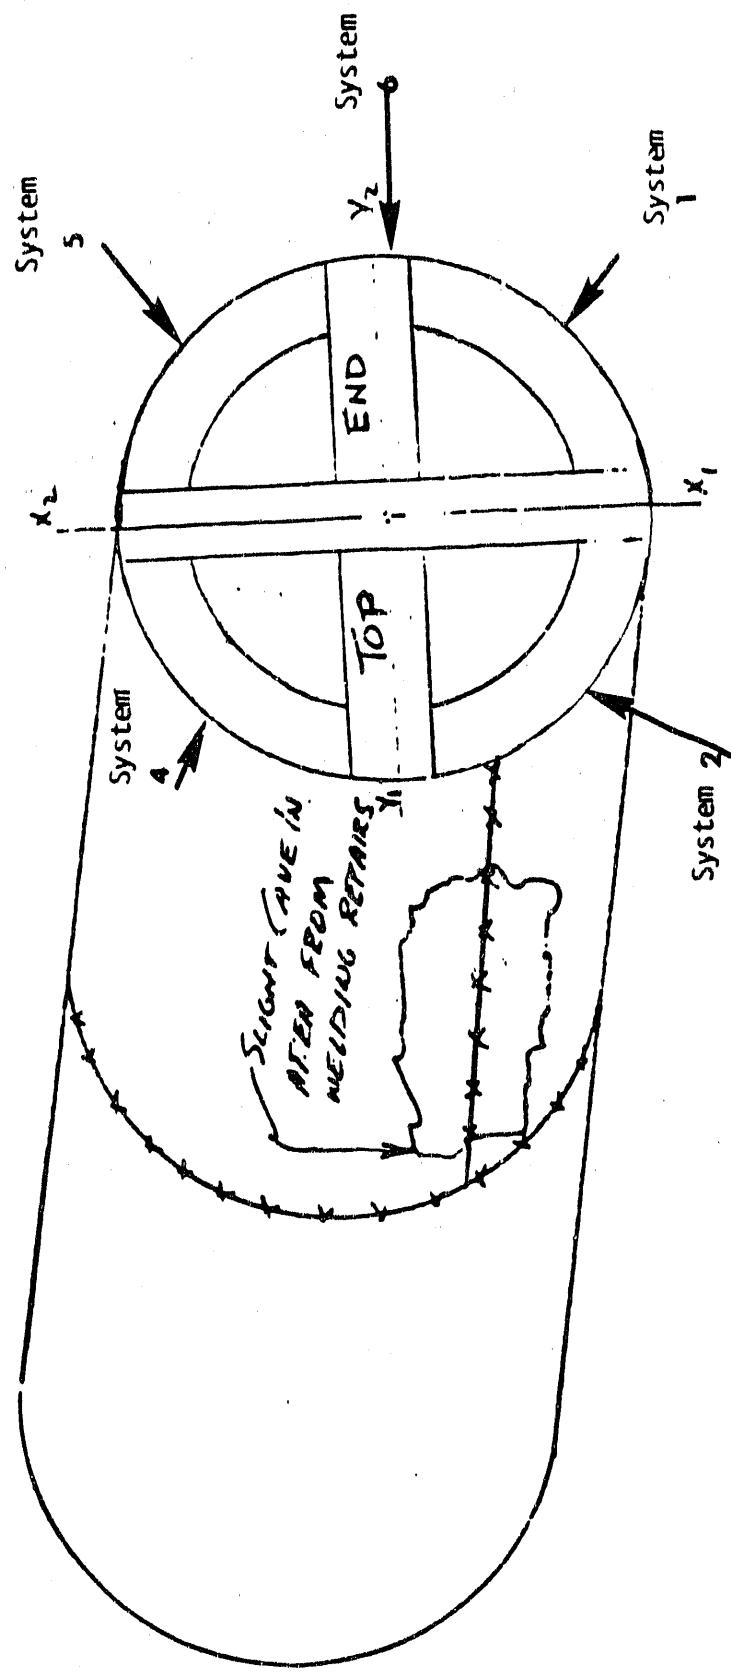
FIGURE 4. DAMAGED AREA ON UPPER VERTICAL WALL OF L-AREA REACTOR TANK

Special ET scan 3B-1 (Figure 2) was made to investigate this area. As indicated in Figure 2, the scan area was extended significantly to assure that the scar-welded area was covered. As described in IRC Reports 6 and 7 in Appendix A, very little evidence of weld metal was detected. However, there were a number of areas identified where weak ET signals were indicative of slight creases, ridges, gouges, high and low spots. These are mapped in the attachment to IRC Report 7. The concentration of these features in this area was greater than found elsewhere in L tank, and it was concluded that this region is probably the scar-welded area noted in Figure 4. No evidence of cracking or other service induced degradation was detected.

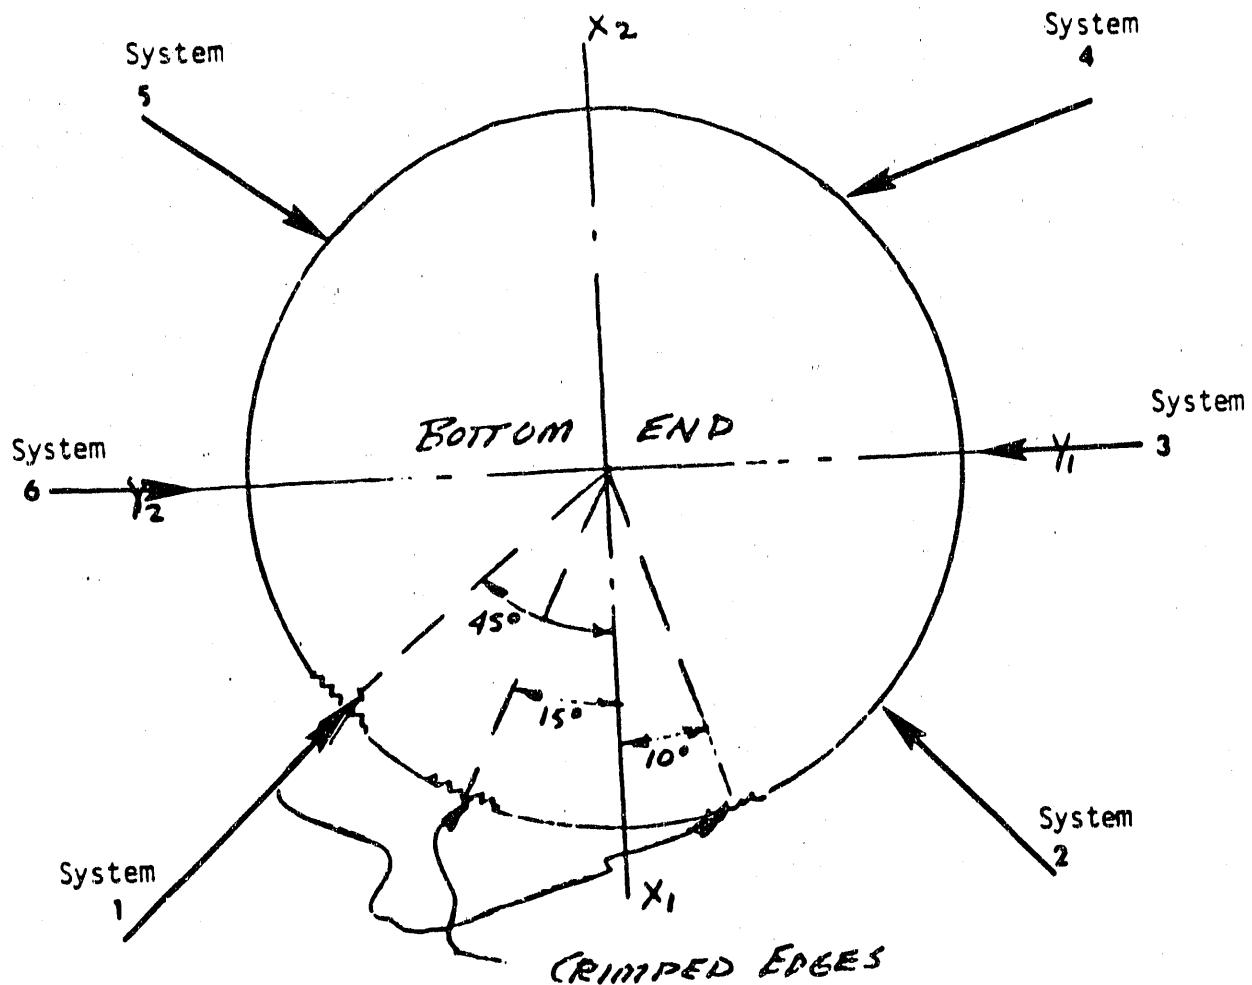
FIGURE 5. DAMAGED AREA ON UPPER VERTICAL WELD BETWEEN SYSTEMS 2 AND 3.

c. Cave In Area from Welding Repairs (Figure 5):

The location of this area based on Figure 5 would appear to be associated with a vertical weld between Systems 2 and 3. As shown in Figure 2, the nearest vertical weld in this region is L-VC2. UT scans of this weld showed nothing unusual (IRC Report 22) other than a slightly irregular weld width, two possible weld repairs, and several attachment removal areas. A large area of base metal was scanned (2A-1, see Figure 2) covering the area in the upper plate between Systems 2 and 3. The results were negative in this scan with no unusual features noted. It was concluded that the repair in this area identified in Figure 5 was effective and no sign of any related service induced degradation is apparent.

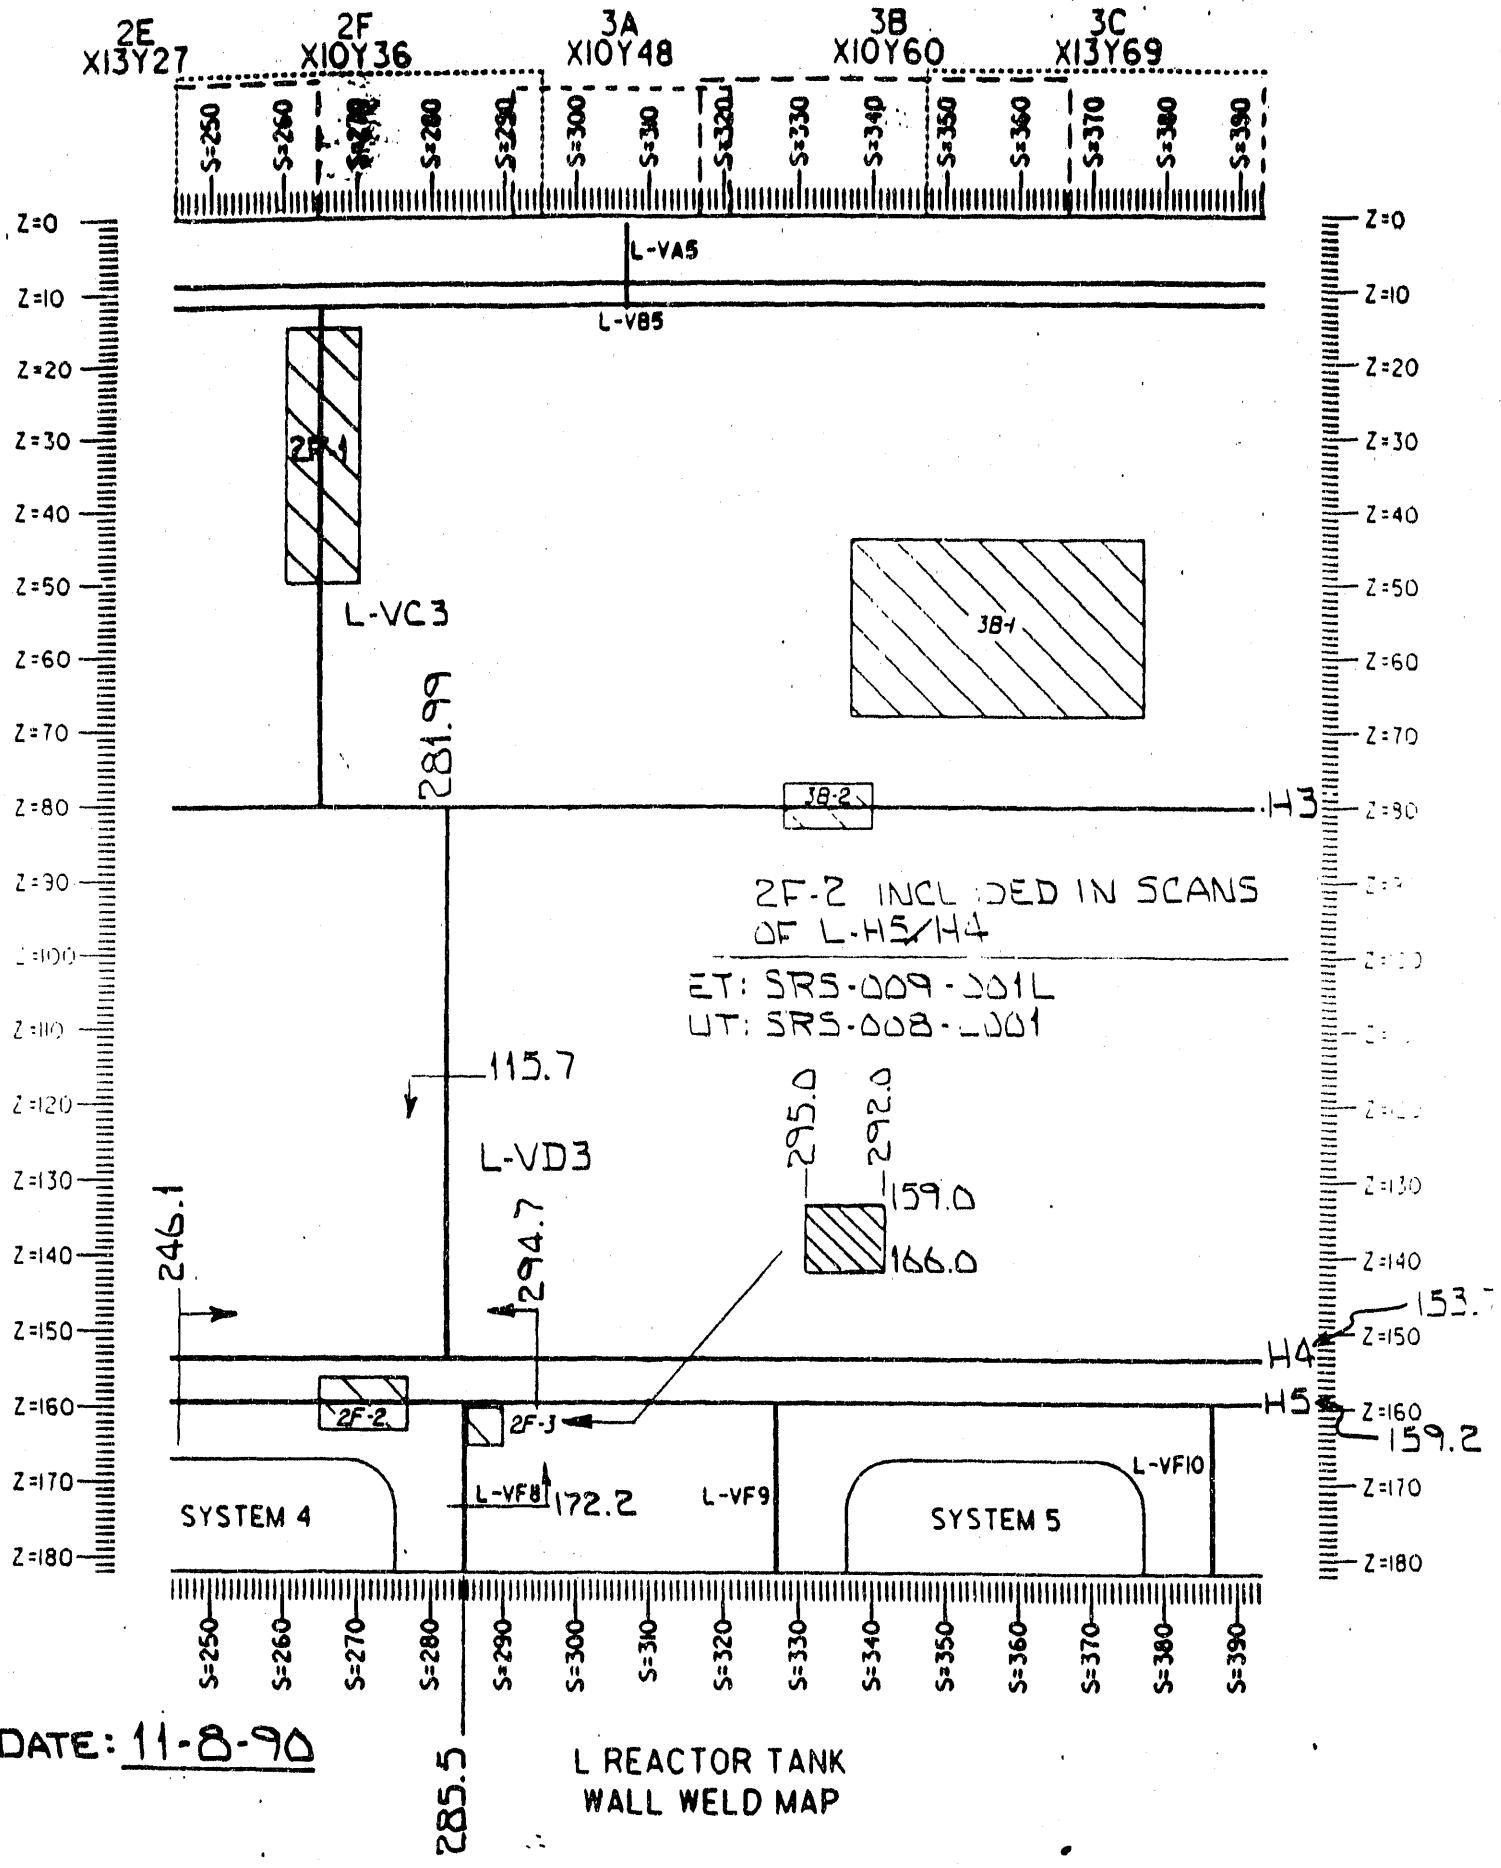
Comments: Vertical welds V-C3 and V-D3 in Sector 2F. All welds examined were clean, no indication of defects. Special Area 2F-3 appears to be an attachment removal area. Near L-H4 is an area with 2 weld deposits on I.D., one on O.D., each n 2" long, no depth. All 3 are just above L-H4. No confirmed embedded weld reflectors were found. There are indications of several weld repairs on the O.D. of L-V D3, some extending almost to the inside surface. Tank has very little oxide, UT and Robot performance is very good.

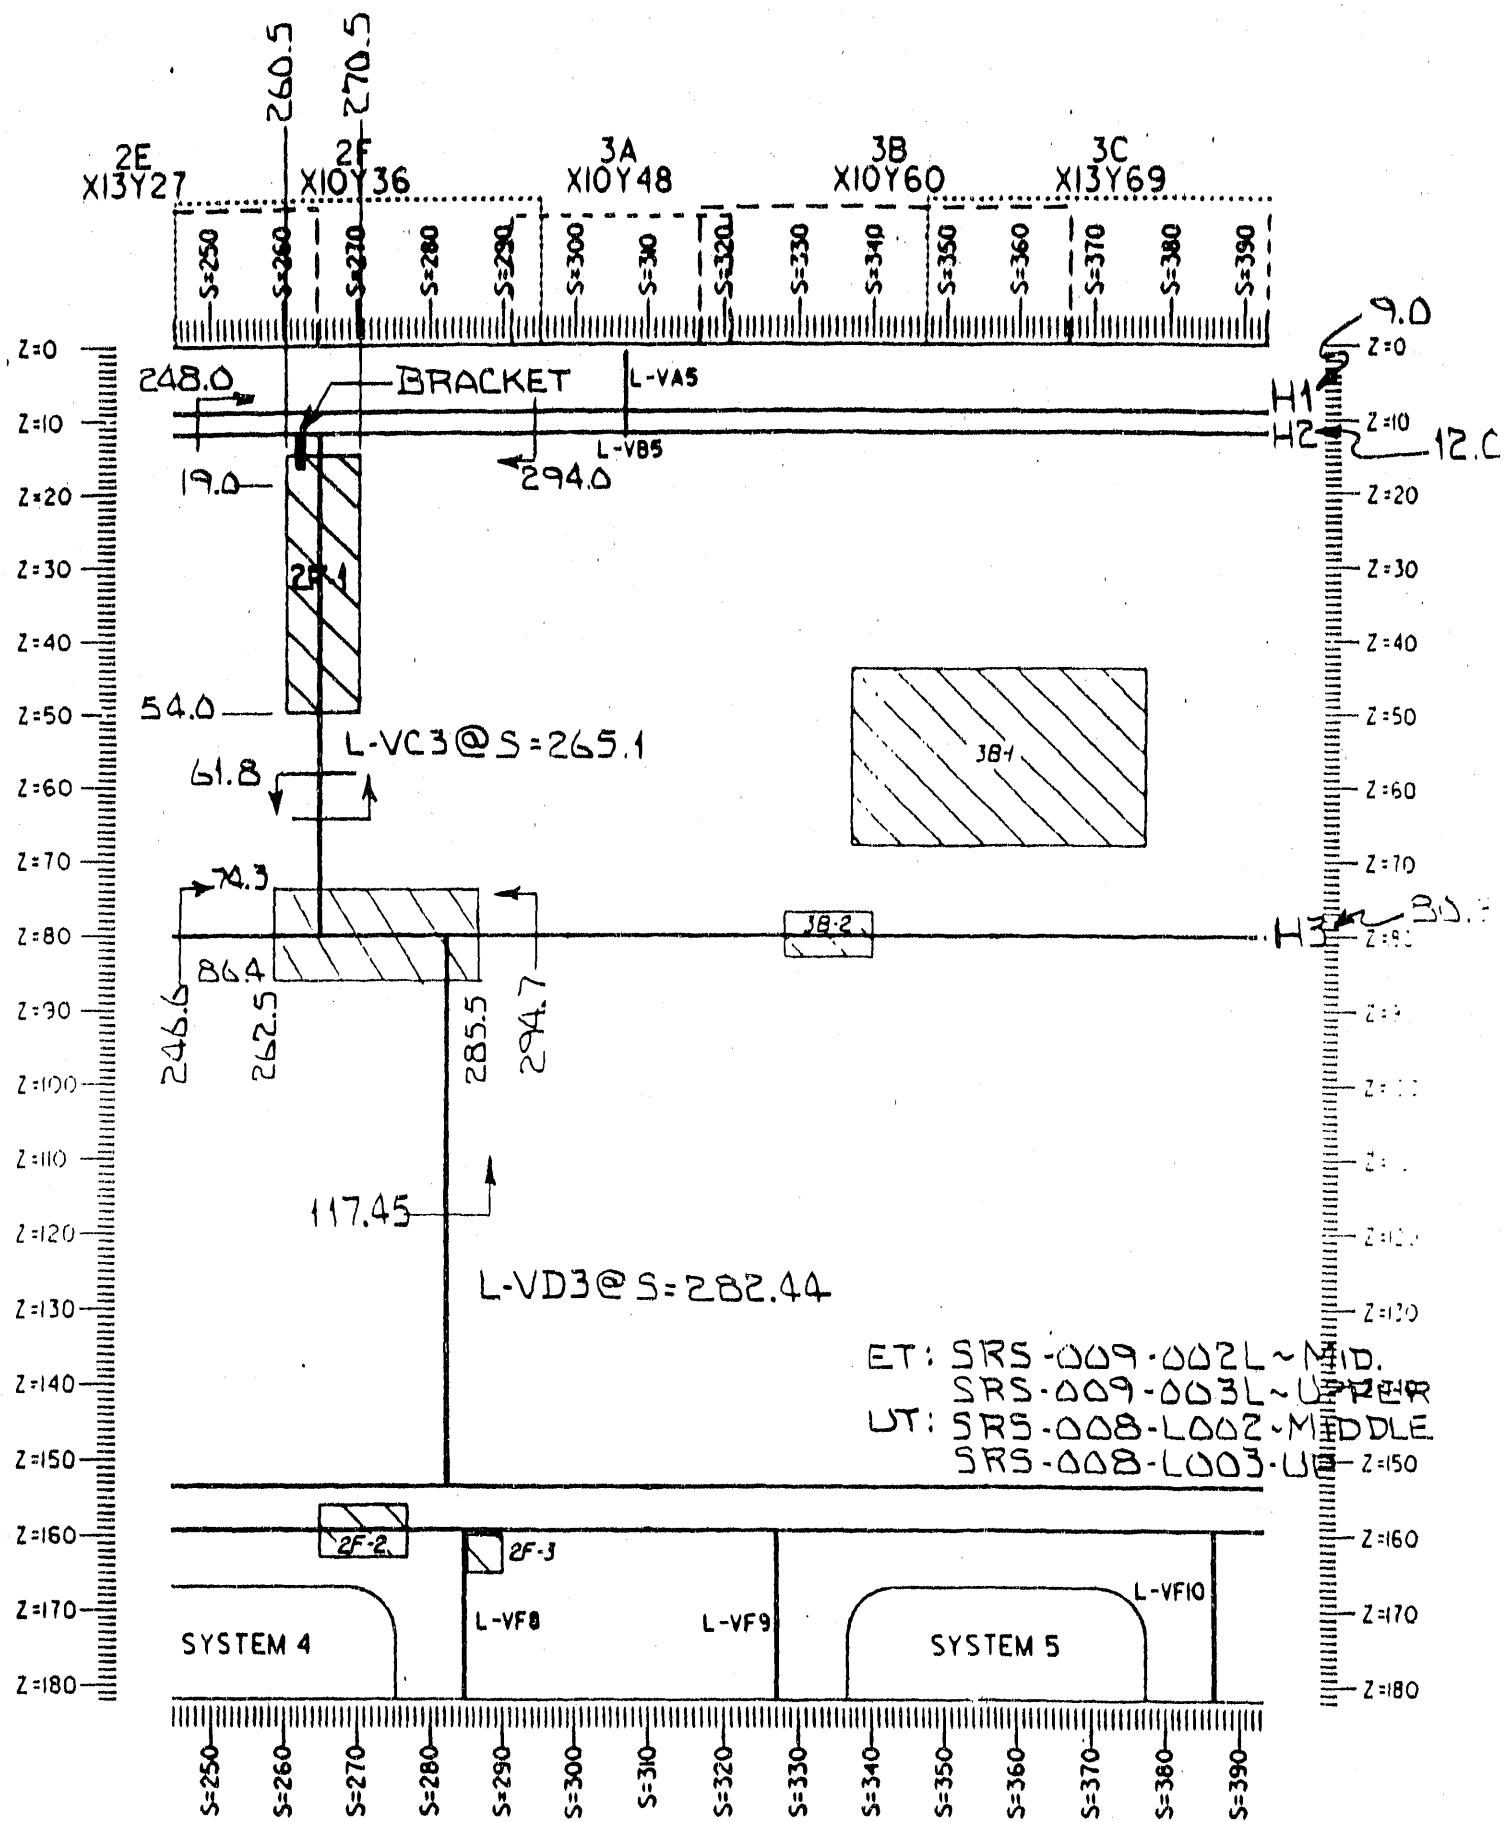
L REACTOR TANK
WALL WELD MAP

Classification of Indication:		
N/A		
NCR's Generated: (Yes <u> </u> No <u> </u>)		
NCR Nos.: <u>N/A</u>		
Comments: Data covered middle and upper windows of Sector 2 F. Motion measurement bracket located at top. Base metal scan made between vertical welds, no reportable indications. Weld L-H3 very

irregular, probable repair area, considerable grinding, but no openings to surface either O.D. or I.D. Some mild geometry noted on lower portion of L-VC3. Evidence of former attachments on L-VC3, 2 ID, one OD. (OD could be alignment pin or thermocouple pad).

1. THERE HAS BEEN INTERMITTENT GRINDING IN THE AREA OF INTEREST.
2. THE HIGH AMPLITUDE REFLECTORS ARE PROBABLY AREAS IN WHICH THERE HAS BEEN SOME OVER-GRINDING WHICH CREATES A 'LIP' ALONG THE EDGE OF THE WELD.
3. VISUAL INSPECTION WAS CARRIED OUT AT A MAGNIFICATION OF OVER 25X. MORE THAN ONE HOUR WAS SPENT VIEWING THE AREA OF INTEREST. NO CRACK-LIKE OPENINGS ARE VISIBLE IN THE AREA OF INTEREST.

THE AREA OF INTEREST HAS NO CRACK-LIKE INDICATIONS.

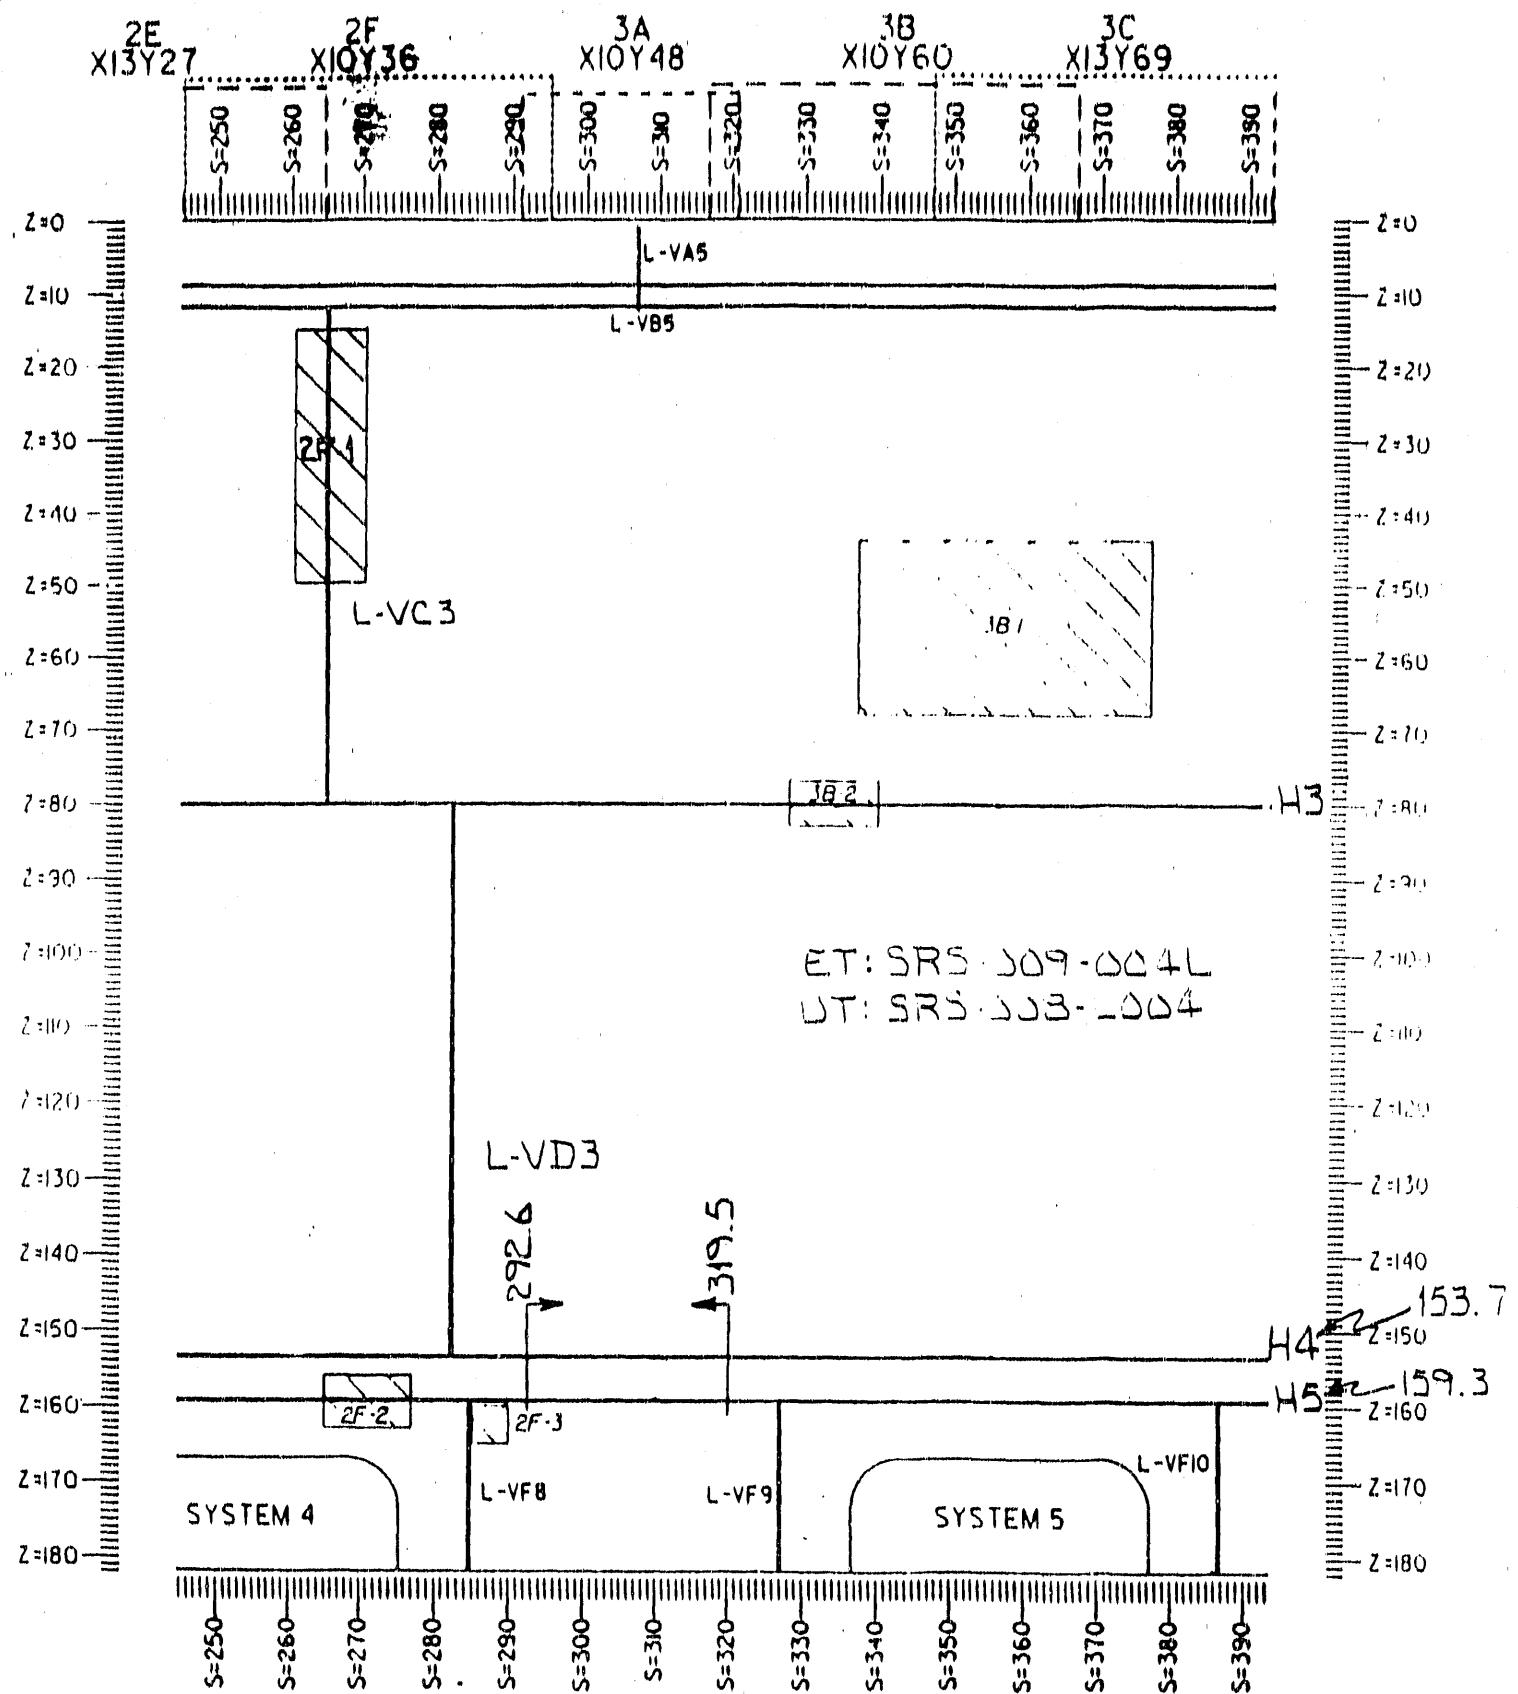
I. REACTOR TANK
WALL WELD MAP

The inspection team reported a visual indication observed during the course of conducting a visual scan of Weld L-H3 at the extreme left side of Sector 2F. At approximately 4" to 6" into Sector 2E, the overhead camera with high-magnification lens (25X) detected a vertical linear indication in the vicinity of L-H3. The indication appears to be up to about 4 inches in length. Inspection by UT and ET is not possible without relocating the robot 2 positions to the left.

UT/ET data reviewed for bottom window of
sector 3A. ET results indicate a small vertical gouge
0.8" long x 0.1" wide about 2.5" above L-H4. Another area
evaluated as an attachment removal area was located on the
ID between H4 and H5, also a weld metal deposition spot.
No vertical weld exists between H4 and H5.
LT results confirm the ET results on the ID
near H4 and H5. On the OD, 4 attachment/
removal areas were located (vertical) below H4 and 2
(horizontal) above H4. Also confirmed the attachment/removal
area on OD above L-H5, which was found at the extreme
right side of Sector 2F last week. No other findings.

3. Action will be undertaken beginning immediately to determine if this finding is coincident with Indication #11 found during the 1986 visual examination.

4. Action will be taken immediately to verify using the mockup tank in Building 305-A if the robot can be safely relocated in Sector 2F sufficiently to permit UT/ET examination of the area of concern, without damage to adjacent assemblies. This action should be complete by November 12, 1990.

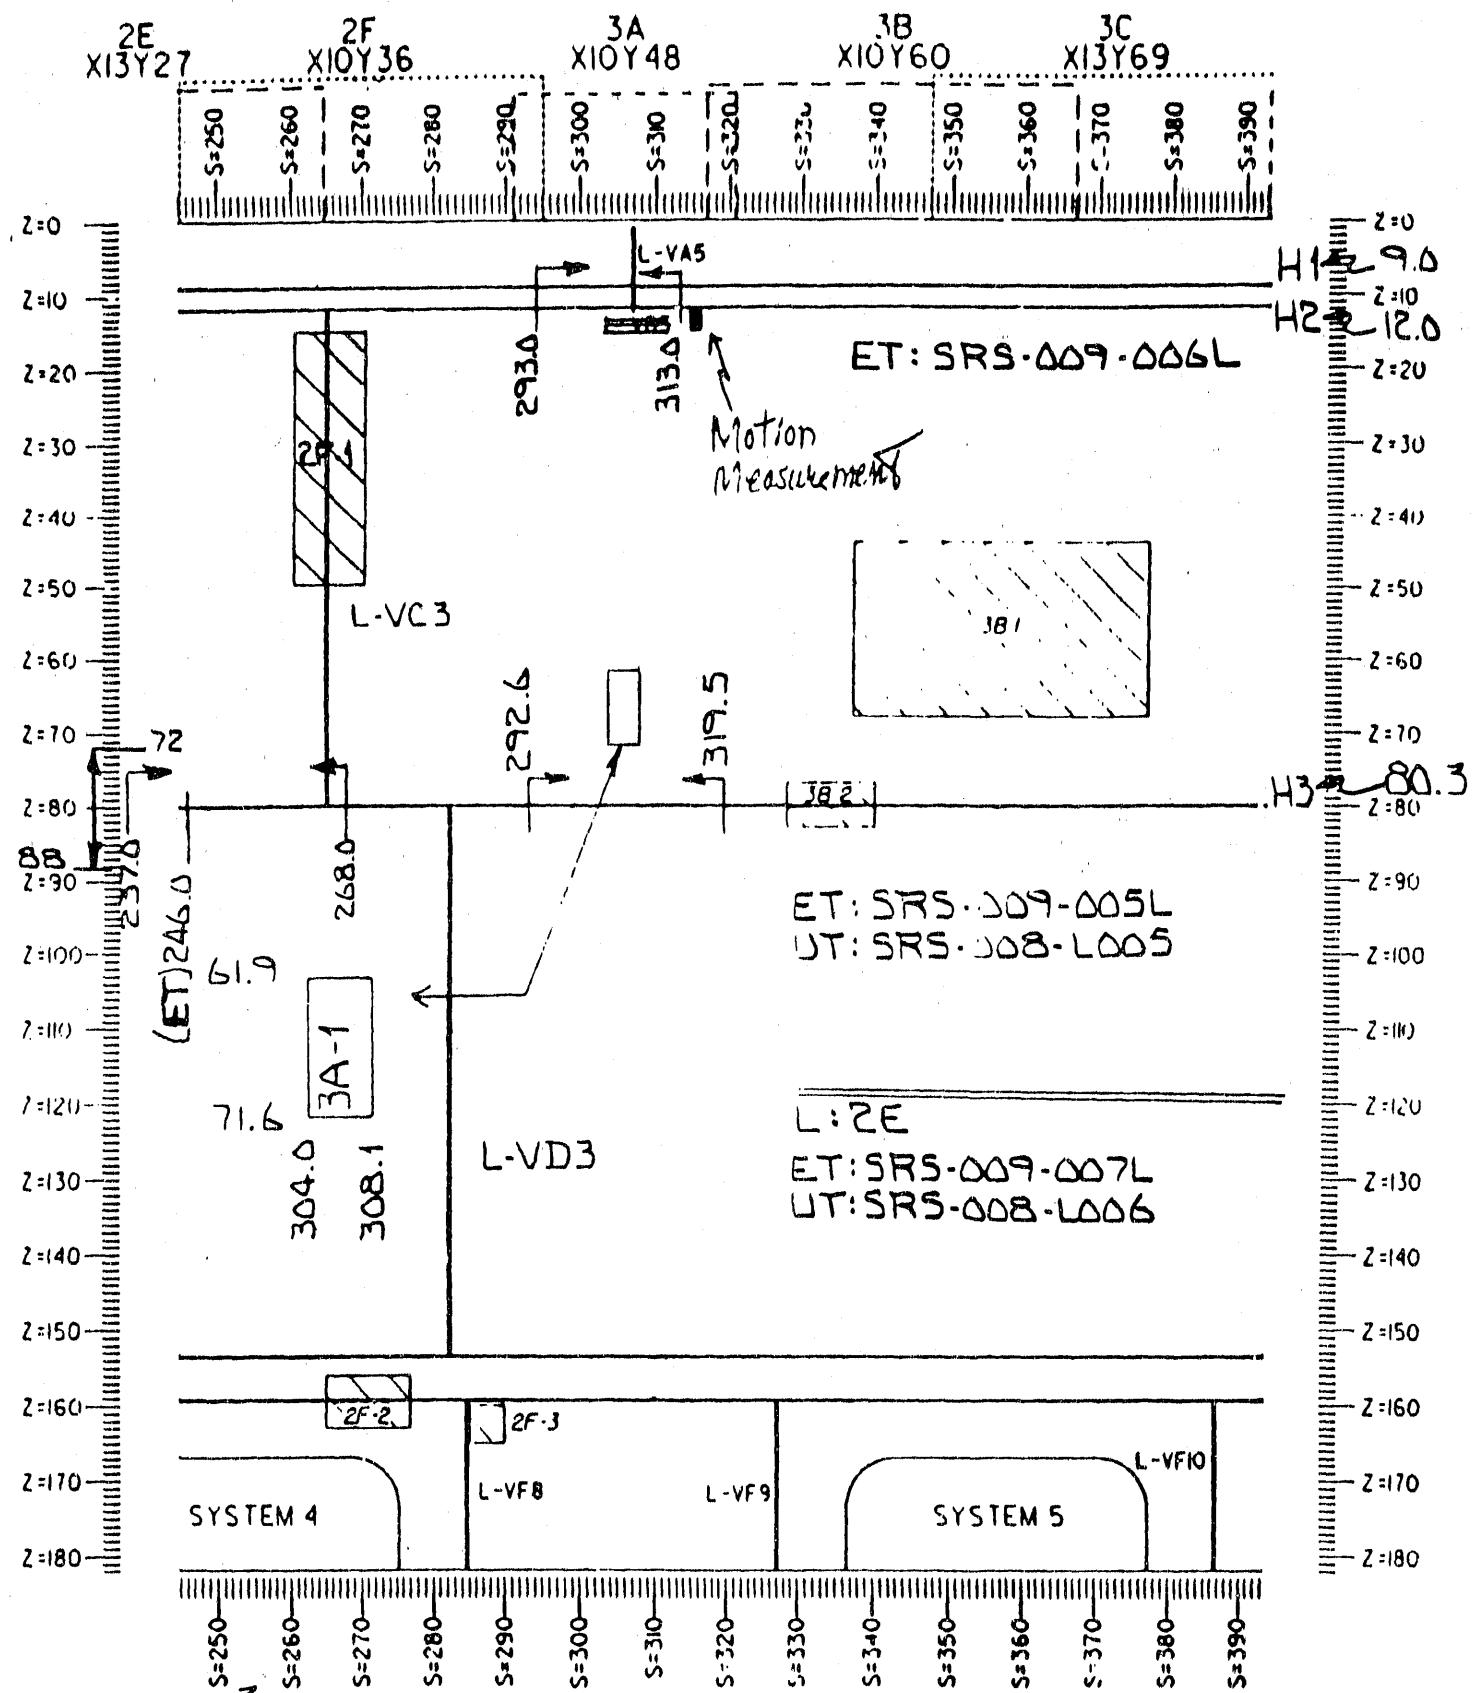
I. REACTOR TANK
WALL WELD MAP

Middle window: A 30" wide envelope was scanned (E up to the top of the window, to verify presence or absence of a repair area. The ET scan showed some signals in an area 4" x 10" (3A-1) which was scanned by UT. No flaw indications were detected. Further evaluation showed the ET signals were not metal, but could have been

caused by a slight raised surface or "ridge" in this area.

Top window: Motion measurement bracket found at S=316". No vertical nulls were located between L-H1 and L-H2. L-H1 and L-H2 were determined by ET to be clear, with no reportable indications.

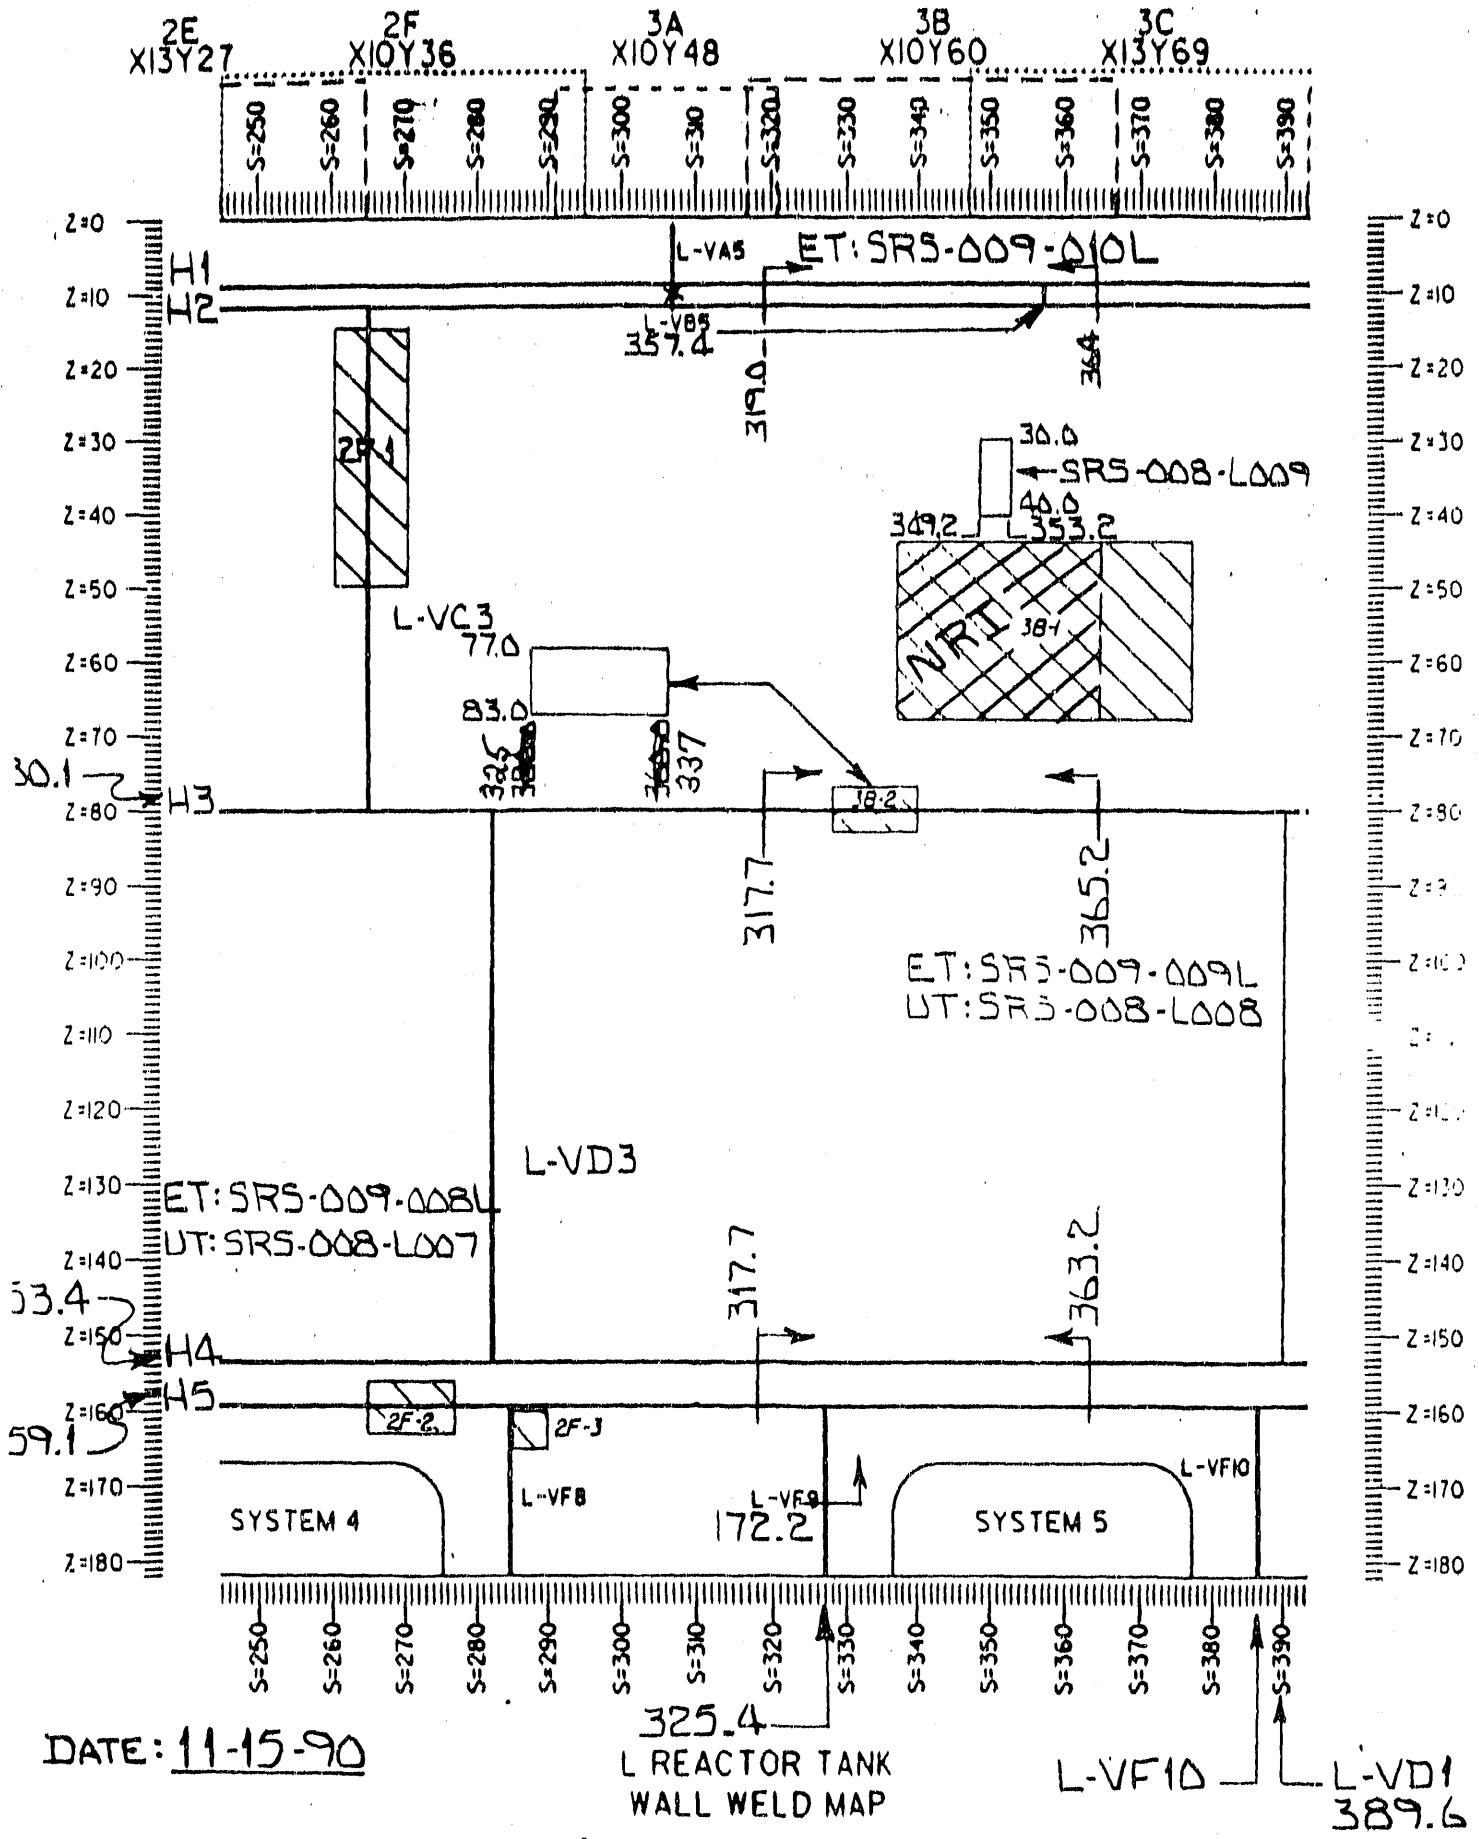
Data packages were reviewed for all of Sector 3B.
Bottom window: attachment removal area on ID near L-VF9
On L-H5, numerous attachment removal areas ("ARAs")
on ID and OD. For a length of about 5 inches above
Nozzle #5, weld is much wider, indicating repair.
In this length, an embedded reflector, 5 stripes was
located 0.228" beneath ID, of no measurable thickness
dimension (< 0.100"), no surface break. Exists at sidewall
of weld. Confirmed no break by ET.
On L-H4, a number of ARAs were found. At
 $S = 354.6$ and $Z = 157.20"$, indicator of a lug still
attached on O.D. On others, orientation of ARAs
is random, either vertical or horizontal. Otherwise,
weld is clean, no indication. Below L-H4,
evidence of former attachments found at 5 locations,
ranging from 0.5" to 1.5" below weld, using ET.

Middle window; On L-H3, UT ring of reflectors from the
double bevelled weld toe on the far surface (incorrectly
marked "weld repair"). No indication, UT or ET.
On Special Scan area 3B-1, no indication of weld
metal was found. Some ET signals in small
area immediately above were detected and may

have been lift-off; no UT indications. In conclusion, extensive scanning has shown no clear indications of base metal repair, nonetheless, the slight ET offset might be indicative of small ridges in the metal, conceivably one possible manifestation of a tank repair, though not confirmed.

Top window: Vertical weld L-VBT located at S = 357.4. No indications found by ET associated with L-H11 and L-H21.
