Type B Investigation of the  
Iridium Contamination Event at the  
High Flux Isotope Reactor  
on September 7, 1993

Investigation Board

Date Published: March 1994

Prepared by  
MARTIN MARIETTA ENERGY SYSTEMS, INC.  
Oak Ridge, Tennessee 37831  
for the  
U.S. DEPARTMENT OF ENERGY  
under contract DE-AC05-84OR21400

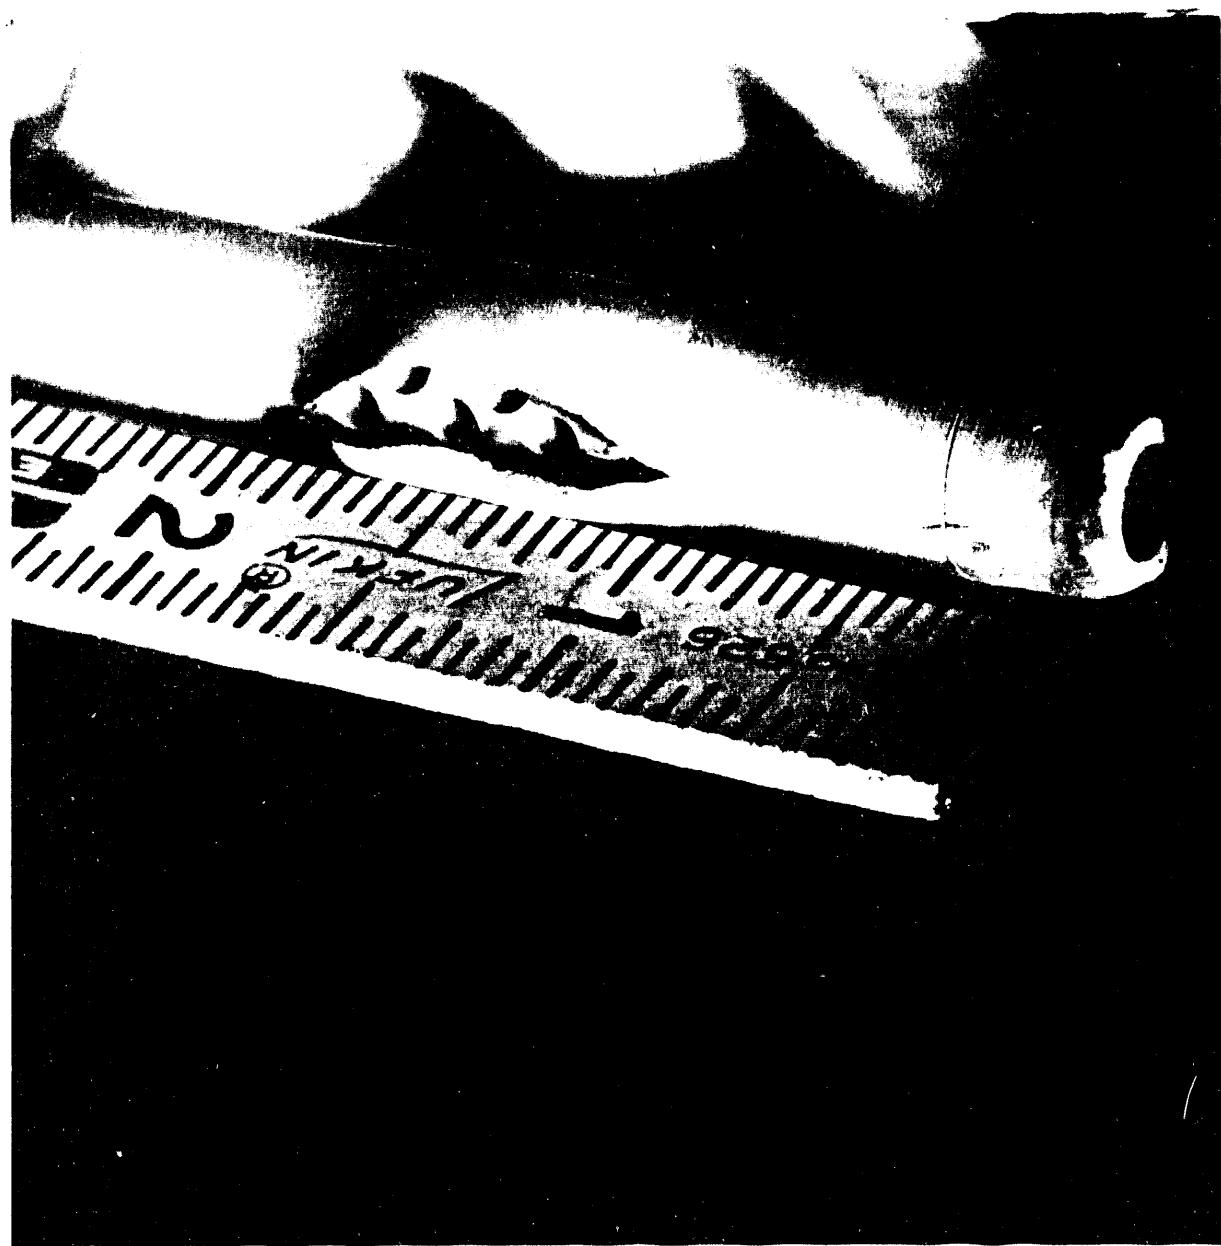
- 3.6.5 Removal of the seven target rods from the can revealed a rupture in target rod IR-75 but not in any of the others. The rupture was oriented longitudinally. It was about 1 inch long, and the center was about 1.5 inches from the upper end of the target rod. The maximum lateral opening was about 0.2 inches.

The specific failure of target rod IR-75 was a 1-inch-long, longitudinally oriented rupture of the target-rod sheath, with the center of the rupture being ~1.5 inches from the weld at the upper end (Figs. 4.1 and 4.8). The maximum opening in the sheath was ~0.2 inches, large enough to observe that at least ten pellets were missing (Fig. 4.8).

Fig. 4.1. Rupture in upper end of iridium target rod IR-75.

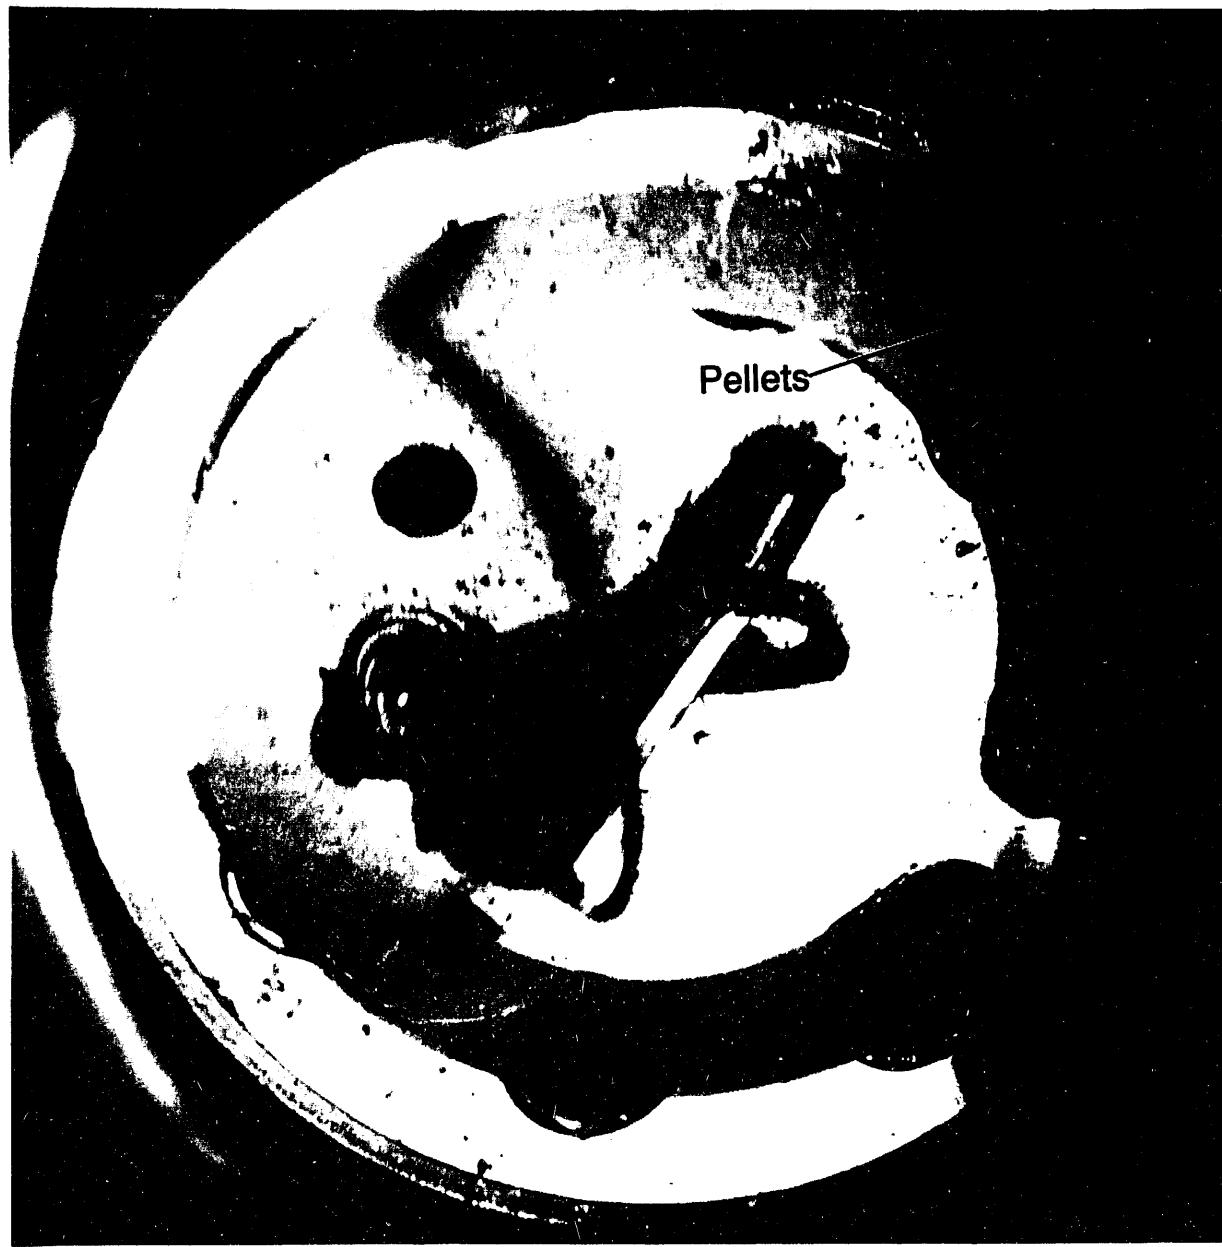
Upon opening the top of the cask, several pellets and small pieces of a dark fluffy material were found on top of the can (Fig. 4.7). After removing the can from the cask and then removing the locking ring at the top of the can, several more pellets were found. Smears were taken from the upper end of each target-rod holder tube and counted for radioactivity. The count rates indicated that the target rod in position 5 (Fig. 4.6) had ruptured. The target rod in this position was IR-75. Subsequent removal of the target rods from the can, and a close visual inspection, confirmed that target rod IR-75 was the only target rod that had failed.

Fig. 4.7. Photo of top of iridium target-rod transfer can showing several iridium pellets and a dark fluffy material.

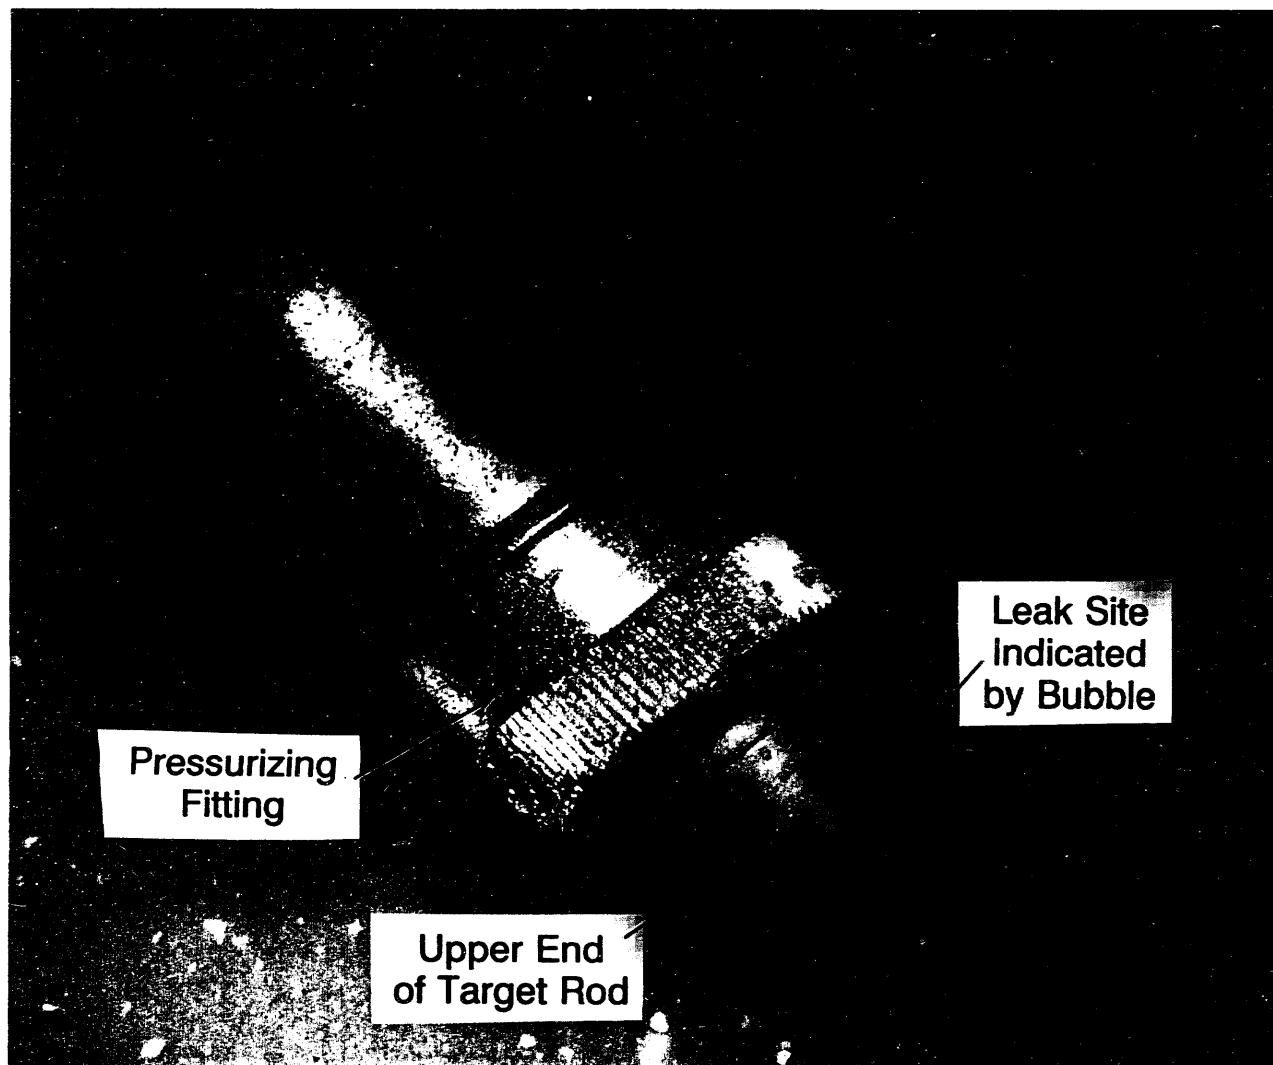
- 3.6.8 A leakage path through the upper-end weld was discovered by pressurizing the interior void space in the target rod with nitrogen gas through the rupture and submerging the target rod in water. With 15-psi differential pressure, there were no bubbles, but with 30 psi, bubbles emanated from a location in the weld at the upper end. There were no other indications of leaks, even at 60 psi.

Fig. 4.10. Evidence and location of leak in upper end of iridium target rod IR-75.

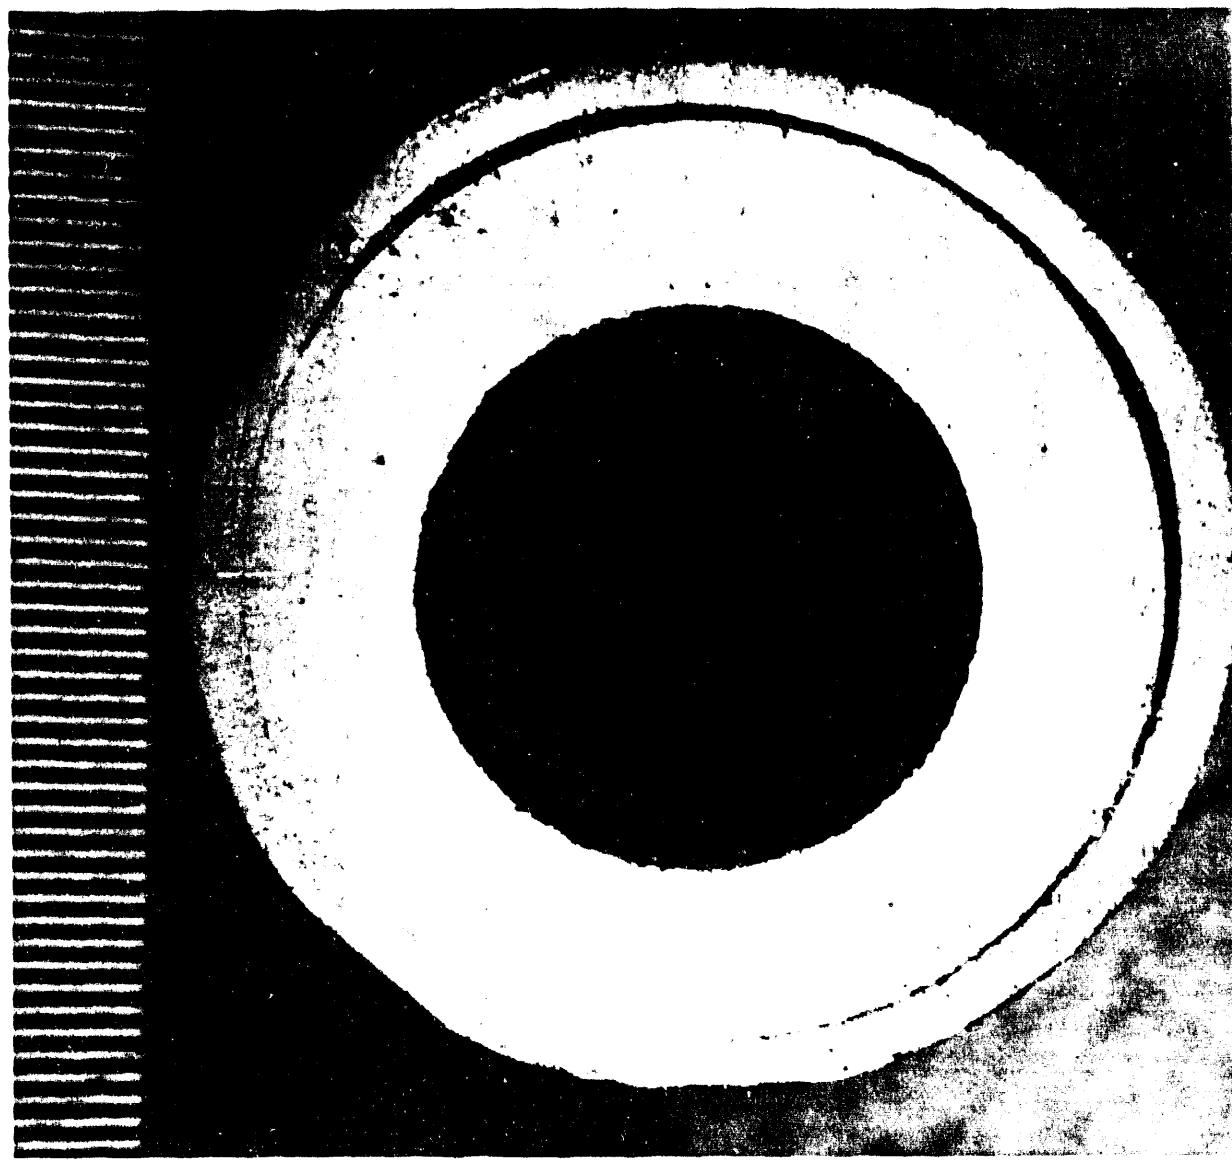
Fig. 4.14. Closeup of cut end of cutoff upper end of iridium target rod IR-75.

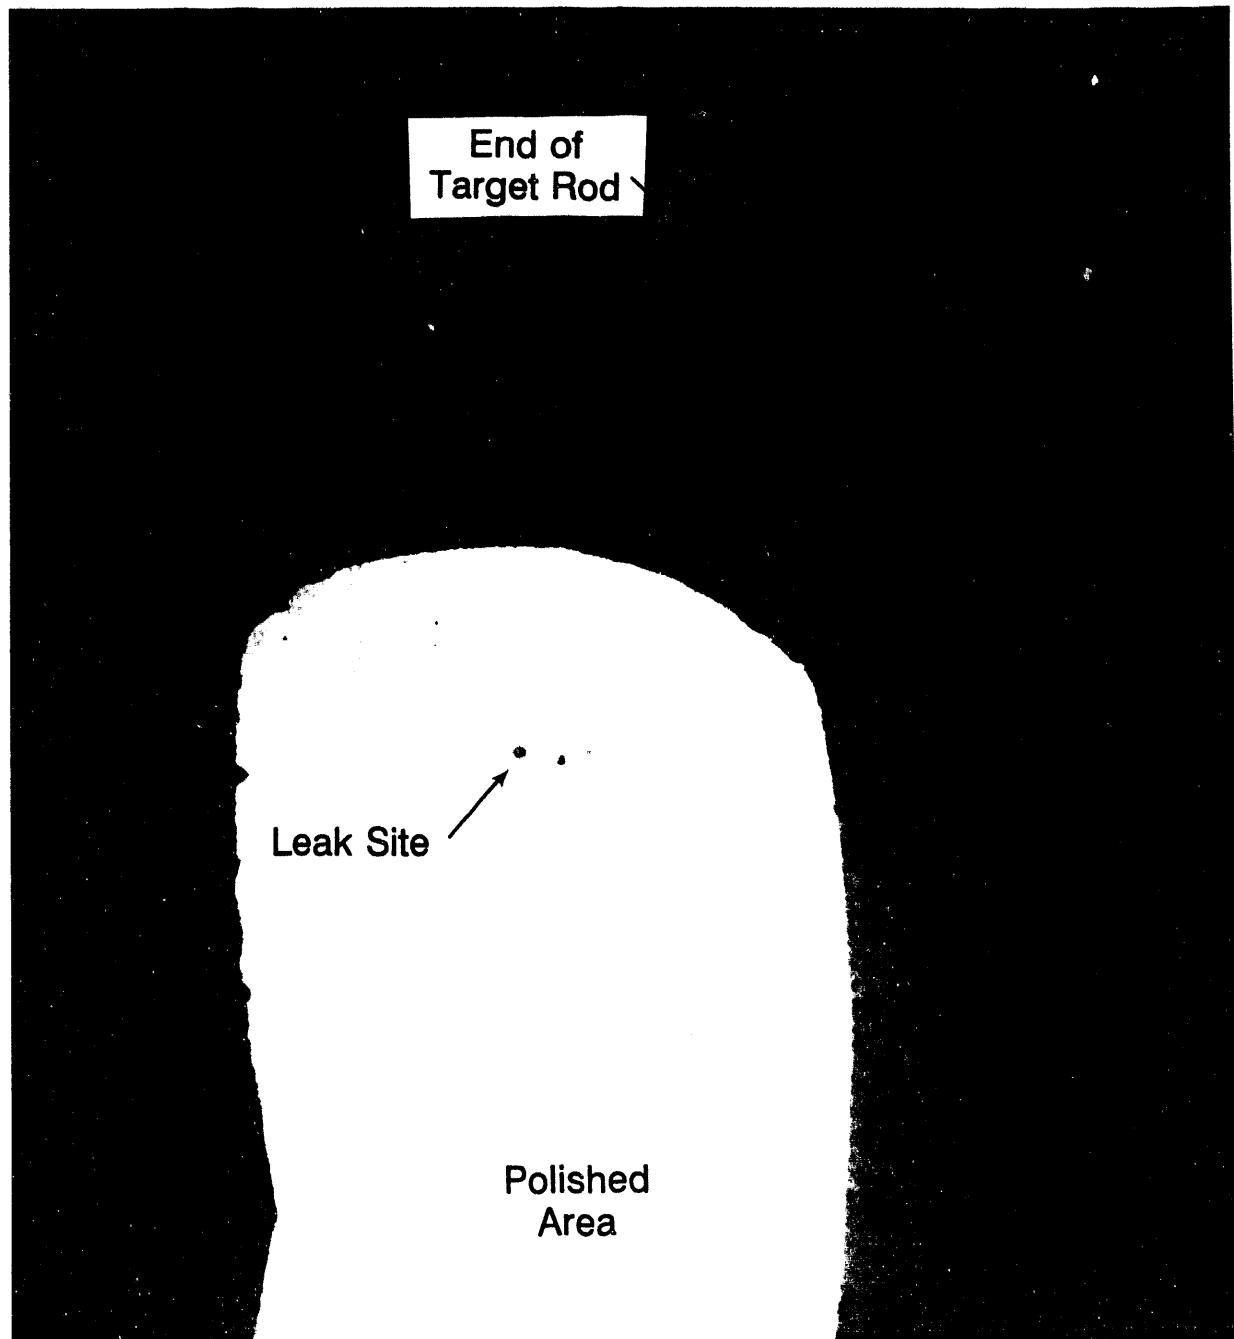
Fig. 4.15. Polished outer surface of upper end of iridium target rod IR-75, showing cross section of leakage path close to outer surface (polishing depth  $\sim 0.014$  in.).

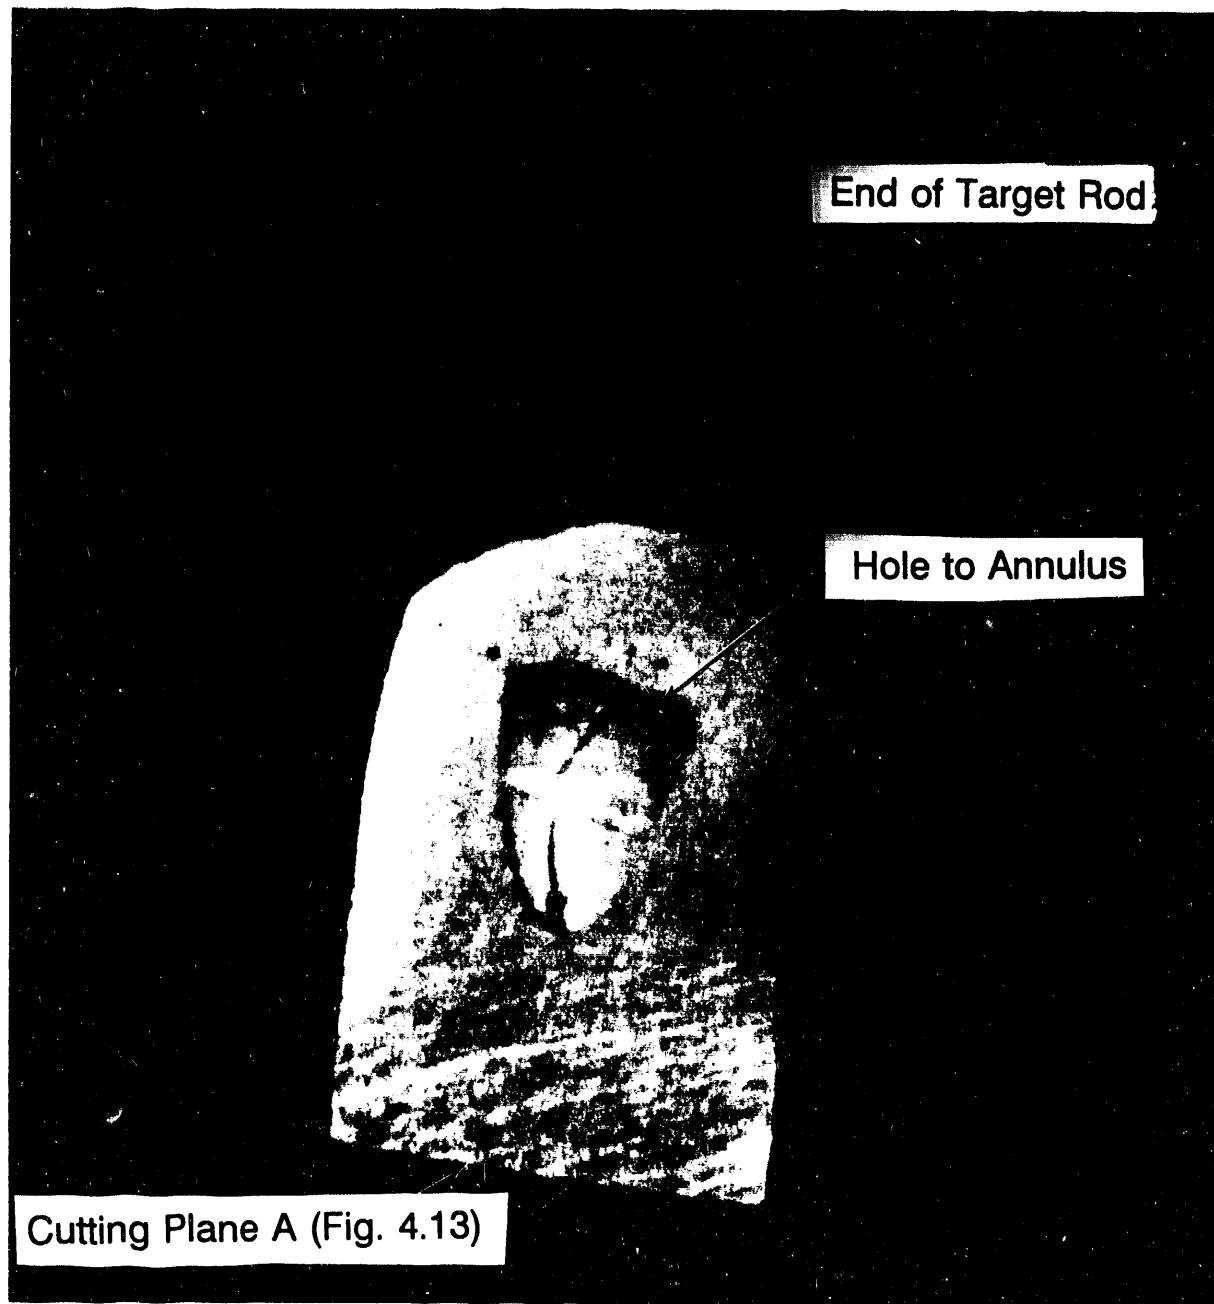
Fig. 4.17. Final step in polishing of outer surface of upper end of iridium target rod IR-75, showing triangular-shaped opening to annulus between sheath and core (polishing depth ~0.023 in.).

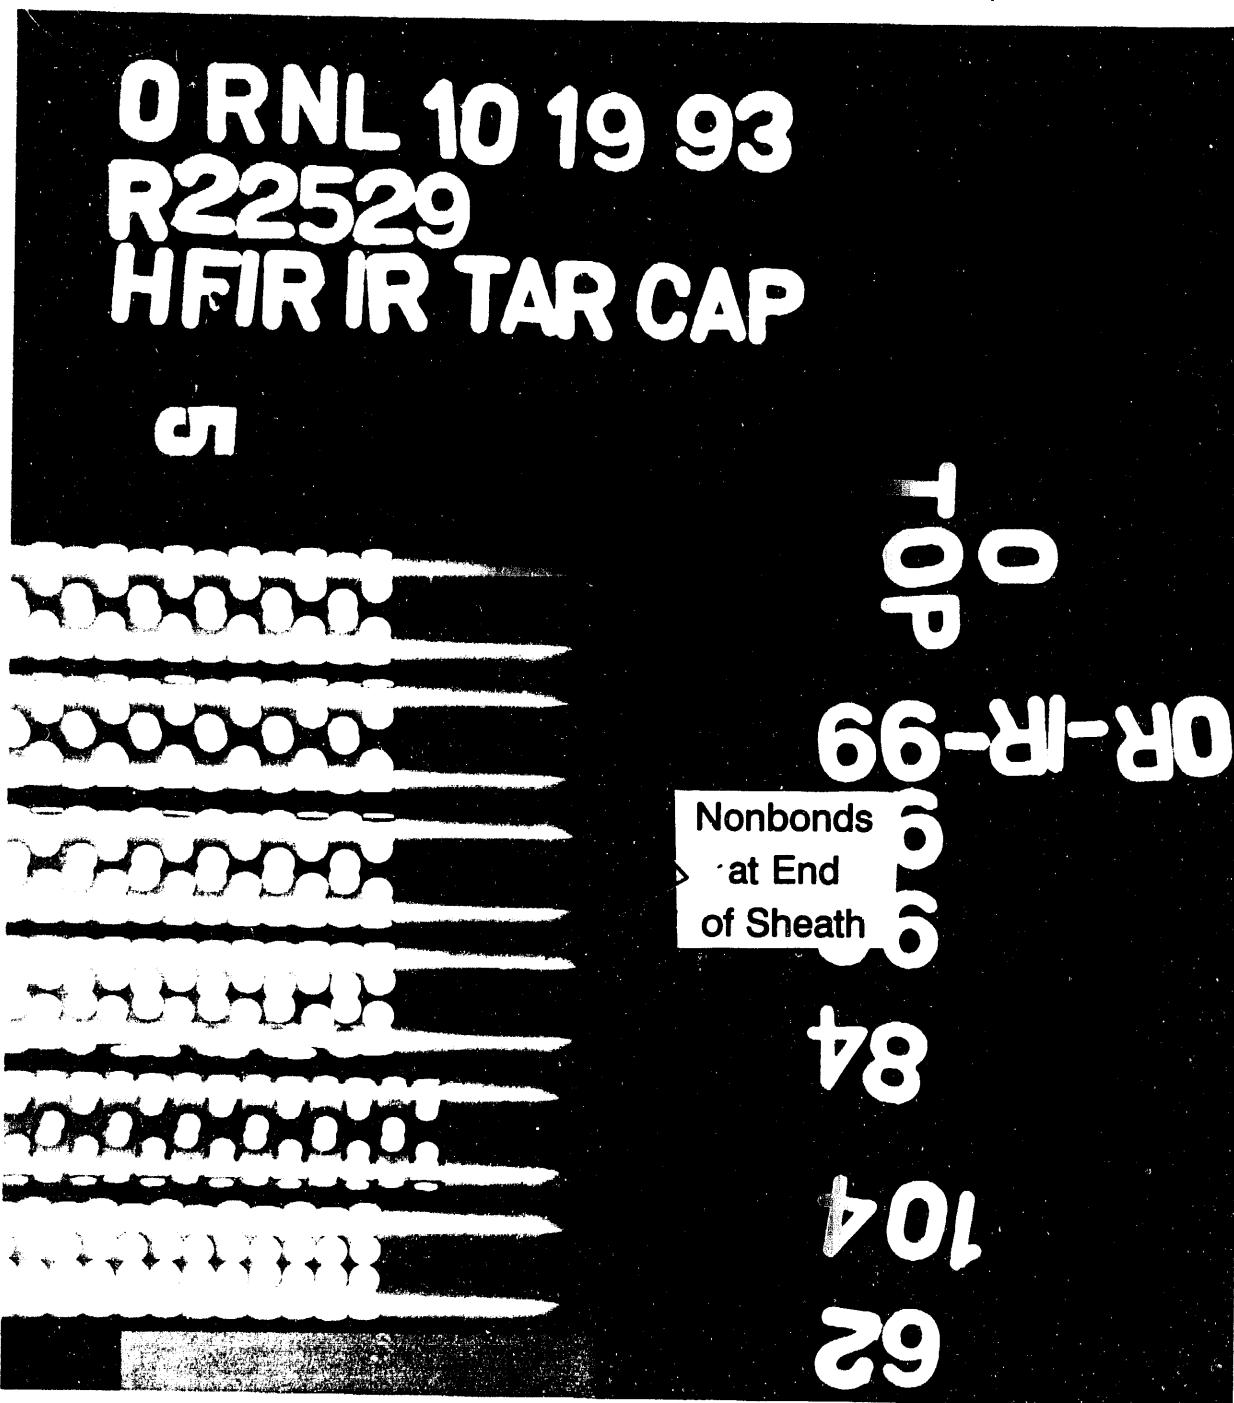
Fig. 4.21. Radiograph of six unirradiated iridium target rods, showing nonbonds (unfused areas) at the ends of two sheaths.
