HW-65269
C-65

EXISTING REACTOR

REAR FACE PIPING REVIEW

May 25, 1960

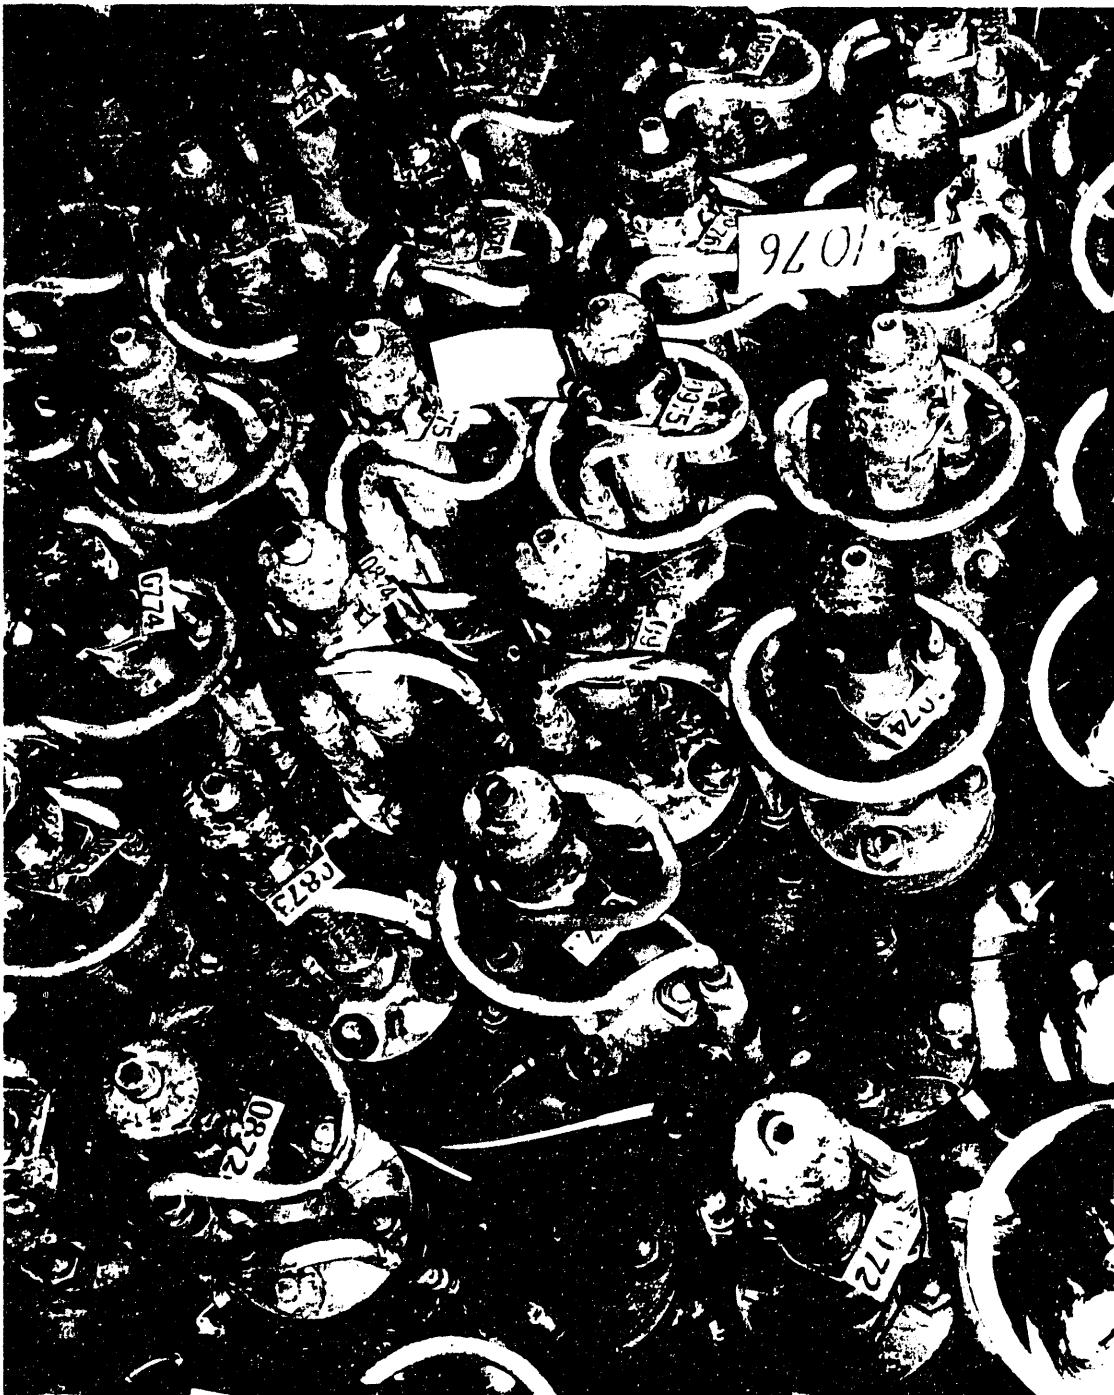
Piping on a reactor rear face is almost wholly 18-8 austenitic stainless steel. Components which are not are process tubes and nozzles of aluminum, nozzle caps of carbon steel and connector fittings of plated brass. In this combination of materials of varying thermal expansion there are approximately 22,000 mechanical joints in the piping system and some percent of these leak. Due to stress and cyclic fatigue caused by stuck gun barrels, numerous Van Stone flanges shear or are cracked and resultant leakage wets the surrounding system. Hot ionized effluent of pH 7 (corrosive to carbon steel) flashes to steam on the hot piping around and below the leak and leaves a deposit of mineral salts. (Exhibits 9, 10, and 11) The analysis of a typical scale deposit is shown below.

EXHIBIT NO. 9
105-F REAR FACE - VIEW SHOWING SCALE BUILDUP

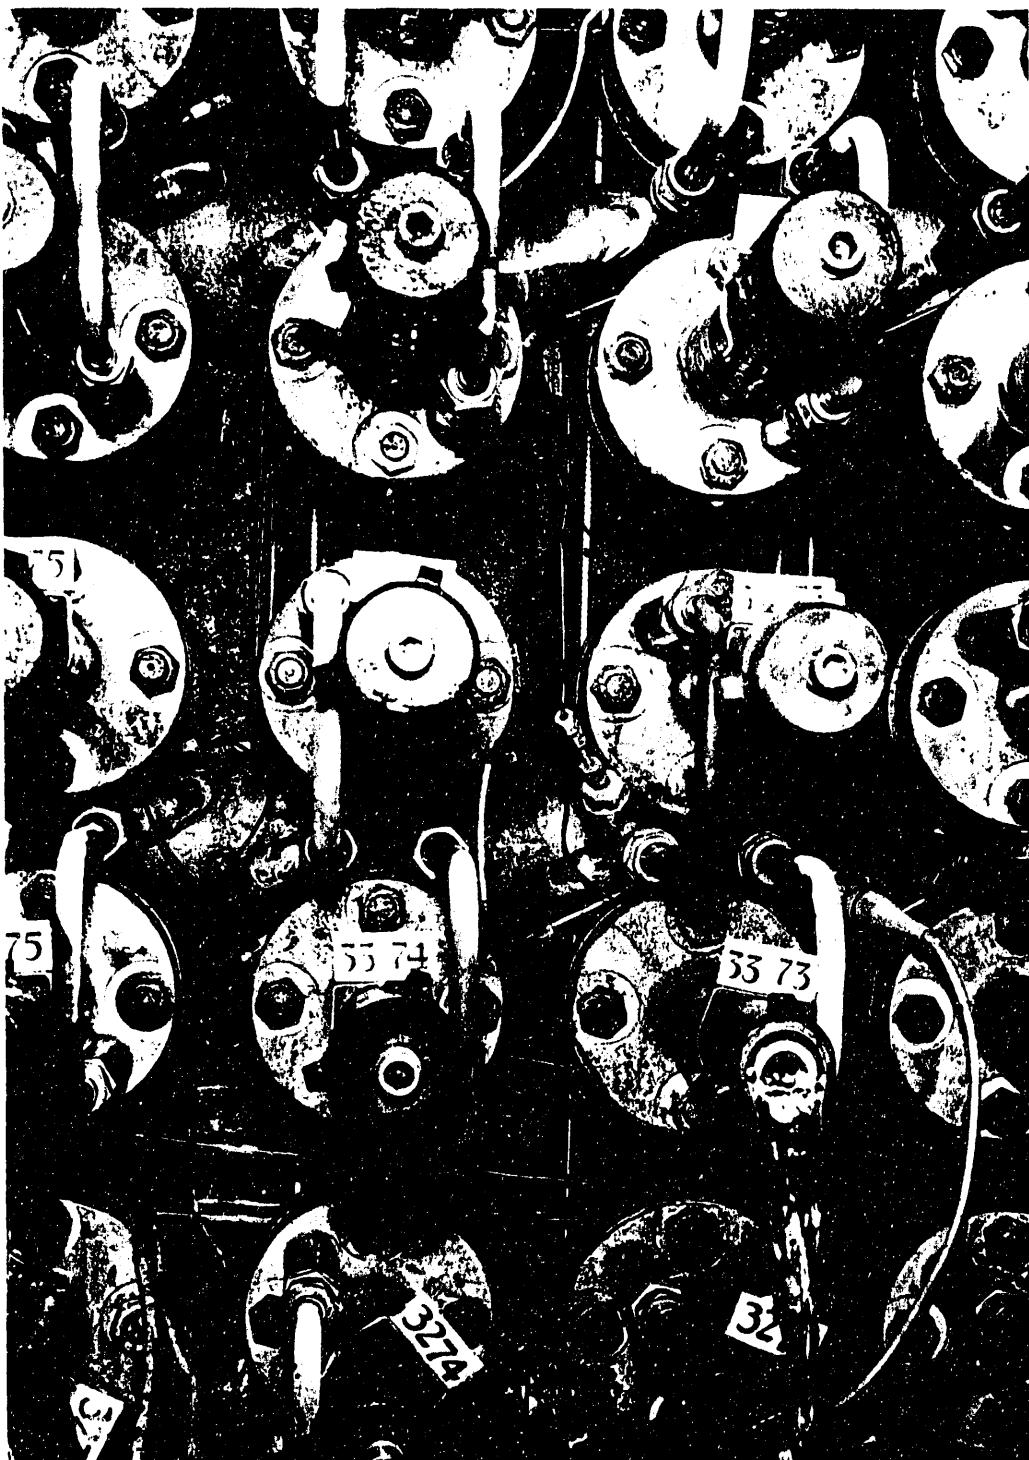
EXHIBIT NO. 10
105-H REAR FACE - VIEW SHOWING SCALE BUILDUP
ON CROSSHEADERS AND LOOSE THERMOCOUPLE FITTINGS

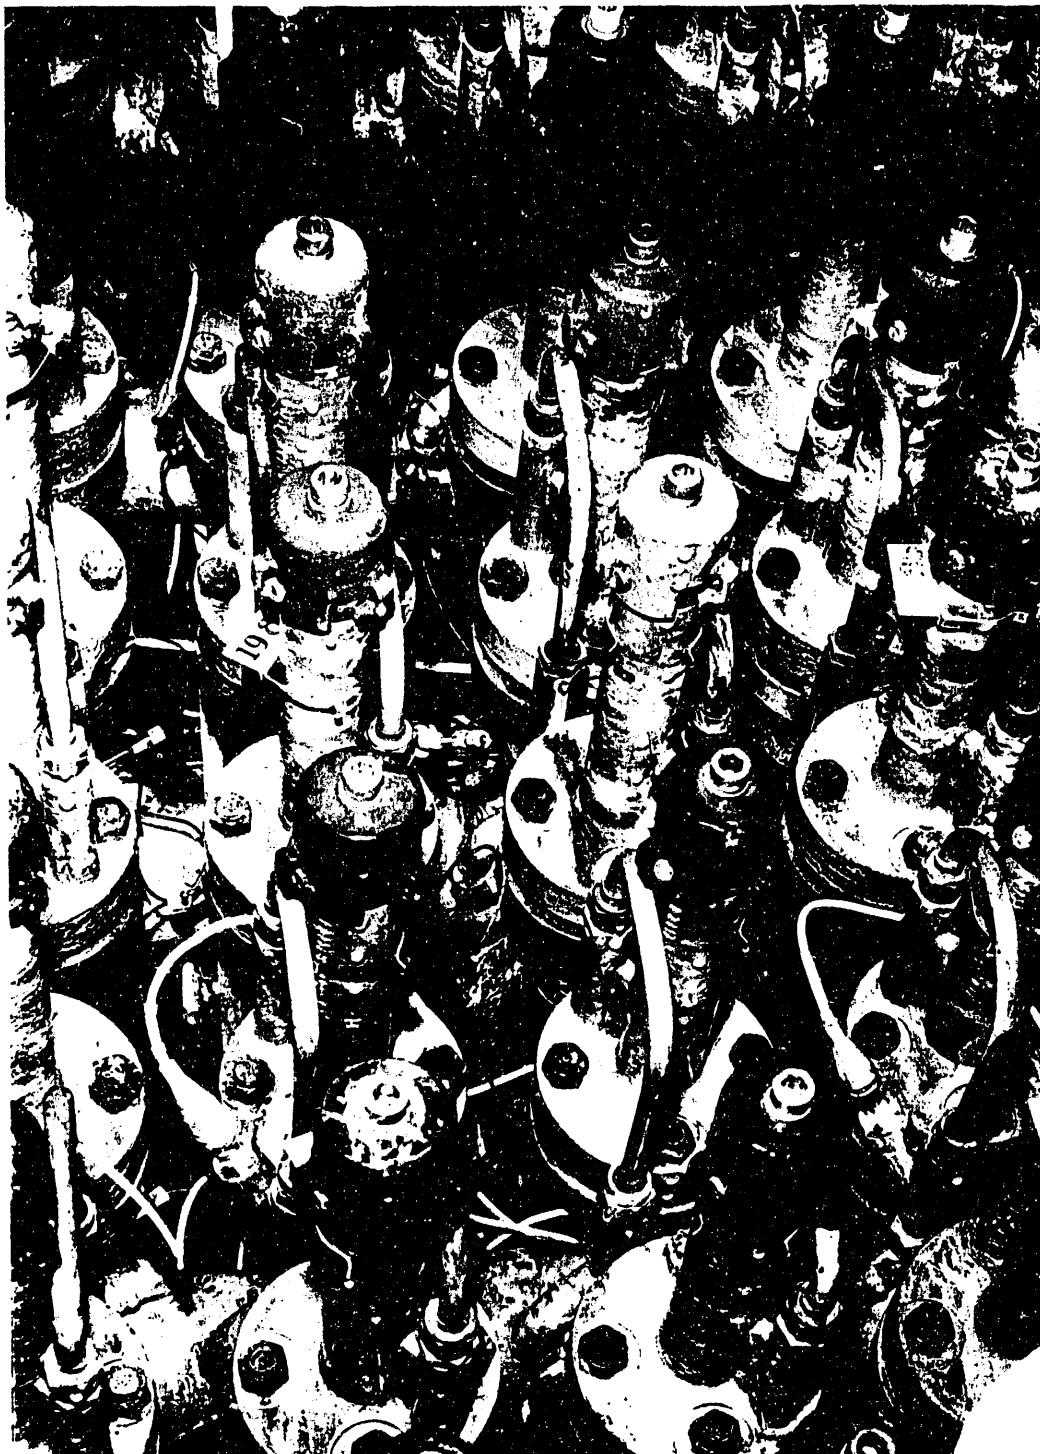
EXHIBIT NO. 11
105-H REAR FACE - VIEW SHOWING WET CONDITIONS, SCALE
BUILDUP, THERMOCOUPLE CONNECTIONS LOOSE FROM VIBRATION

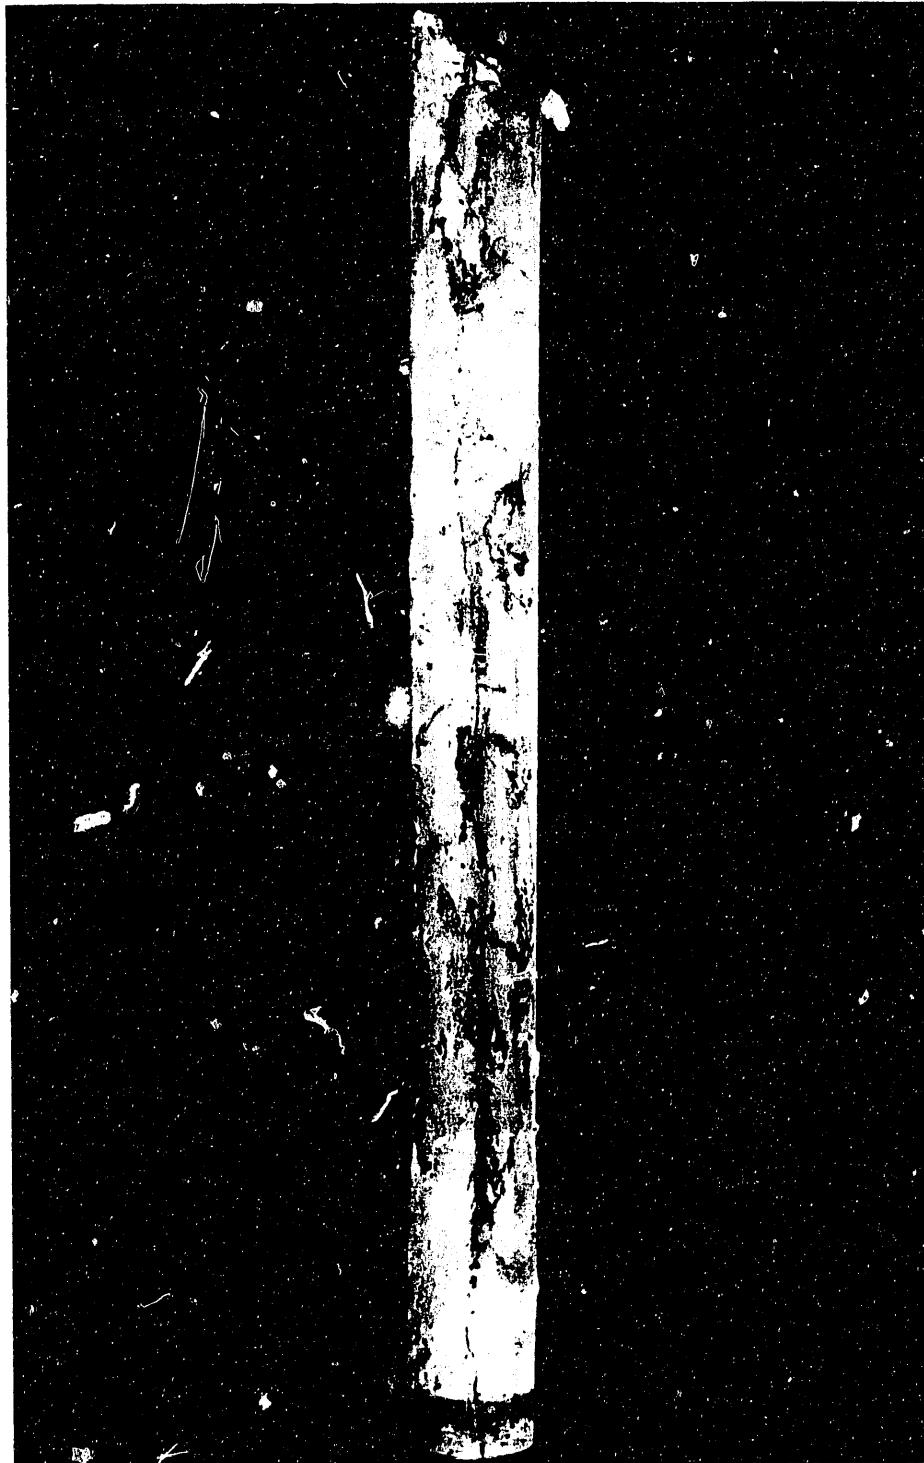
A number of reducing ions in this scale are corrosive to the passive and protective film on the stainless piping components and vigorous pitting develops. It is this pitting combined with stress that characterizes stress corrosion cracking. Examples of component failures through stress corrosion are shown in Exhibits 12 through 16.

EXHIBIT NO. 12
105-H REAR FACE - GAMMA MONITOR WATER SAMPLE LINE
STRESS CORROSION FAILURE

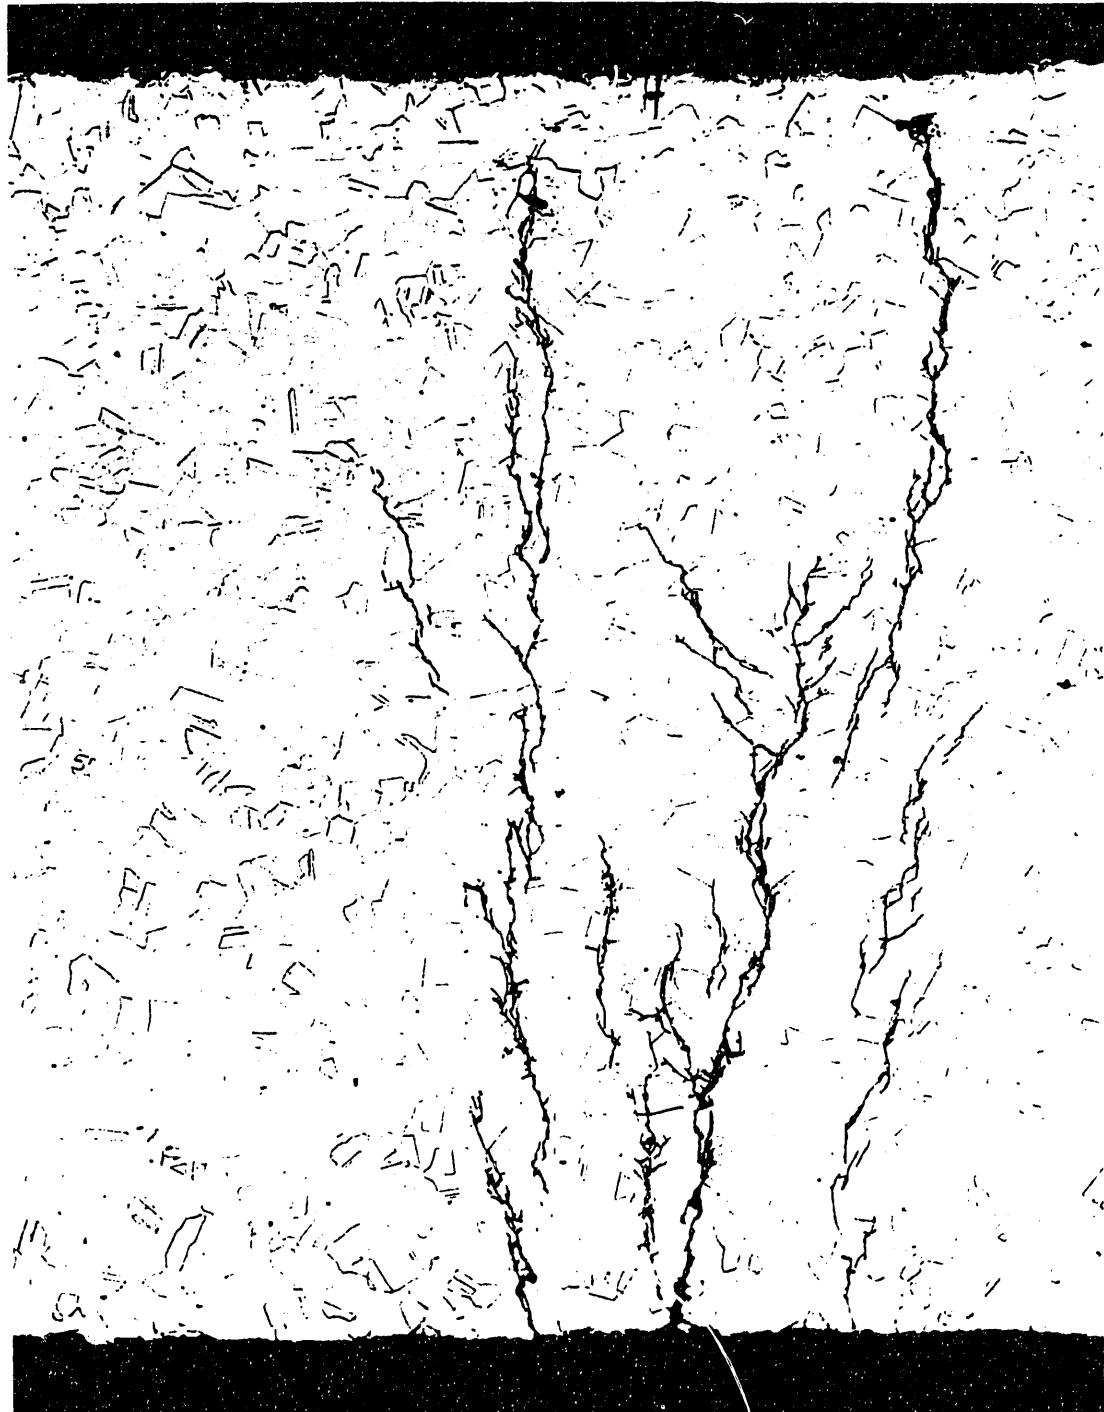
EXHIBIT NO. 14
105-H REAR FACE - PHOTOMICROGRAPH OF STRESS CORROSION
CRACK IN CONNECTOR

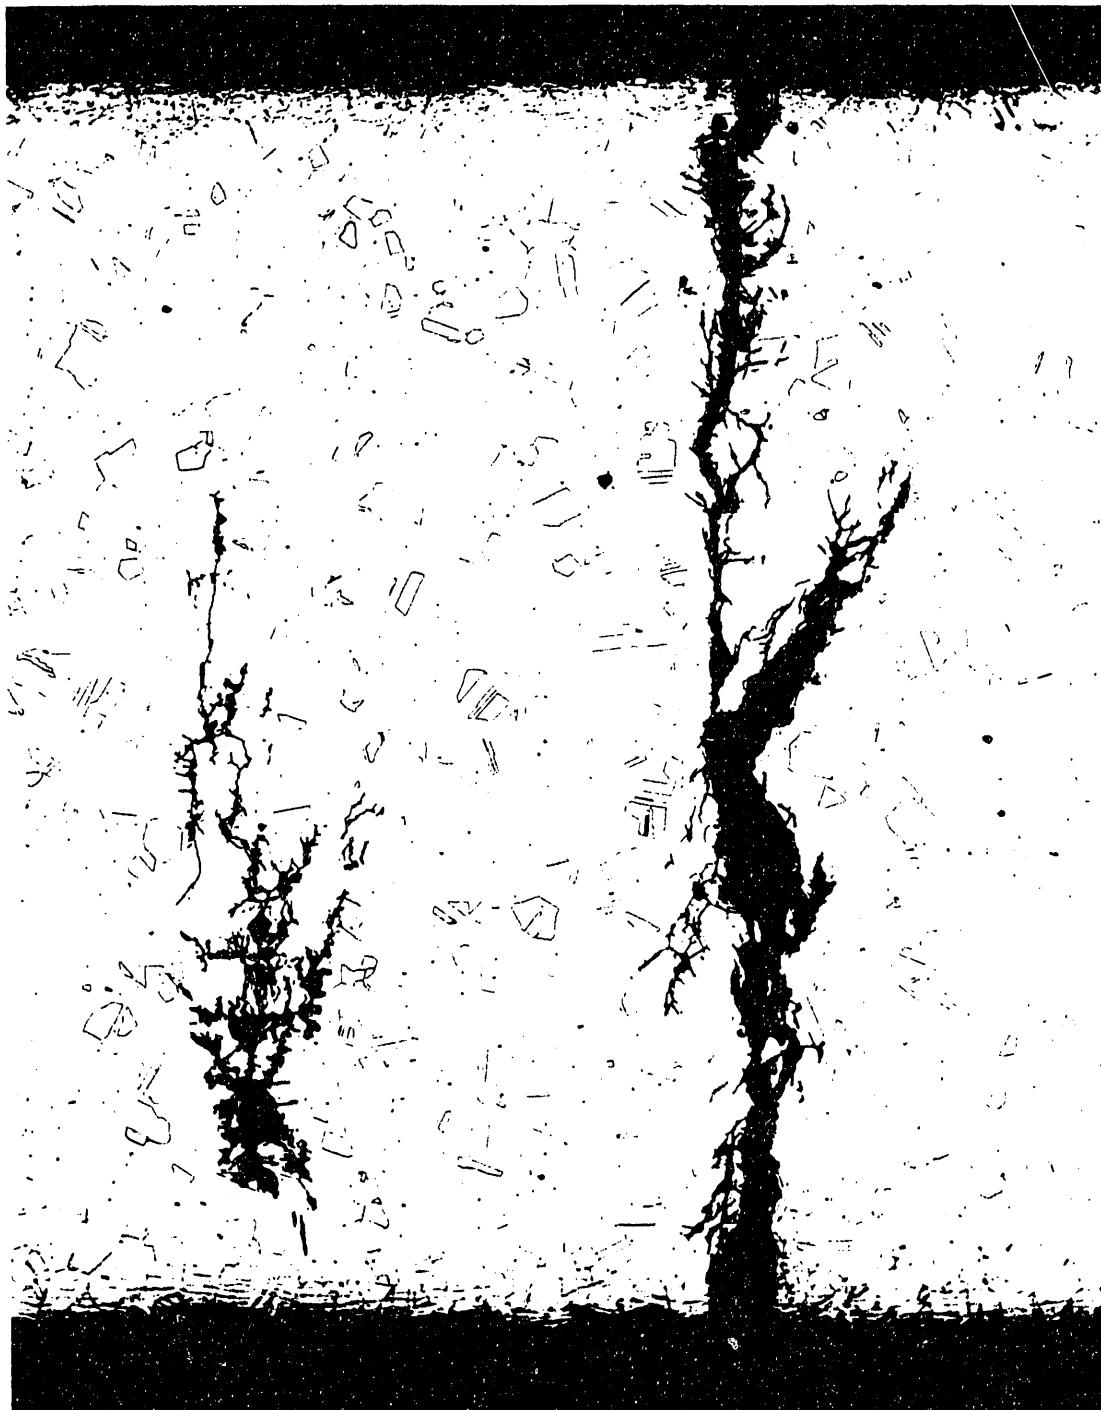
EXHIBIT NO. 15
105-H REAR FACE - PHOTOMICROGRAPH OF STRESS CORROSION
CRACKS IN CONNECTOR

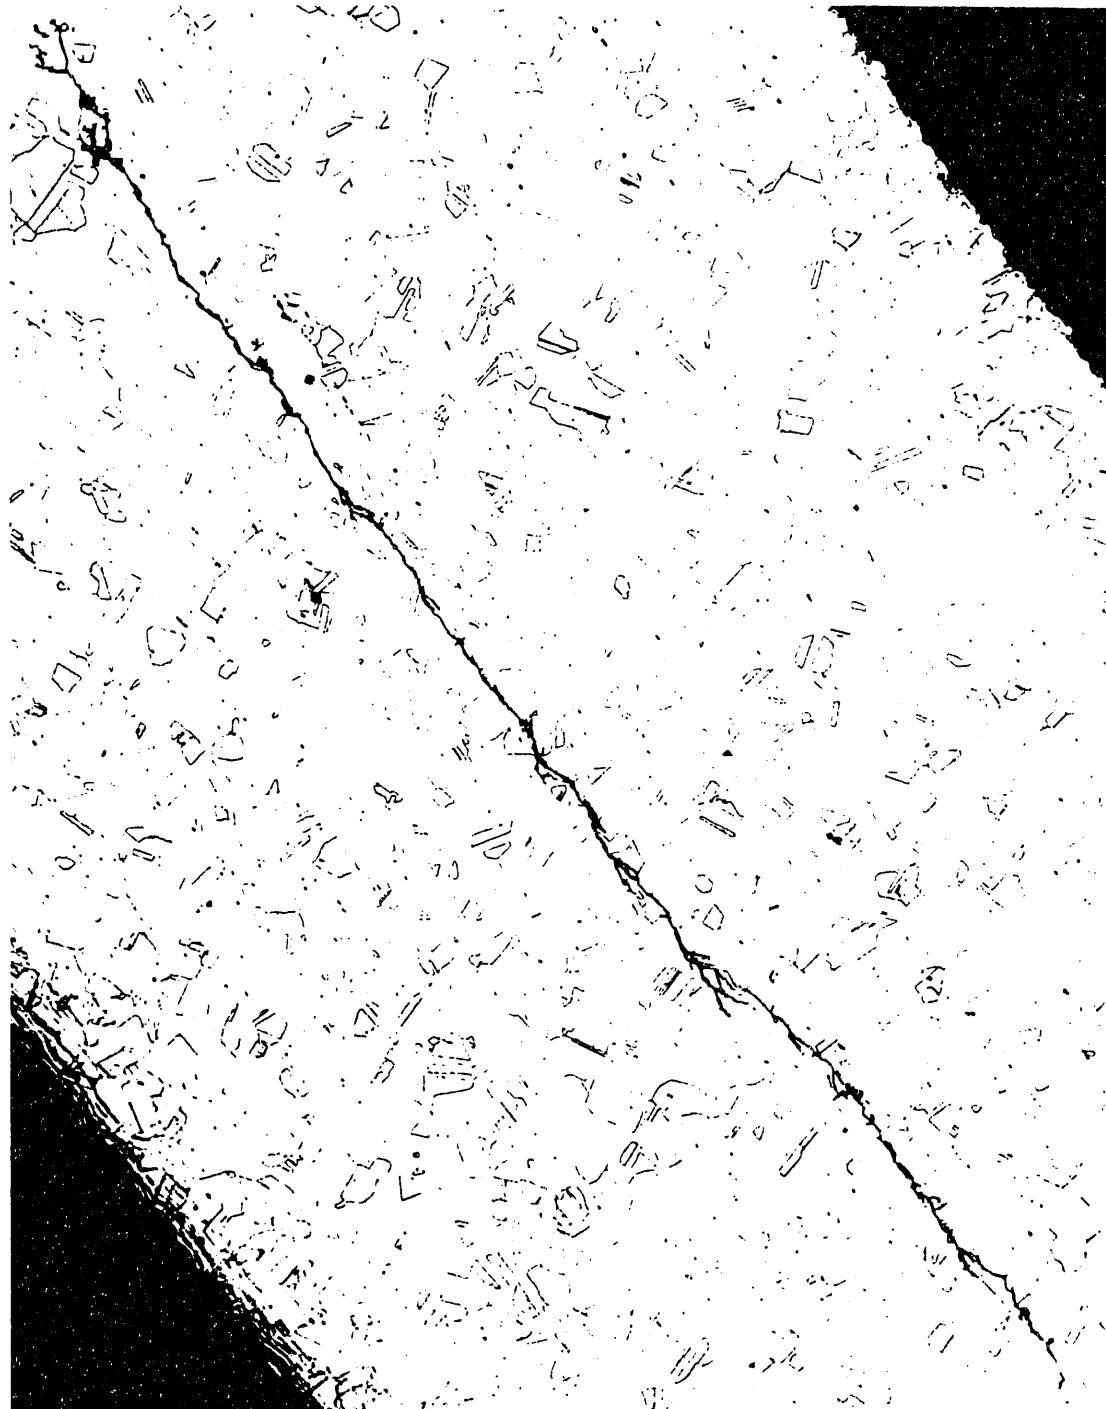
EXHIBIT NO. 16
105-H REAR FACE - PHOTOMICROGRAPH OF STRESS CORROSION
IN CONNECTOR ALONG CENTRAL AXIS- UNDETECTABLE FROM
THE SURFACE

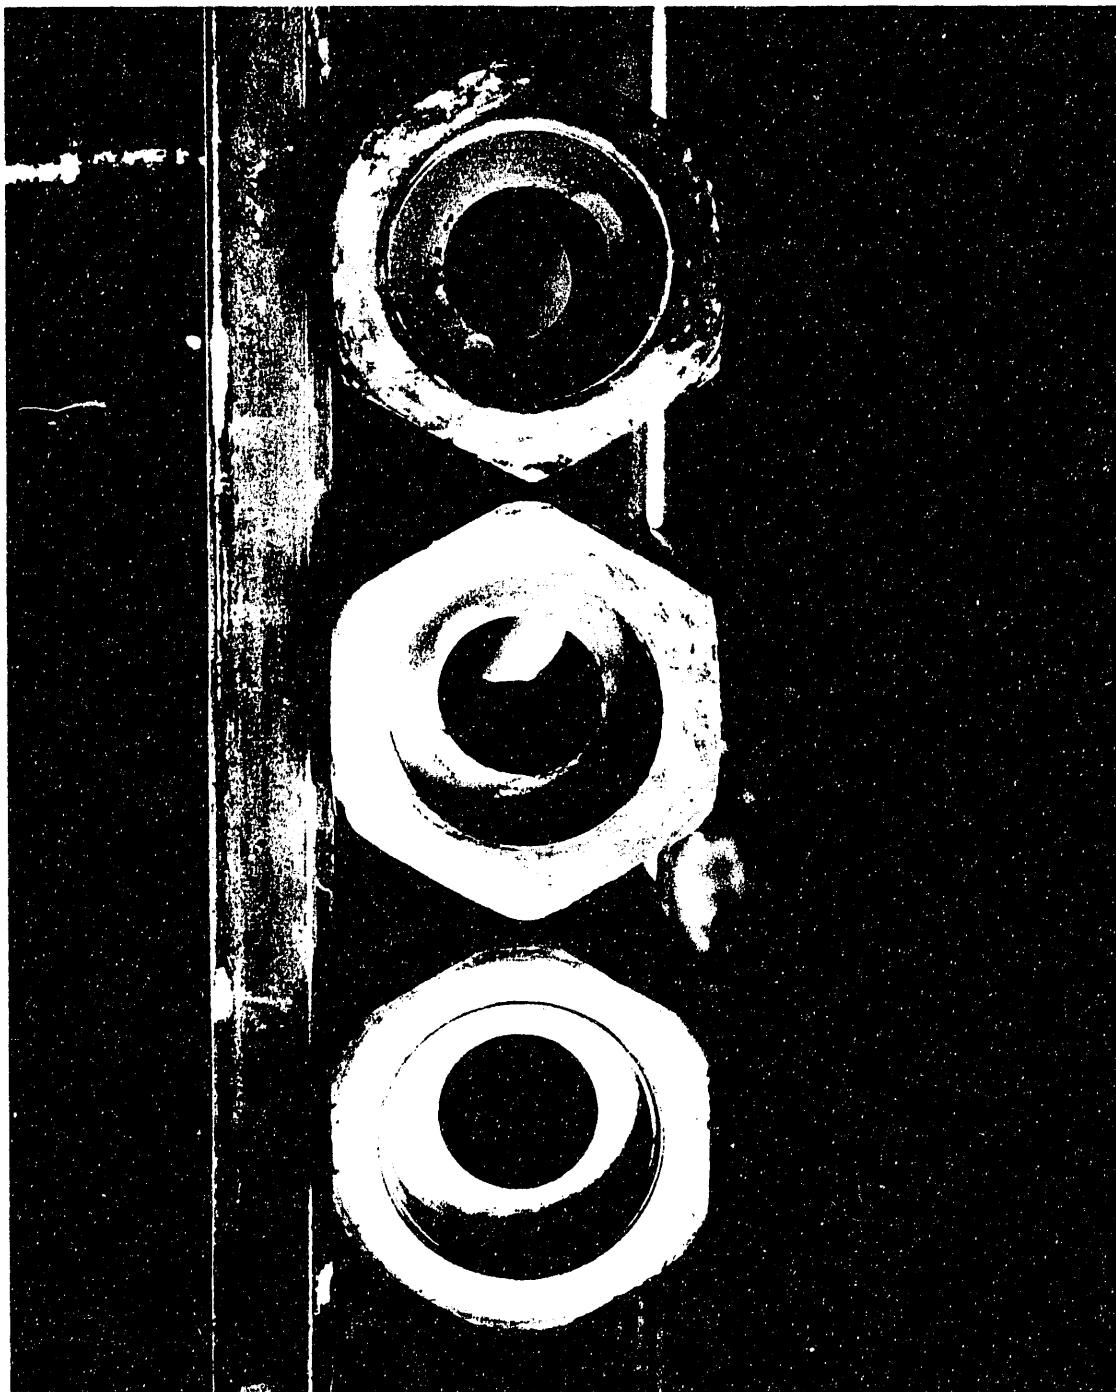
EXHIBIT NO. 17
105-H REAR FACE - CAVITATION OF BRASS ADAPTERS

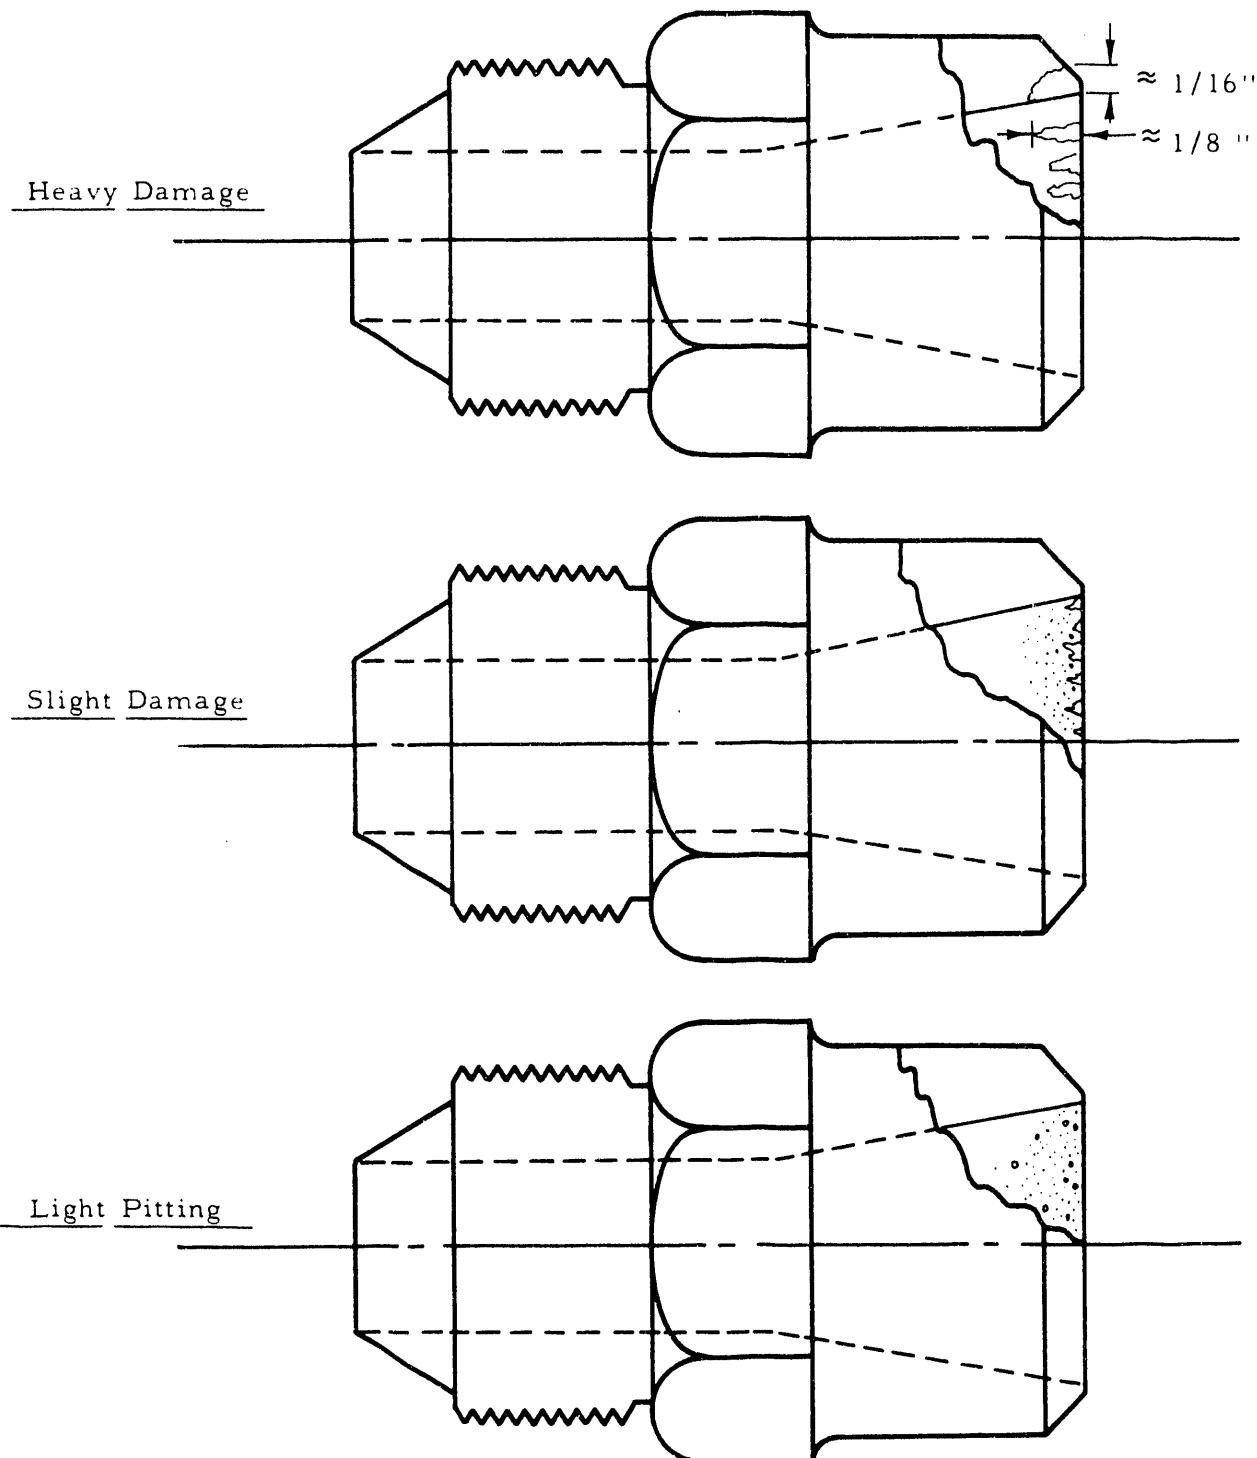
Cavitational flow has been known to exist in rear crossheader "Parker" fittings at B, D, DR, F, and H Reactors for the last five or six years. Calculations indicating the initiation of cavitational flow as a result of high flow rates and temperatures in the present fittings were verified by experimental data in 1954⁽⁸⁾. To obtain an estimate of the effect of cavitation in rear crossheader fittings resulting from past and current operating conditions, 21 fittings at B, D, and F reactors were visually examined during the period October 6, 1959 to November 30, 1959.⁽⁹⁾

Exhibit No. 21
Parker Fitting Cavitation Damage B, D, F, DR

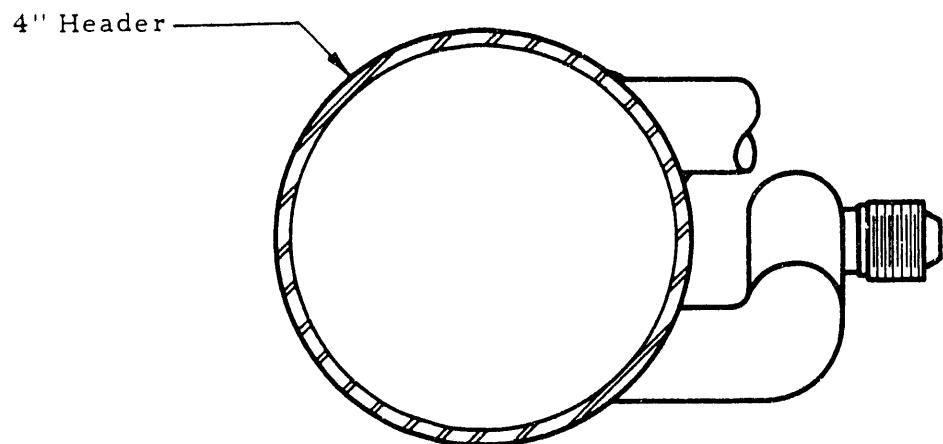
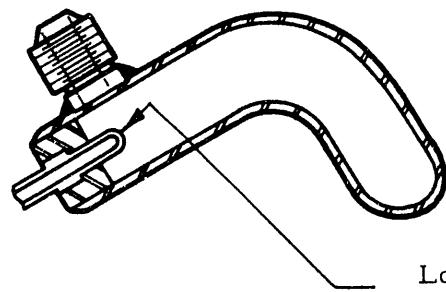
Location of Noted Cavitation
Damage Exhibit No. 18

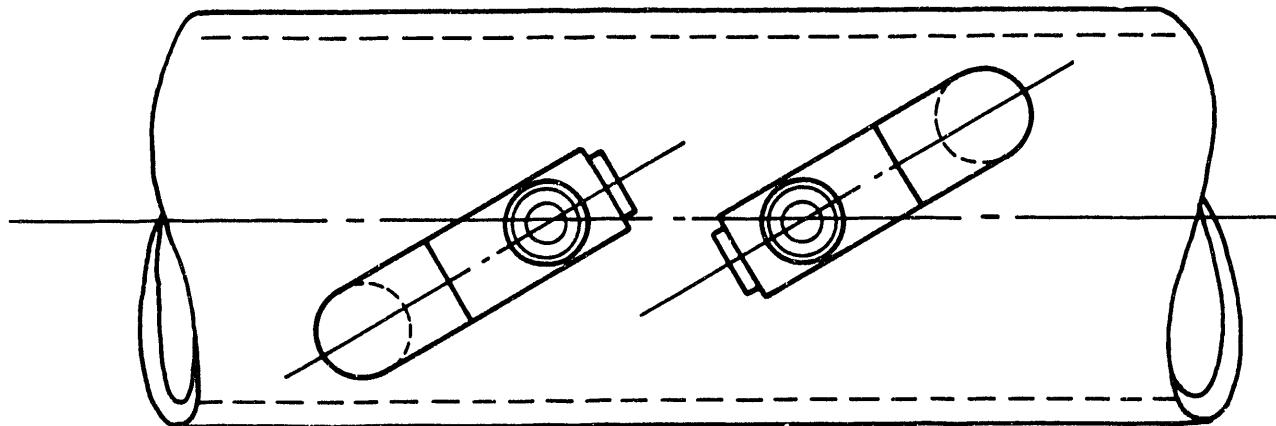
Exhibit No. 22
Cavitation Damage in H Reactor Crossheader Fittings

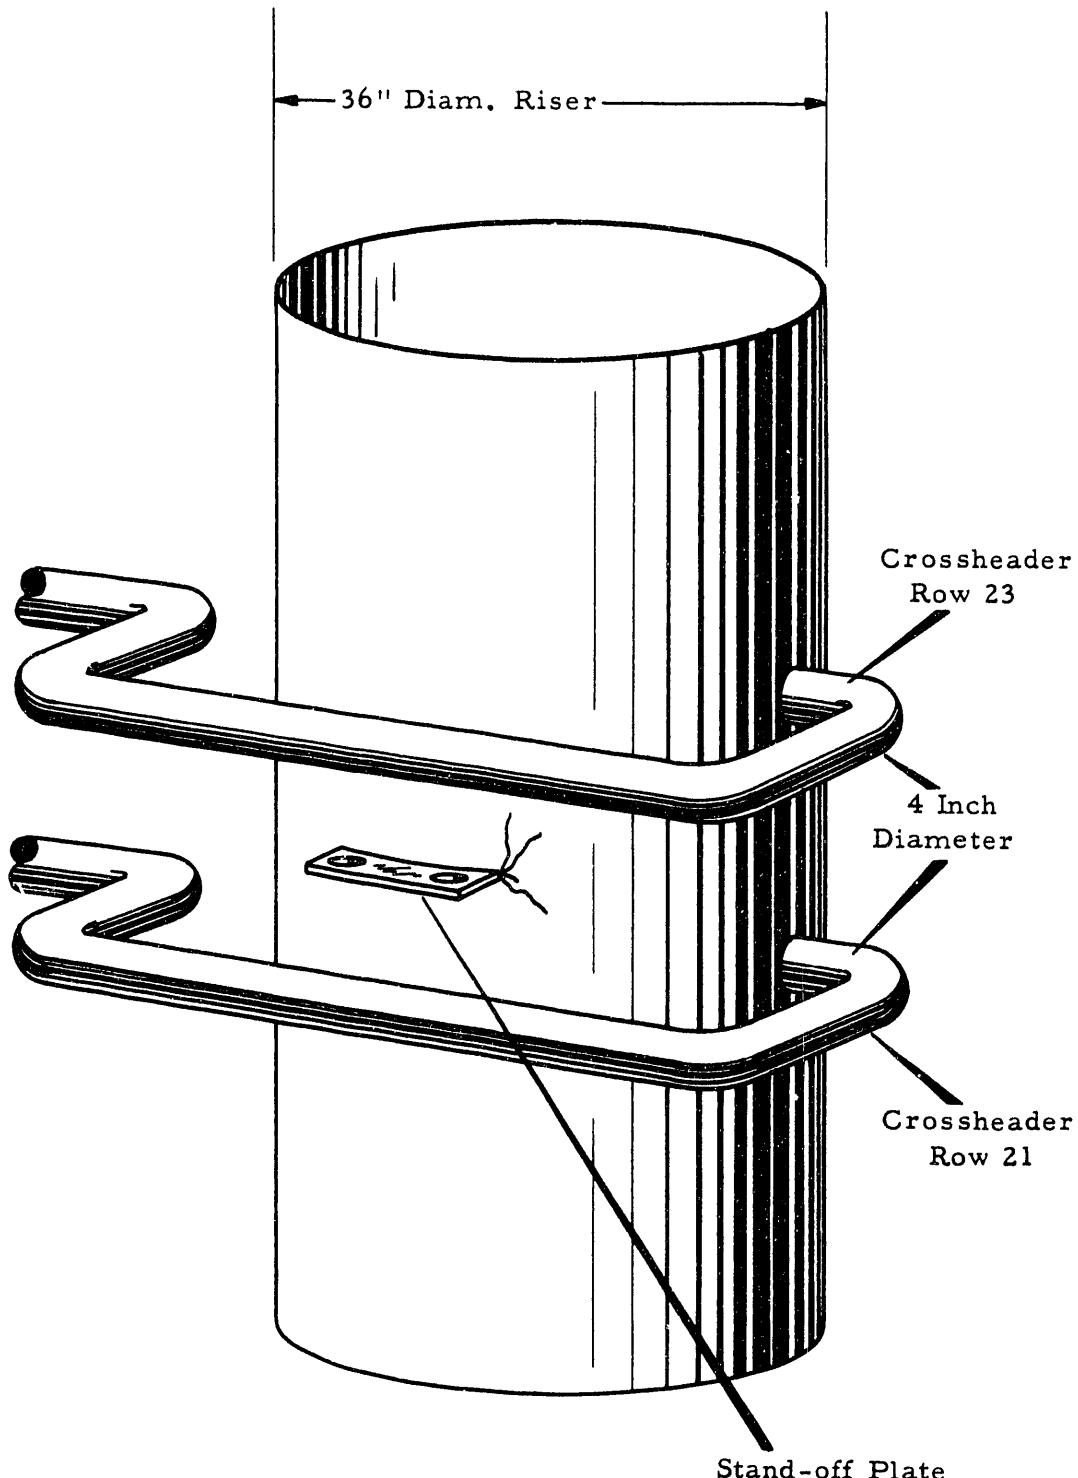
Exhibit No. 25
Example of Crack in Far Side Rear Face Riser 105-H Between
Crossheaders 21 and 23
