HW-75611
Page 1

C REACTOR OVERBORE FUEL EXAMINATION

April 18, 1963

HANFORD ATOMIC PRODUCTS OPERATION
RICHLAND, WASHINGTON

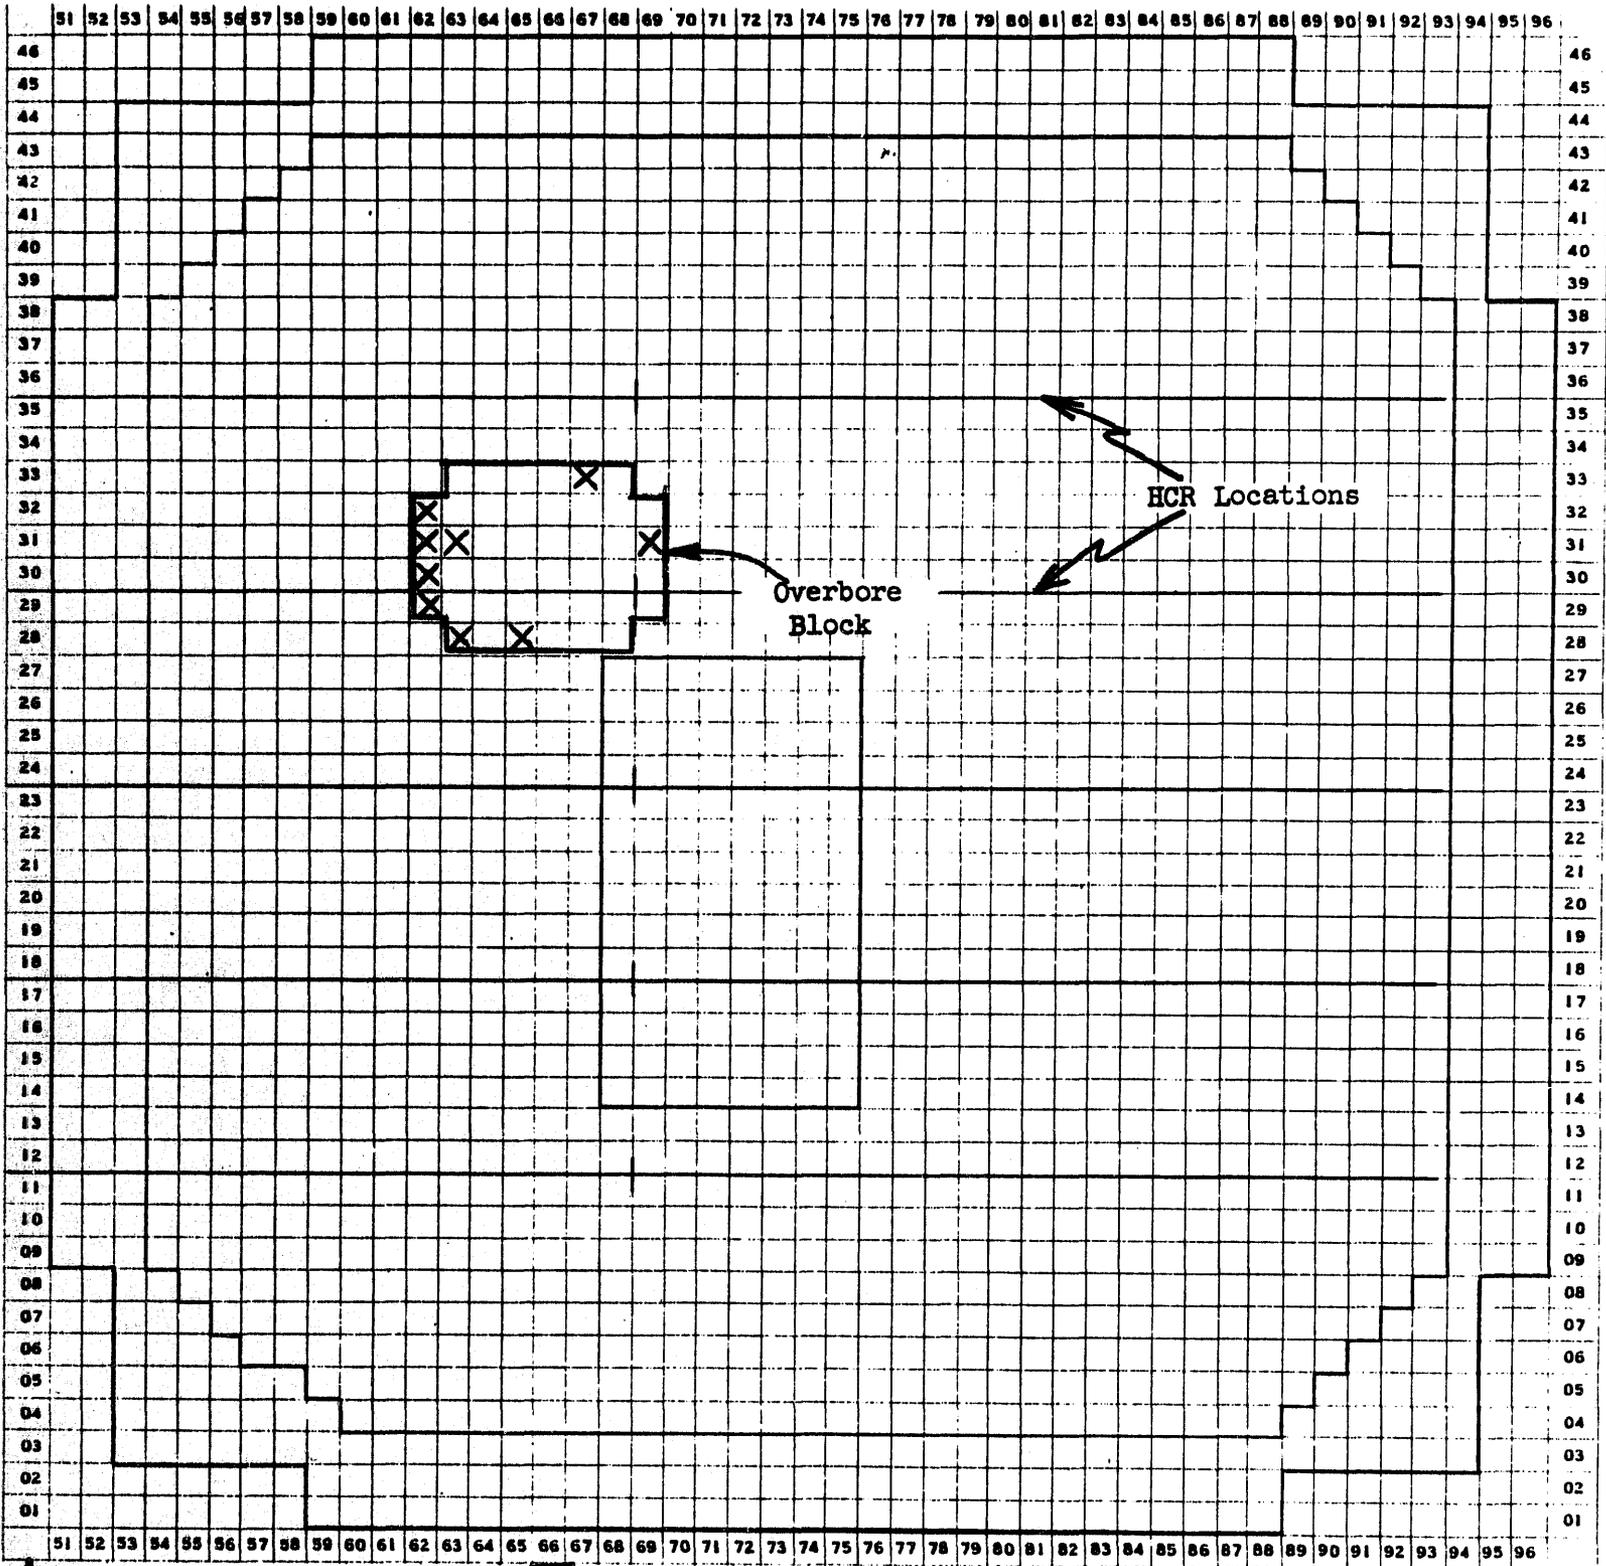
CHART 1

"X" indicates overbore tube location which contained worm-tracked elements.

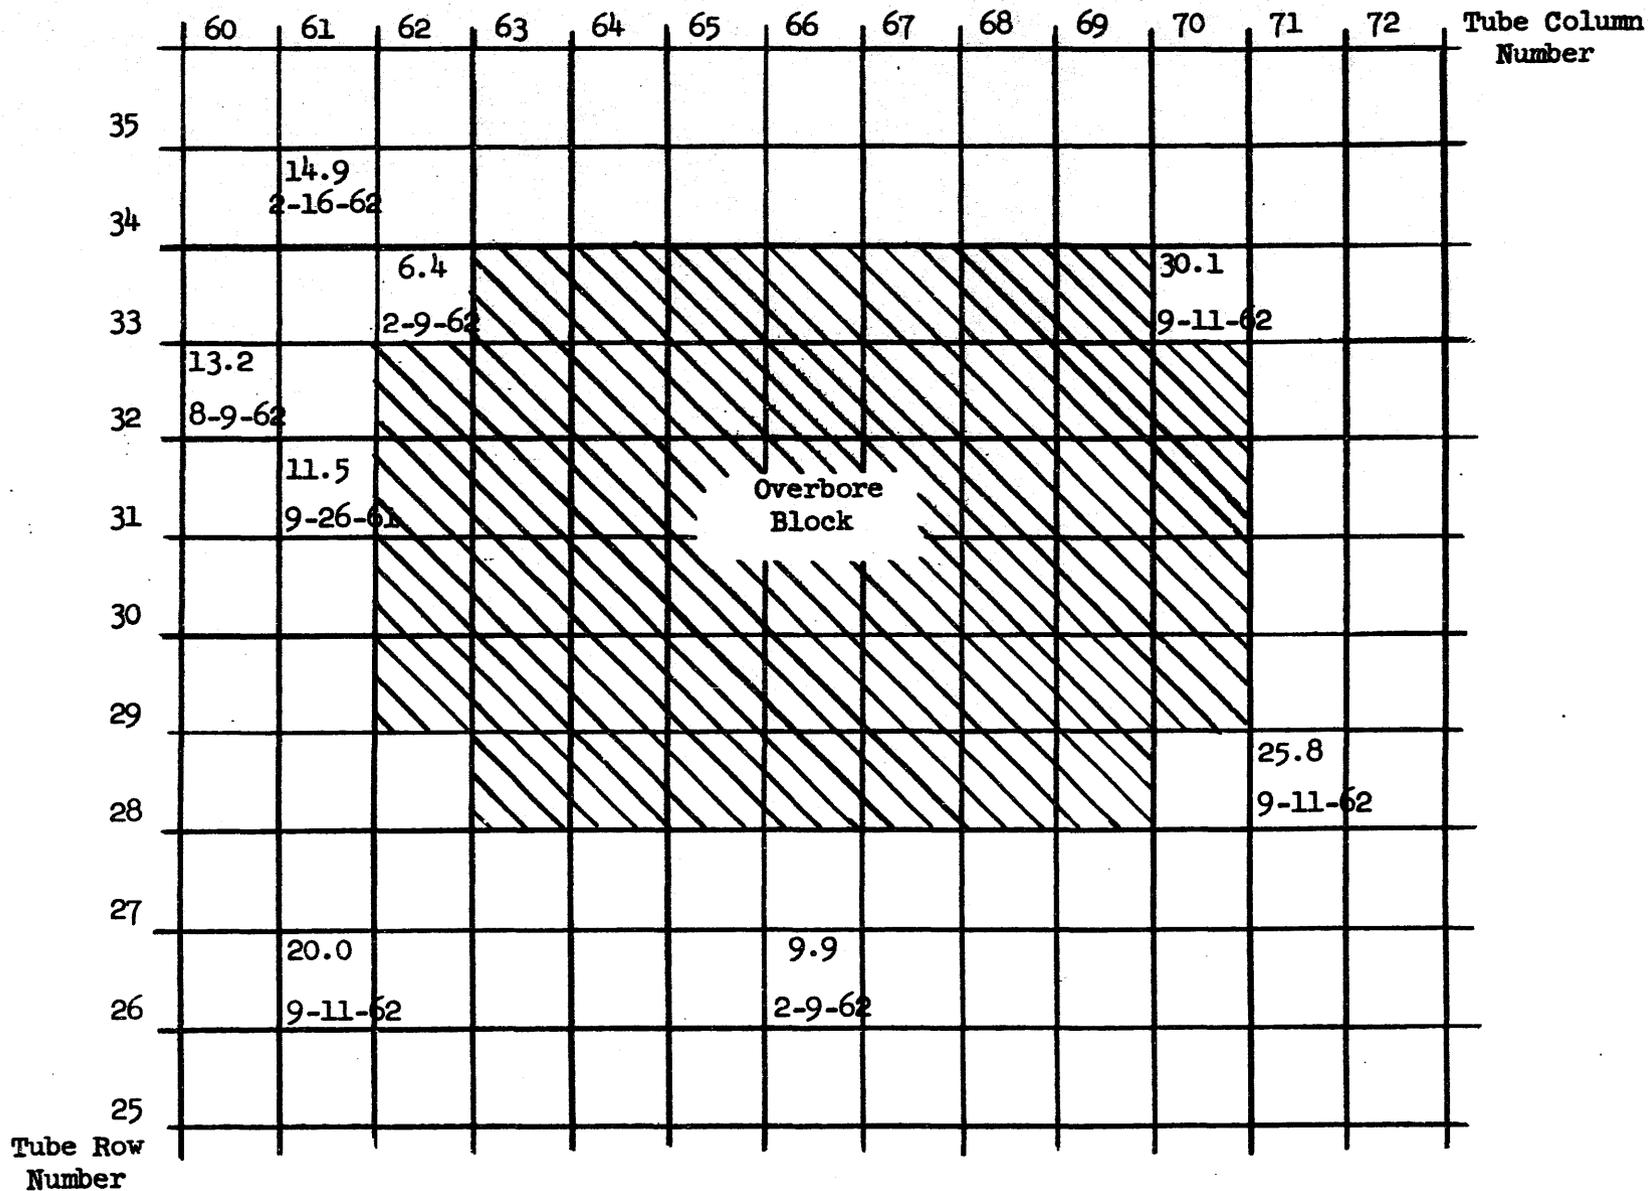
CHART 2

Chart 2 shows the results of recent non-poisonous spline flux traversing at C Reactor. It becomes apparent upon inspection of this chart, by comparing some of the observed flux peaking values with the values which would be needed to produce specific powers in excess of 170 Kw/ft, that these conditions could have existed during the more severe flux cycles.

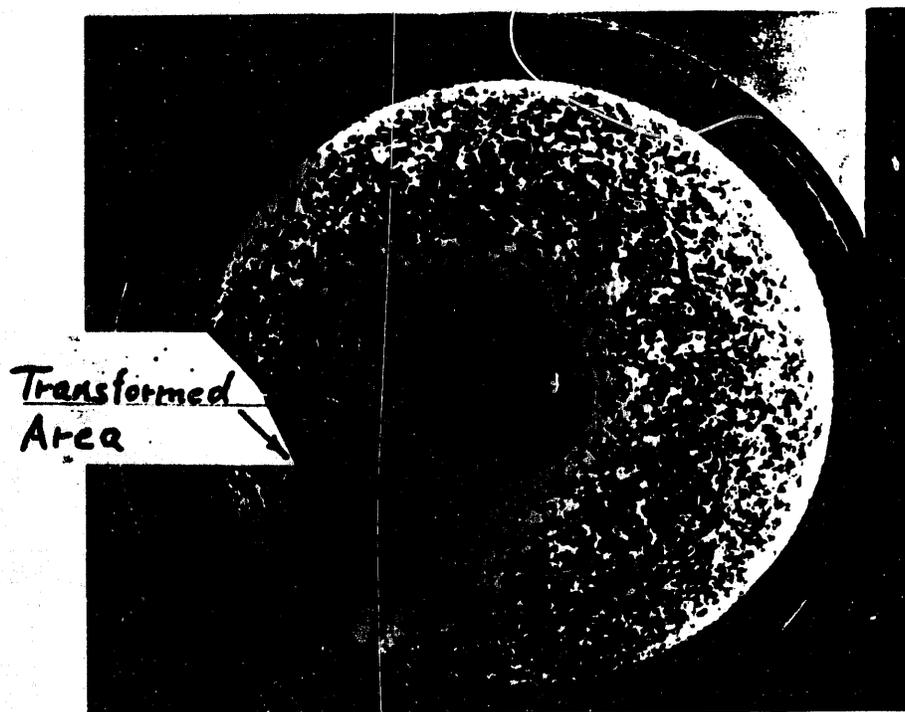
In two of the worm-tracked elements, 75Z10 and 84A1, areas were found near the center of the core that had operated in the beta phase. The well-defined crescent-shaped zones are shown in the etched macro views in Figure 7 and 10. In the zones where the alpha-to-beta transformation had occurred, extensive intergranular cracking was found. These cracks, which were not continuous, were formed at the grain boundaries as a result of the severe thermal cycling stresses. When examined under high magnification, the demarcation line between the transformed and nontransformed uranium is quite distinct. In the transformed zone the recrystallized grains have distinct boundaries and numerous straight twin lines as compared to the typical hashed-up structure in the nontransformed metal. The cracks leading from the worm tracks pass through the center of these zones.

Figure 7 - As-etched section from worm track Element 84A1 showing small transformed area in core and Y-shaped crack at lower left.

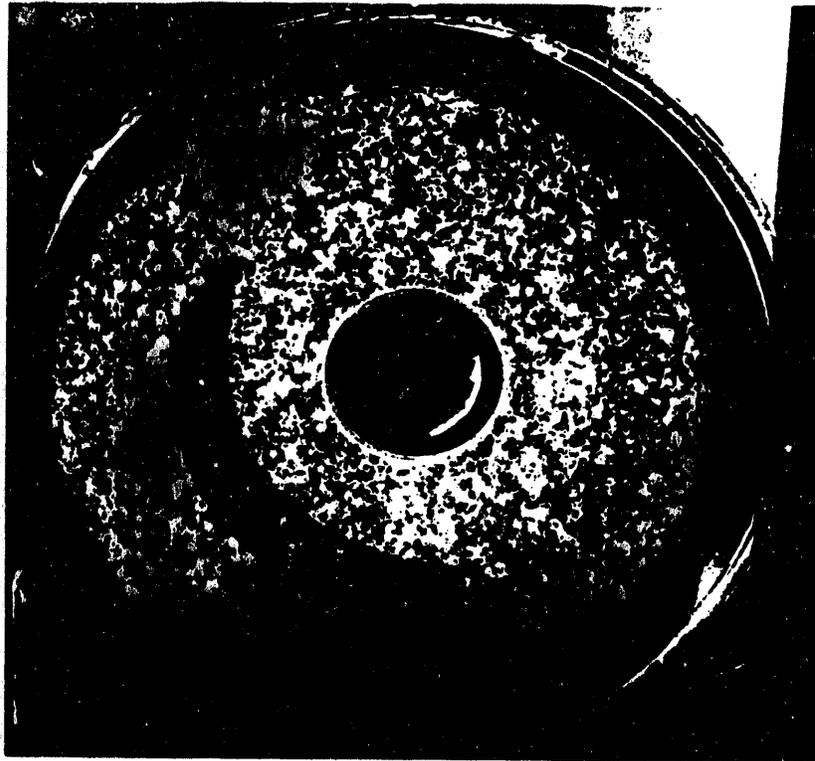
Figure 10 - As-etched transverse section from worm track Element 75Z10 showing crescent-shaped zone where the uranium had operated in the beta phase.

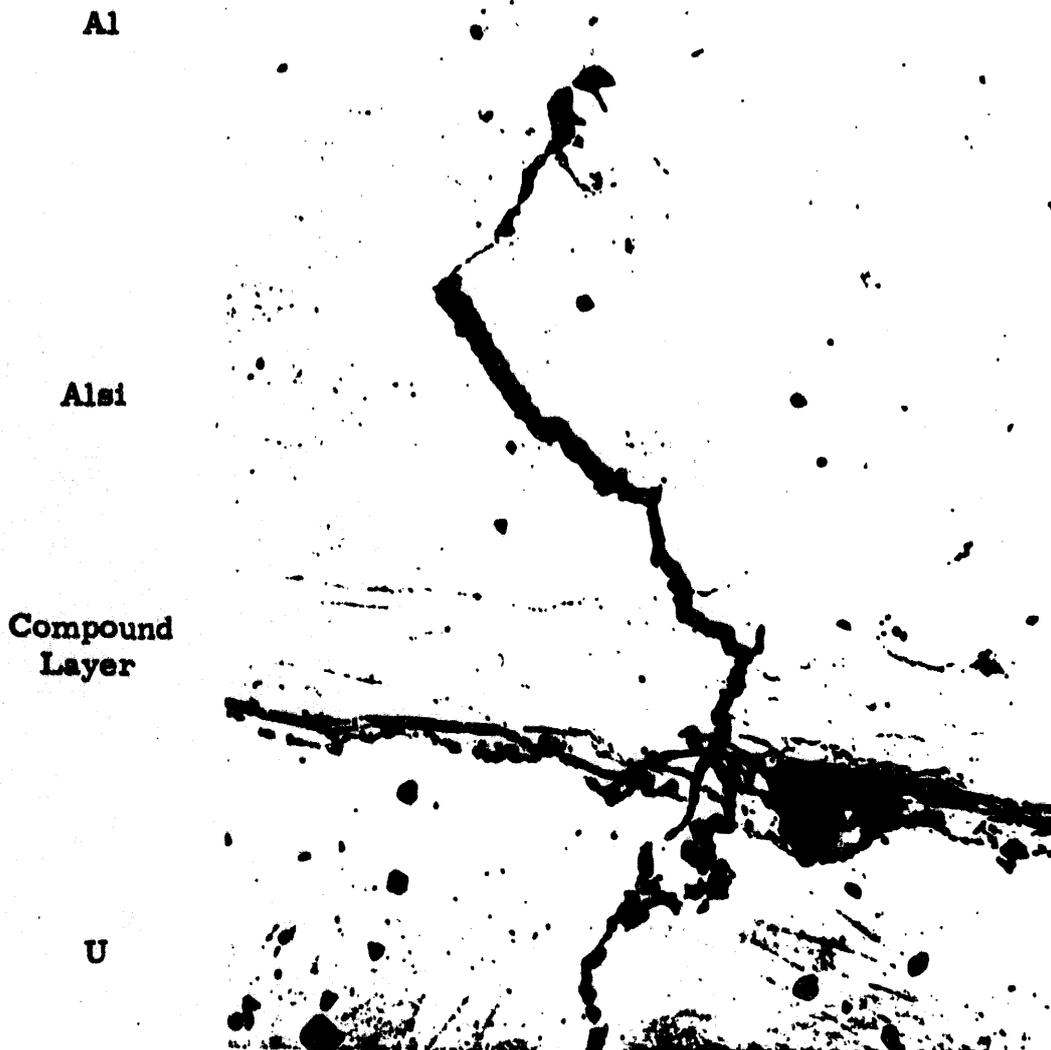
Figure 15 - Transverse section from 74Z12 showing crack continuing from uranium at bottom through compound layer and then across AlSi. Separation at uranium interface continues for more than 90° at the right of crack but at the left the separation terminates at .030" from crack.

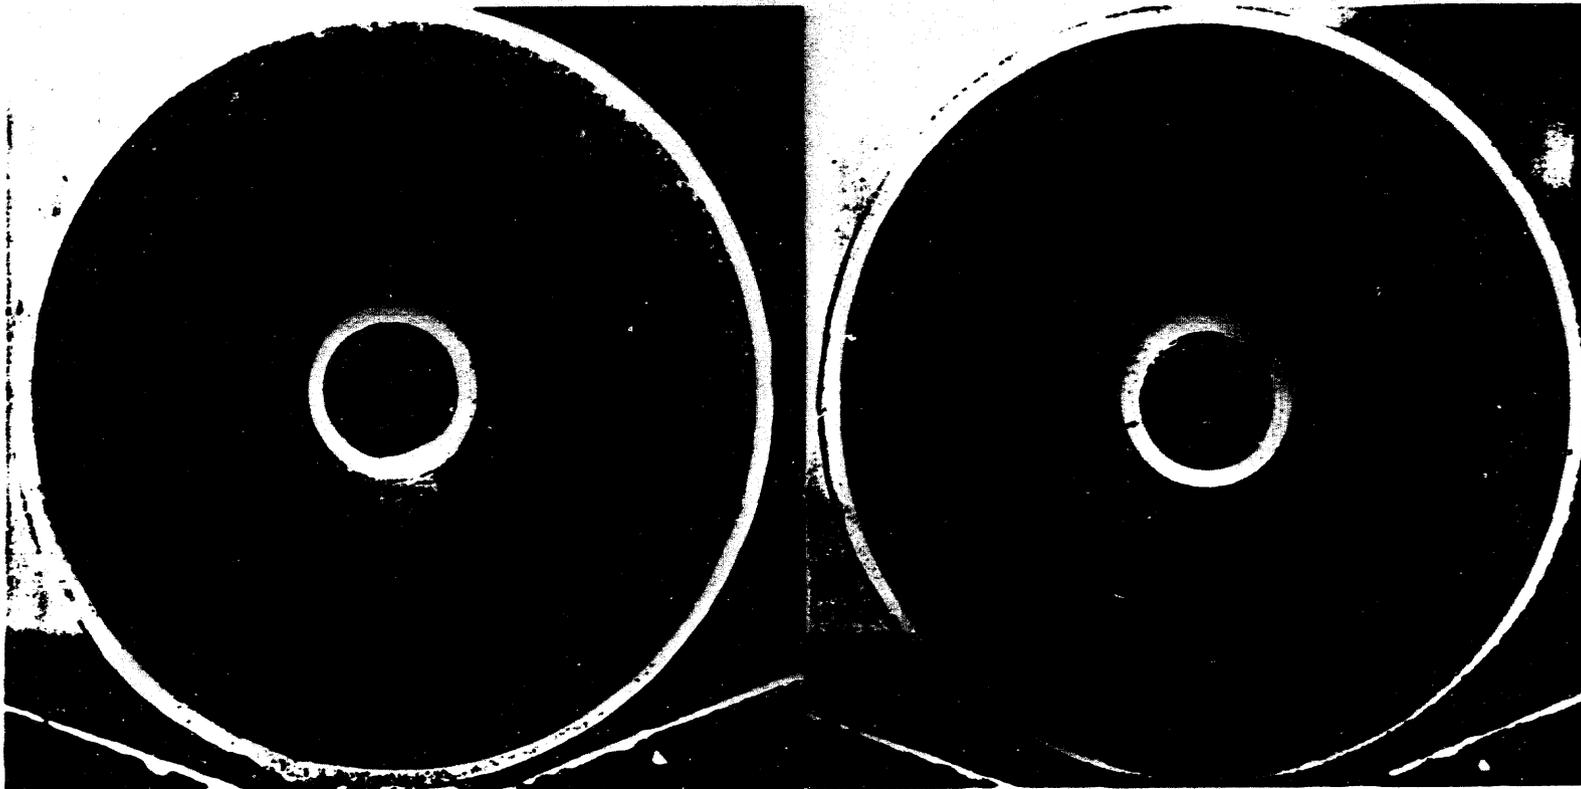
On one of the nonworm-tracked elements, 75Z9, a moderate hot spot had developed on one side of the can wall. Extensive separation of the can wall bonding had occurred in this element as shown in Figure 18.

Examination of polished transverse sections from the centers of the four elements with no worm tracks failed to reveal any cracks in the uranium cores, although some separation of the can wall bonding had occurred. The macro structure of the uranium was discernible in the polished samples as shown in Figure 18, but no evidence of any transformation was found in these cores.

Figure 18 - As-polished sections from 75Z9 on left and 68Z10 showing macro structure of uranium. These elements had no worm tracks or uranium cracking. The extensive canwall bonding separation can be seen on the bottom of 75Z9.
