HW-70807

August 21, 1961

RADIOCHEMISTRY FOR THE RUPTURE OF ZIRCALOY-2
CLAD HEAVY-WALLED TUBULAR FUEL ELEMENT IN
KER LOOP-3

L. D. Perrigo

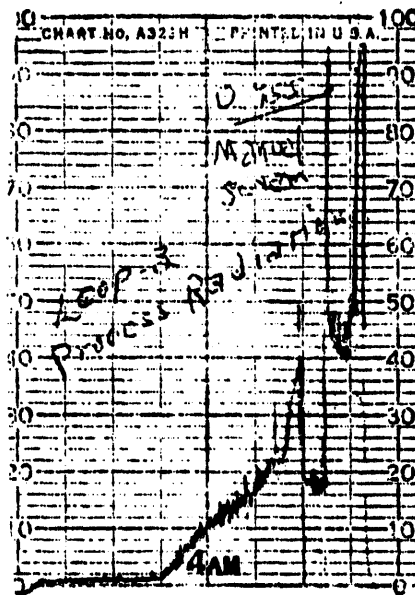
FIGURE 1. KER Loop 3 Delayed Neutron Indications.

rise in the activity indicated on the delayed neutron monitor at approximately 0350 December 9, 1960. By changing the scale from 0 - 250 neutrons/sec to 0 - 500 neutrons/sec the increase in instrument readings was only momentarily checked. At 0450 the readings were such that the KE Reactor shut down. These fluctuations are seen in Figure 1.

Another interesting factor can be noted by comparing the delayed neutron response on KER Loop 3 with a rupture (Figure 1) and the response on KER Loop 1 with a rupture (Figure 2). Figure 1 shows a rise in activity occurring over a period of nearly an hour while Figure 2 shows an abrupt rise that could not be checked even by an instrument scale change.⁽⁴⁾ This behavior sheds light on the difference in rupture mechanisms. The response in KER Loop 3 resulted from the exposure of a small amount of the uranium core to the coolant at low temperatures while the KER Loop 1 failure resulted from the rupture of a blister that discharged at high temperature, relatively large quantities of rupture products very rapidly into the coolant.
