DUN-1010

THORIA TARGET ELEMENT FAILURES

K. C. Bowles
J. P. Schmidt
Reactor Engineering Unit
Process and Reactor Development Subsection
Research and Engineering Section

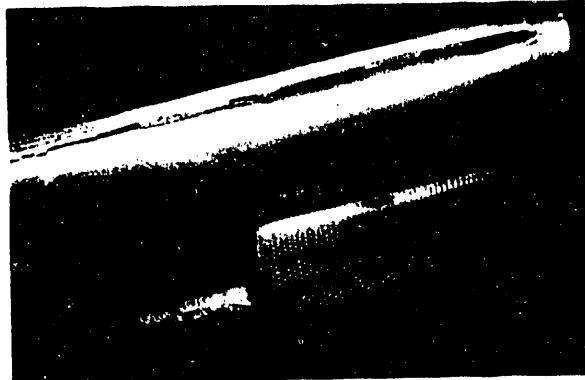
Photo #1

In Photo Number 1 the Thoria Fuel Element Rupture Displaying Overall Swelling and Longitudinal Cladding Failure. In Photos Number 2 and 3 the Thoria Fuel Element Ruptures Displaying End Swelling

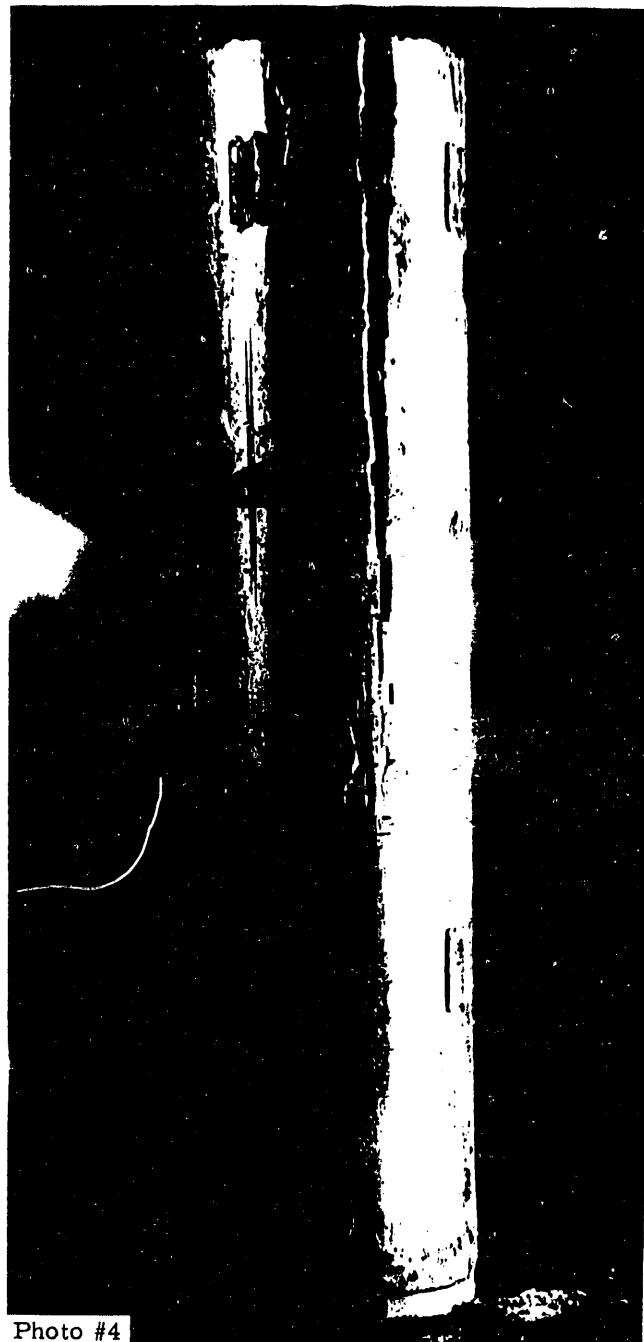
FIGURE 2

Examination of thoria failures exhibiting over-all swelling reveals that the oxide is no longer in powder form. Instead, it is in a fused state and occupies a larger volume. The volume increase of the oxide occurs in somewhat of a uniform manner and produces what is referred to as over-all swelling. Burst tests on thoria cans welded under present process specifications indicate the magnitude of the pressures required to produce swelling and rupture of the cladding. No swelling was evident in this test at internal pressures of 500 psig, and rupture of the cladding occurred at internal pressures on the order of 1300 psig.³

Longitudinal Cladding Failure as a Result of Overall Swelling. Note that the cap had been Removed for Examination Before this Photograph was Taken.

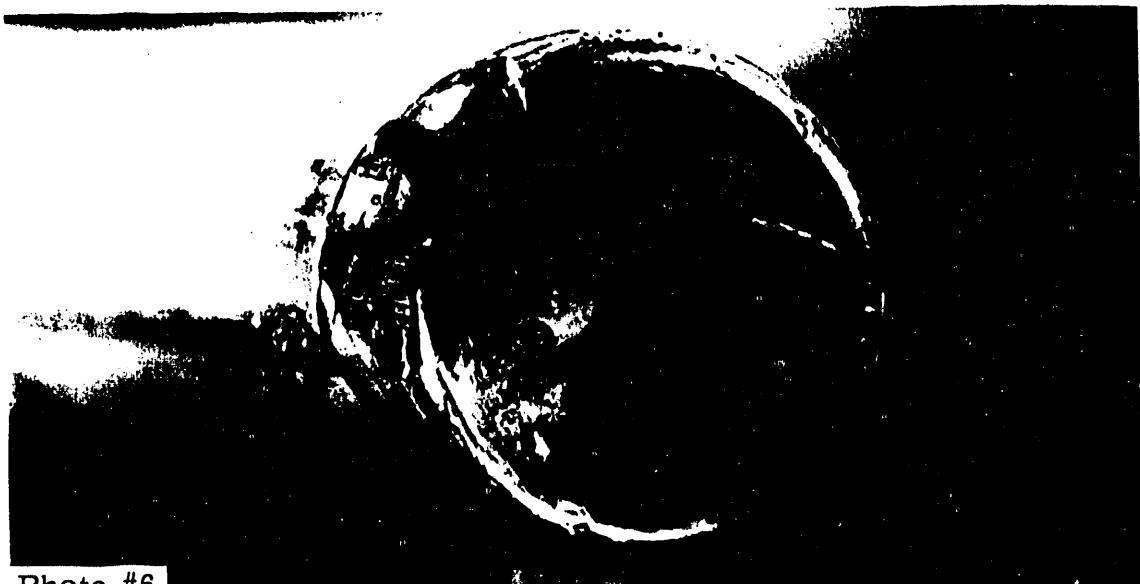
FIGURE 4

Examination of the remaining five elements revealed that the severe mechanical damage to the cladding was effected during or after discharge. The damage was severe enough to allow water entry and indicates the necessity of carefully handling the thoria elements. The thoria failure on December 30, 1965, at KE Reactor was in fact directly attributable to damage inflicted by the charging machine. This failure resulted in an unscheduled reactor outage.

Thoria Fuel Elements Exhibiting Mechanical Damage. The Damage Shown here was Inflicted During or After Discharge but is Indicative of the Serious Nature of any such Damage Occurring Prior to or During The Charging Operation.

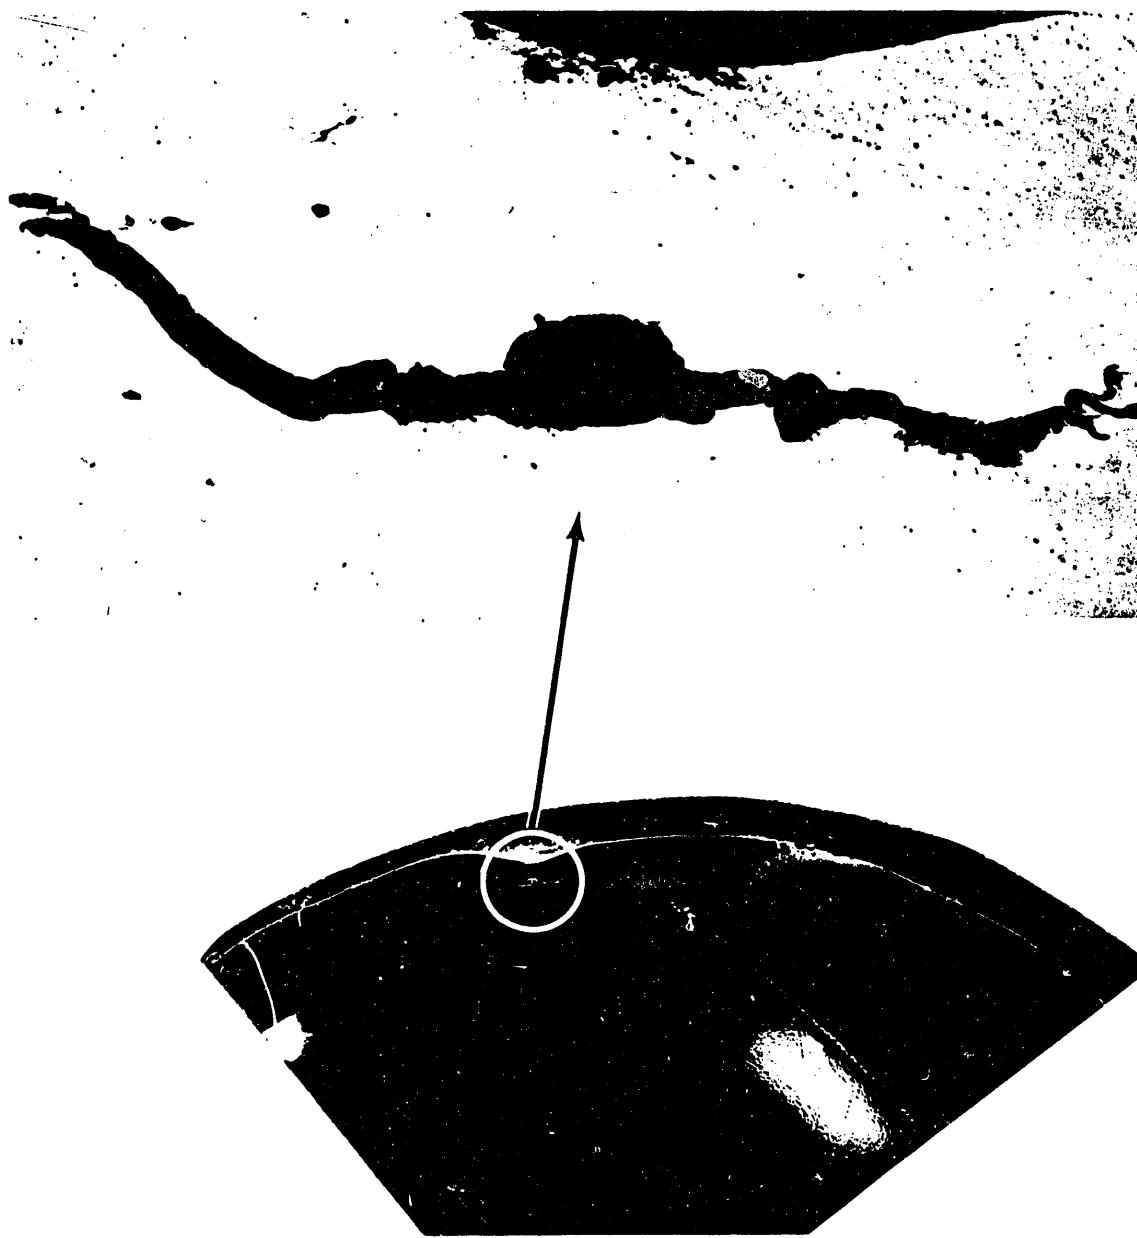
FIGURE 7

"The cause of failure in all six examined elements was water entry through pin holes and/or porosity in the closure weld [Figures 7 and 8]. Three elements contained pin holes, two porosity, and one element had both."²

During the examination, the caps of the failed elements were ground, polished and examined in increments, starting at the exterior, in an effort to trace the path of water entry through the weld. Each of the six failures displayed at least one continuous, traceable path.

These Photographs were taken of a Partially Ground Through Cap of a Thoria Element Exhibiting Weld Porosity (Circled Area). This Particular Weld Porosity Provided a Continuous Path for Water Entry to the Element Core Resulting Ultimately in a Thoria Failure.

testing* and visual weld examination. The high failure rates obtained with these inspection criteria illustrated the need for more reliable methods of weld integrity analysis. On March 1, 1965, the following steps were taken: 1) all welds were radiographed, 2) all thoria elements were autoclaved, and 3) tightened visual inspection was initiated including the brushing of all welds prior to examination. The addition of the quality control measures resulted in increased reject rates.

Element reject rates increased further upon incorporating helium leak testing into the methods for weld integrity analysis. Leak testing was initiated on March 21, 1965, on which date autoclaving of fabricated thoria elements was discontinued due to the capabilities and confidence obtainable from helium leak testing and radiographing.

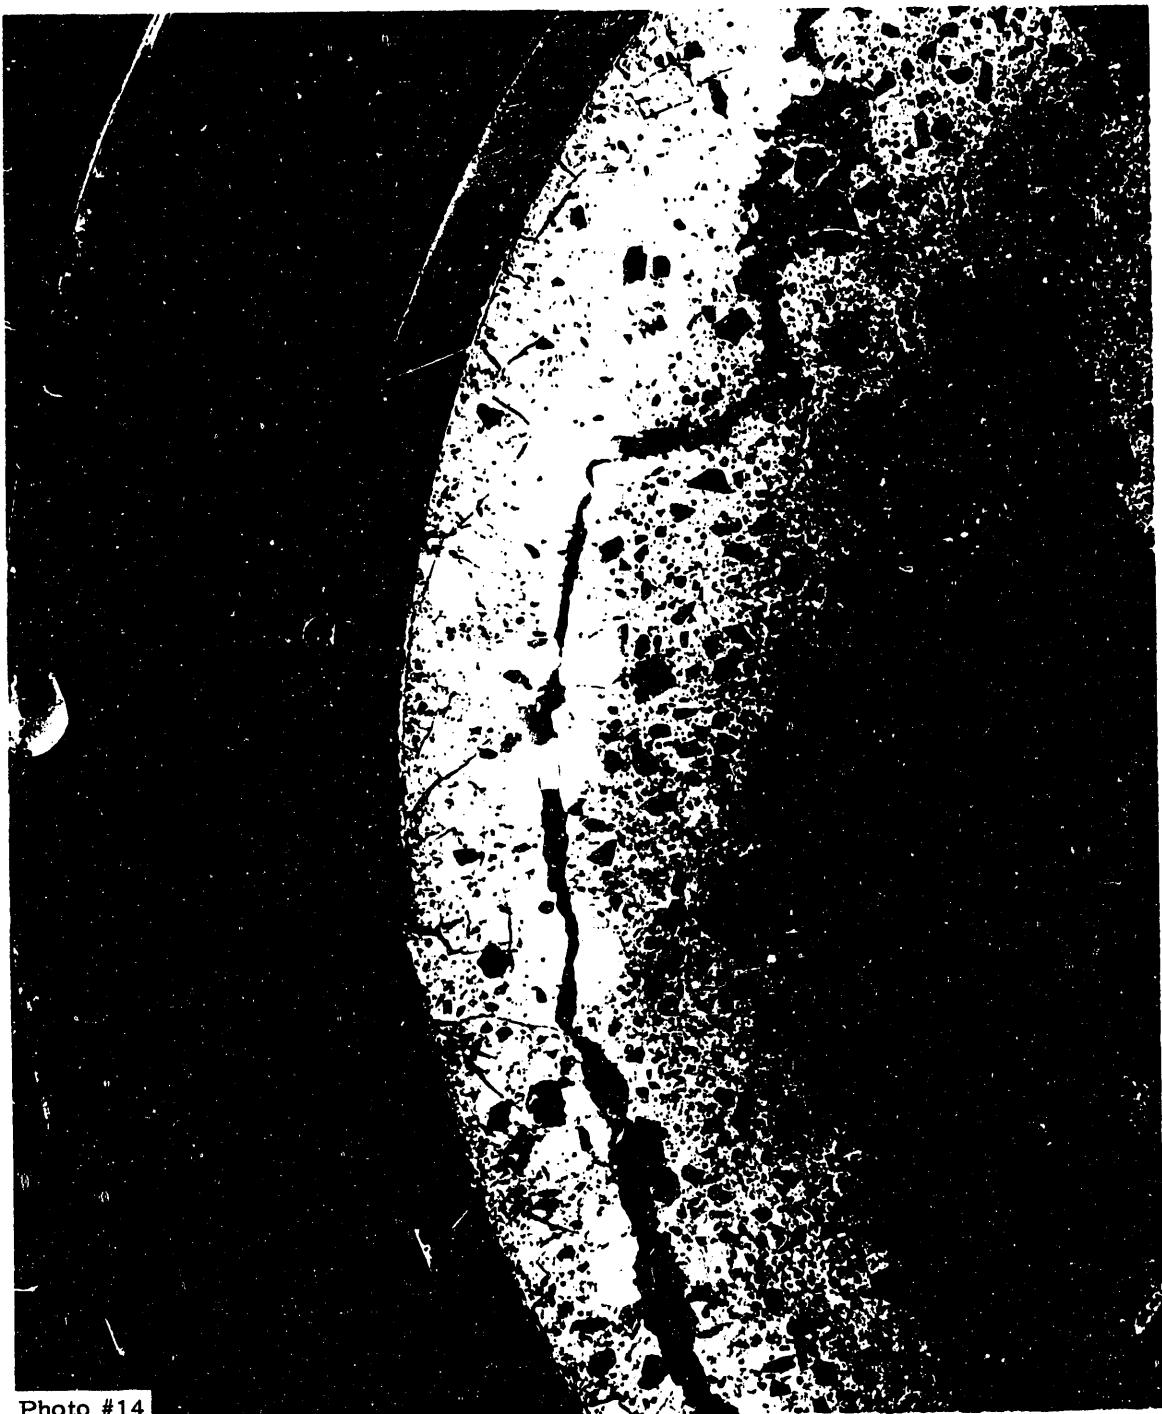
FIGURE 10

A Cross Sectional View of a Typical Failure in the Aluminum Cladding.
