HW-73763

May 25, 1962

HORIZONTAL CONTROL ROD CORROSION -
KW REACTOR

D. L. Renberger

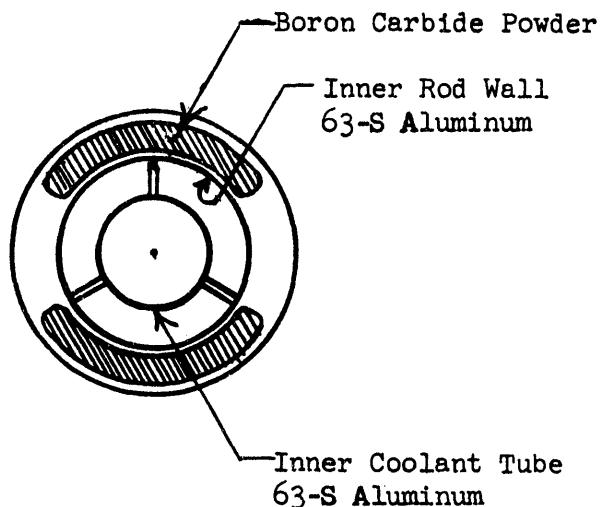
A. Diagram of horizontal control rod

Borescope examination of #3 HCR showed there was no failure of the wall separating the boron carbide powder from the coolant water.¹ There was considerable scale in the rod and one minor (1-2 mil) corrosion pit on the rod wall. The rod and coolant tube are 63-S aluminum.

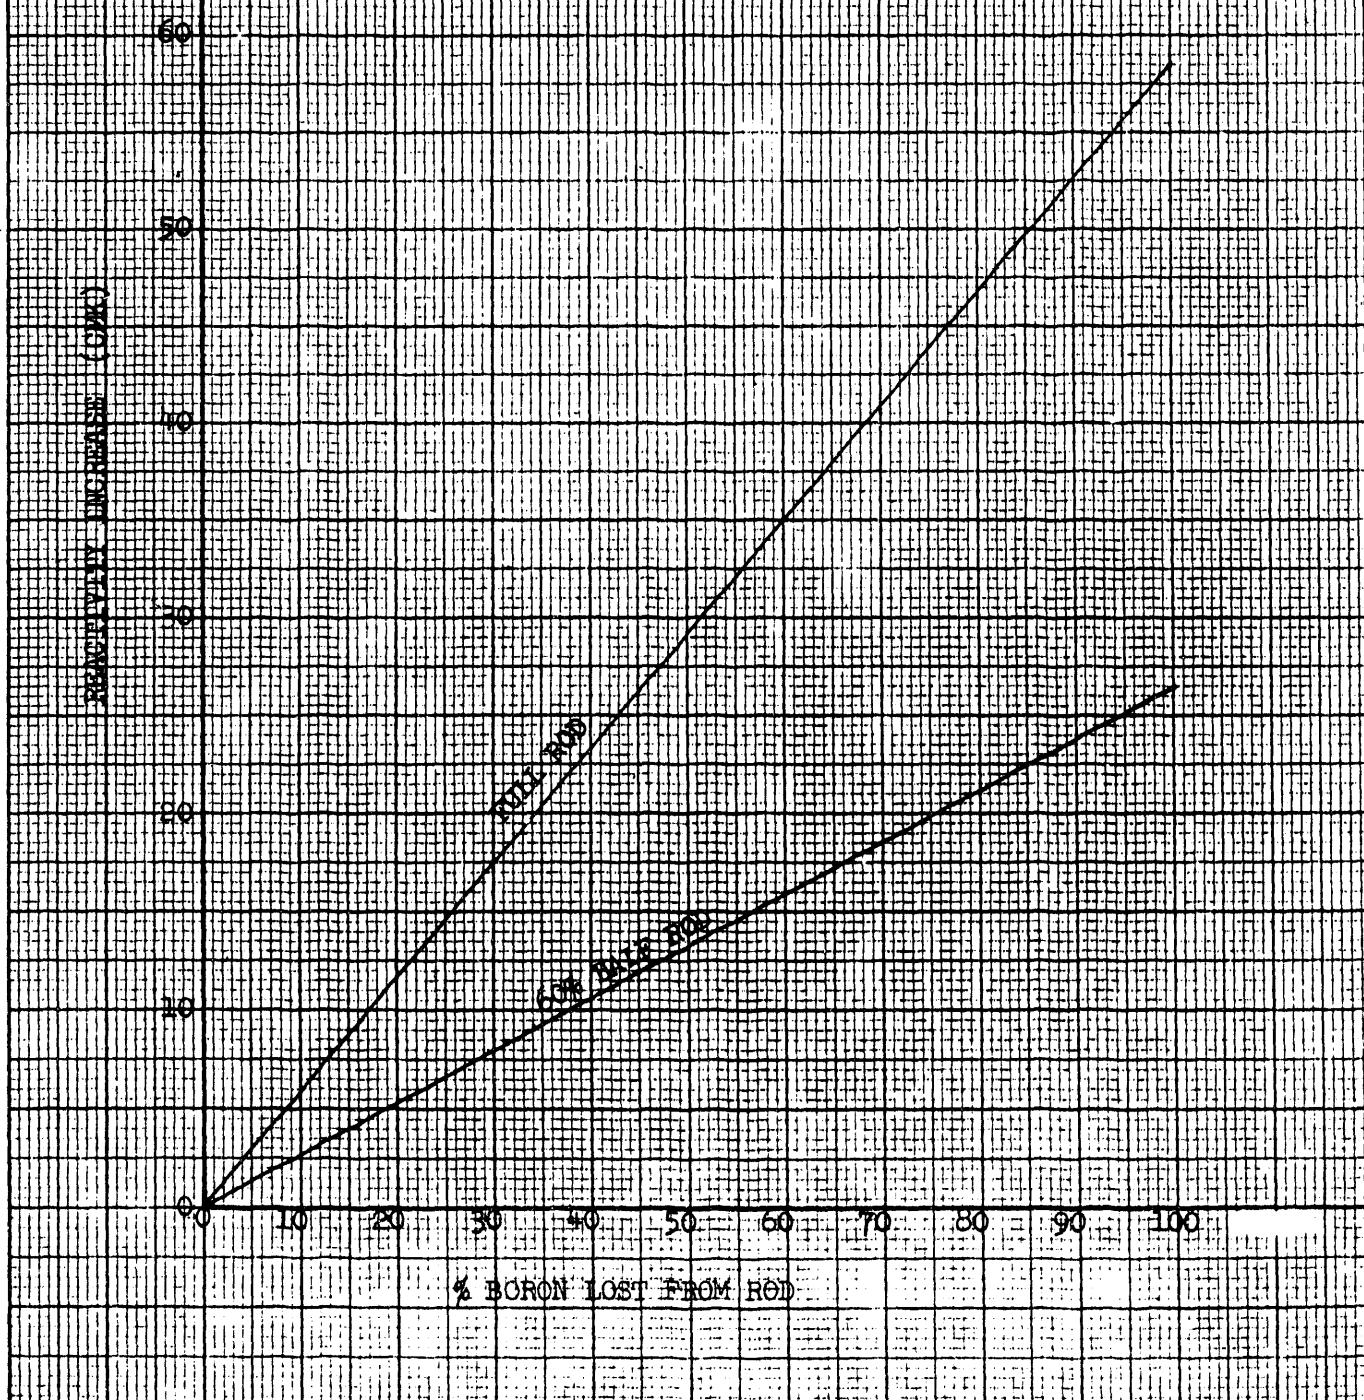
FIGURE 11

REACTIVITY INCREASE DUE TO LOSS OF BORON CARBIDE
FROM A HORIZONTAL ROD- μ REACTOR.
