# Aging, Loss-of-Coolant Accident (LOCA), and High Potential Testing of Damaged Cables

Prepared by  
R. A. Vigil/SEA  
M. J. Jacobus/SNL

Prepared for  
Division of Reactor Controls and Human Factors  
Office of Nuclear Reactor Regulation  
U.S. Nuclear Regulatory Commission  
Washington, DC 20555-0001  
NRC FIN L1903

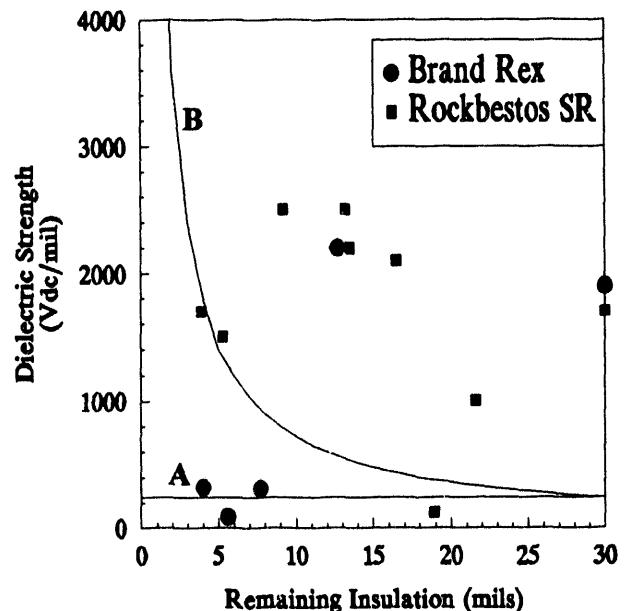
Figure 8 Dielectric Strength Based on Nominal Remaining Insulation Thickness

The results of these post-LOCA breakdown tests are given in Tables 6 and 7. Figure 8 presents the dielectric strength data in Vdc/mil of remaining insulation versus remaining insulation thickness for the Brand Rex and Rockbestos cables. Note that the two Brand Rex cables that passed the accident test with less than 7 mils of insulation remaining (samples 2 and 6) both had breakdown voltages less than the 600 Vac rating of the cable (considering 600 Vac to be equivalent to 1800 Vdc). In addition, the breakdown voltage in Vdc/mil for these two cables was much lower than the expected breakdown voltage of this material after LOCA (i.e. about 14000 kVac for an undamaged cable [6] or the equivalent of about 1800 Vdc/mil). If the cables had been energized with ac potential and/or if the applied voltage had been higher (but still within the rating of the cable), it is possible that these cables would have also failed during the accident exposure. However, unlike the cables that immediately failed the post-LOCA dielectric

tests, neither of these two cables had any indication of problems during the LOCA simulation. There appears to be a clear difference in breakdown voltage in Vdc/mil between the Brand Rex cables with less than 8 mils of insulation remaining and those with greater than 12 mils remaining. With less than 8 mils remaining, the breakdown voltage did not exceed 320 Vdc/mil, while above 12 mils the breakdown voltage was not less than 1900 Vdc/mil.
