HW-62441

October 30, 1959

POST IRRADIATION EXAMINATION OF A NICKEL PLATED
FUEL ELEMENT FROM PT-IP-207-A (RM-306)

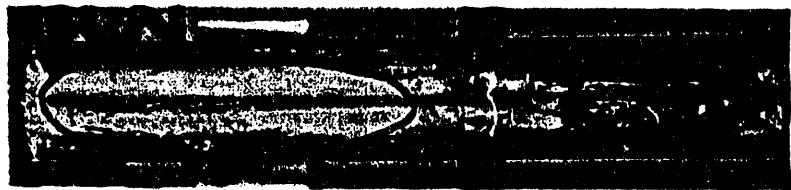
were devoid of nickel but these were associated with mechanical damage received after discharge. A "hot spot" was observed which was approximately one and one-fourth inches wide and extended from one-half inch from the cap end to the mid-point of the slug. Orientation of the "hot spot" was not possible as rib marks were not visible. The deposition film was missing from the heated area, and the edge of the "hot spot" was outlined by dark surface discoloration of the nickel. Near the cap end of the slug several bumps about the size of a pin head were seen and appeared to be small blisters in the nickel. (Figure I.)

The fuel element as received. In the second view the slug was rotated 90°. The outline of the hot spot has been inked. Cap end of the slug is to the left.

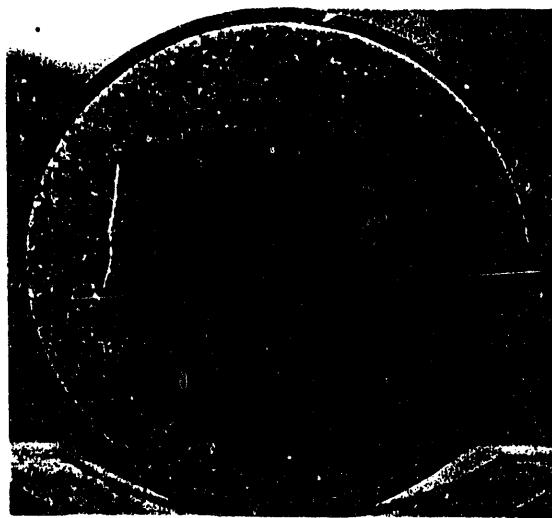
Neg. #12459

The one half inch thick wafer, which was removed one and three fourths inches from the cap end of the slug near the center of the "hot spot", was cathodic vacuum etched. Examination of the uranium showed a uniform structure across the section with no evidence of over-heating. The Al-Si bond was intact in both the interior and exterior jacketing. (Figure IV.)

Macro photograph of the wafer sectioned from the "hot spot". Note annealing is not evident.
