HW-58281

## I & E DEPLETED URANIUM FUEL ELEMENT RUPTURES EXPERIENCED UNDER PT-IP-132-AC

W. A. Blanton

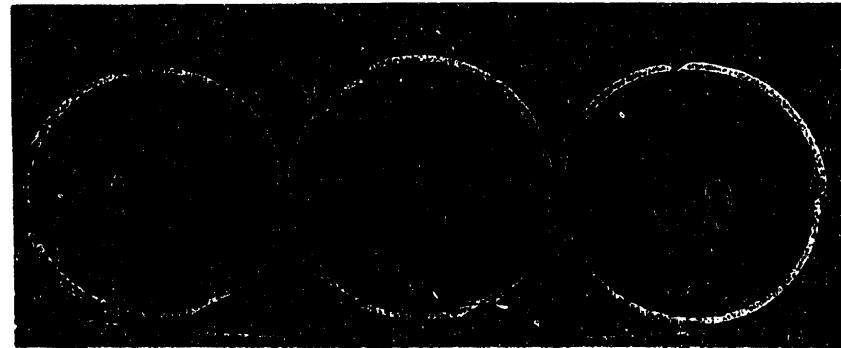
**FIGURE 1**

**Transverse Section about One-Inch Below Cap Showing  
Mass of Corrosion Product Resulting from Water-Uranium Reaction**
