**Phased Construction Completion Report
for Bldg. K-1401 of the
Remaining Facilities Demolition Project at the
East Tennessee Technology Park
Oak Ridge, Tennessee**

Date Issued—October 2008

Prepared for the
U.S. Department of Energy
Office of Environmental Management

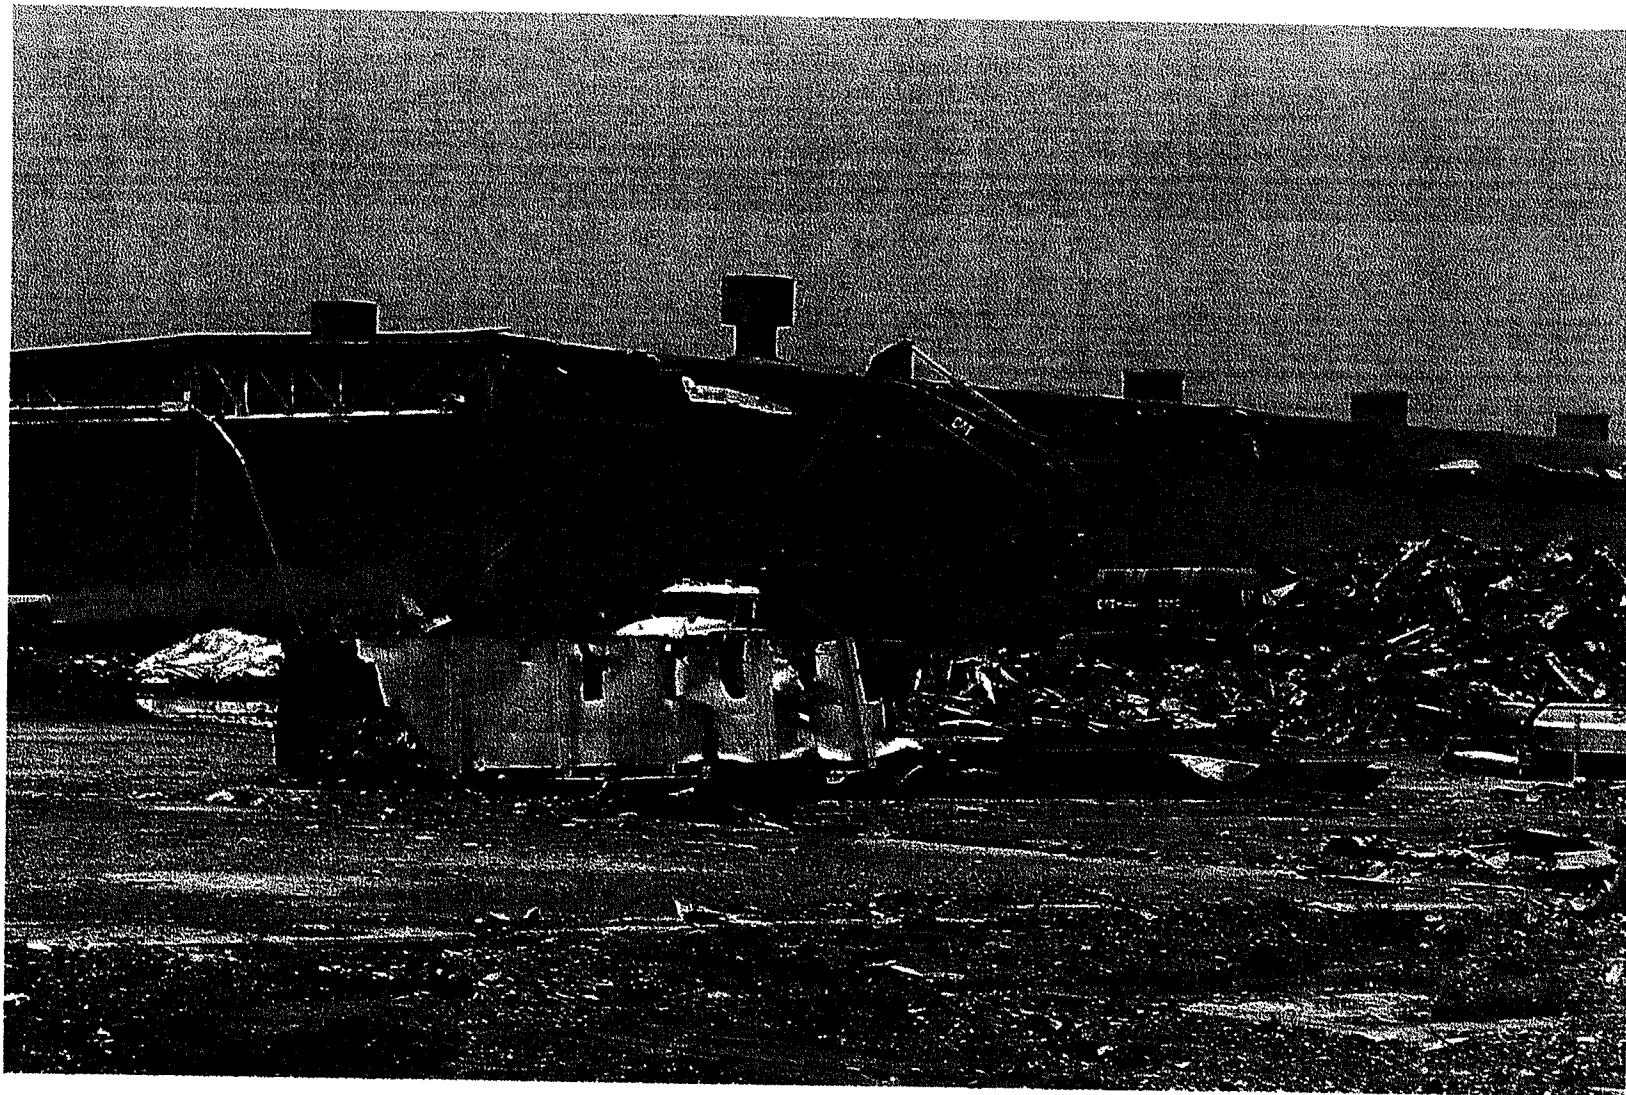
Fig. 4. Bldg. K-1401 during demolition.

- The remaining building structure and its contents were demolished and disposed at EMWMF (Fig. 4).
 - Loose contamination remaining inside the facility was sprayed with a fixative prior to demolition.

- The facility was demolished and size-reduced with mechanical equipment. The floor over the basement was collapsed into the basement. Any debris in the basement from the demolition of the first floor slab was removed and disposed with the balance of the Bldg. K-1401 waste. All debris was loaded into dump trucks and hauled to EMWMF for disposal.
