THE APPLICATION OF NONDESTRUCTIVE TECHNIQUES TO THE TESTING OF A WIND TURBINE BLADE

Herbert J. Sutherland
Sandia National Laboratories
Albuquerque, NM 87107

Walt Musial
National Renewable Energy Laboratory
Golden, CO 80401

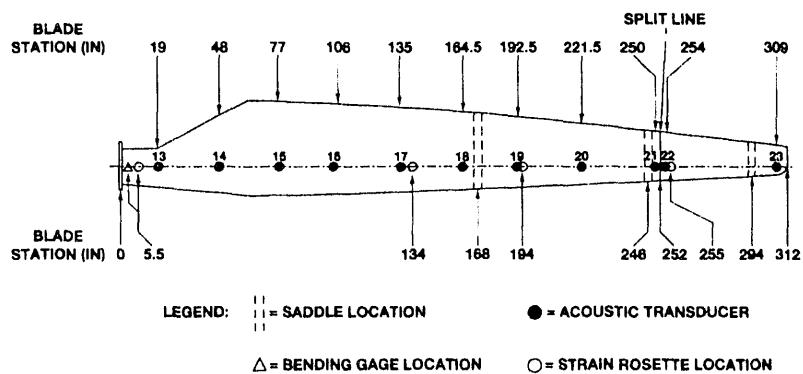
Figure 1. Schematic Diagram of the 7.9 Meter Blade.

The deflection of the blade and strains in the skin of the blade were measured during the course of the experiment, see Fig. 1. The deflections were measured at the three load saddles. The strain gages were three-element rectangular rosettes placed on the tension (bottom) side of the blade at

stations 15.5, 134, 194 and 255; (39, 340, 493, and 648 cm). A half-bridge bending gage was used at station 5.5 (14 cm) also.

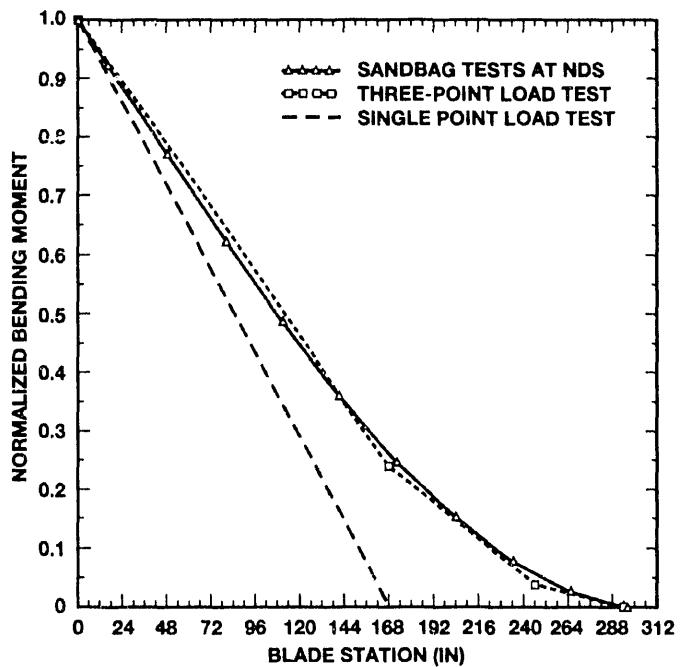
Figure 2. Load Distribution on the 7.9 Meter Blade.

Figure 2 shows the bending moment distribution used to load the blade for this experiment. This figure shows that the three-point load is a good approximation of the ten point triangular distribution used at North Dakota State University in a previous quasi-static test to failure of this blade. The saddle locations used to achieve this load distribution were at stations 168, 246, and 294; i.e., 427, 625 and 1588 cm (168, 246 and 294 in.) from the root-end of the blade.

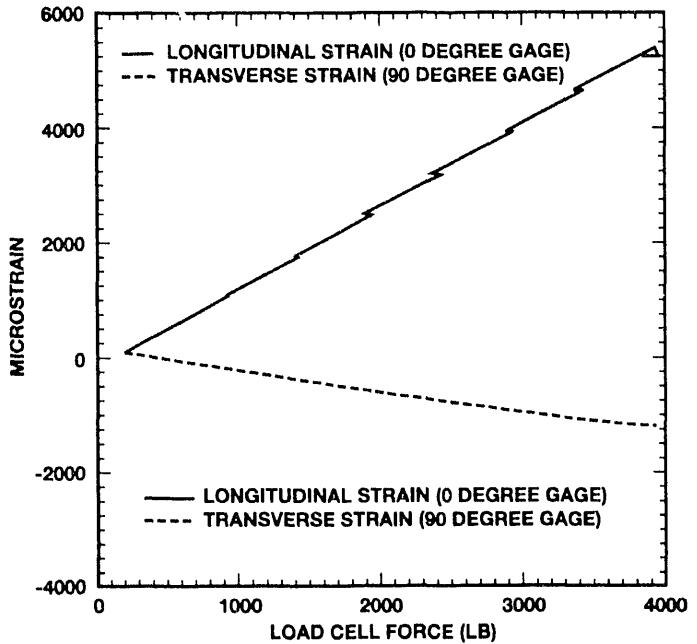
Figure 3. Blade Skin Strains at Station 134.

Typical strain measurements for station 134 are shown in Fig. 3. Stations 134 and 194 had the highest strains in the blade, see Ref. 3. Strains at these locations were over an order of magnitude higher than the root strains. Strains at station 255 were in the same range as the root strains.

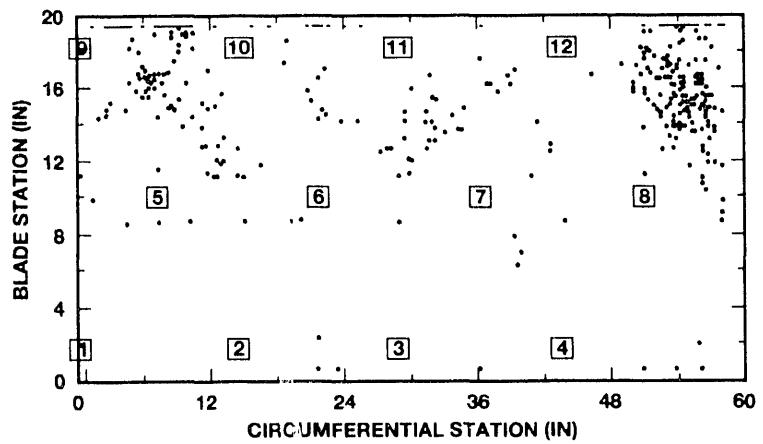
4a. Around the Circumference of the Root

Figure 4a shows a plot of the location of AE emission for the root of the blade during the course of the experiment. In this figure, the circumferential distance around the root has been "unfolded" into a linear plot. The break line for this plot is at circumferential station 0 which is coincident with approximately circumferential station 60. Transducers 1 and 9 are on the compression side (top) of the blade and transducer 3 and 11 are on the tension side (bottom) of the blade. The other transducers are placed about the circumference of the root as shown in Fig. 4a. As can be seen in this plot, most of the emissions came from the compression side (top) of the blade, between transducers 9 and 12. The events were located primarily between blade stations 12 to 20. Figure 4b shows a similar plot along the span of the blade. This figure is the linear location plot for the blade region. There was a small cluster of events between stations 40 and 55, near sensor 14. Most of the events were from a region near station 240 (between sensors 20 and 21).

In the root of the blade, Fig. 4a, about 460 events were located during the loading. Most of the events were in the band between stations 12 and 20. In this band there is a concentration of events on the upper (compression) side of the blade and toward the leading edge; i.e., from transducer 9 towards transducer 12. The root region continued to emit on subsequent loading up to 36.9 kN (8300 lb) but did not fail, see Ref. 3. Examination of a post-test section from this region showed cracks in the epoxy running parallel to the fibers but no obvious sign of fiber damage.

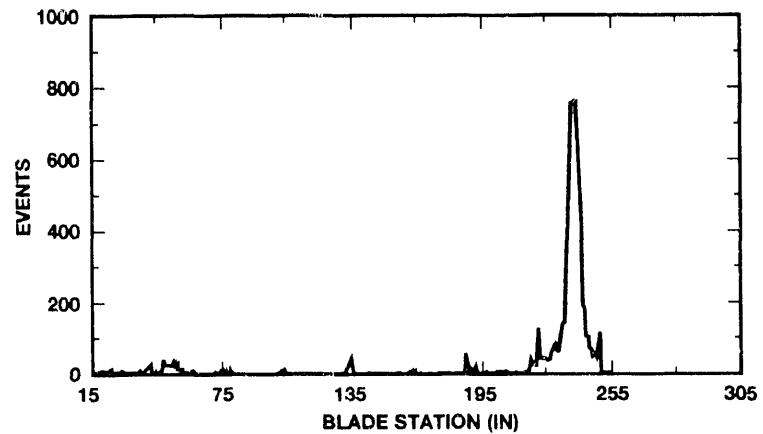
4b. Along the Span of the Blade.

transducers 13 through 23 are summed together. This plot indicates that the on-set of failure started at about 12.9 kN (2900 lb) load. Fig. 4b illustrates that these AE events are clustered at or near the blade failure zone between stations 240 and 250.

The region from station 40 to station 55 showed a clustering of events, see Fig. 4b. Appreciable emissions started at a load of 10.7 kN (2400 lb) and remained at a relatively constant rate with increasing load, see Fig. 5b. In the initial loading of the blade, the AE activity occurred primarily as the load on the blade increased. During periods where the load was held constant, there was little AE activity. This is a sign of

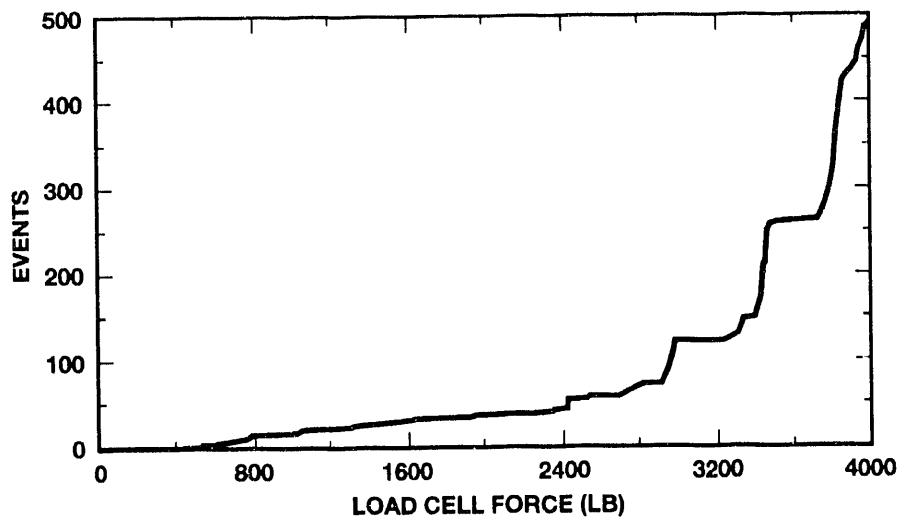
5a. Around the Circumference of the Root.

Figure 5a shows the AE events in the root of the blade plotted as a function of the load on the blade. In this plot, the number of AE events for transducer 1 through 12 are summed together to get the total number of events emanating from the root of the blade. The large number of events noted in this figure implies that significant damage may be accumulating in the root of the blade. However, the location graph, Fig. 4a, illustrates that the damage is wide spread and not concentrated into a few serious flaws. Figure 5b shows the events versus load curve along the span of the blade; i.e., the AE events from

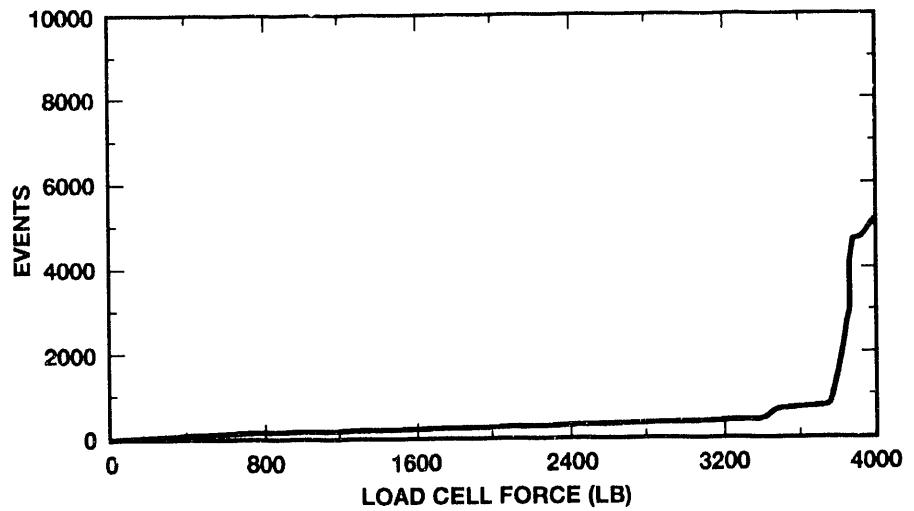
5b. Along the Span of the Blade.

The AE events for stations 234 to 242 started at approximately 12.4 kN (2800 lb). Appreciable emissions indicated that failure started at approximately 15.1 kN (3400 lb) and continued to the ultimate load of 17.46 kN (3925 lb). The post-test examination of the sectioned blade showed that the spar was debonded from the compression side (top) from about station

230 to the end of the spar at about station 239. There was also buckling and tearing of the top skin between 236 and 242 inches. This failure zone is exactly the region of failure located by AE.
