DUN-5299 RD  
Hanford Category C-65  
Copy No. 1

REACTOR INCIDENT FILE

### C REACTOR FUEL FAILURES 2562 C AND 3361 C

RESULTS OF BORESCOPE EXAMINATION OF 2562C

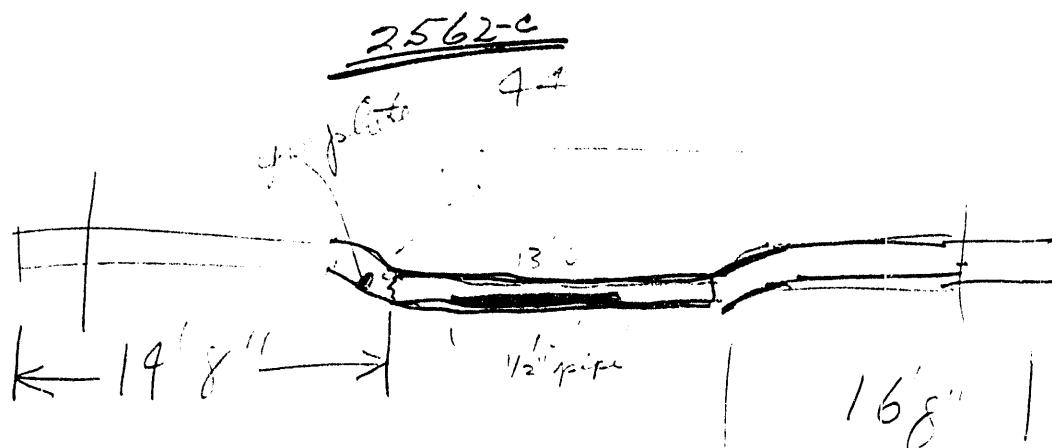
graphite in rear of tube, good.  
lost at least 1 tube block in front

May have just one graphite block in front of tube.  
Front of tube angled.

2<sup>nd</sup> block in front the many - may be cut and bent in  
4 pieces of which 1 is bent in 2

core bit shattered - most of piece out.  
probably ~~the~~ haven't gone as far as will drill -  
they weren't in that far.
