HW-62732

RADIOMETALLURGICAL EXAMINATION OF DIRECT CAST CORE
FUEL ELEMENTS, PT-IP-93, (RM-318)

R. Teats

November 12, 1959

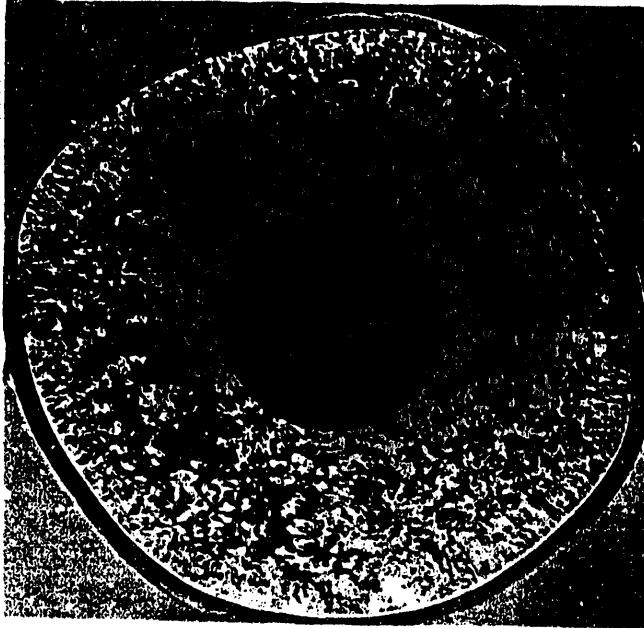
A comparison of the grain size from three positions along the warped element with a section cut from the unwarped element revealed a greater number of large grains in the zones of highest distortion. The maximum size grains, were in the order of 2.5 mm - 3.8 mm vs normal .2 mm. Also prevalent in all sections examined was a columnar type grain structure around the outside periphery. It is evident that the pre-irradiation heat treatment failed to refine the grain size sufficiently to prevent non-uniform growth of this element during irradiation.

The transverse section from the male end of element #9 was examined to determine if there was any damage to the canwall or to the bonding at the point where the maximum distortion had occurred. No particular damage to the canwall or bonding was found; however, it was found that the bonding on the inner spire was broken completely around the inner hole.

Neg. #12099 2.3X
Transverse section from male
end of element #9.

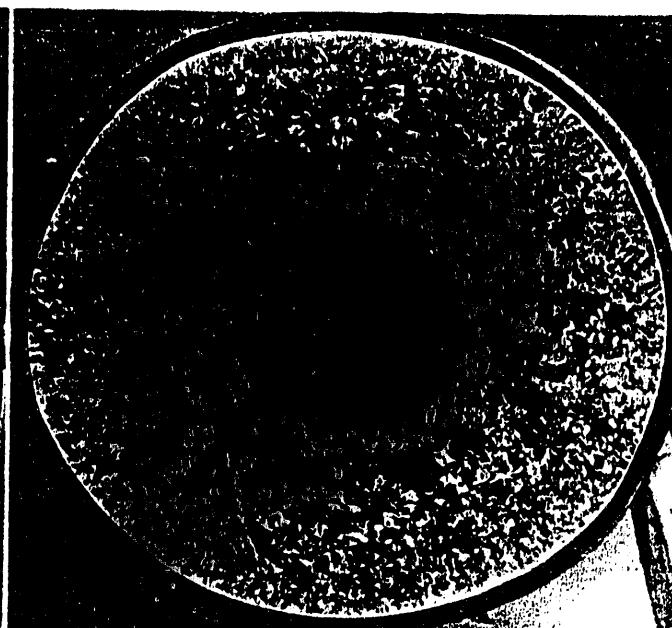
Neg. #13100 2.3X
Transverse section from center of
element #9.

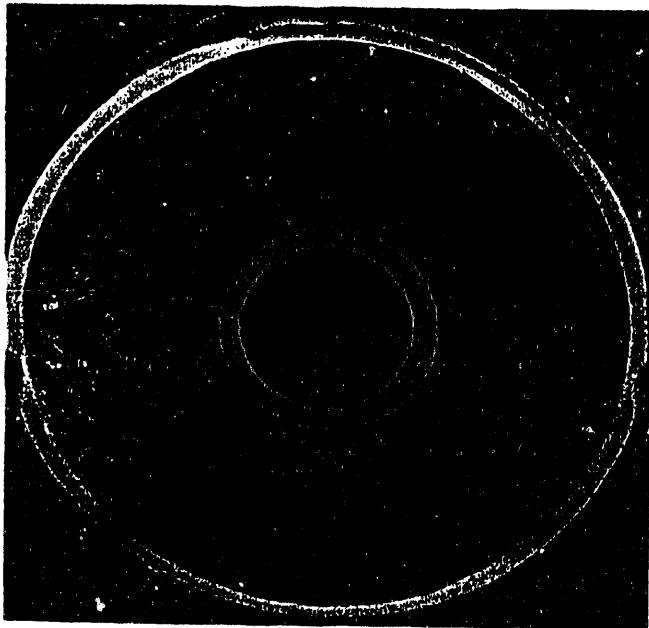
Neg. #12776 2.3X
Transverse section from female
end of element #9.

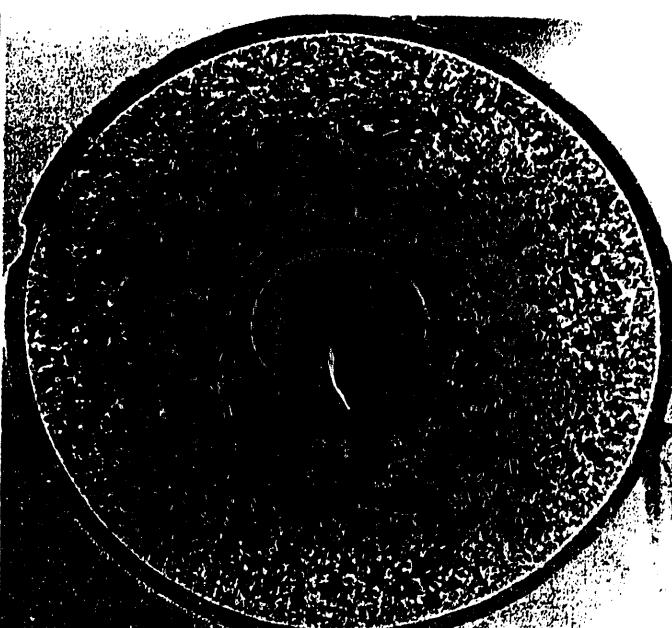
A section from the male end of element #7 showed only a few large grains. All sections examined had some columnar grains around the outside periphery. The largest uranium grains as scaled from the photomacrographs were of the order of 2.5 mm - 3.8 mm. From the pre-irradiation examination of these cores by R. S. Kemper (1) it was shown that the grain size of the sections nearest the top of the casting was consistently larger than the bottom sections. This would explain the larger grain size found in the male end of the warped element.

Neg. #13153 2.3X
Transverse section from male end
of element #7.
