HW-69285

April 17, 1961

POST-IRRADIATION EXAMINATION OF
CHEMICALLY NICKEL-PLATED FUEL ELEMENTS
FROM PT-IP-263-A (RM-414)

W. J. Gruber

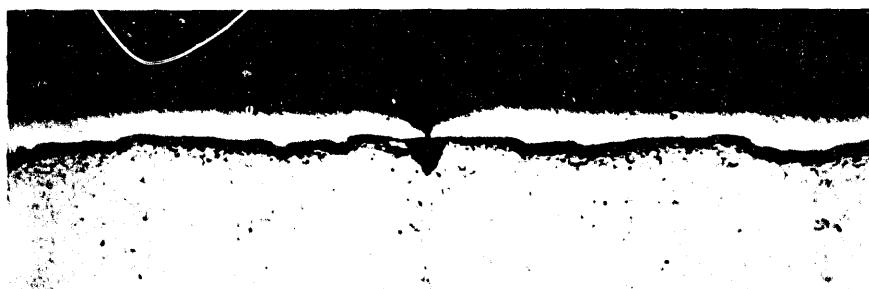
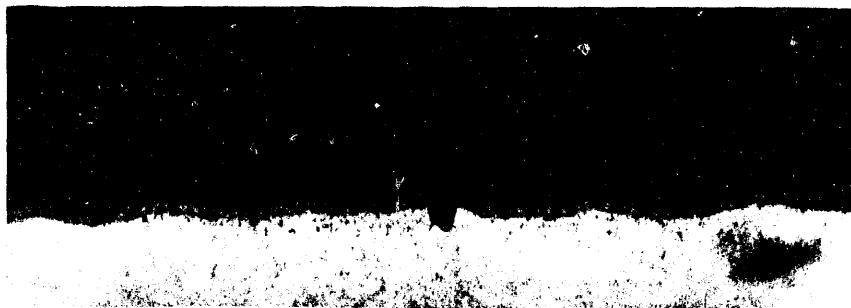
FIGURE 4

The cause of the cracking in the nickel plate was not determined. Probably it resulted from an external occurrence as there were no abnormal conditions in the element at the site of the cracks. The cracks in the plate did not propagate into the aluminum, and corrosion of the aluminum under the cracks was negligible. None of the corrosion pockets associated with the examined cracks was greater than 0.001 inch in depth or width (Figure 4). The appearance of the etched nickel plate differed from that seen in an earlier irradiation, PT-IP-207-A (RM-306). The plate from PT-IP-263-A which had the 300C pre-irradiation anneal did not display a fine laminar structure. An intermediate layer including approximately ten per cent of the total thickness was seen in the nickel at the Ni-Al interface. The presence of the intermediate layer had two obvious beneficial effects. The previously described cracks narrowed to a thin line in the layer adjacent to the aluminum which may account for the absence of corrosion under the cracks. Also, the nickel to aluminum bond was more tenacious than that seen in PT-IP-207-A plating. The difference in bond strength was readily seen when pitted areas from PT-IP-263-A and PT-IP-207-A cladding were compared (Figure 5).

Variation in the composition of the nickel in the initial and final plating process was revealed by the etch. The variation appears as a thin layer at the Ni-Al interface.

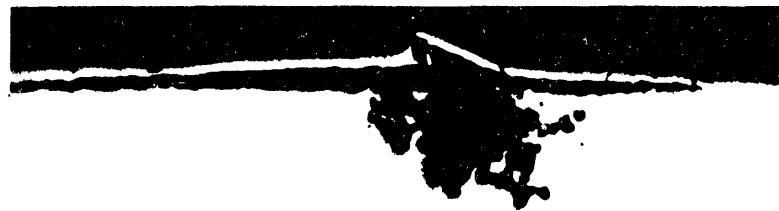
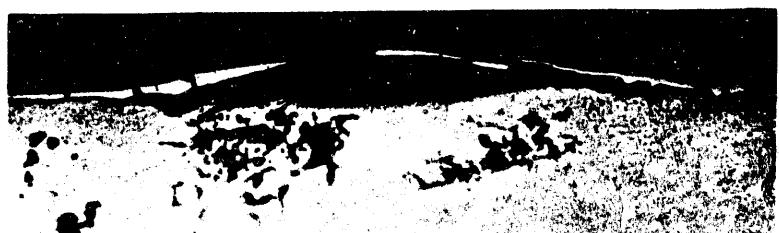
The nickel plate on elements from PT-IP-263-A was superior to that seen on elements from a previous irradiation, PT-IP-207-A. Bond strength was improved. Also, corrosion of the aluminum under cracks in the nickel may have been minimized by an intermediate layer in the plate of PT-IP-263-A elements. The intermediate layer did not exist in the plate of PT-IP-207-A elements.

Plate above is PT-IP-207A material.

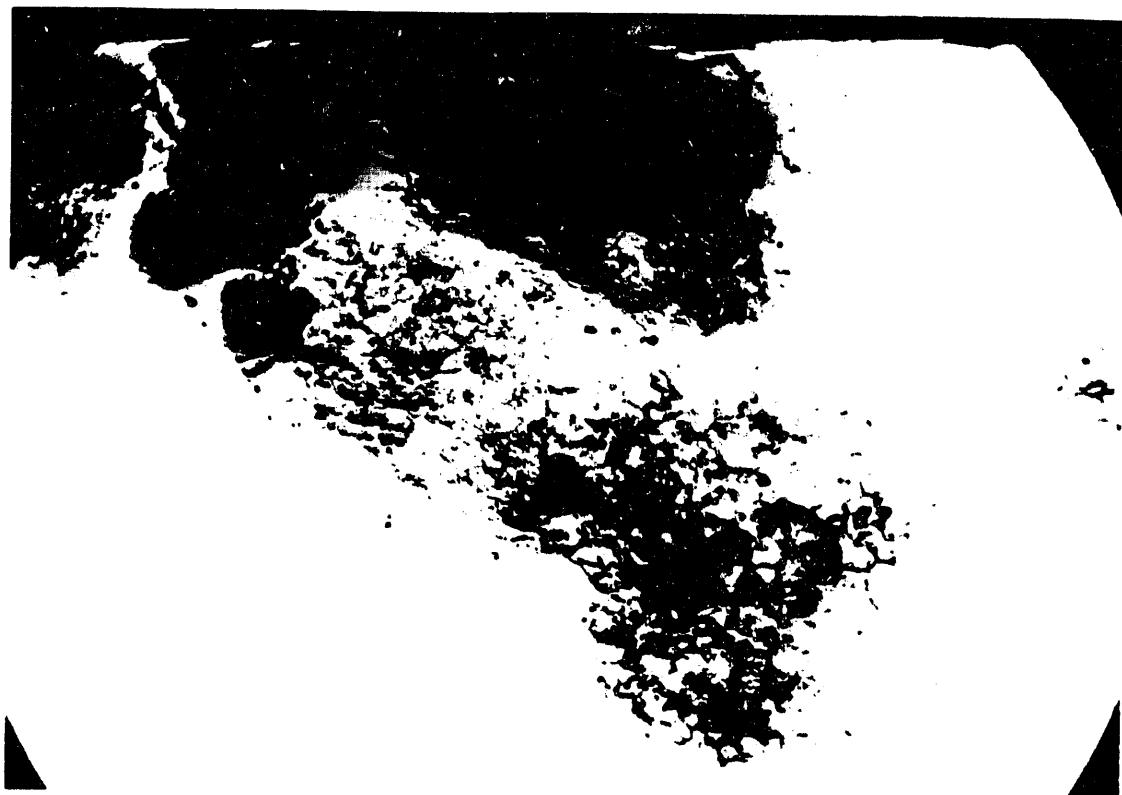
FIGURE 6

Eight corrosion pits in irradiated cladding were examined and compared to a similar pit in unirradiated cladding. Corrosion in both irradiated and unirradiated cladding was similar in appearance and identical in mode of attack. It was surprising to see intergranular attack in the unirradiated cladding (Figure 6). All pits appear to have resulted from mechanical damage to the protective nickel plate which exposed the aluminum to water (Figure 7). Probably the reason there was less pitting in the unirradiated elements was that they never experienced the rigors of discharging and subsequent handling with basin tongs. The corrosion in the irradiated elements probably occurred after, not

PITS IN UNIRRADIATED CLADDING

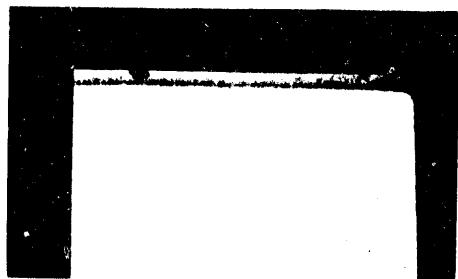
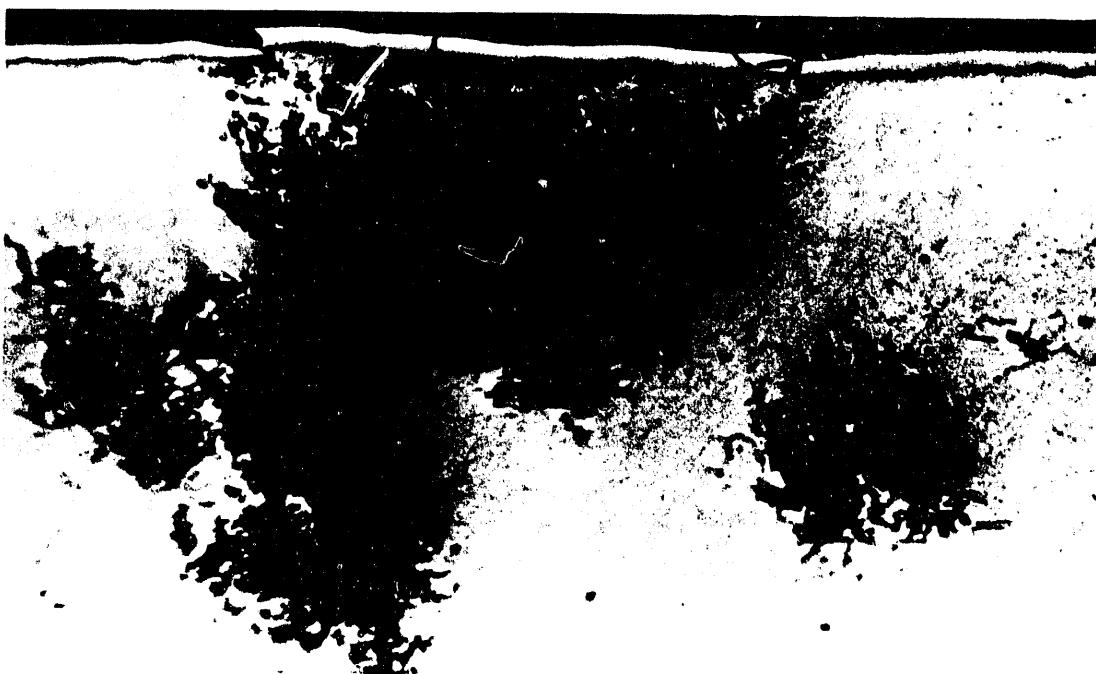
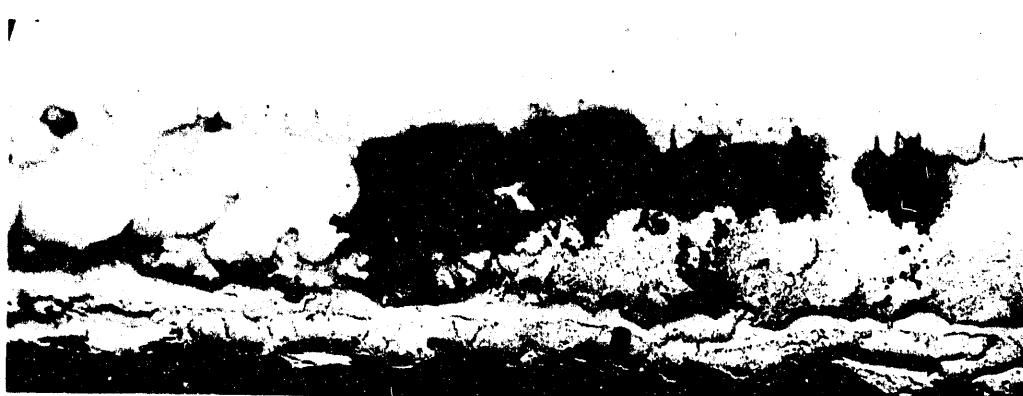
FIGURE 7

Severe pitting of the aluminum cladding of both elements was observed. Corrosion had penetrated to the Al-Si in one of the elements. Comparison of irradiated and unirradiated cladding revealed that the corrosion attack was identical. Therefore, the observed pitting in the irradiated elements probably was the result of mechanical damage to the nickel plate during discharge and/or subsequent handling with basin tongs, and corrosion occurred while the elements were standing in basin water.

during, irradiation since the mode of attack in unirradiated and irradiated cladding was identical. No undercutting by corrosion or sloughing of the nickel plate was observed in any of the examined samples. There was evidence that some of the pits penetrated the aluminum cladding, although none was actually seen during examination. "Water trails" in the Al-Si were detected at several locations; however, no reaction with the uranium fuel was observed (Figure 7).

PITS IN IRRADIATED CLADDING
