GENERAL INFORMATION
REACTOR INCIDENT FILE
SECTION VII

DOUGLAS UNITED NUCLEAR, INC.

At 0308 on January 10, 1966, both B and C Reactors "scrammed" due to an electrical fault on Line C2-18 caused by a raccoon coming in contact with the 13.8 KV line on top of transformer No. 2 at 182-B Building. Line C2-18 relayed out at the 151-B Building. Details of the occurrences at 151-B are covered in the attachment.

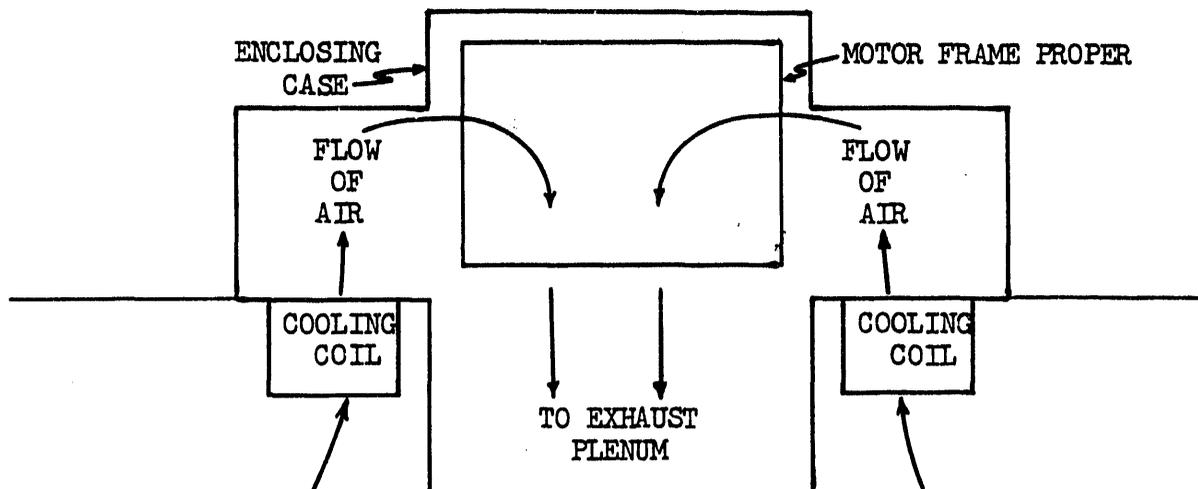
Jim told us that he was surprised that this had not occurred before because most of the other areas have experienced this problem before. Past failures appear to be caused by stress corrosion failure. As background material, Jim told us that each pump motor combination has three cooling systems. First, a hydraulic system for cooling the bearings; secondly, a system for cooling the flywheel; and thirdly, the cooling coils used for cooling the air which is circulated through the motor windings. It is the latter systems we are concerned with. The system is shown in the following sketch.

The cooling coils are essentially "off the shelf" two pass, finned tube coils. The cooling water is drawn from the filtered water supply and exhausted back into the supply header of the pump. The motor is enclosed and provided with a cooling coil for two reasons:

In summary then, the loss of these two cooling coils is not a serious problem, is not a new situation, and will be remedied during the next outage. They can not be repaired now because the vaults they are located in contain extremely high voltages.

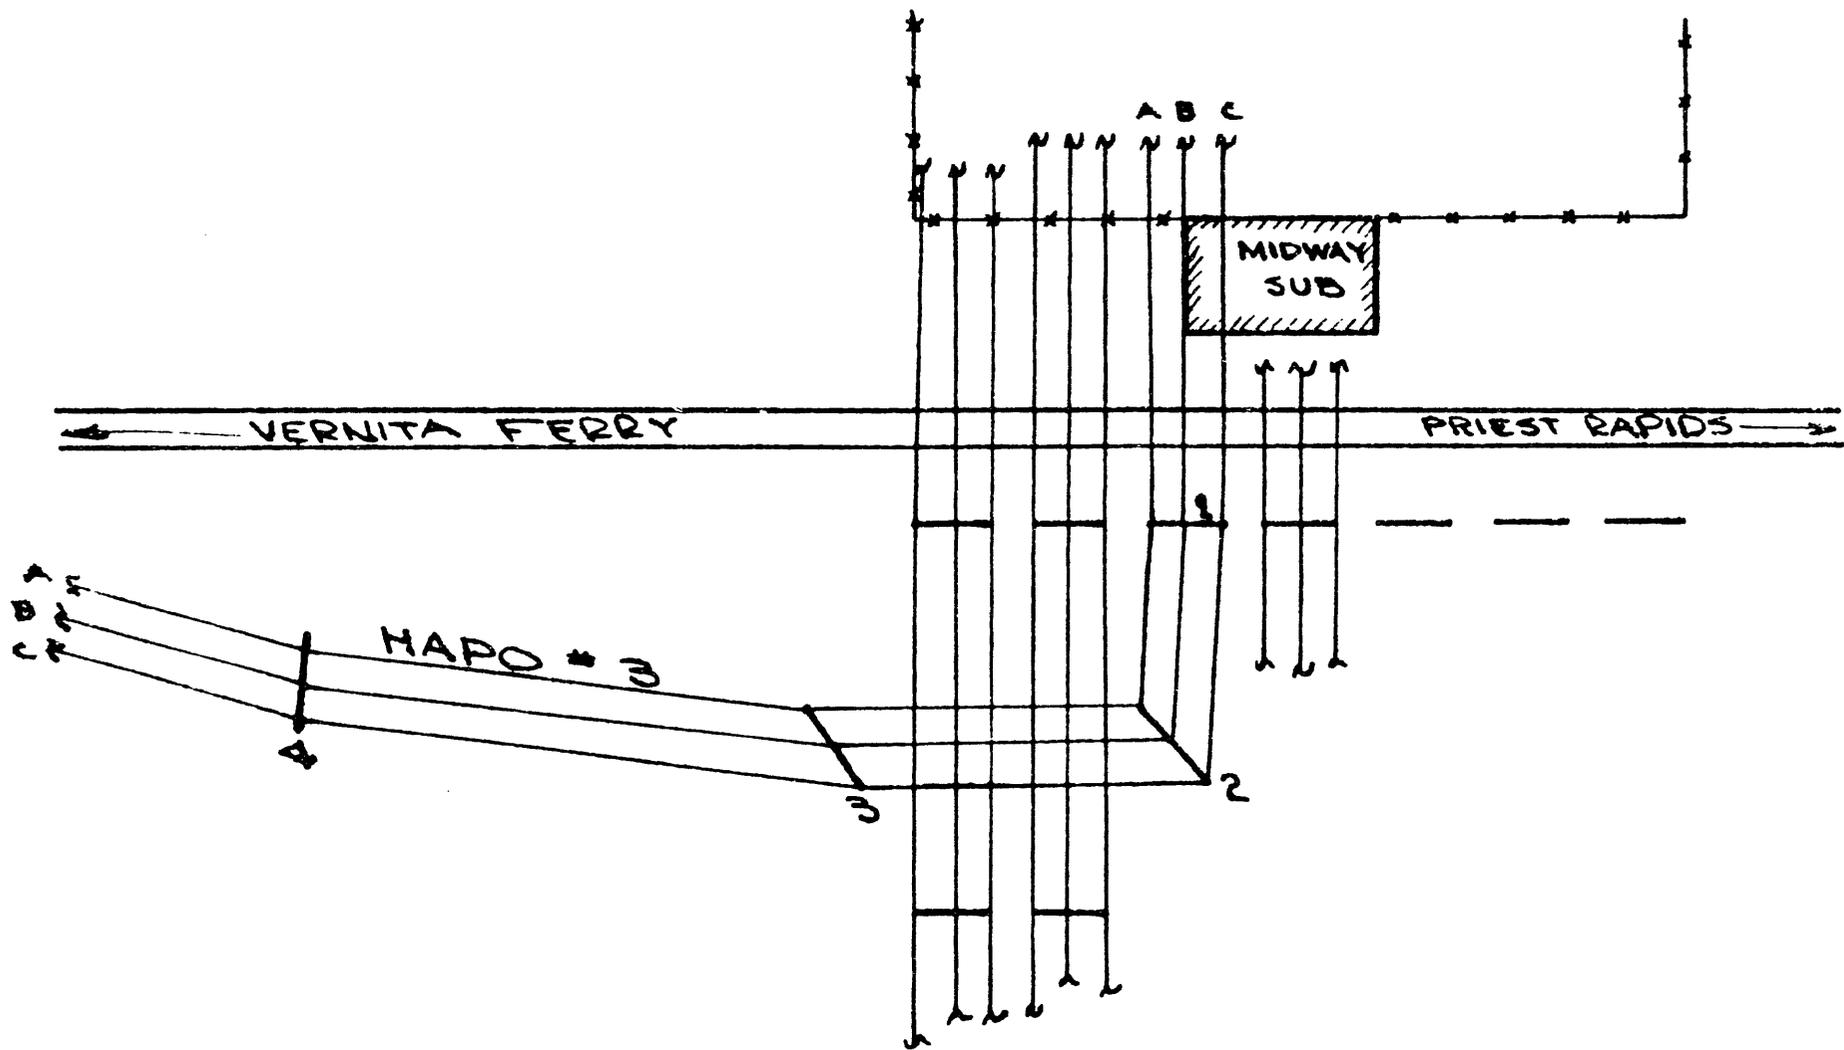
FIGURE VI

FIELD SKETCH OF HAPO #3 TRANSMISSION LINE
NEAR MIDWAY SUBSTATION

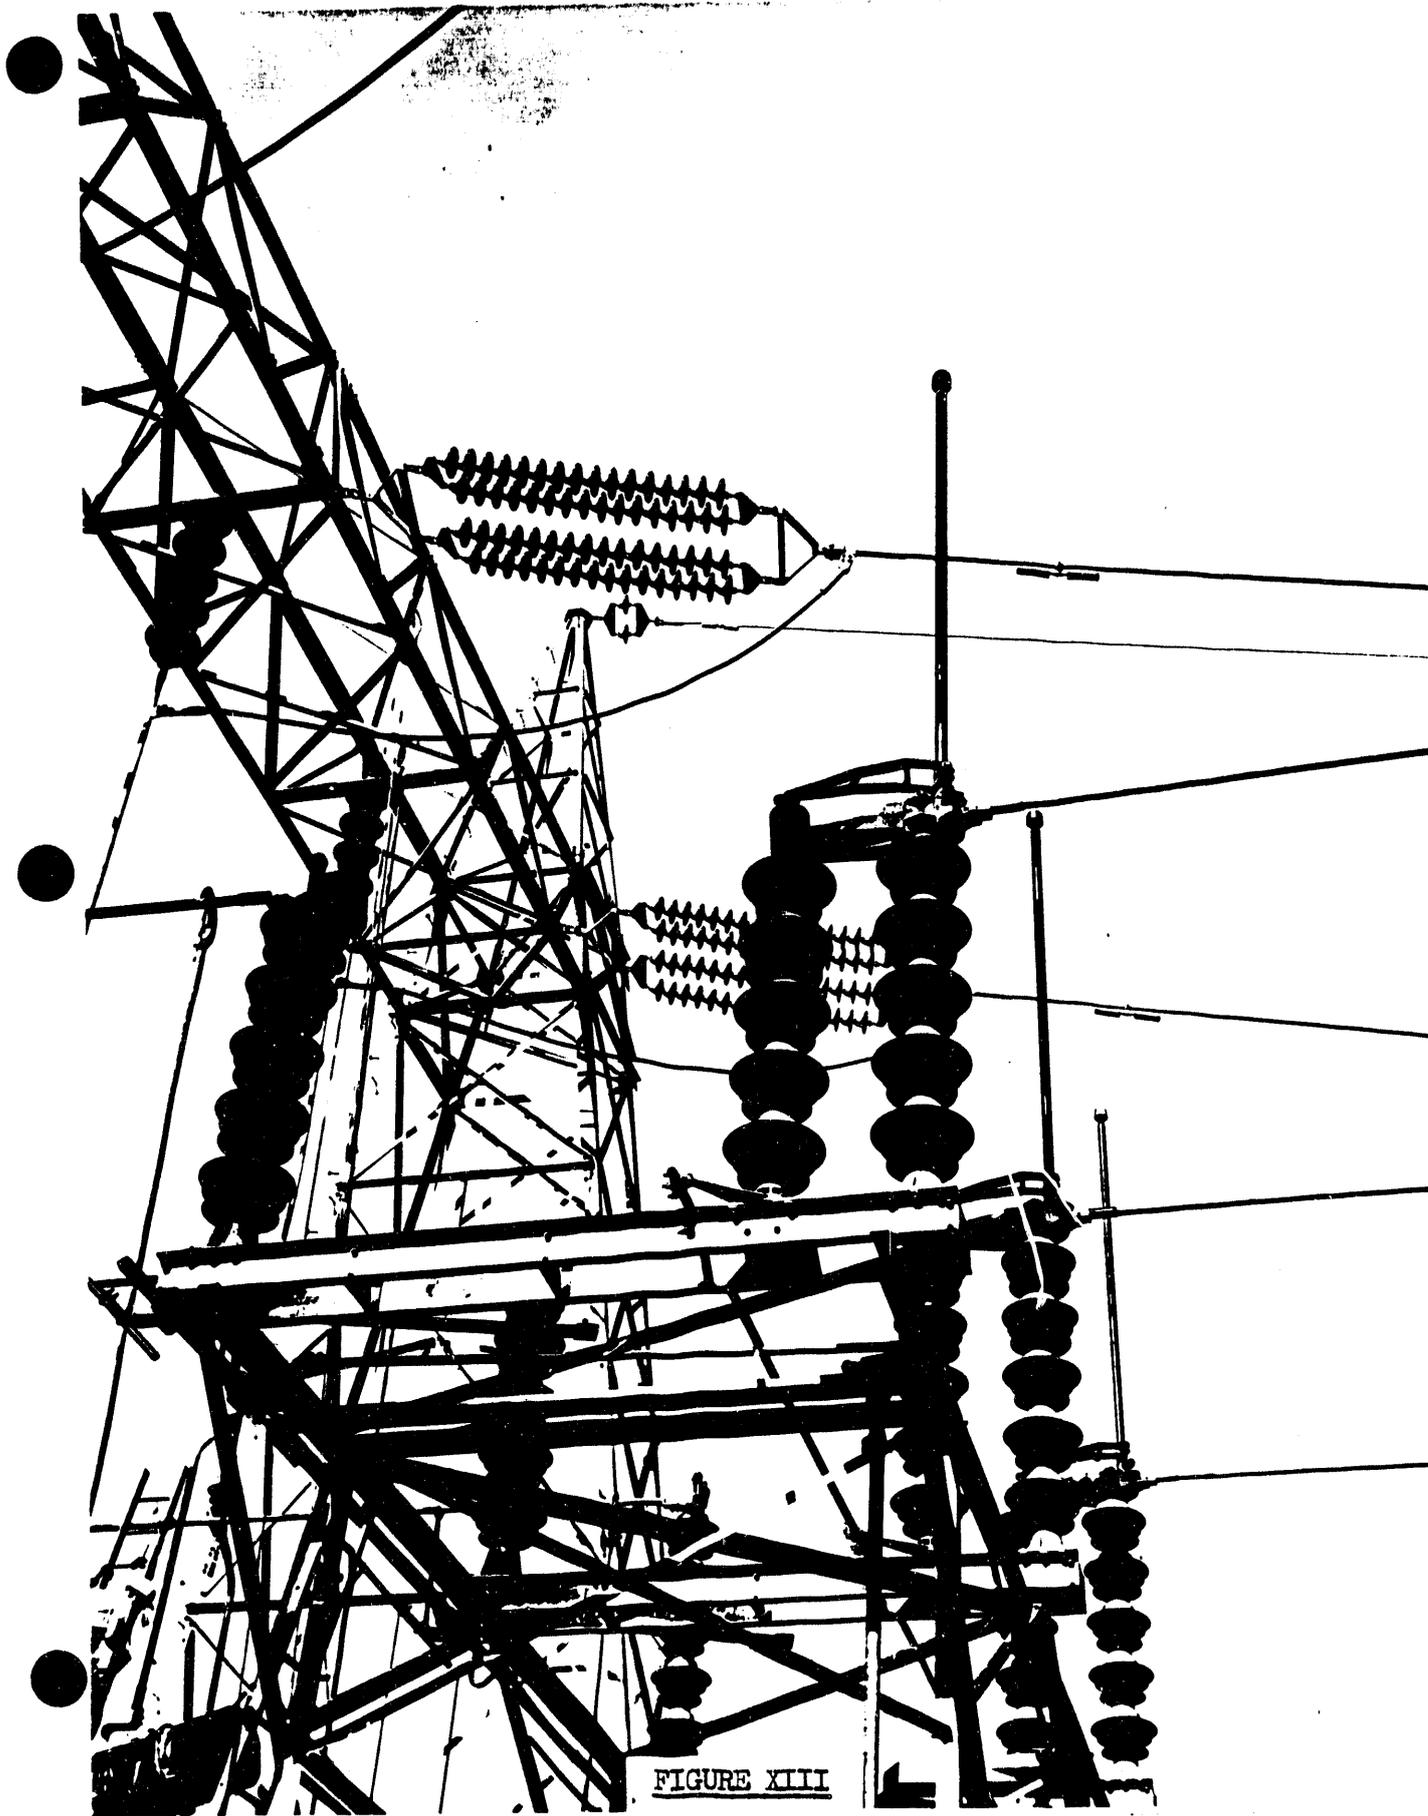
FIGURE XIII

DISCONNECT BETWEEN 230 KV LINE (PRIEST RAPIDS #1) AND 230 KV BRKR
SHOWING SMOKE BLACKENING OF INSULATORS, TOP OF FAULTED CT(4/9/62)
