HW-41661

DATE
March 2, 1956

TITLE
100-D AREA
CLASSIFIED FILES.
SLUG COCKING & COLUMN BOWING EXPERIMENTS

SLUG COCKING & COLUMN BOWING EXPERIMENTS

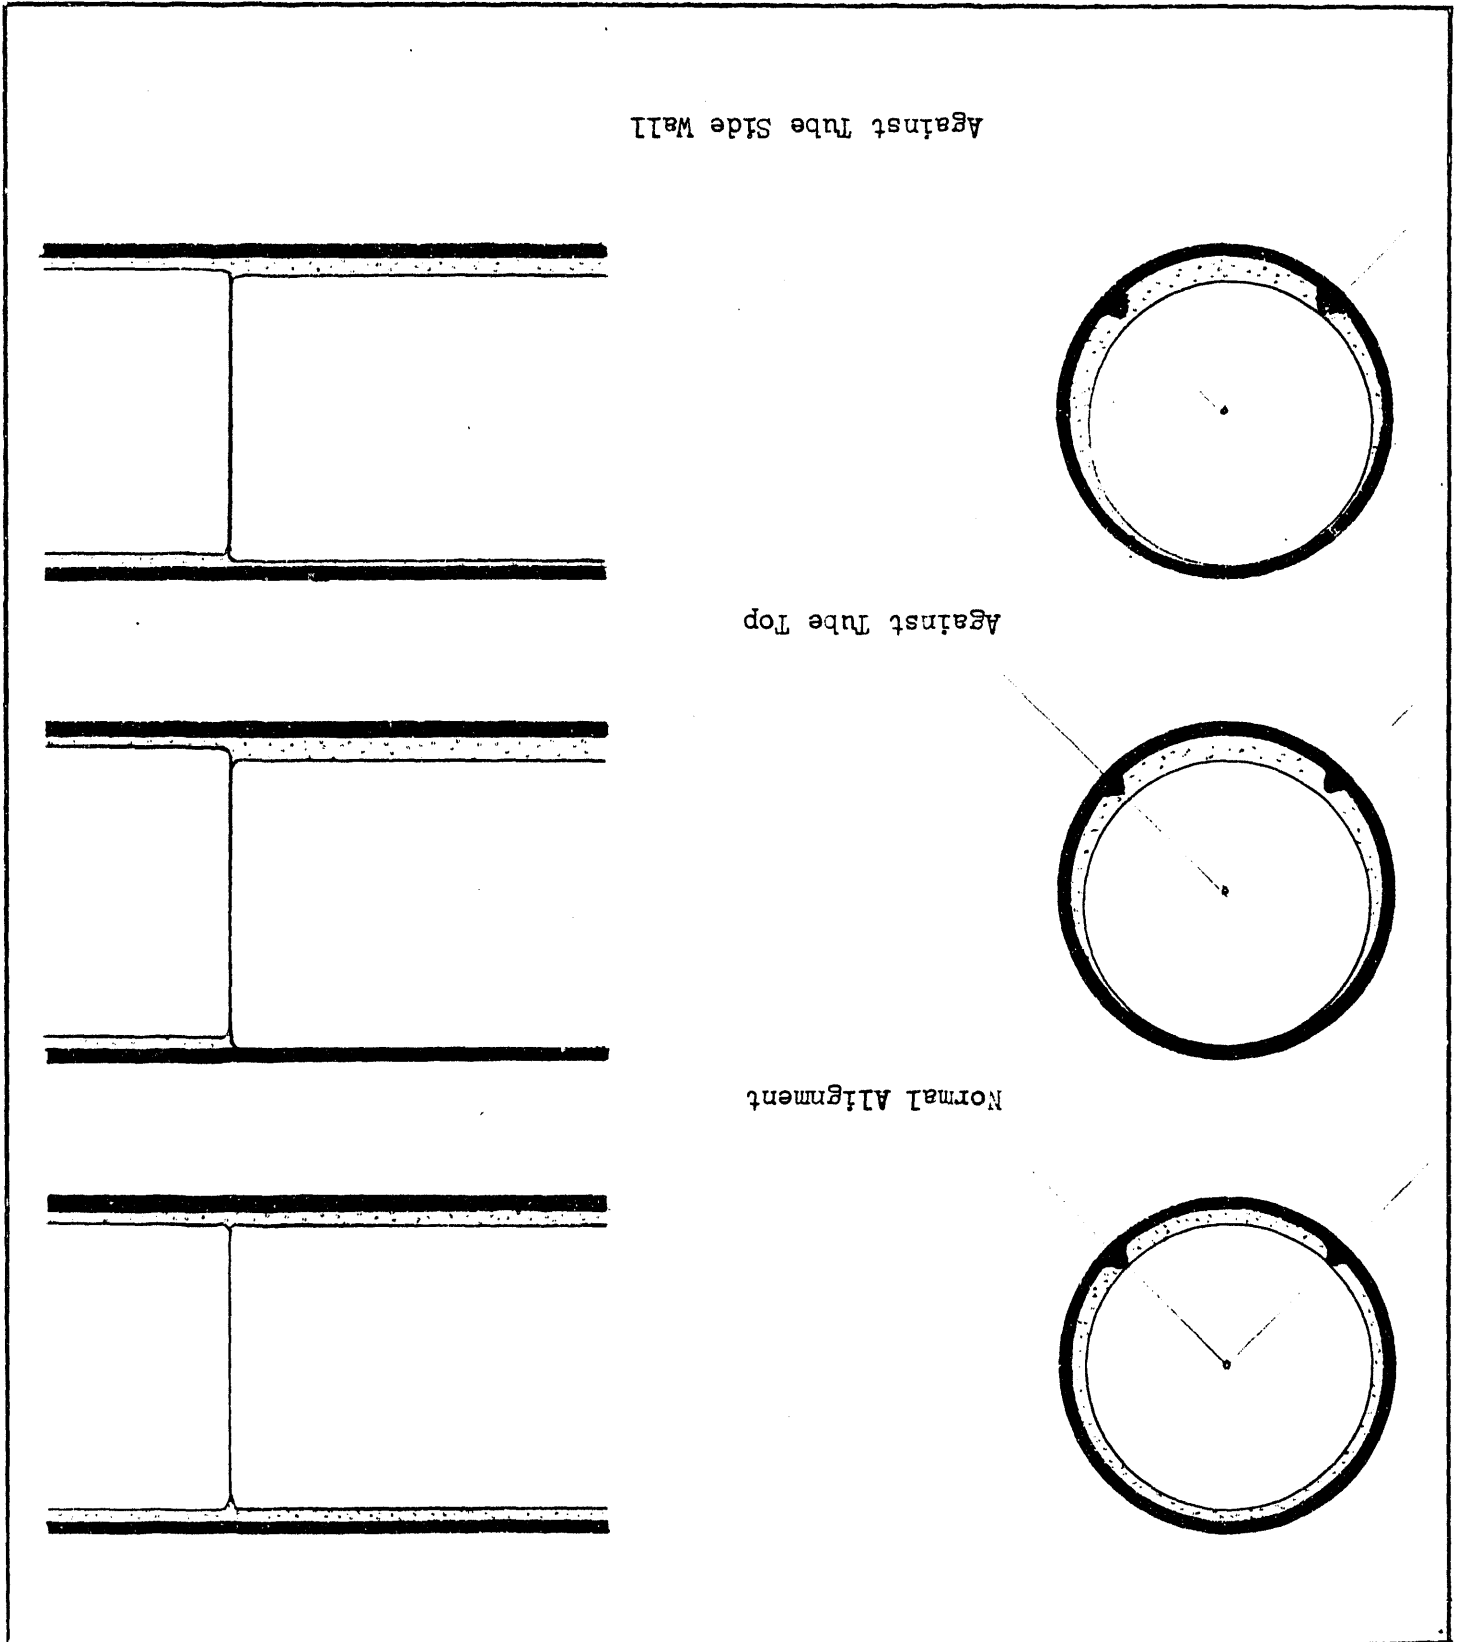
Figure 9 - Possible Slug Orientations as Interpreted by X-Rays in the Vertical Plane

The vehicles for the suspected misaligned slugs have been cocked slugs and bowed slug columns. A cocked slug is defined as one which is not in axial alignment with adjacent slugs. A bowed column is one where two or more slugs are lifted from contact with the tube ribs by axial loading of the slug column. A third possible explanation for serious misalignment, discovered by these tests, is in reality a combination of the other two.
