INVESTIGATION OF CRACKING AND ERRATIC BEHAVIOR
OF THE URANIUM-TITANIUM ALLOY

**OAK RIDGE
Y-12
PLANT**

E. L. Bird

Date of Issue: July 7, 1993

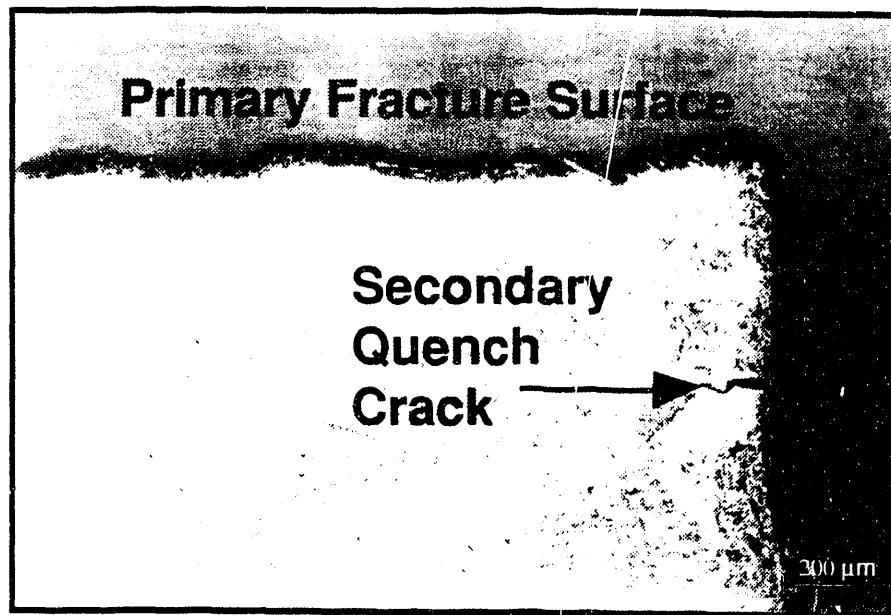
A section of one of the components that cracked during and/or following the quenching process is shown in Fig. 1. The amount of α' martensite is estimated to be <50%, which is indicative of a cooling rate <50°C/s. Other cracked components resulted in the same findings, except for one component that exhibited a martensitic structure that was predominantly α' martensite. This finding was inconsistent with the other cracked components that clearly demonstrated an ineffective quench. The crack origin could not

Figure 1. Microstructure of component that cracked during quenching. Phase transformation from γ to α' martensite was incomplete and indicative of cooling rate $<50^{\circ}\text{C}$.

All but one of the components that cracked as a result of the quenching process exhibited a sluggish phase transformation indicative of a cooling rate $<50^{\circ}\text{C/s}$. The exception to this observation revealed a predominantly martensitic microstructure

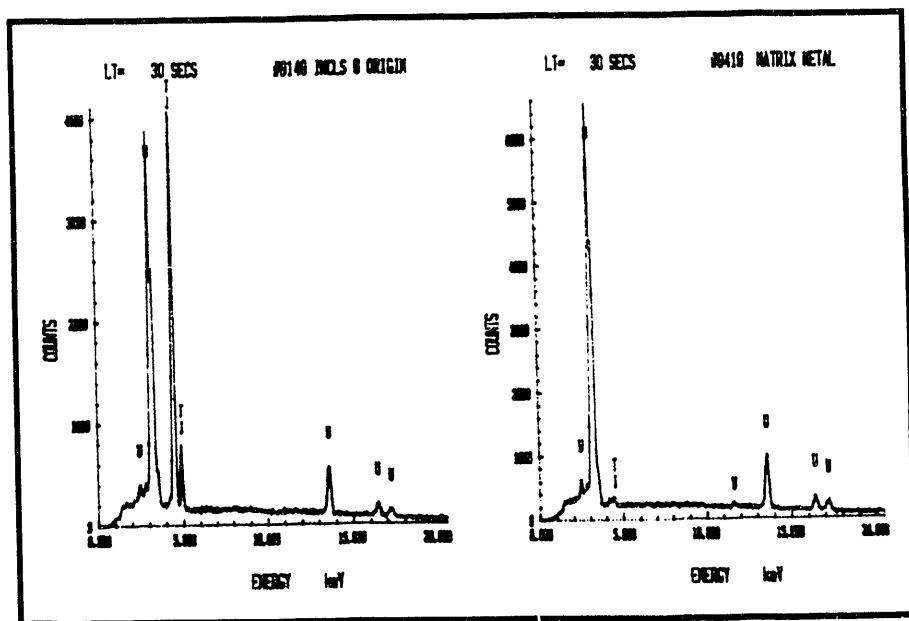
Figure 4. Energy dispersive X-ray spectra of titanium-rich inclusions at fracture origin.

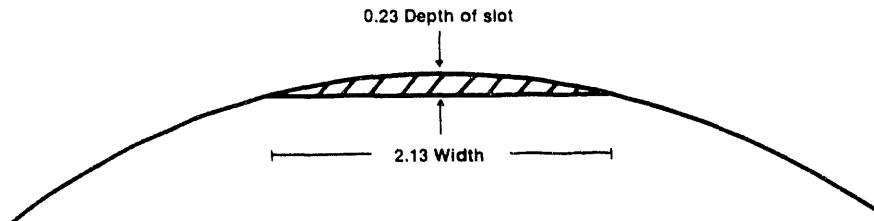
To test the theory that inclusion clusters were the primary cause of erratic ductile values, a flaw (shown in Fig. 7) was machined into tensile specimens and tested at two levels of internal hydrogen content and two different strain rates. These results, which are shown in Table 2, showed a 50% reduction in elongation in the notched specimens with no appreciable effect on strength.

DIMENSIONS (0.23 mm X 2.13mm X 0.53mm)

Figure 7. Geometry of notch machined into tensile specimen to simulate surface defect.

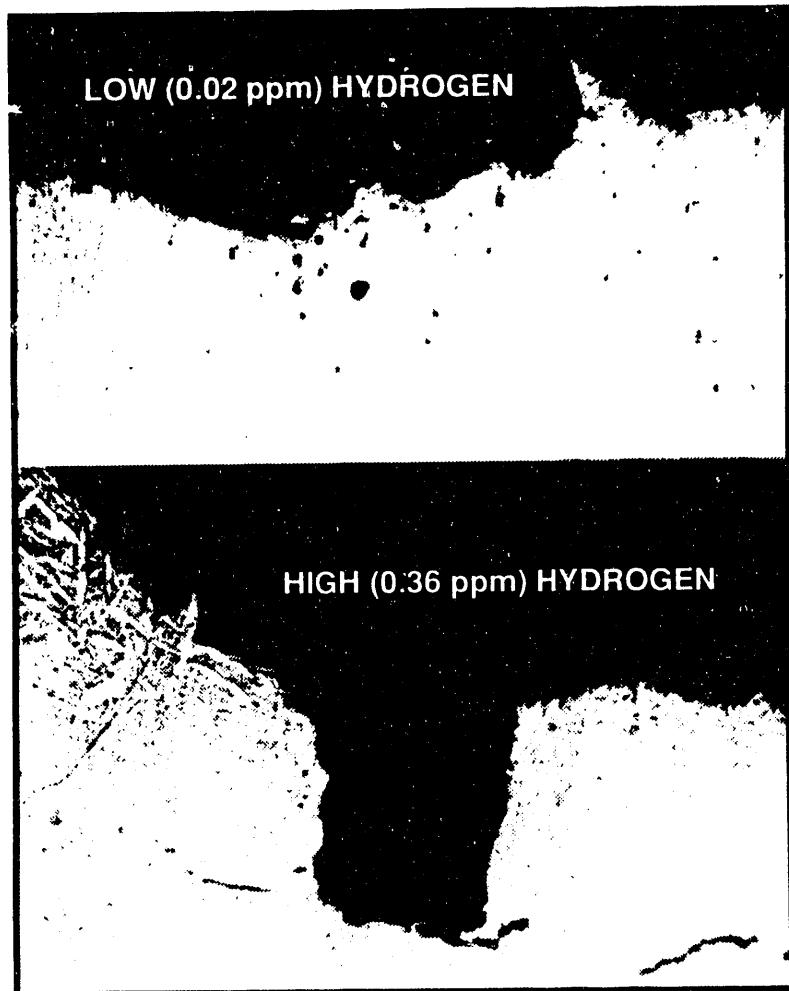
Material that was outgassed (vacuum solution heat treated) for 1 h resulted in an internal hydrogen level of 0.36 ppm, whereas material that was outgassed for 8 h resulted in 0.02 ppm hydrogen. Tensile specimens taken from these two test groups were pulled at two different speeds by varying the crosshead velocity, which in effect, changes the strain rate. Table 3 shows these results. No significant differences in strength resulted from either hydrogen or strain rate. However, the effects of both hydrogen and strain rate on ductile properties is evident, as shown in Fig. 8. Fracture morphologies associated with each test condition revealed mixed fracture modes with slightly more microvoid coalescence observed in the test group with lower hydrogen content. In addition, secondary cracking (shown in Fig. 9) was observed in the higher hydrogenated specimens.

Figure 9. Fracture paths associated with predominantly ductile failure through martensitic platelets (above) and brittle, mixed mode along martensitic platelets (below). Also, in bottom photograph note secondary cracking observed in higher hydrogen specimen.

Fracture morphology also seems to be dependent on hydrogen content and strain rate. At slower strain rates, material with more abundant hydrogen has more time to migrate in larger quantities in the affected plastic zone immediately in front of the crack tip. Crack propagation along the martensitic platelet boundaries produces a brittle appearance that is characterized as predominantly quasi-cleavage.

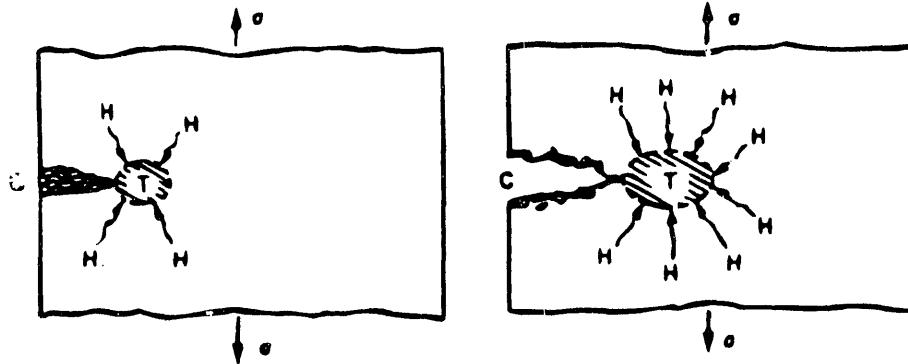
An inclusion cluster or notch serves as an excellent site for crack nucleation, especially in this alloy, which is sensitive to hydrogen embrittlement. As a tensile load is applied, a triaxial stress field is created in the vicinity of the defect. Hydrogen atoms, present as absorbed hydrogen in the alloy, migrate toward and into the triaxial stress zone. As a sharp crack begins to emanate from the inclusion cluster discontinuity, the triaxial stress field becomes more intense, resulting in even greater migration of hydrogen atoms. The region immediately preceding the sharp crack tip becomes more saturated with hydrogen, primarily in the form of hydrides (UH_3), thereby causing local embrittlement and a lowering of the threshold stress intensity for subsequent crack growth. Figure 10 is an illustration of a theoretical model depicting this mechanism.

Figure 10. Theoretical model of hydrogen-assisted crack originating at inclusion cluster. (Left) Uniaxial load (σ) applied to tensile specimen with inclusion cluster (C) at surface. Triaxial stresses (T) develop at tip of inclusion cluster as hydrogen (H) migrates to stressed region (T). (Right) Crack propagates into matrix as more hydrogen (H) migrates to region of triaxial stresses (T) immediately in front of crack tip.
