**ADVANCED PARTICLE FILTER**

Technical Progress Report No. 11  
January through March 1993

Westinghouse Science and Technology Center  
Pittsburgh, Pennsylvania

# **TIDD ADVANCED PARTICLE FILTER**

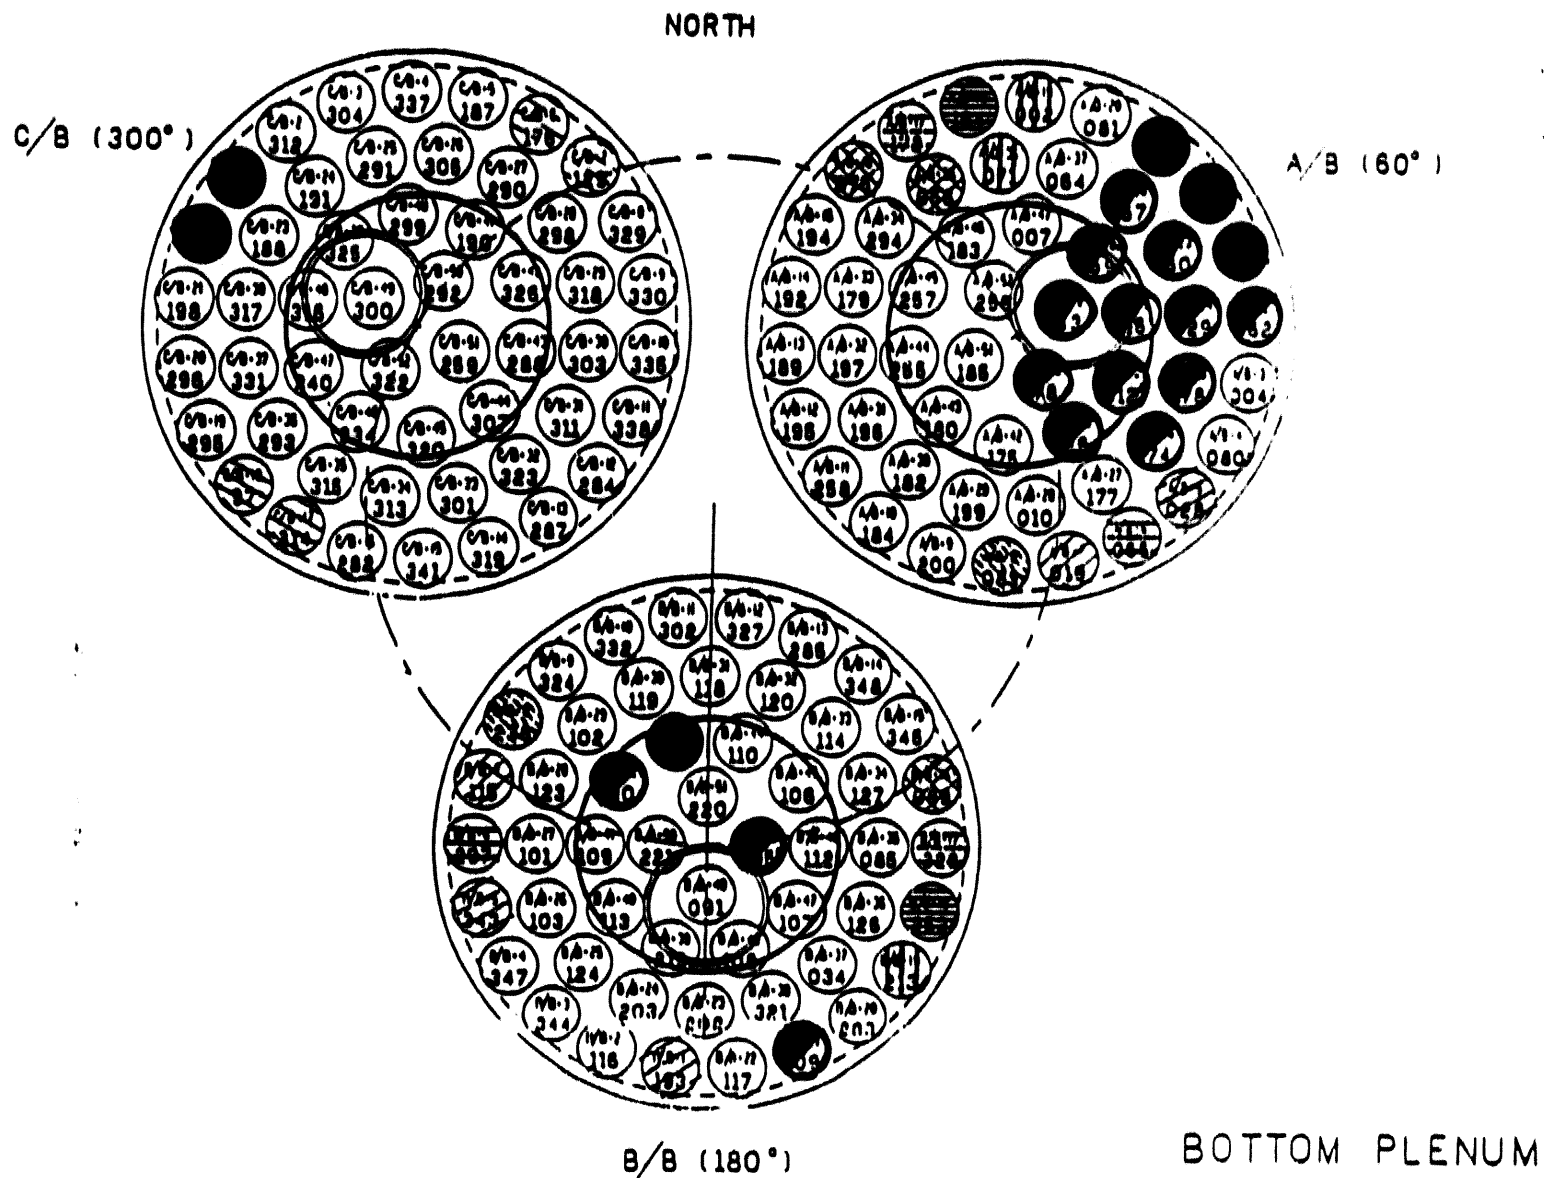
After 500 hours of exposure in the pressurized fluidized-bed combustion (PFBC) gas environment, 21 candle filters in the bottom plenums had fractured. Typically 17 of the failed candles fractured near or below the fine-to-coarse grain transition section (i.e., 101 to 165 mm from the flange top) of the filter elements. Four candles fractured near the bottom closed end section of the filter elements (i.e., 1105 to 1270 mm). These candles were in close proximity to the filter vessel wall.

Figure 3.7 - Location of the Fractured Candles in the Bottom Clusters of the W-APF System

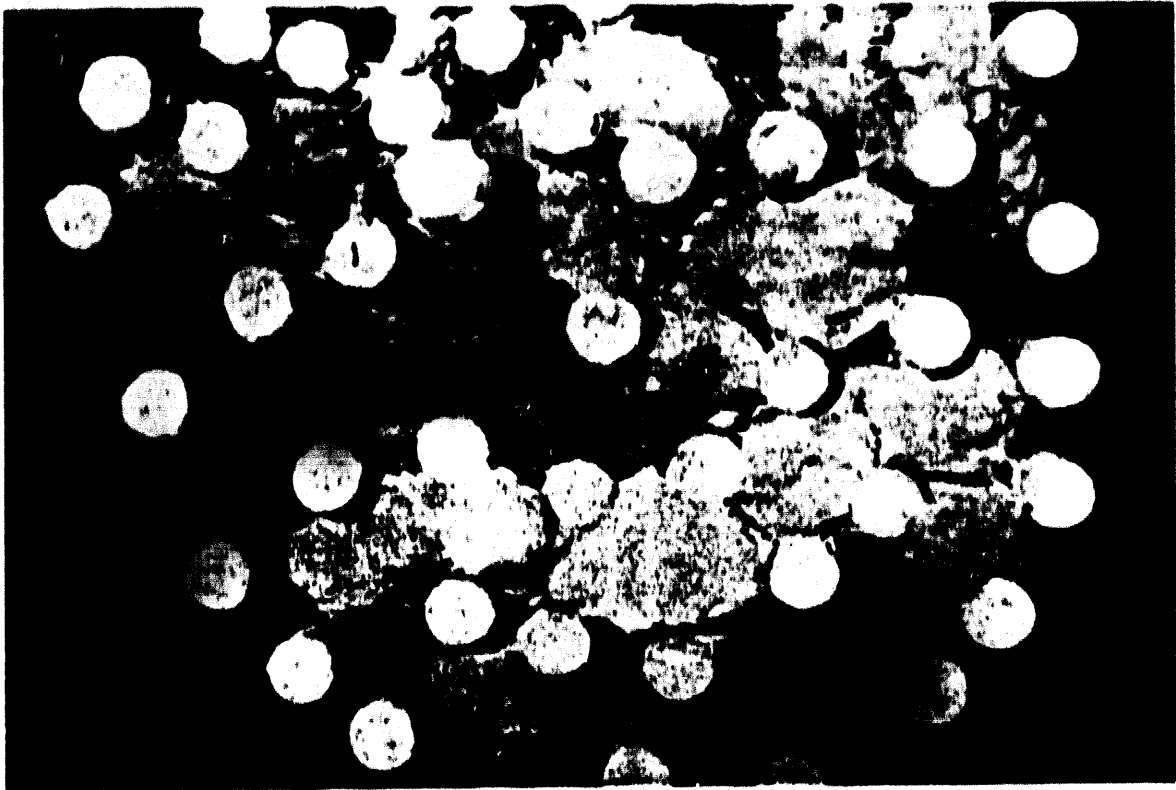
When viewed from the manway, severe bridging of ash was evident in the bottom plenum of Cluster B (Figure 3.8), while only marginal ash bridging was identified along the bottom to the mid-section of candles located in the bottom plenum of Cluster C (Figure 3.9). The bottom plenum of Cluster A (Figure 3.10) was virtually free of ash buildup, but had the greatest number of candles that failed during testing at Tidd.

**Figure 3.8 - Photo Of Bottom Cluster B In The Westinghouse APF System  
During The December 16, 1992 Manway Inspection**

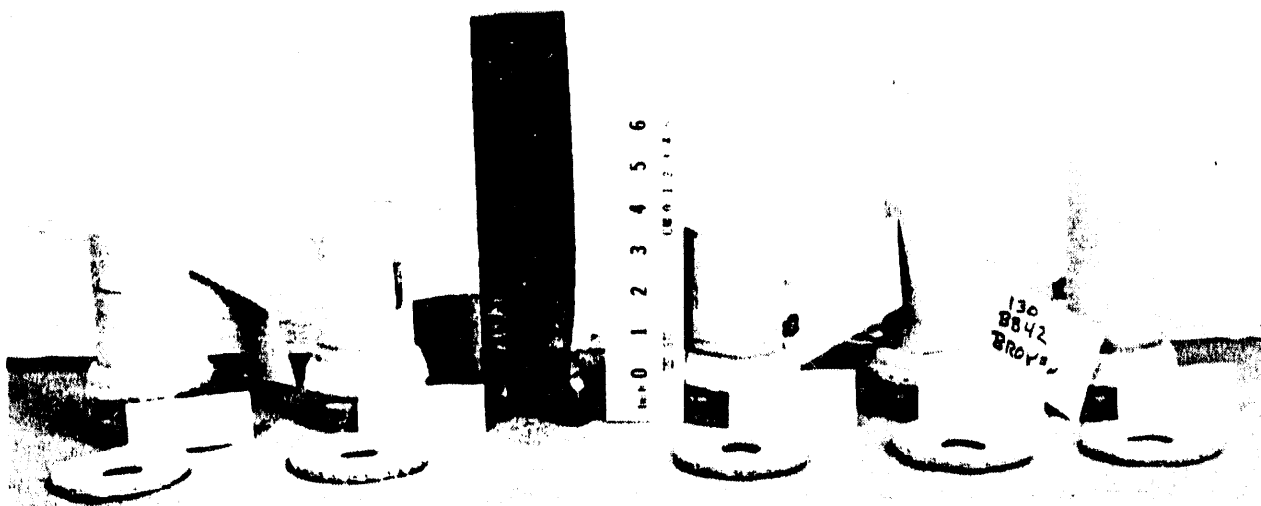
Figure 3.12 - Photograph Illustrating The Length Of The Fractured Candle Sections That Remained In The Filter Holders. A Heavy Deposit Of Ash Is Seen To Coat The Fractured Surfaces.

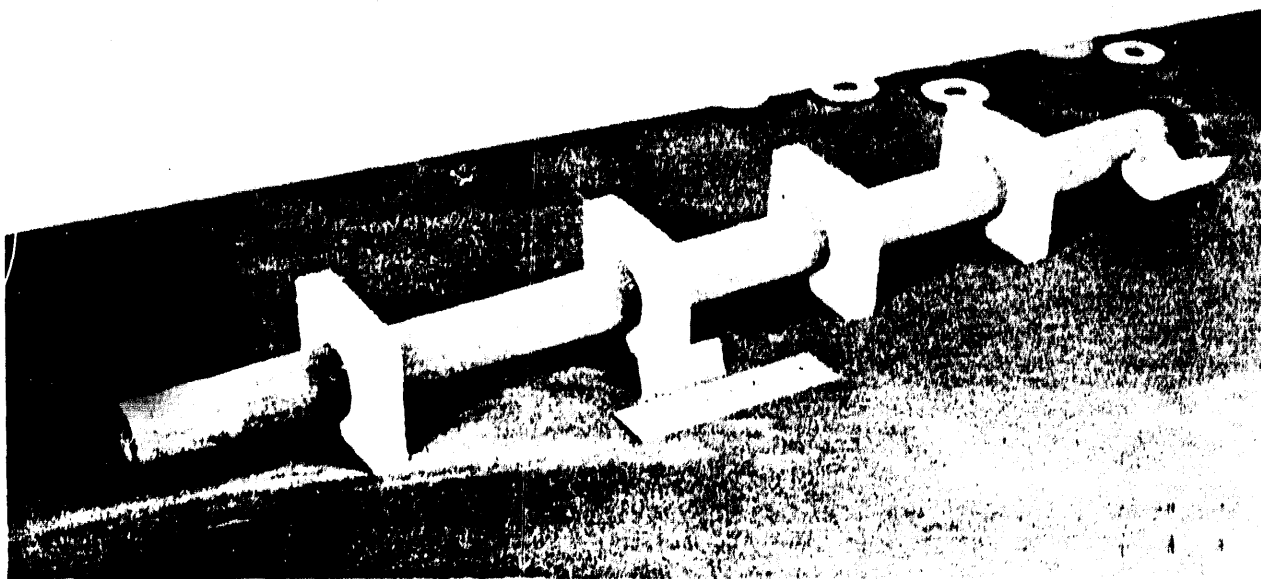
Figure 3.14 - Fractured Candle #062 (A/B-2)

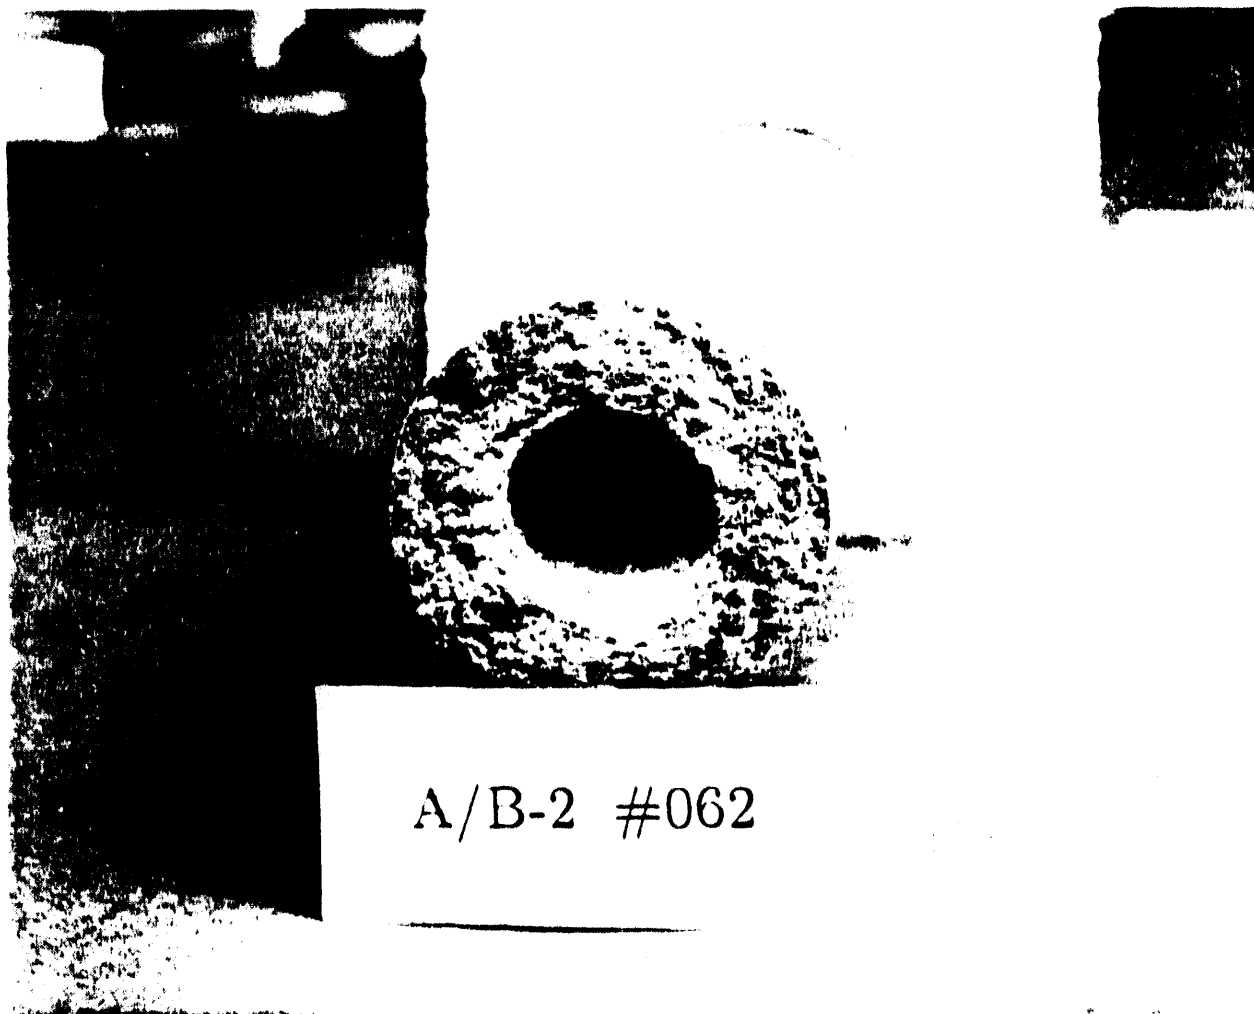
Figure 3.15 - Heavy Deposit Of Ash Along The Fractured Surface Of  
Candle #062 (A/B-2)

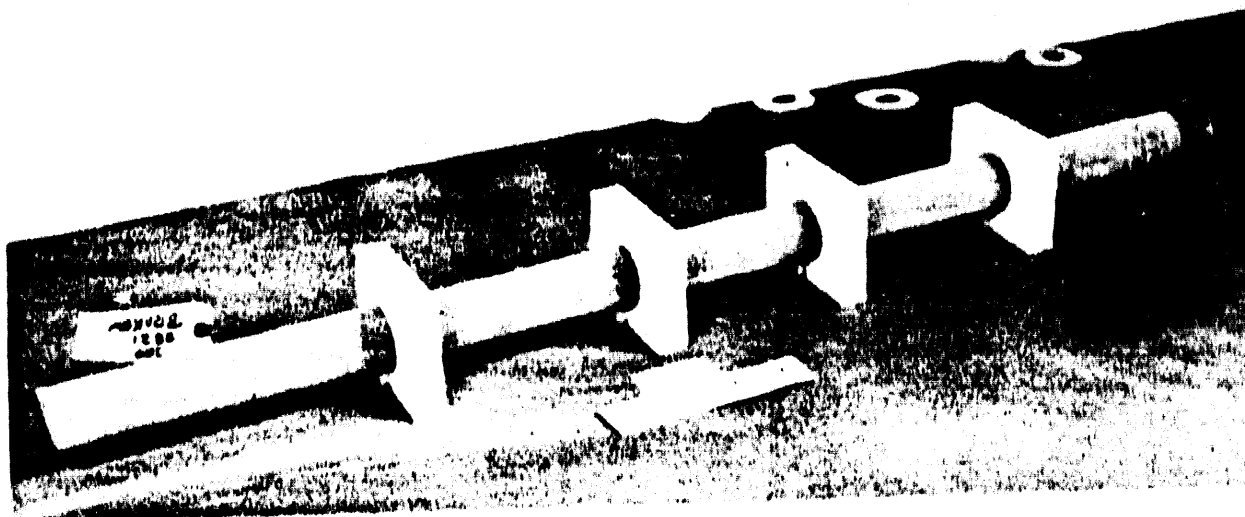
Figure 3.16 - Fractured Candle #309 (B/B-21)

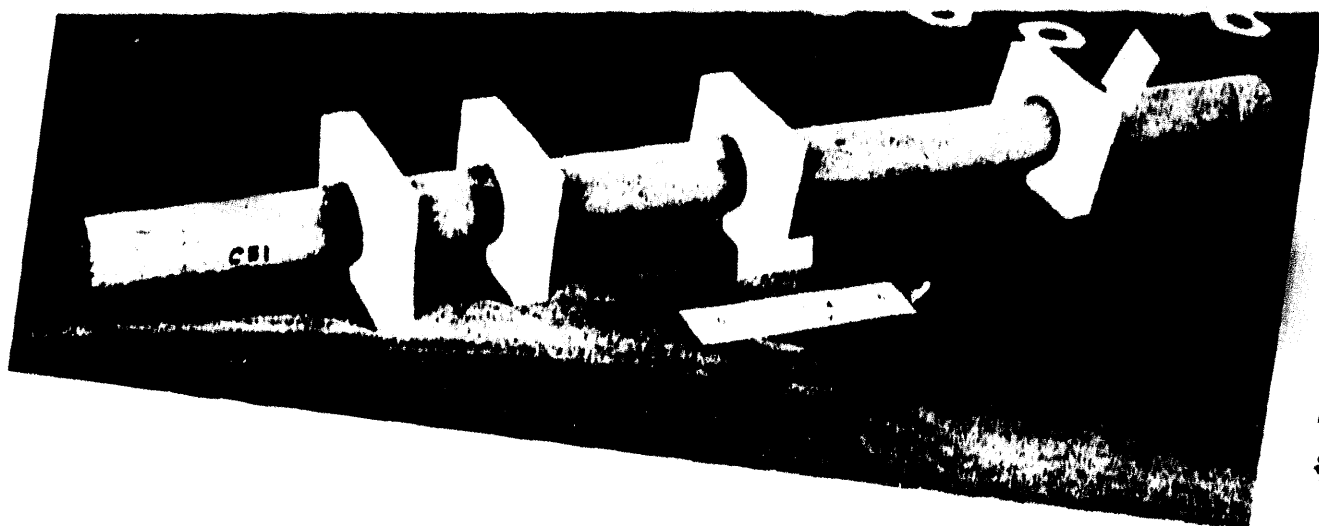
Figure 3.18 - Fractured Candle #308 (C/B-1)

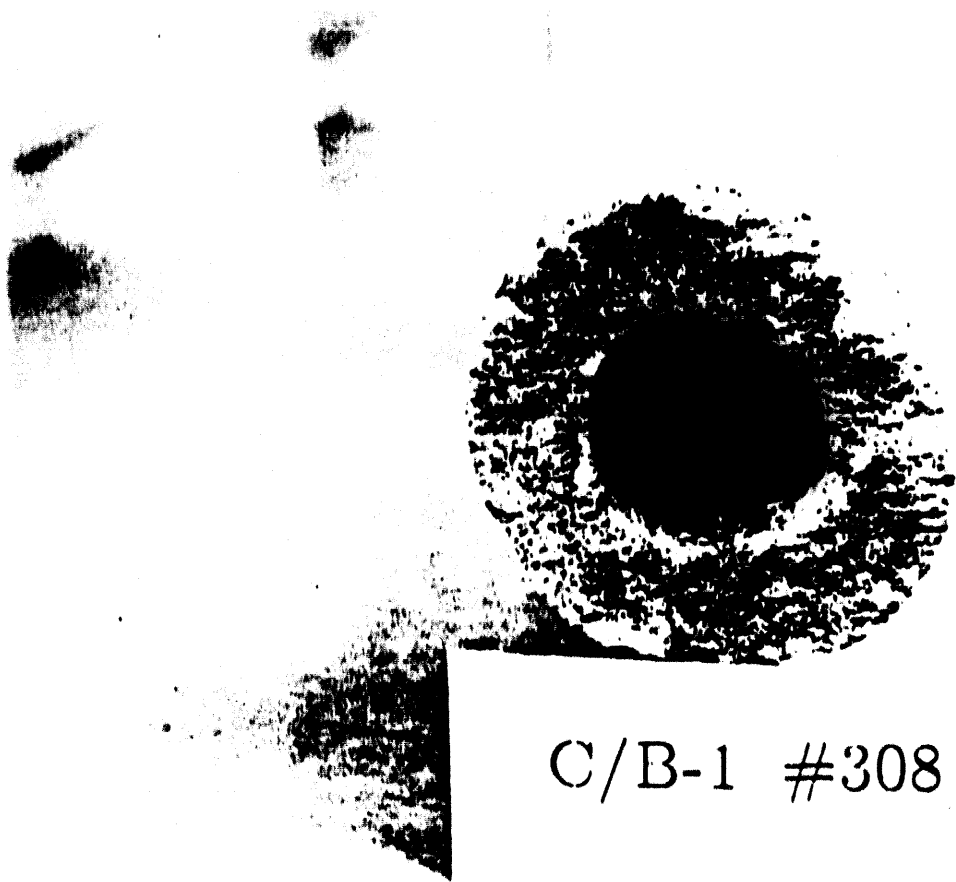
**Figure 3.19 - Fresh Fractured Surface Of Candle #308 (C/B-1)**

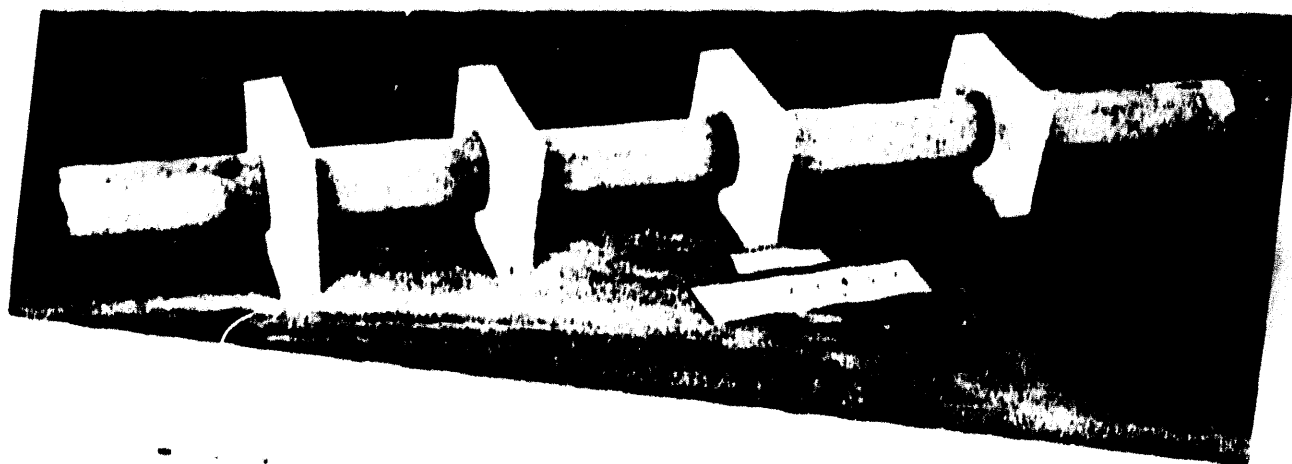
Figure 3.20 - Fractured Candle #310 (C/B-22)

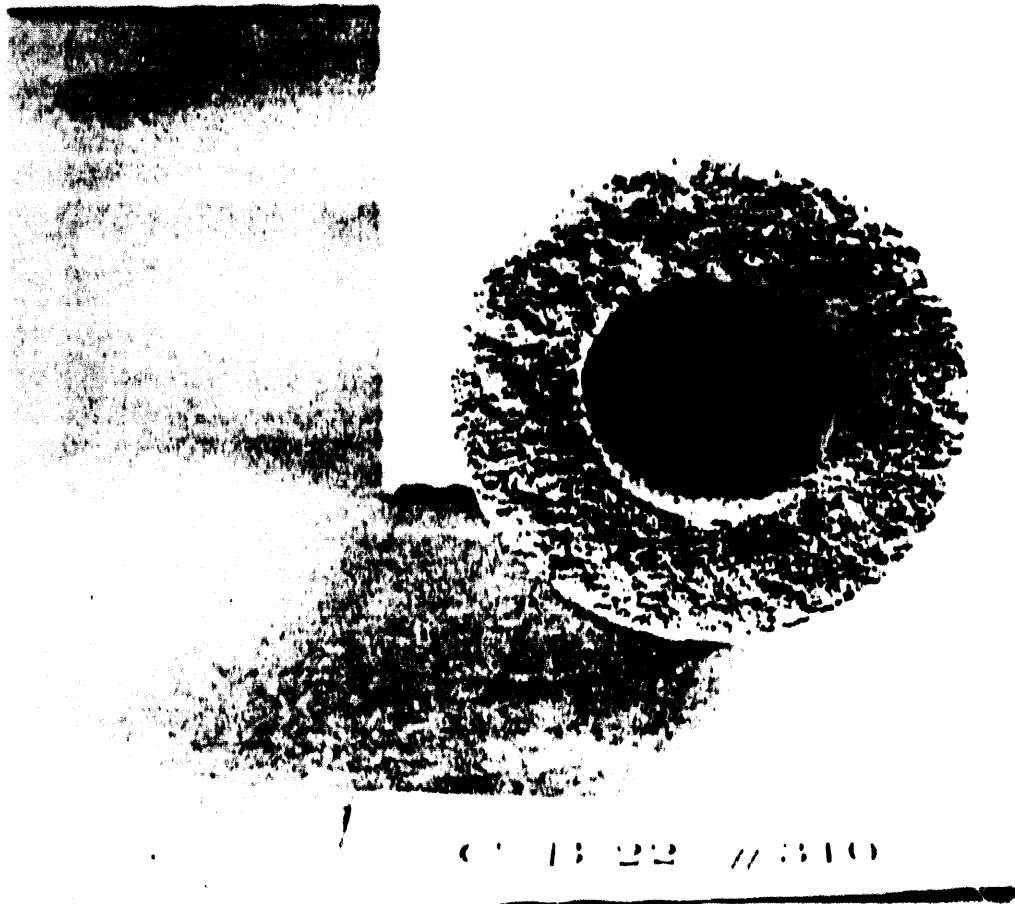
**Figure 3.21 - Fresh Fractured Surface Of Candle #310 (C/B-22)**

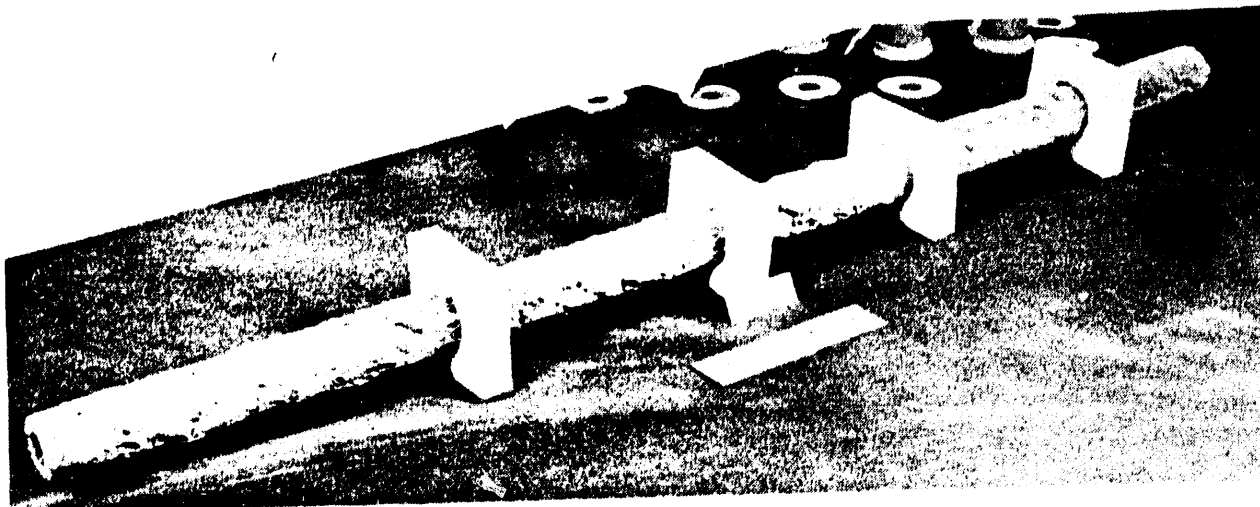
Figure 3.22 - Bottom Section Of Candle Filter #125 (B/B-43).  
Note The Dumpling-Like Ash Formations Along The  
Candle Filter Surface.

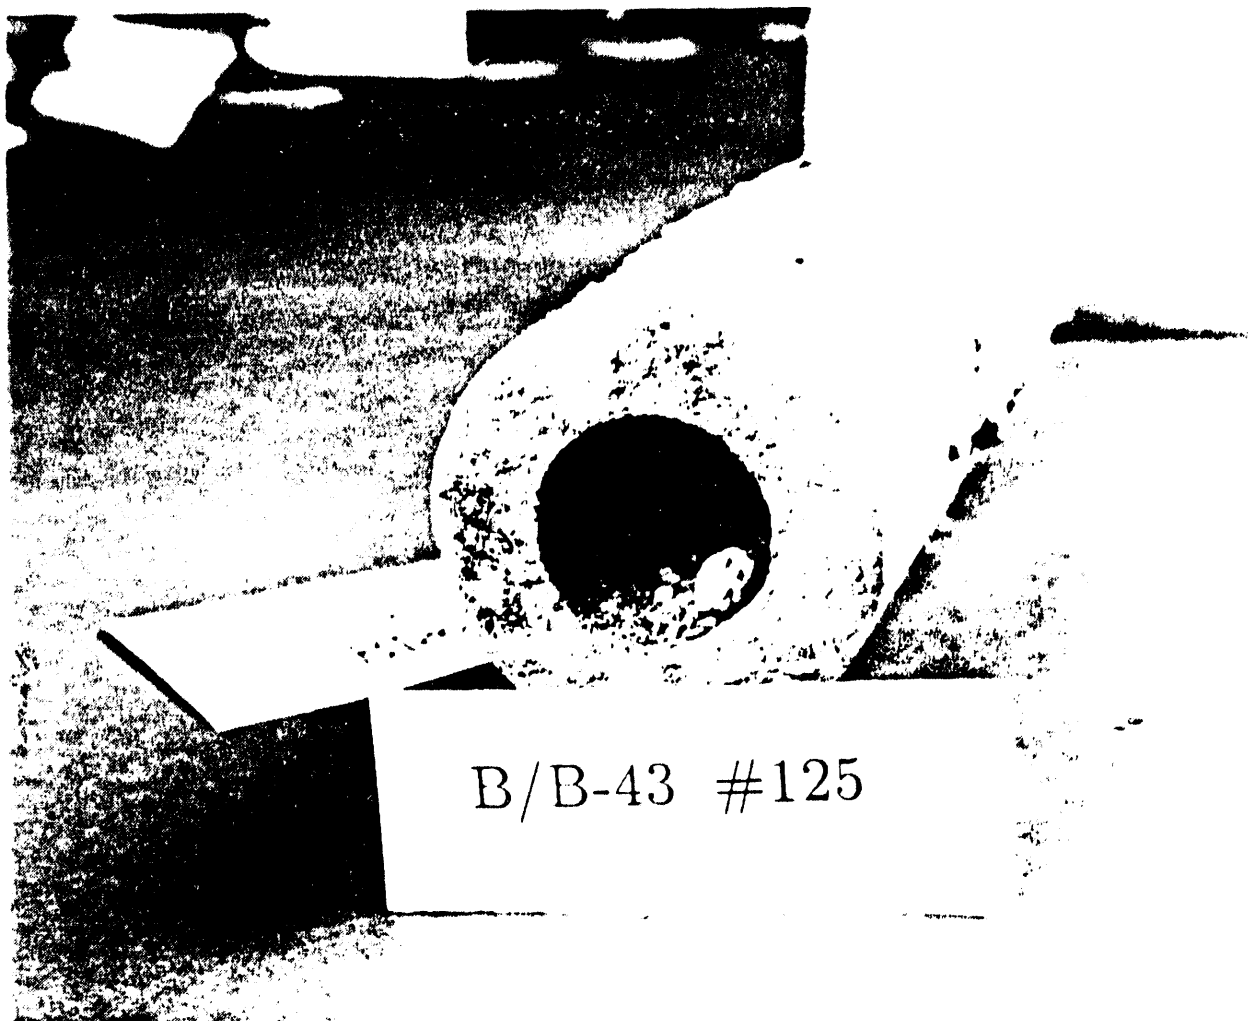
Figure 3.23 - Light Coating Of Ash Along The Fresh Fractured Surface Of Candle #125 (B/B-43)

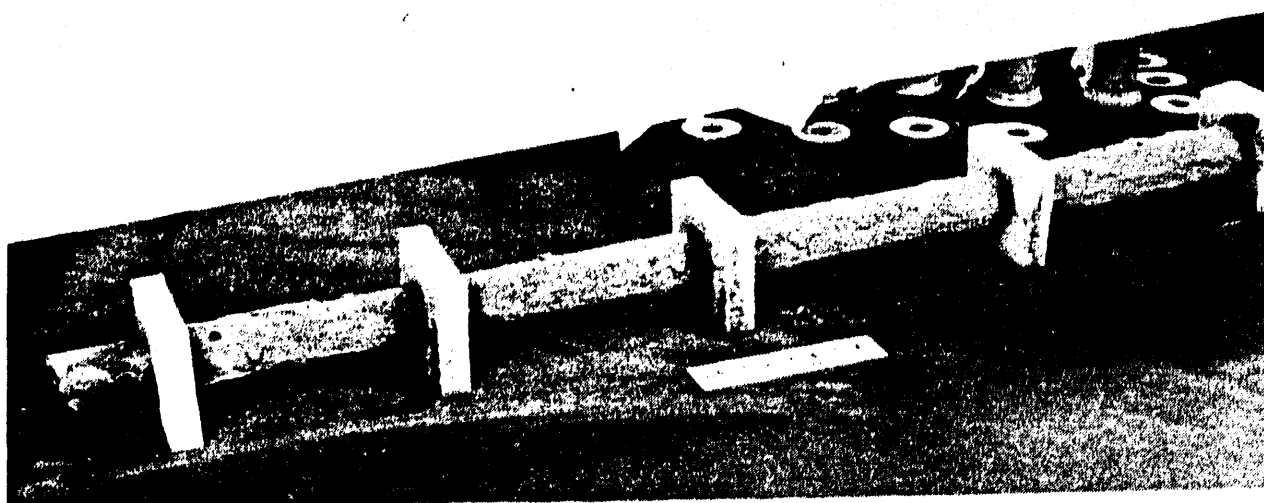
**Figure 3.24 - Bottom Section Of An Unidentified Candle Filter.  
Note The Dumpling-Like Ash Formations Along The  
Candle Filter Surface.**

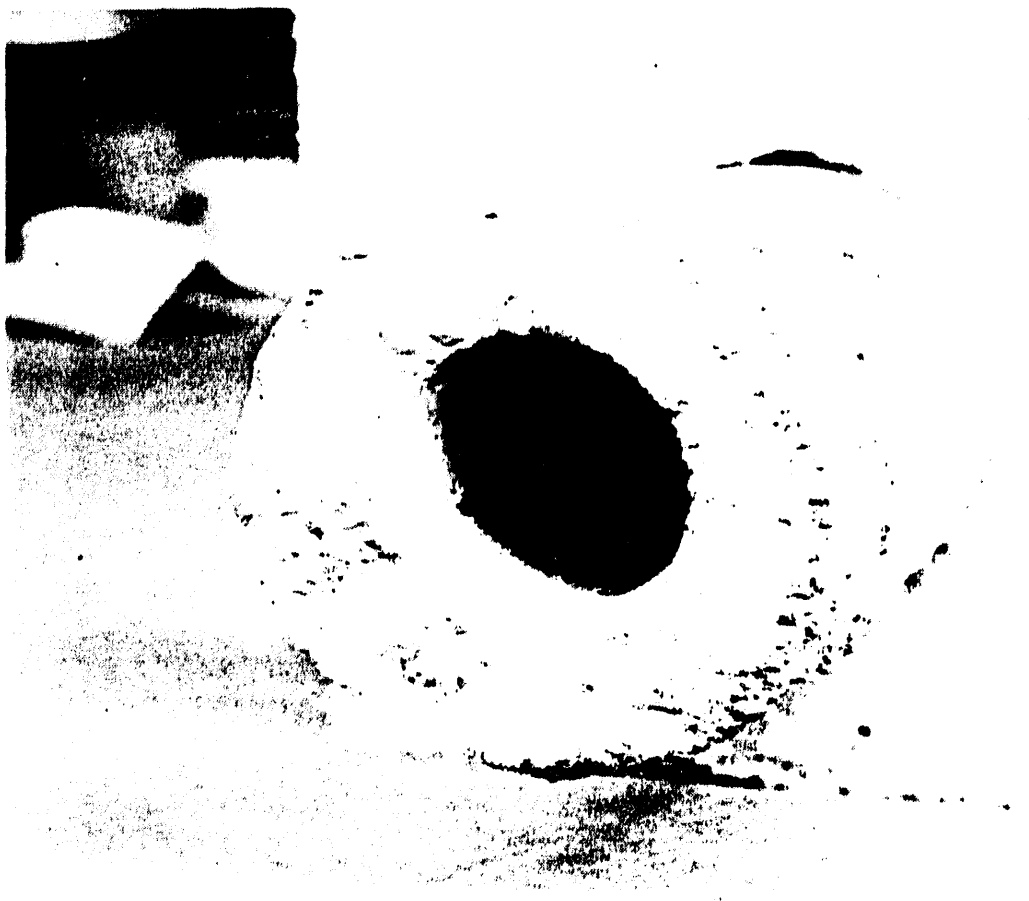
**Figure 3.25 - Heavy Coating Of Ash Along The Fractured Surface Of The Unidentified Candle**

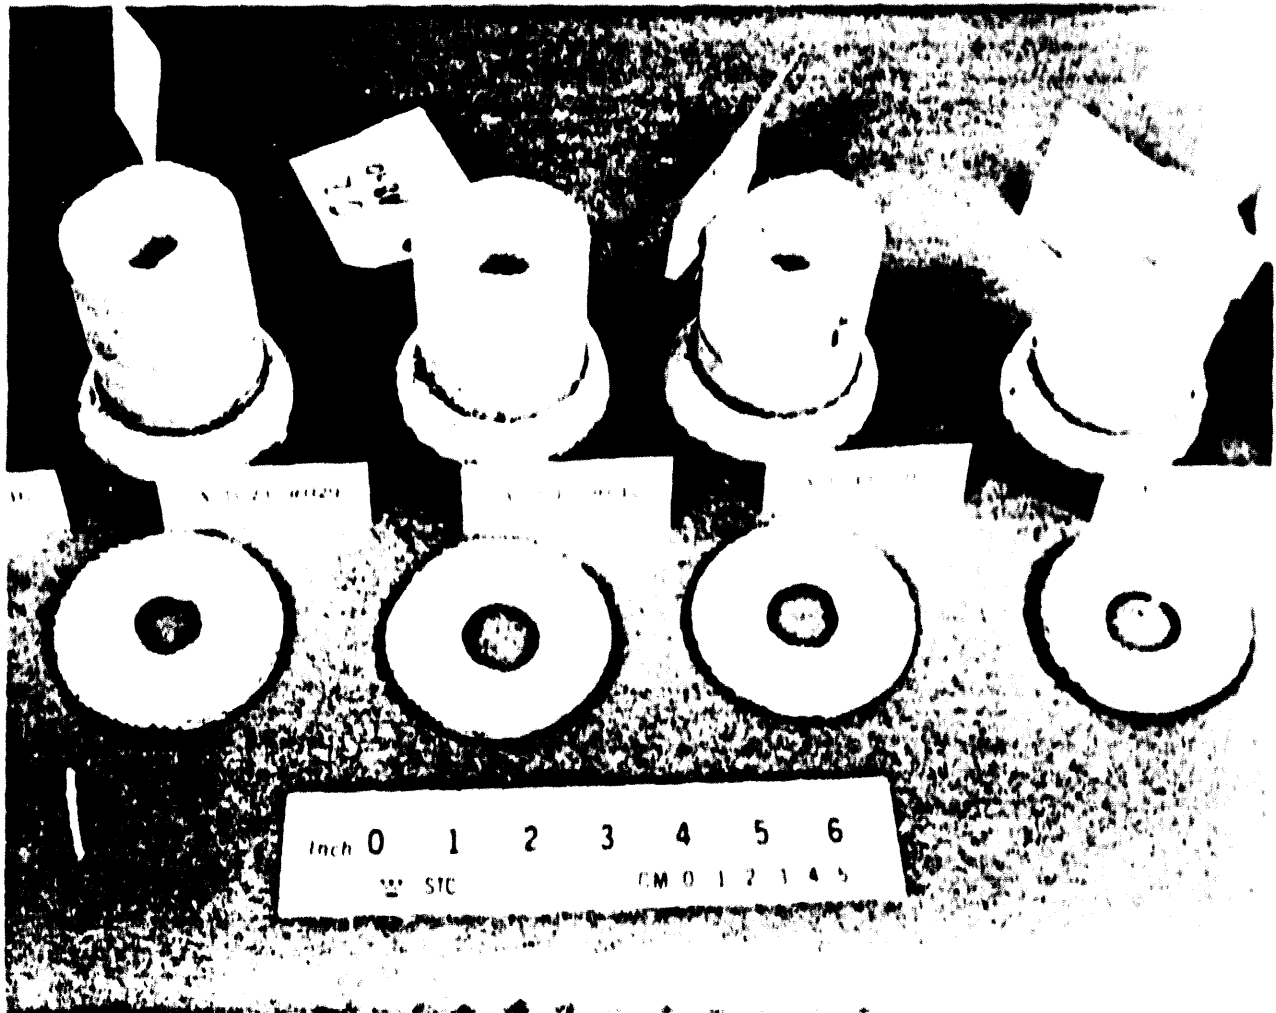
Figure 5.18 - Sorbent Deposit Along The ID Surface Of The Fractured Candle Filters

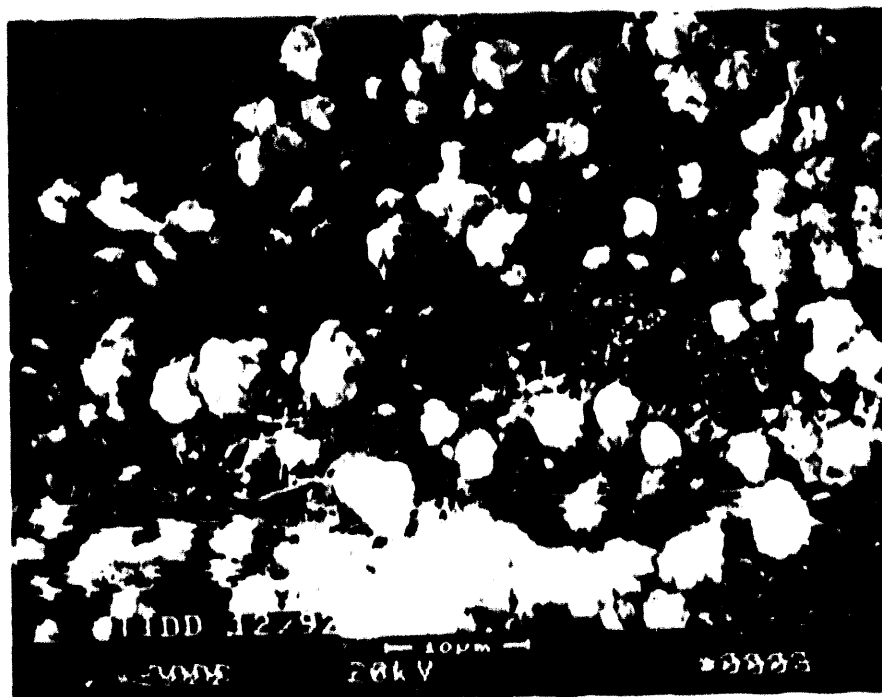
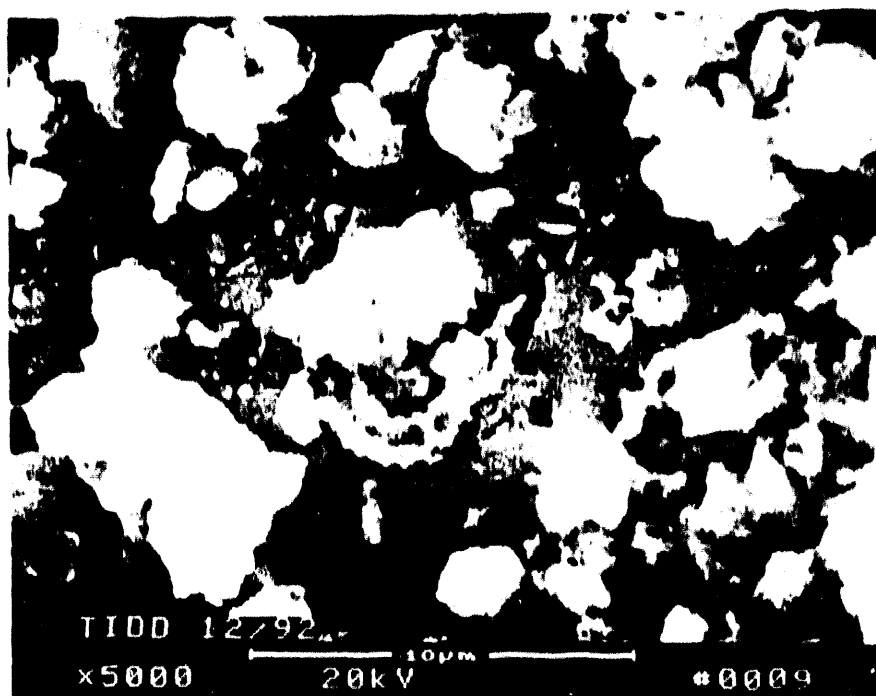
Figure 8.11 - Adherence Of A Crystalline-Like Phase Along The Binder Coating Of The Second Silicon Carbide Grain Layer. Deterioration Of The Binder Coating Beneath The Adhering, Deposited Phase Is Evident.

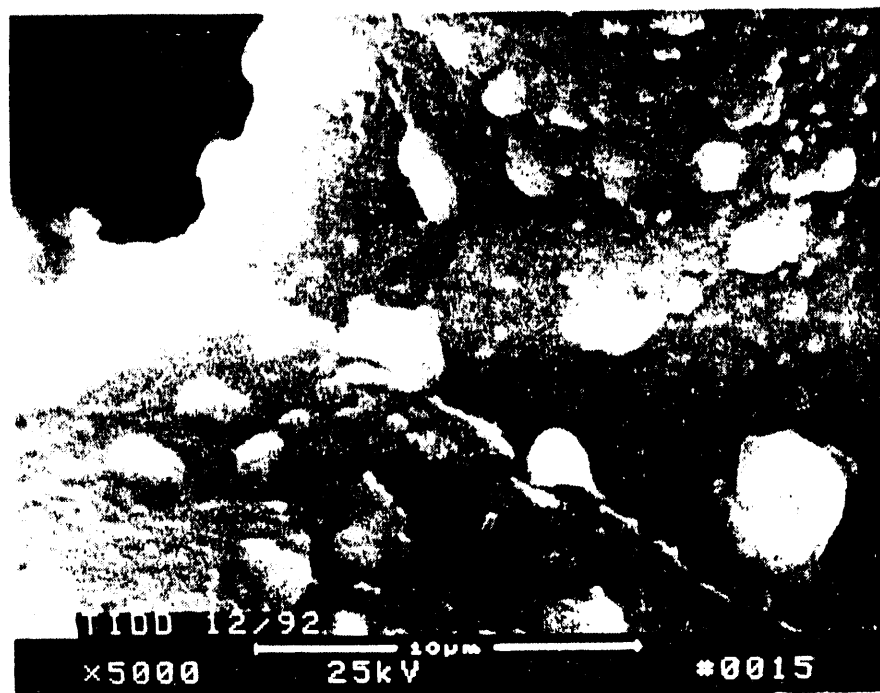
Figure 6.15 - High Magnification Micrograph Illustrating A Crack-Like Feature, As Well As Surface Adhering Or Binder Phase Change Along The Binder Interconnect Areas Between Two Adjoining Silicon Carbide Grains

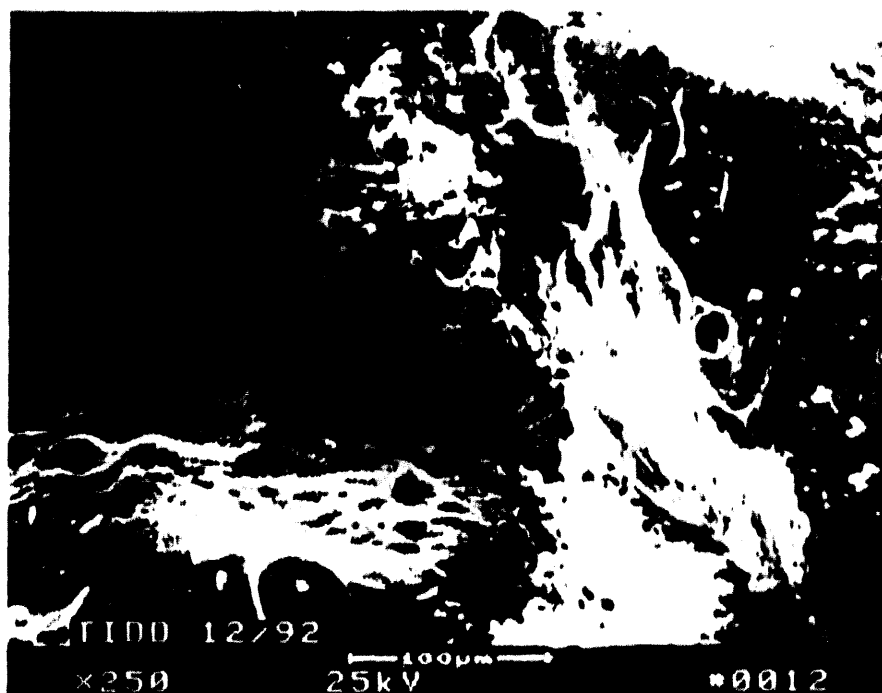
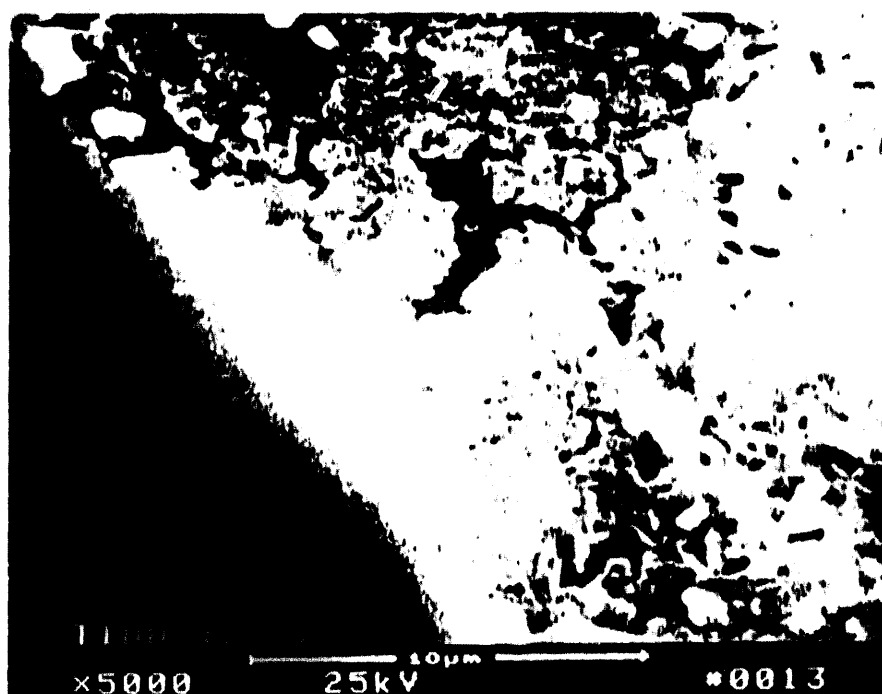
Figure 6.41 - Extensive Phase Change Along The Binder Surface Of The Silicon Carbide Grains That Are Located At ~12 mm From The Membrane Coated OD Wall (~3 mm From The ID Surface)
