Case History: Failure Analysis of a 16K ROM with a Polysilicon Gate Defect

R. E. Mikawa and A. N. Campbell

Sandia National Laboratories

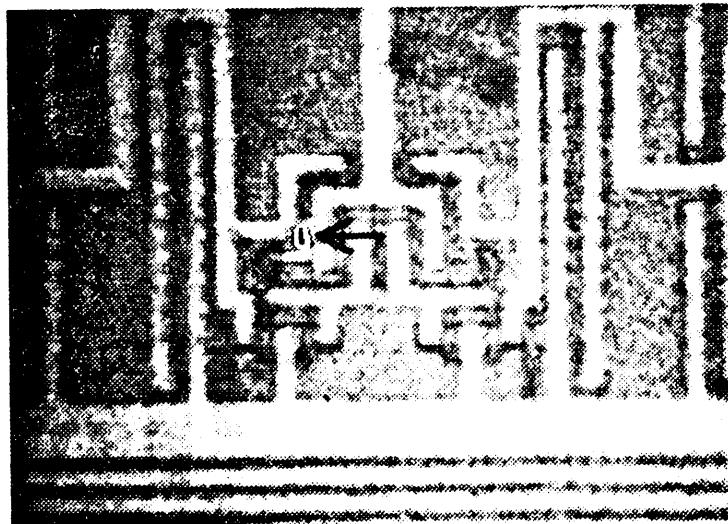
A Hewlett Packard HP81810 tester was used throughout the remainder of the analysis to repeat the light emission inspections. Figure 1 shows light emission data obtained near the AD4 pin with $V_{DD} = 7$ V. The area of light emission is indicated in the image by the black region left of center (see arrow). The intensity of light emission increased when V_{DD} was greater than 7 V and detectable light emission ceased when V_{DD} was reduced below 7 V.

Figure 1. Light emission observed from AD4 port cell; $V_{DD} = 7$ V. The arrow denotes the location of light emission.

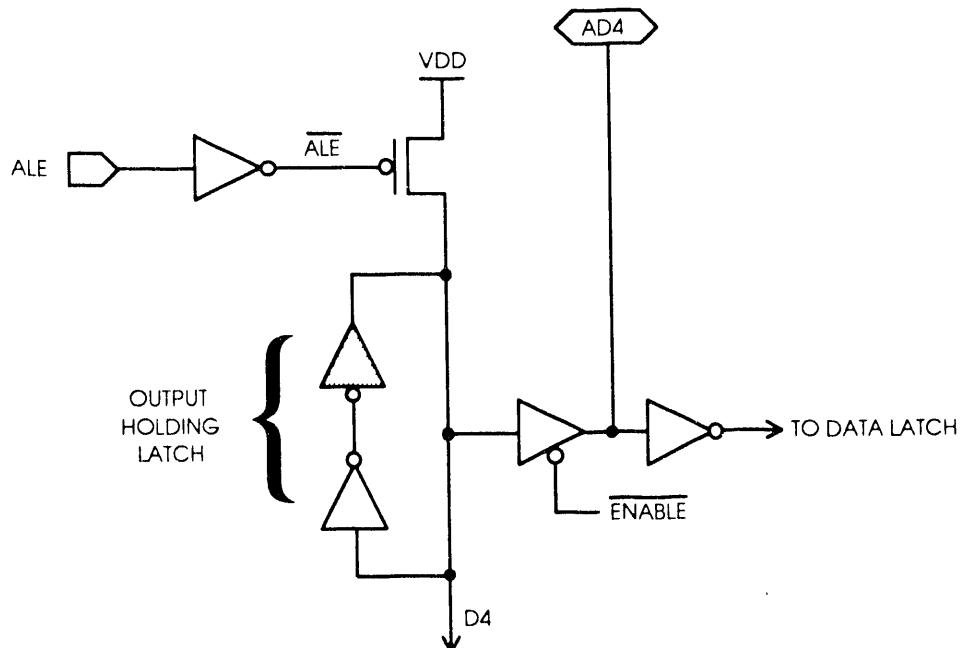
As mentioned previously, Sentry testing with $V_{DD} = 5$ V showed functional failures on the AD4 pin. Figure 2 is a simplified electrical schematic diagram of the AD4 port cell. While the IC was in this stuck-at-0 functional failure mode, the HP81810 and SEM tool of Schlumberger's IDS 5000 electron beam prober revealed that the output holding latch located in the AD4 port cell was not holding the data line (D4) at the proper pre-charge voltage. The output stage of the latch circuit that was found defective is shown shaded in the diagram.

Figure 2. Schematic diagram of the AD port cell of the 16K ROM. The defective output stage of the latch circuitry is shaded.

The shaded inverter of the latch circuit, as shown in the schematic diagram of Figure 2, contains the defective polysilicon interconnect associated with the gate of the *p*-channel transistor. The purpose of this latch is to hold the data line at a high logic state when the ALE line is enabled; at a low logic state when the ROM data is low. Elevated currents were measured on the failing IC during a read operation when the ROM bit information was a low logic state. The voltage of the section of gate labeled as probe_7 in Figure 6 (node 5 of Figure 13) is such that it is 180° out of phase with probe_1 (node 4). Under normal conditions, MP2 would be off while MN2 was biased on. Because the gate voltage for MP2 is inverted, both MN2 and MP2 are biased on when node 4 potential goes high. This causes high current in the inverter circuitry of the output stage since both the *n*- and *p*-channel transistors are biased into conduction long after the application of the address latch/read vector. Thus, the polysilicon interconnect defect at MP2 causes the component to fail the I_{DDQ} tests when the ALE and RD pins are enabled.

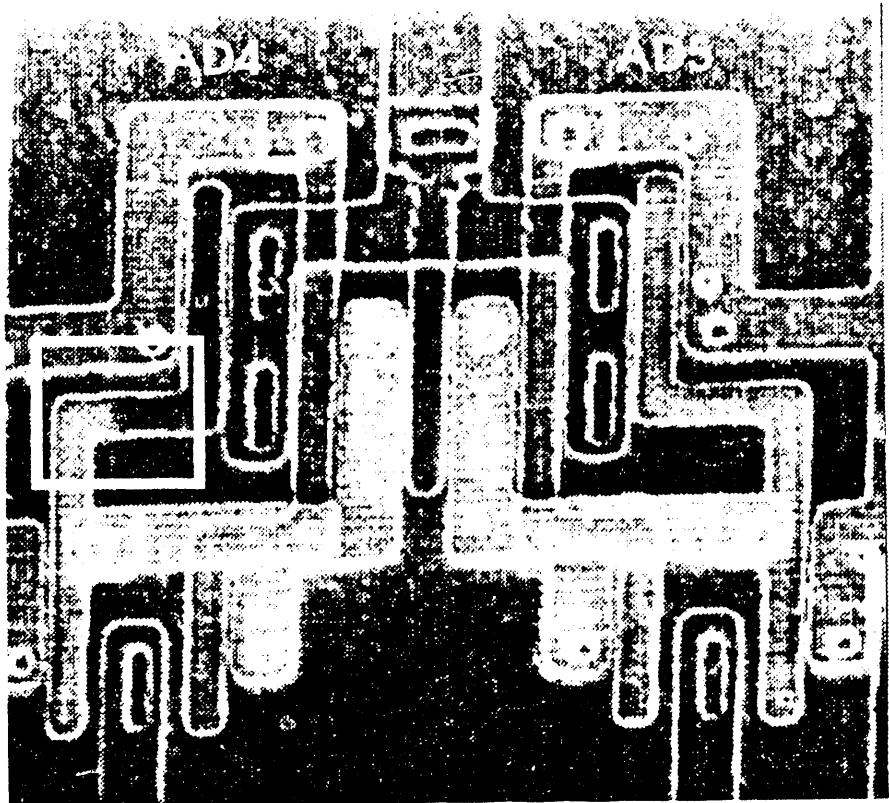
A dynamic voltage contrast image of the AD4/AD5 output holding latches during the functional failure mode is shown in Figure 3. Voltage discontinuity is shown as an abrupt image contrast change on the *p*-channel transistor's polysilicon interconnect/gate of the AD4 latch output stage. The discontinuity is located in the center of the box in the left half of the image. The anomalous contrast of this interconnect can be compared with the uniform interconnect potential of the AD5 *p*-channel transistor's gate which is shown in the right half of Figure 3. (The AD5 latch layout is a mirror image of the AD4 latch layout.)

Figure 3. Voltage contrast image of the AD4 and AD5 port cell latches. The highlighted region in the left center of the image denotes the location of electrical discontinuity in the AD4 latch.

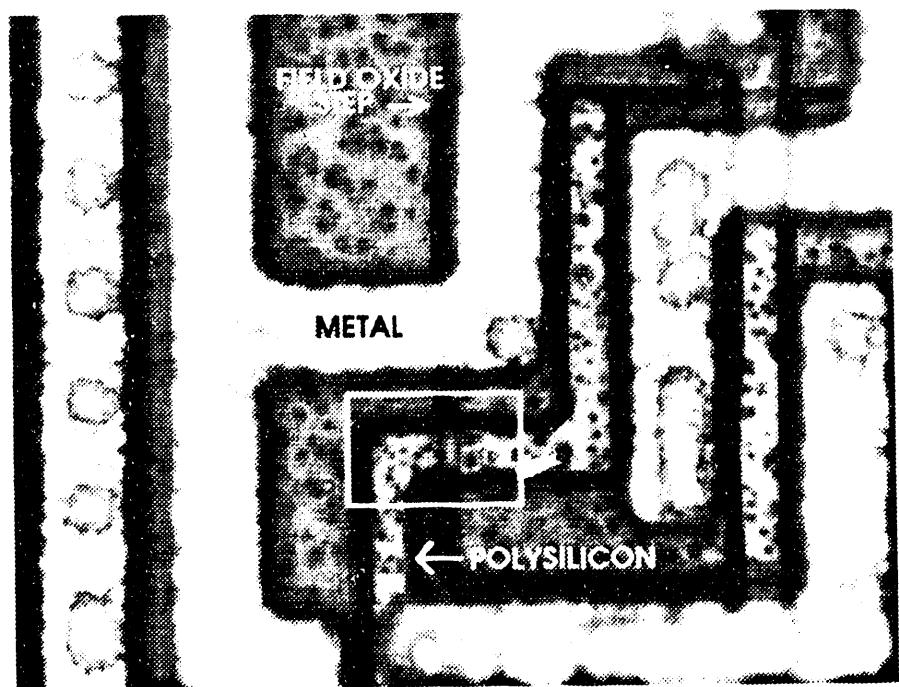
Figure 4 is an optical photomicrograph of the AD4 latch. The portion of the polysilicon interconnect where electrical discontinuity was observed is located inside the box. The field oxide step at which the potential change of Figure 3 occurs is indicated by the field oxide step arrow. The various metal (aluminum) and polysilicon interconnect layers are labeled in this figure. The nominal width of the polysilicon interconnect is 3 μ m.

Figure 4. Higher magnification optical photomicrograph of the AD4 *p*-channel polysilicon interconnect. Nominal width of the polysilicon is 3 μ m.

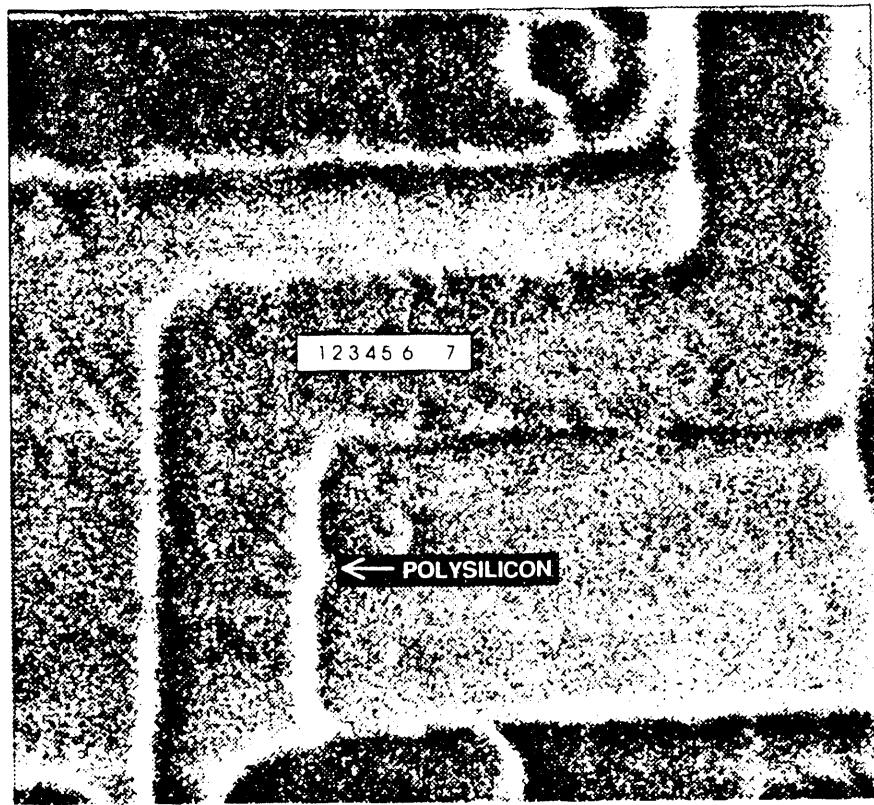
Electron beam probing of the gate area associated with the oxide step using the waveform tool of the IDS 5000 showed a marked change in the acquired waveforms of the polysilicon interconnect/gate. As we will discuss below, the voltage changed abruptly in magnitude and phase as a function of position along the length of the polysilicon interconnect. Figure 5 shows the section of the polysilicon that was probed. The numbers labeled on the image correspond to IDS 5000 acquired waveforms of Figure 6. In Figure 6, probe_1 through probe_3 correspond to the expected electrical potential of the polysilicon interconnect. (The full voltage swing of 10 V is not observed since attenuation of the signal(s) is due to the interlevel dielectric and passivation layers.) Wave_4 through wave_6 represent the region of transition. Wave_7 corresponds to the *p*-channel transistor's actual gate potential. It is clear that between wave_3 and wave_7 there is a dramatic change in the electrical waveforms, indicating a loss of electrical continuity. The gate signal becomes noisier and eventually becomes inverted. (Note that wave_6 shows the complete degradation of the *p*-channel transistor's gate voltage.) For a normal interconnect/gate, all waveforms would appear nearly identical to wave_1 regardless of the probe location.

Figure 5. SEM image of the probed section of the defective polysilicon interconnect. The numbers denote the probing positions during IDS 5000 waveform acquisition.

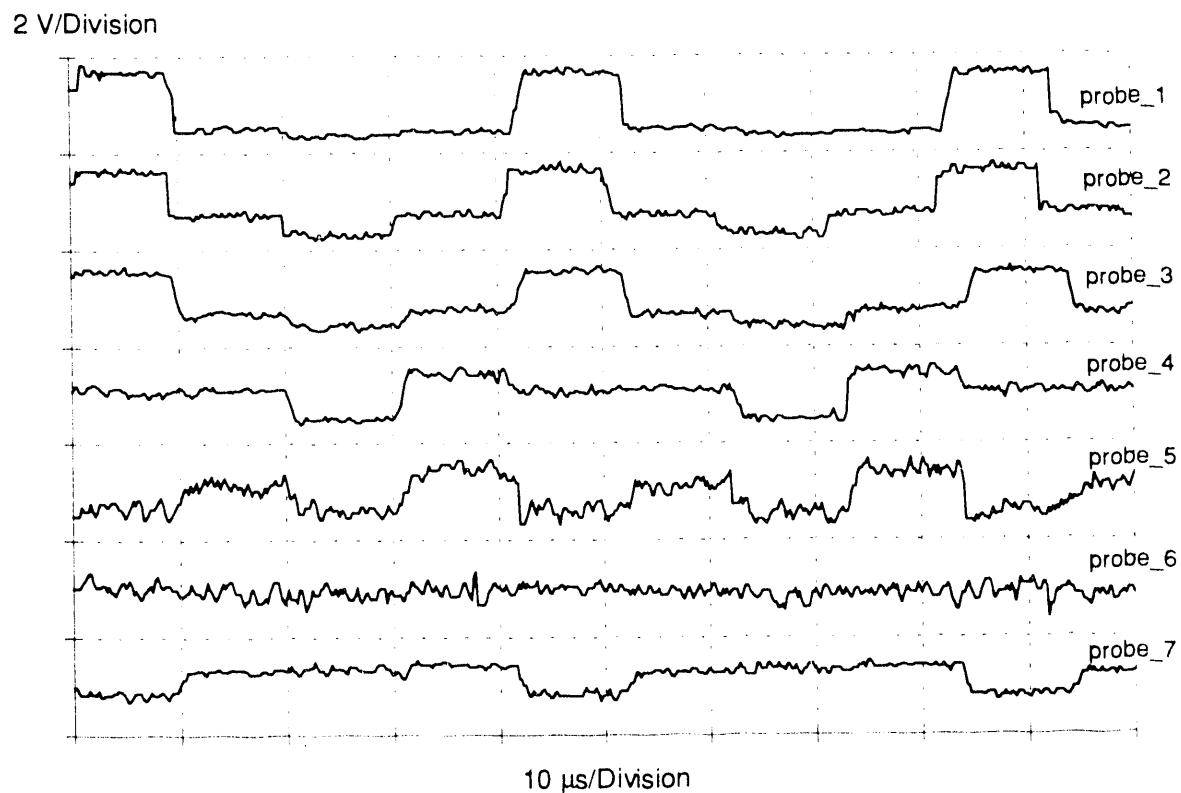
Figure 6. IDS 5000 waveforms obtained with reference to position on polysilicon gate (see Fig. 5).

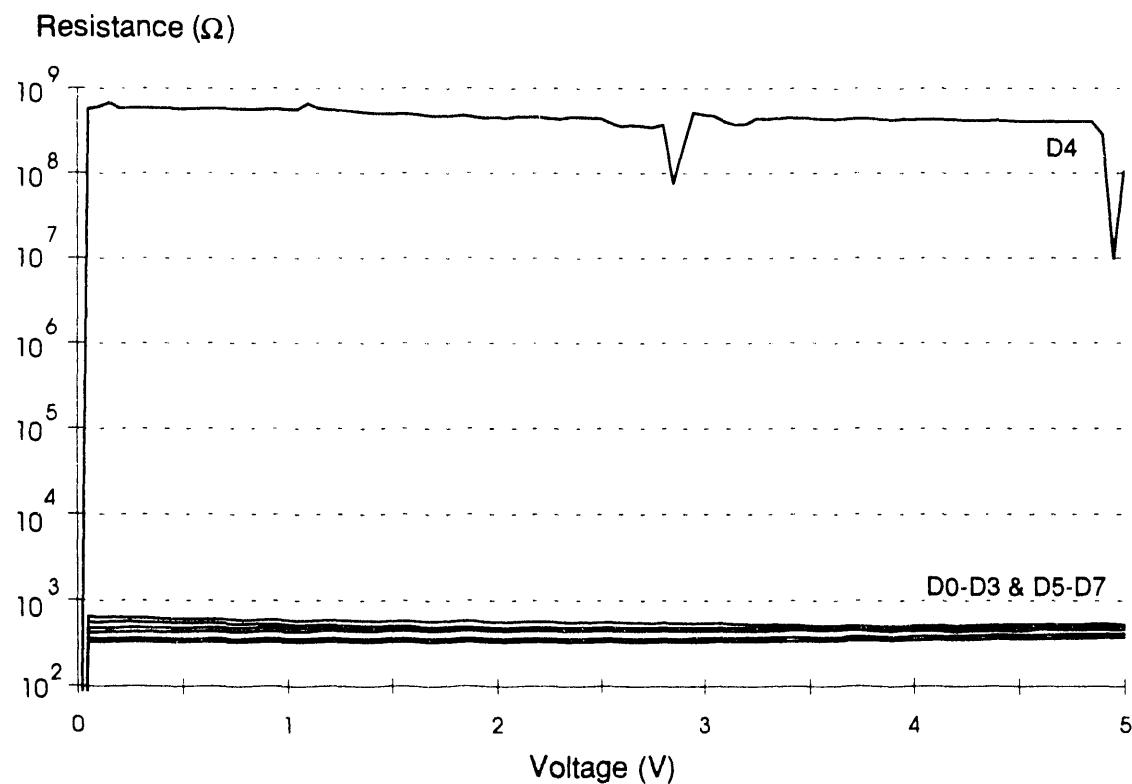
After the polysilicon gate was exposed, DC current measurements were performed to assess the current-voltage characteristics of all the *p*-channel transistor gates that are associated in the output stage of the latches. An HP4145 parameter analyzer, a Keithley 616 electrometer, and a Micromanipulator mechanical probe station were used to acquire the electrical data. Current measurements on the *p*-channel transistor gates were obtained by placing mechanical probes on the polysilicon interconnect and applying the electrical stimulus. The current measurement for AD4 was extremely low when compared to the other seven. These data are shown as resistance measurements in Figure 7 for the eight AD ports. Note the high resistance value ($3-5 \times 10^8 \Omega$) of the *p*-channel transistor gate of AD4.

Figure 7. Resistance measurements of the eight AD port *p*-channel transistor interconnects.

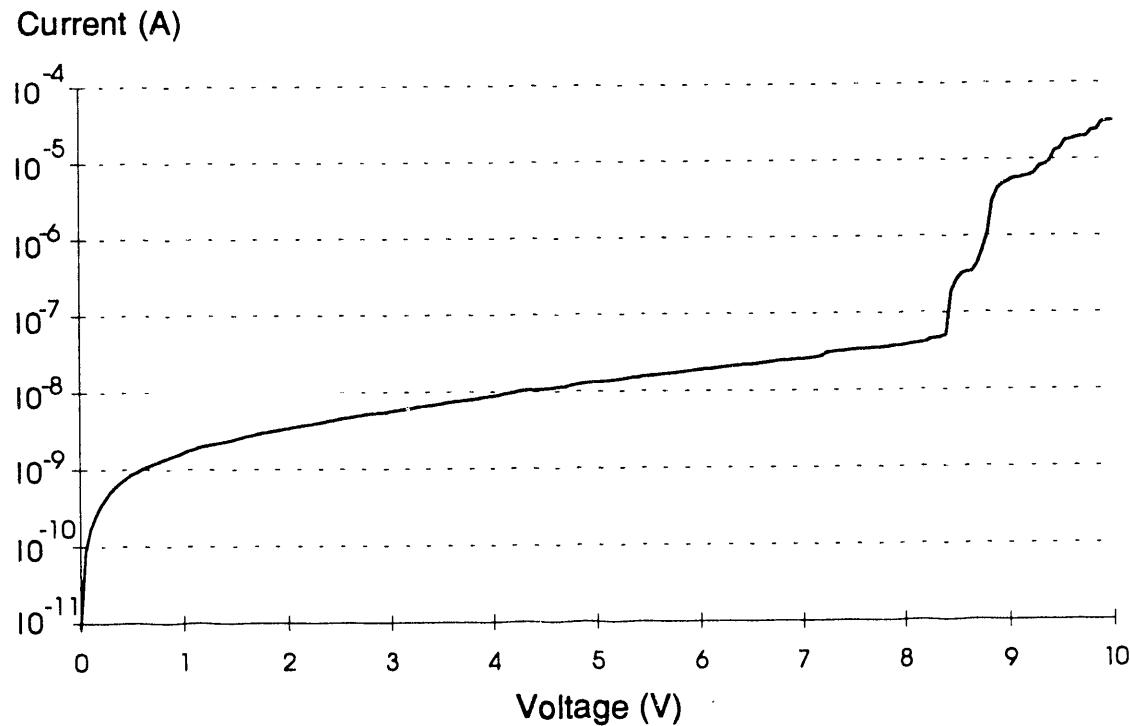
Further probing was performed on the defective interconnect/gate of AD4. Figure 8 shows the results of using a maximum applied voltage of 10 volts. These data show clearly that there is an abrupt increase in interconnect current when 8.5 volts and greater is applied. This abrupt increase in current may account for why functional failures occurred at 5 V but not at 10 V. The grain boundaries in the polysilicon interconnect are assumed to behave as an intrinsic wide-band-gap semiconductor forming a heterojunction with the grains. The carrier transport mechanism in polycrystalline silicon has been proposed as quantum mechanical charge tunneling through the grain boundaries [2]. The abrupt current increase shown in Figure 7 is most likely due to an increase level of charge tunneling that occurs in the polysilicon interconnect at the higher voltages.

Figure 8. Current measurements (DC) on the defective interconnect of AD4 port. The magnitude of current for the other interconnects was approximately 1×10^{-2} A.

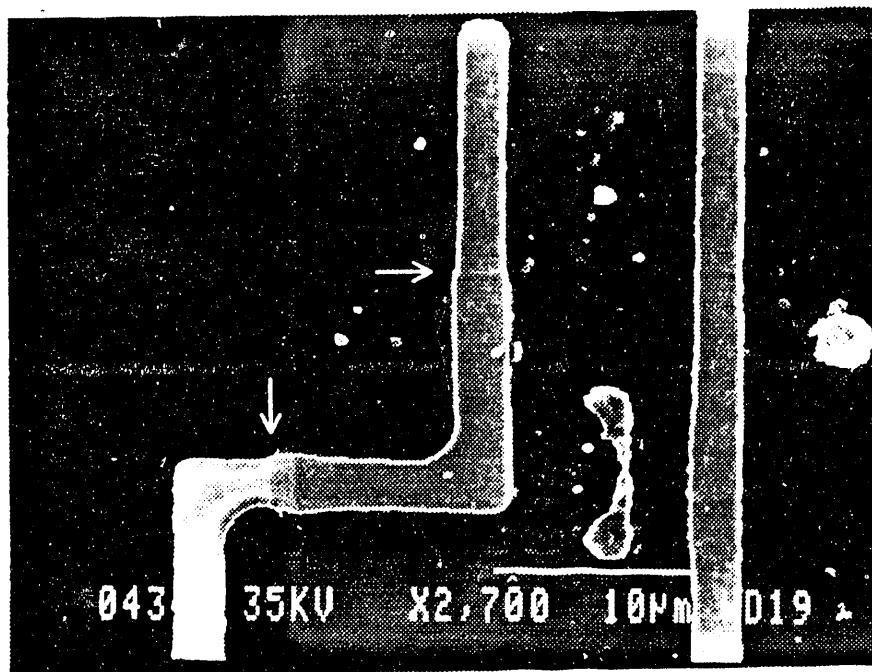
Figure 9 shows the polysilicon interconnect of AD4 (0° tilt). Note the changing width of the interconnect at locations denoted by the arrows. The portion of the interconnect between the arrows appears less etched and is wider. Figure 10 is a higher magnification image of the AD4 interconnect region at the edge of the oxide step. The sides of the polysilicon appear to be vertical and well defined over the field oxide but less vertical and poorly defined over the gate oxide region.

Figure 9. SEM image of the AD4 polysilicon interconnect after chemical deprocessing (0° tilt).

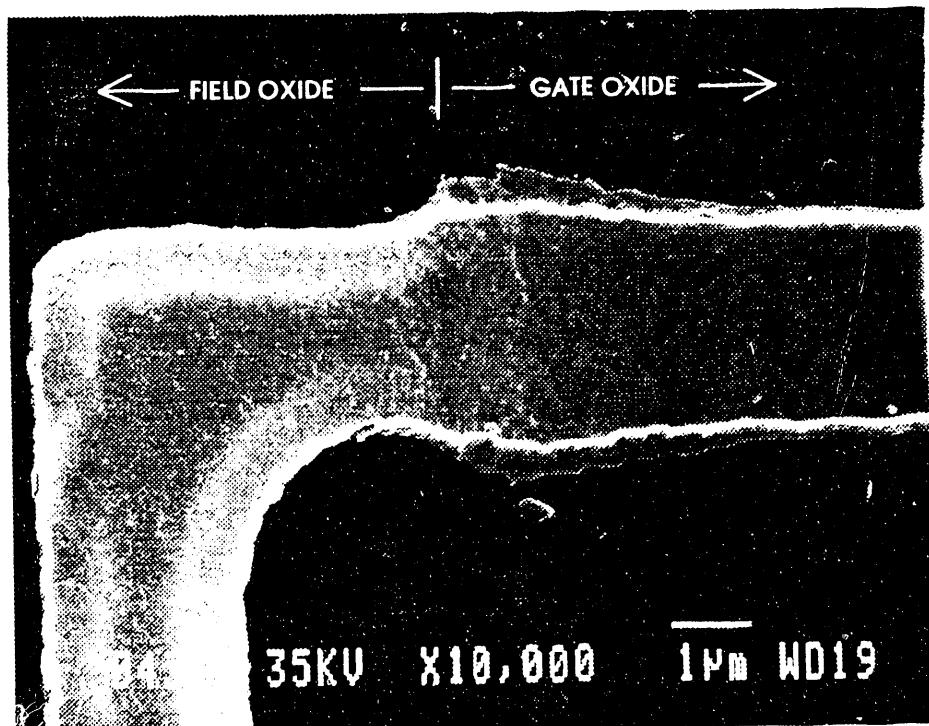
Figure 10. A higher magnification SEM image of the defective interconnect. Note the varying width and anomalous sidewall slope of the interconnect beginning at the oxide step.

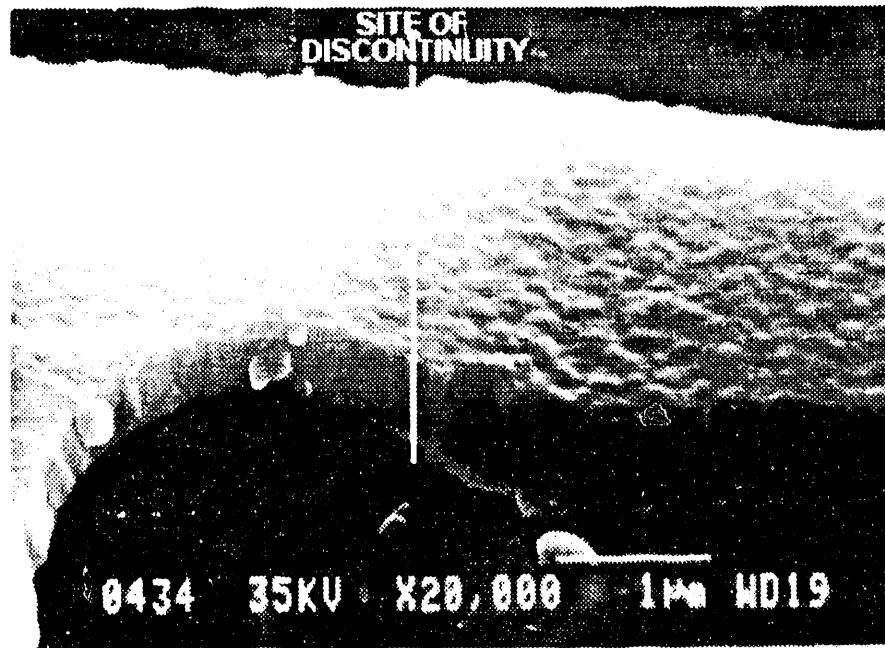
Figure 11 shows a marked change in the polysilicon microstructure as the AD4 gate steps over the field oxide onto the gate oxide. The appearance of the polysilicon on the left hand side of the figure is typical. The polysilicon over field oxide located to the left of the oxide step has well delineated grain boundaries. By contrast, the polysilicon to the right of the oxide step appears less etched. It is wider and the grain boundaries are not well delineated. The location of morphological discontinuity corresponds to that of electrical discontinuity which was observed in Figure 3. Figure 12 is the AD5 neighboring interconnect for comparison.

Figure 11. SEM image of AD4 polysilicon interconnect at field oxide step (45° tilt).

Based on the etch rate of polysilicon which increases with increasing dopant (phosphorus) concentration, the region of the AD4 polysilicon to the right of the discontinuity apparently had an anomalously low phosphorus doping level [3]. The cause of the locally low dopant concentration is not known but could result from particulate masking during the phosphorus ion implantation of the polysilicon. The global or blanket ion implantation process step immediately precedes the lithographic patterning to define the polysilicon interconnects.

The voltage discontinuity and polysilicon gate morphology can be hypothetically explained by incorrect doping concentration of the *p*-channel transistor polysilicon interconnect/gate. The lack of grain boundary definition and non-vertical sidewalls of the anomalous polysilicon region can be attributed to less rapid etching of a lightly n-doped region, whereas the well defined grain boundaries and vertical sidewalls are more representative of the typical highly n-doped regions. It is well known that a highly n-doped region etches faster [3] and as the concentration of dopant atoms increases, grain growth is encouraged [6]. Therefore, it is likely that the lightly doped polysilicon grains are smaller. (Since the surface didn't etch well it's not possible to ascertain the exact grain size from the photomicrograph.) The varying widths of the defective interconnect are the patterning result of the two differently doped regions abutting each other.

To possibly screen components from this type of failure mode, this device should be tested at a lower operating voltage. The normal operating power supply potential is 10 volts, but when the power supply was reduced to 5 volts, the device failed functional and I_{DDQ} tests. Since electrical conduction in polysilicon thin films occurs by tunneling of charge carriers across grain boundaries, a lower operating voltage reduces the probability of carrier emission and provides a more sensitive screen for defects of the type found on this IC. There was no indication from the Sentry timing tests that a change occurred at the interim monitoring points of the life test. A test using a reduced power supply potential may detect such changes.

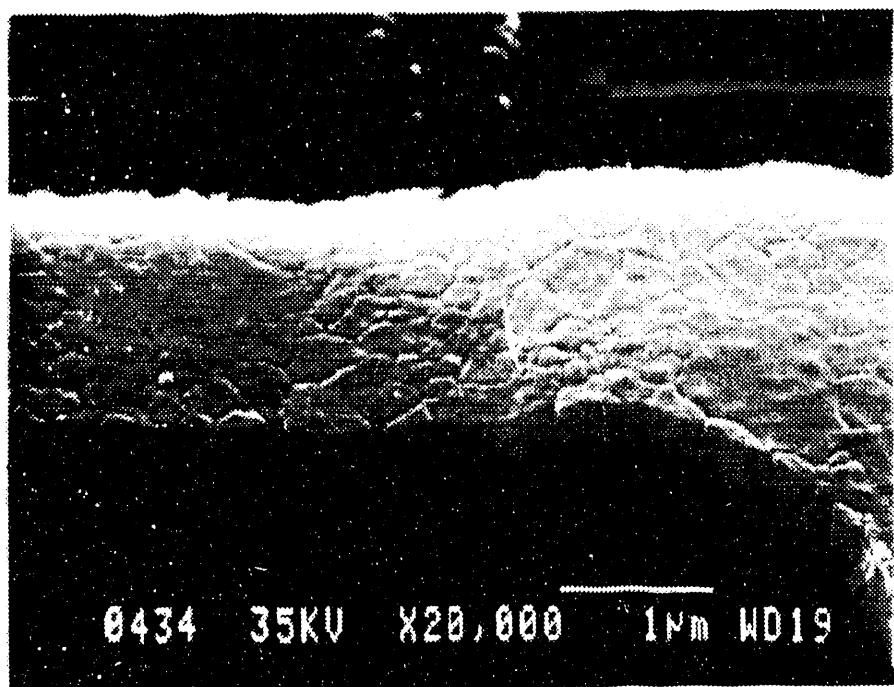
Figure 12. SEM image of AD5 polysilicon interconnect. Compare this image to the AD4 interconnect (Fig. 11).

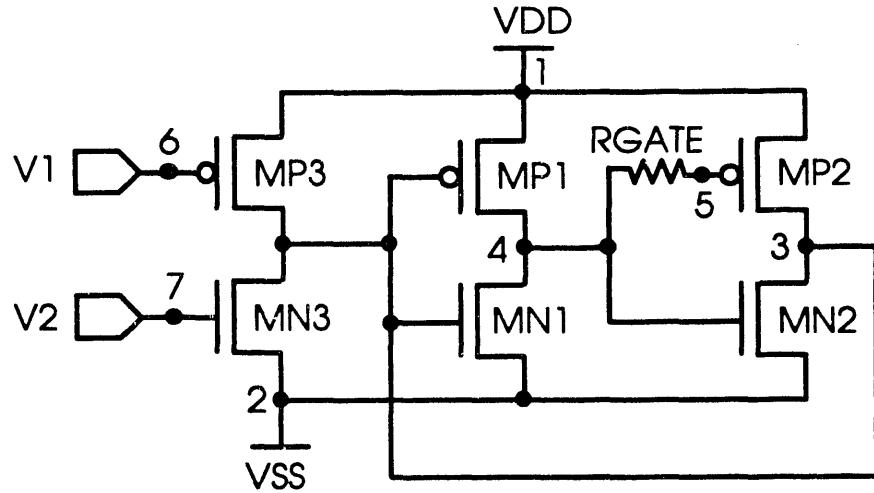
PSpice simulations were performed on the output holding latch circuitry to investigate the effects of the gate defect [4,5]. The gate defect was represented by a series resistor in the interconnect path between the *n*- and *p*-channel transistors of the output stage of the holding latch. Figure 13 shows the electrical schematic of the holding latch simulation circuit with the series gate resistance and node numbers. The simulations were performed with $V_{DD} = 10$ V and $V_{SS} = 0$ V at a temperature of 27 °C. All *n*-channel transistors had a threshold voltage, V_{tn} , equal to 1.0 V. All *p*-channel transistors had a threshold voltage, V_{tp} , equal to -1.4 V. The model index for all transistors was three (LEVEL = 3). All SPICE parameters used in the simulations were obtained from wafer lot characterizations. Gate oxide thickness for this technology is nominally 45 nm. Since statistics of the gate oxide thickness were not available, variances of $\pm 10\%$ on the oxide thickness were simulated to account for process variations and the corresponding effect on gate capacitances.

By increasing the series gate resistance, RGATE, the simulations showed that when RGATE exceeded $1 \times 10^9 \Omega$, the potentials at nodes 4 and 5 became 180° out of phase. Recall that DC current measurements showed the resistance of the polysilicon gate was approximately $3 - 5 \times 10^8 \Omega$ (see Fig. 7). The value of RGATE required for inversion of node 5 voltage is well within an order of magnitude of the measured interconnect resistance. (By varying the gate oxide thickness by $\pm 10\%$, small differences were noted but the effects were not significant.)

Figure 13. Electrical schematic diagram of PSPICE simulation circuit of holding latch circuitry.

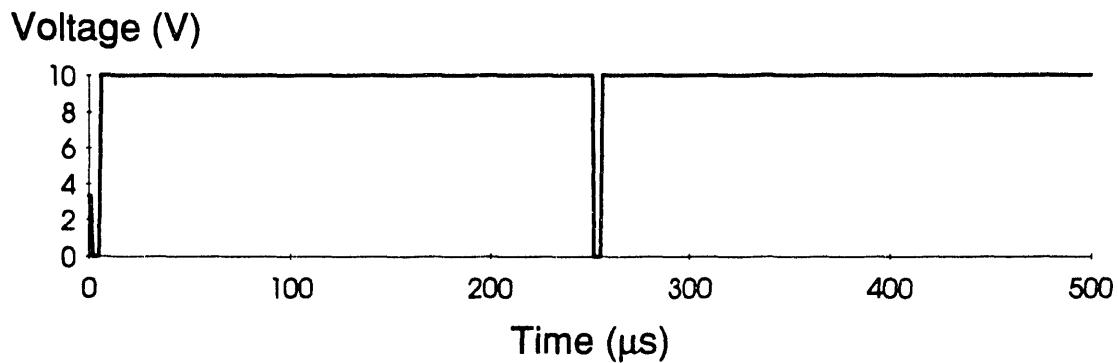
Figure 14 shows the voltage waveform for node 4, the input node to the output stage of the holding latch. This waveform appears normal with a voltage swing of 0 to 10 V ($V_{DD} = 10$ V). This waveform corresponds to the "probe_1" waveform obtained during the electron beam probing (see Fig. 6) and represents the gate signal to transistor MN2 which is routed through a normal polysilicon interconnect. Figure 15 shows the potential waveform of node 5 which is the gate potential of the *p*-channel transistor, MP2. This waveform would correspond to the "probe_7" waveform obtained during the electron beam probing studies. Figure 16 shows the simulated power supply current response of the latch circuitry. By comparing Figures 14 and 15, high current exists when a high voltage is input to the output stage of the latch. Under these conditions, the waveforms indicate that both transistors, MP2 and MN2, of the output stage of the latch would be active during this stimulus. In addition, the magnitude of simulated current during this logic state exceeds the Sentry electrical test (I_{DDQ}) failure criteria of 200 μ A.

Figure 14. Simulation results of holding latch, node 4. This is the input node to the output stage.

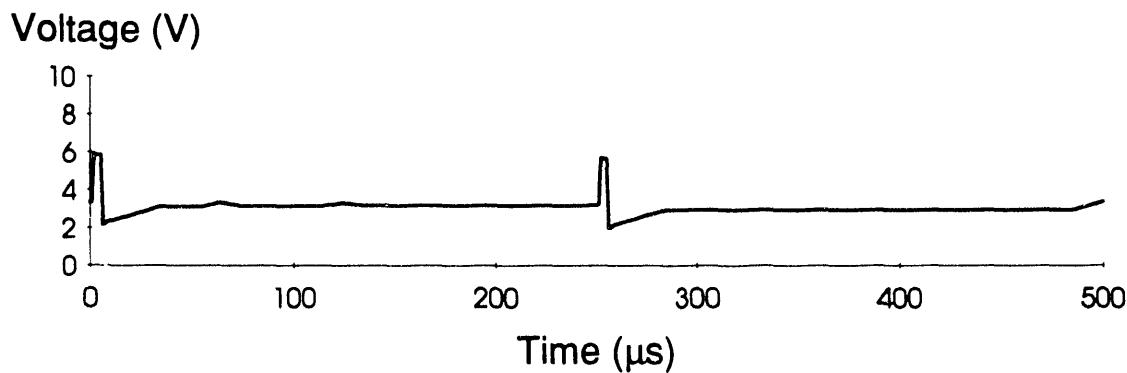
Figure 15. Simulation results of holding latch, node 5. This is the input node to the *p*-channel transistor of the output stage.

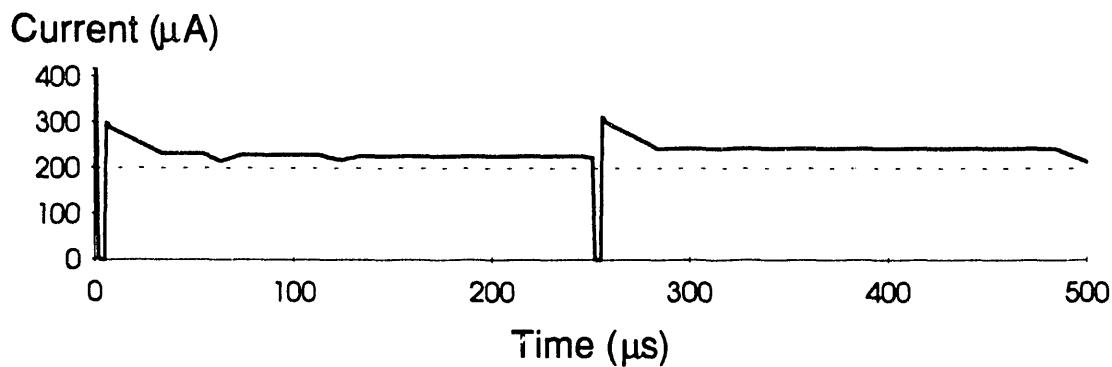
Figure 16. Simulated power supply current response of the latch circuitry. High current exists when both MP2 and MN2 are active.
