**Cover Sheet for a Hanford
Historical Document
Released for Public Availability**

PILE ENGINEERING - GROUP IDETAILS - W. K. Alexander

HW-10160
HW-10160

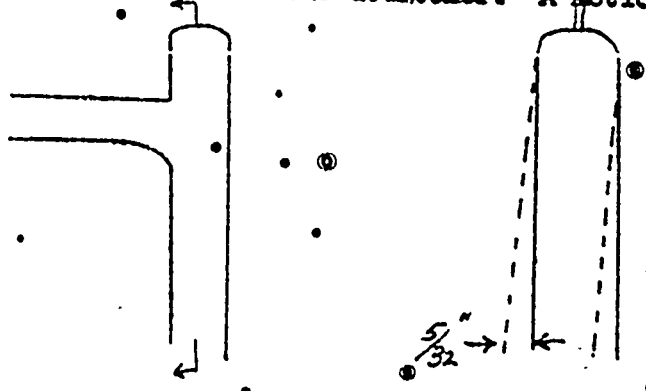
Measurements were made of the motion of the B downcomer at 350 lb. header pressure. A measuring gauge which would measure only the maximum movement of the downcomer was placed at the base of the downcomer. A motion of 5/32 of an inch was measured.

At 200 lb. header pressure this motion was 3/32 of an inch. At 100 lb. header pressure this motion was less than 1/32 of an inch.
 The downcomer support brackets are loose and in need of repair.

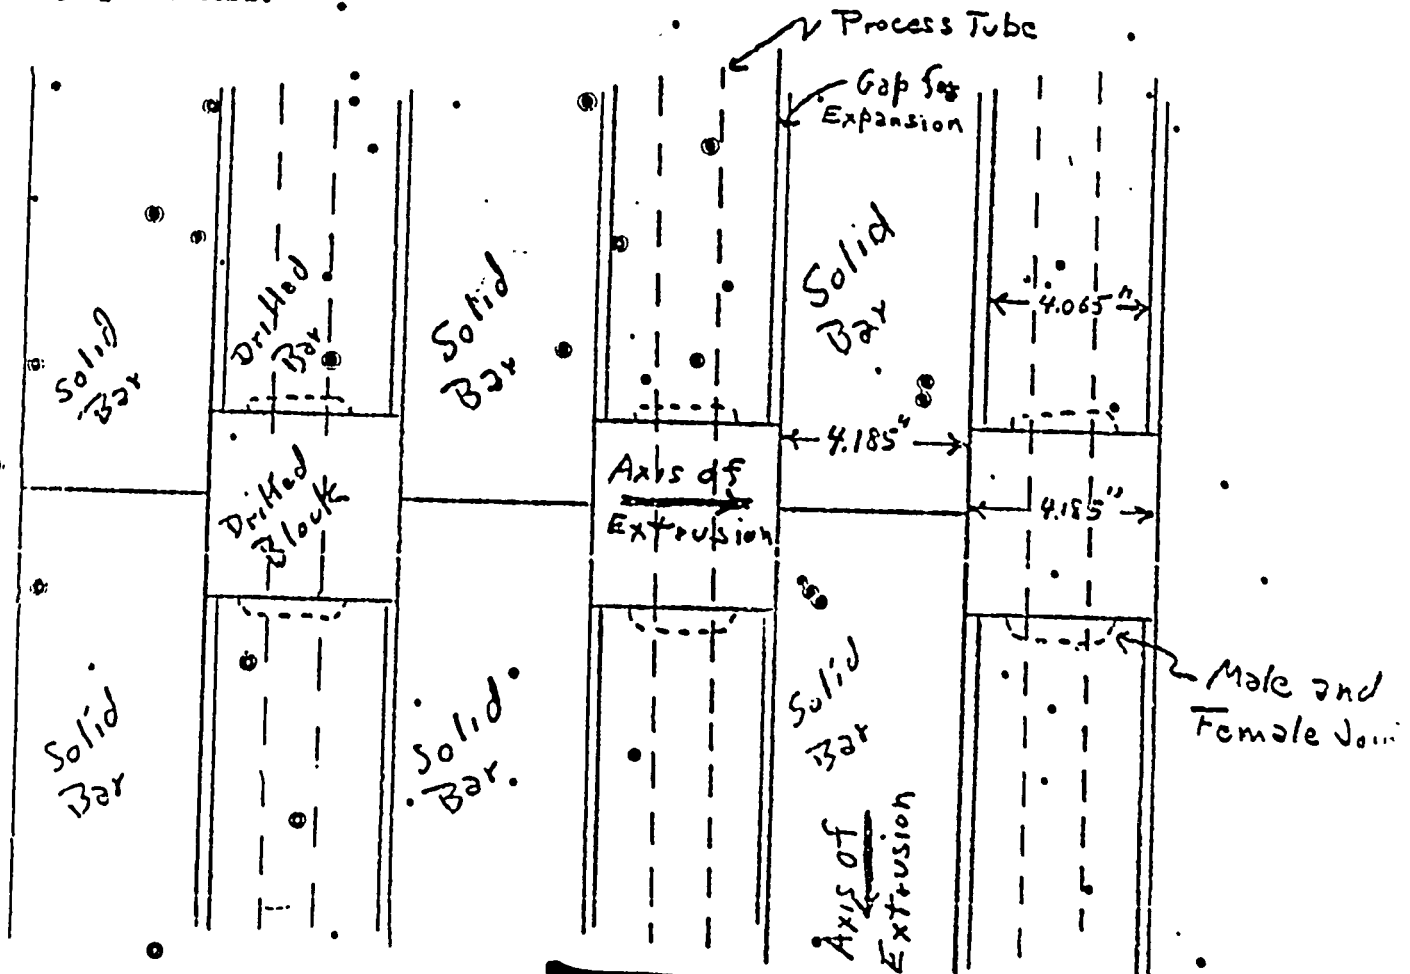
The use of undersized process tube blocks for H Pile has been recommended by the Technical Division to minimize adverse effects of graphite expansion. This has met with opposition from the Construction Department because of the time involved in spacing the tube blocks laterally during assembly. An alternative was worked out whereby the tube blocks in the pile would be alternately 4 1/4" and 4" long. The 4" blocks are to be cut so that the axes of extrusion are horizontal and perpendicular to the process tubes. Since the graphite does not expand in the direction of extrusion, these small blocks will be 4.185" in the dimension perpendicular to the process tubes and a laterally rigid structure will result. The following sketch illustrates this. Arrows show direction of extrusion of the raw graphite bars.
