DOCUMENT NO.
HW-28207

DATE
June 1, 1953
 COPY NO. AND SERIES
15

TITLE
FLOW LABORATORY INVESTIGATION OF "F-TYPE"
PITTING OF SLUGS AND TUBES

AUTHOR
C. D. Wilson

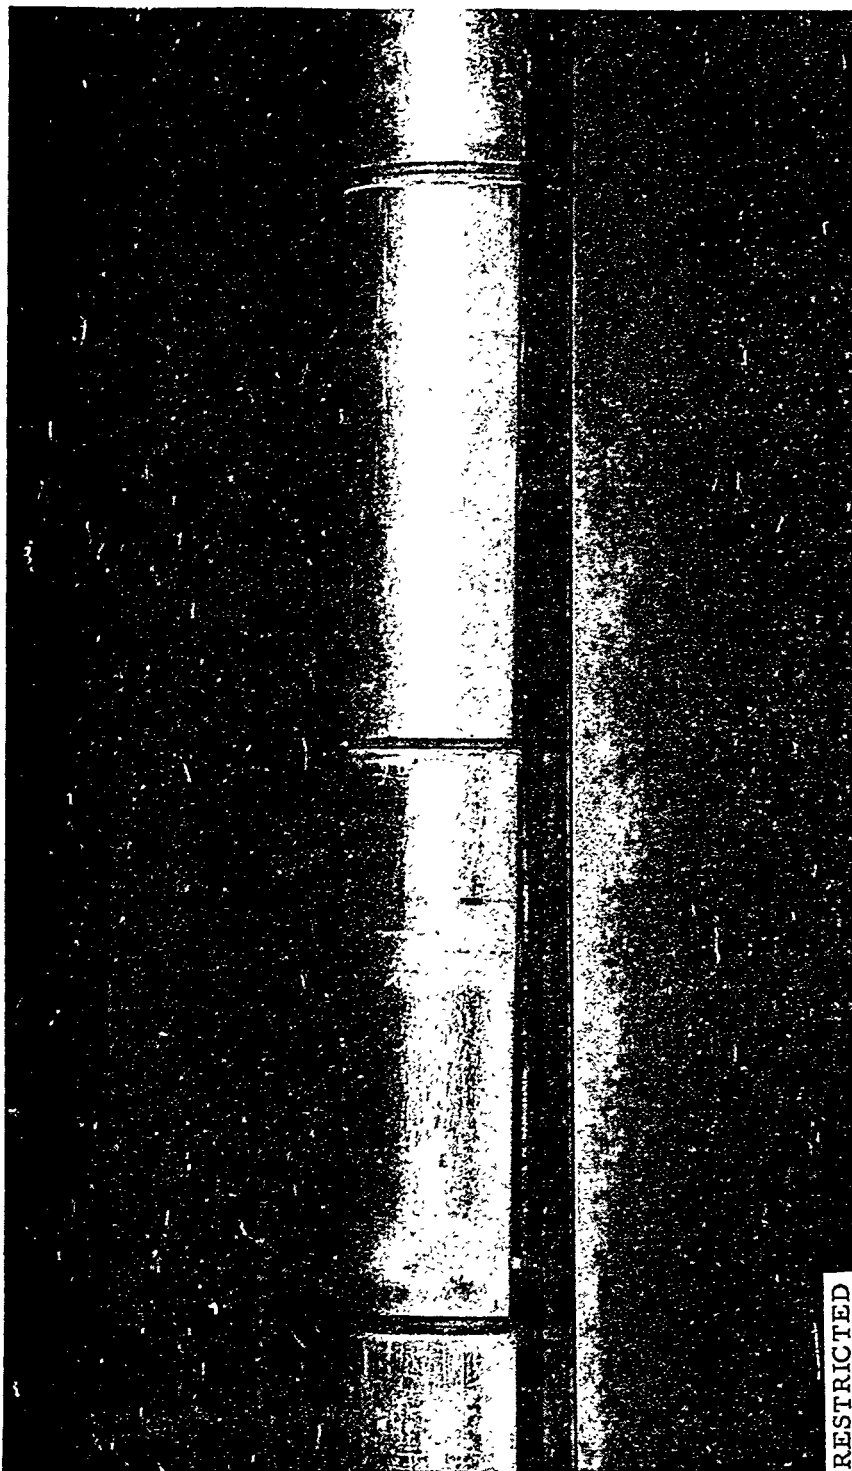
FIGURE 1
GLASS TUBE INSTALLED IN HIGH TEMPERATURE MOCK-UP
Note: slug at left center is cocked from near rib.

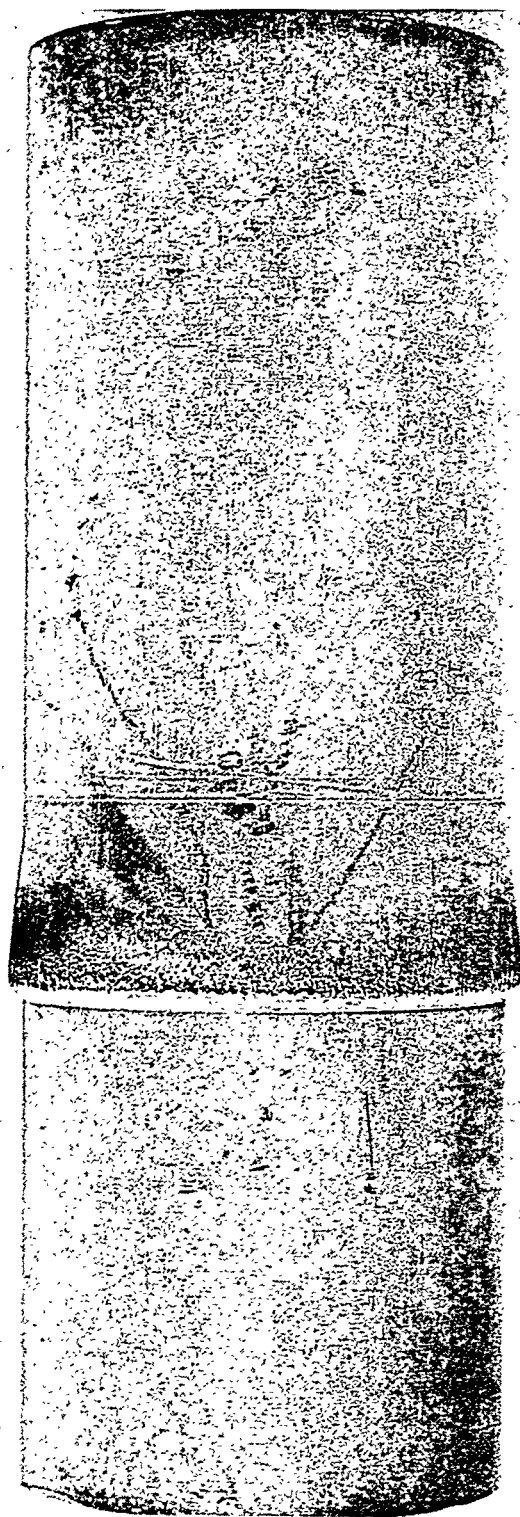
FIGURE 3
 "VENTURI" SLUG AFTER EXPOSURE.
 Note pits just downstream of bevel.

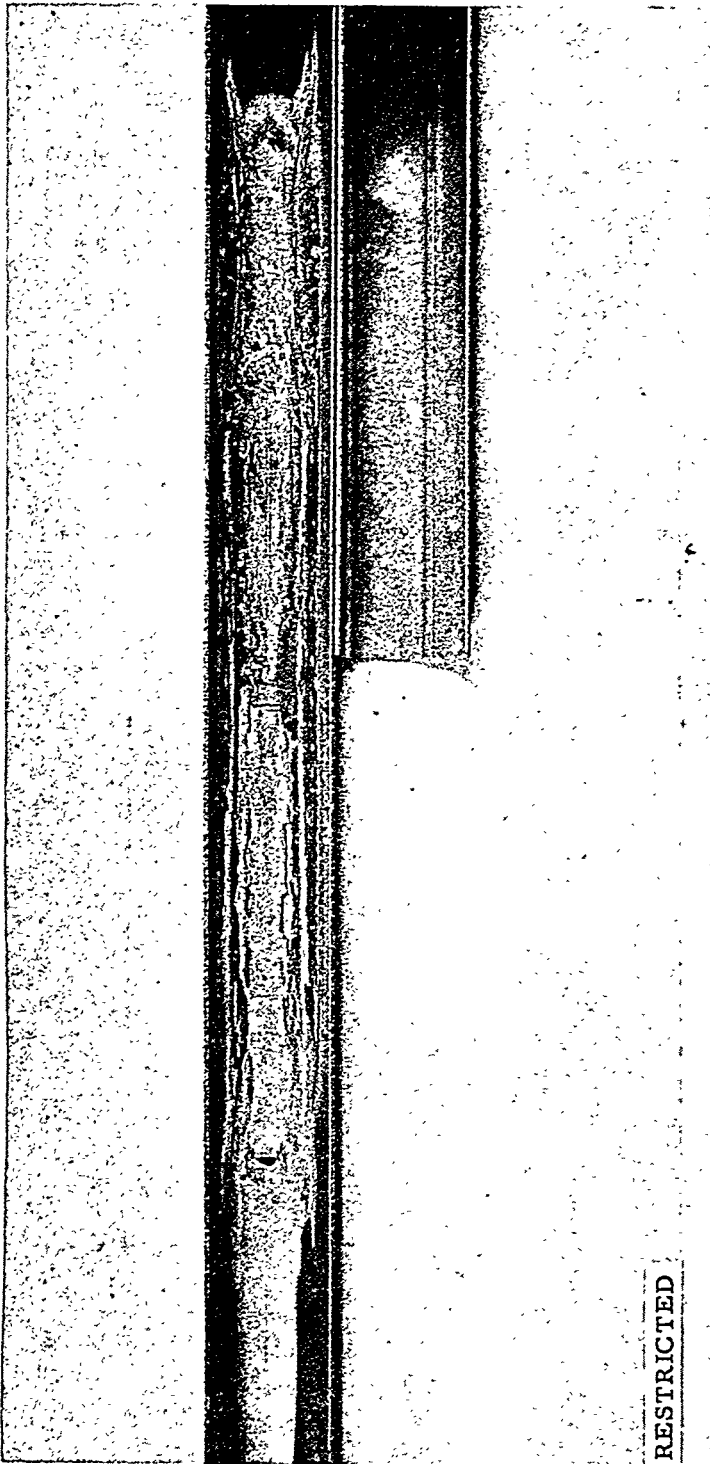
FIGURE 4
TUBE SECTION EXPOSED TO LOCALIZED BOILING
Note heavy scale and water vapor trail on upper half of tube.
Half of rib section removed for examination.

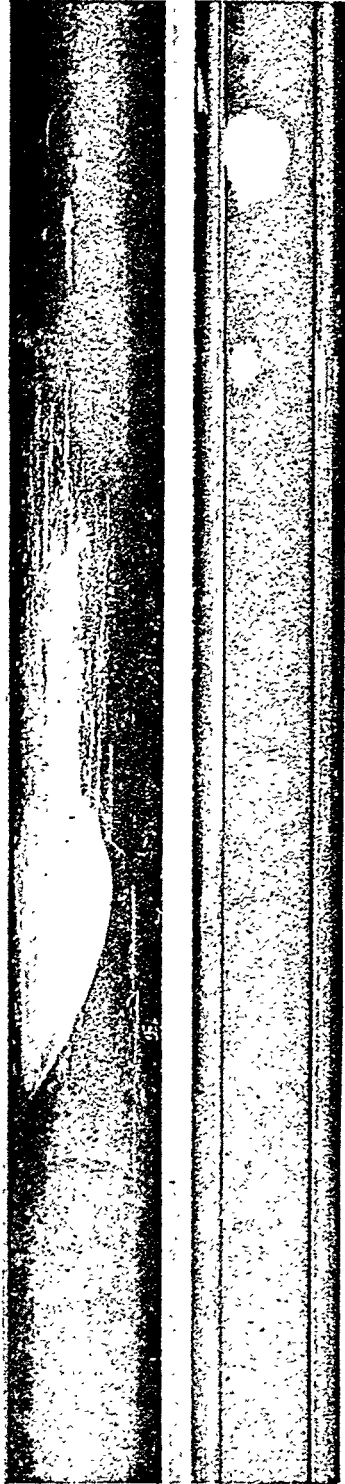
FIGURE 5
TUBE EXPOSED TO LOCAL BOILING AT A COCKED SLUG POSITION

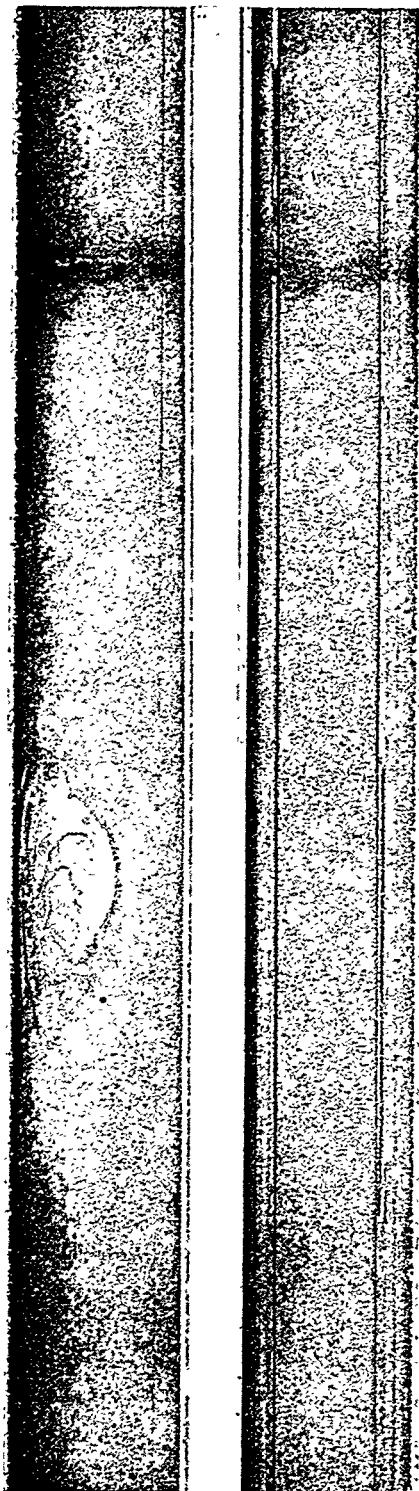
FIGURE 6
TUBE SECTION EXPOSED TO LOCAL BOILING
Note slug junction mark caused by "Finned" slug.

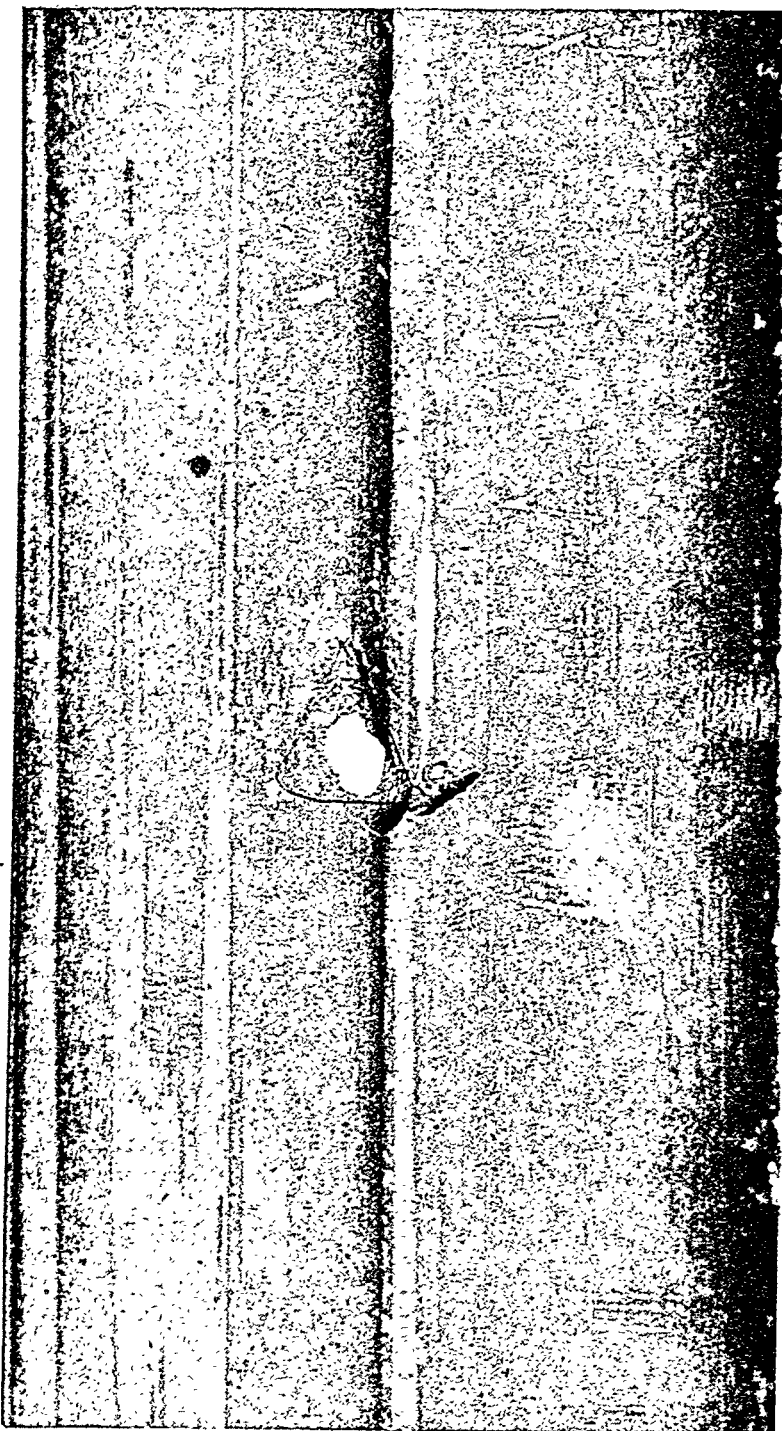
1. On June 18, 1952, a tube exposed in the 105-D Flow Laboratory to raw river water at 95 C and 20 gpm developed a leak after 12 days operation. An attempt was made to seal the leak with hose clamps and the tube was run for an additional four days. After 16 days exposure the tube was removed and slit open for examination. It was found that the leak had occurred adjacent to a rib and at a spot corresponding to a slug junction. The tube was also pitted on the opposite rib one slug length upstream of the tube perforation. Figures 8 and 9 are photographs of the tube rib section showing the hole and pitted rib. An indication of the flow pattern and slug positions can be obtained by an examination of the upper tube section shown in Figure 10. The light spot just downstream of the lead dummy position is where the first aluminum dummy slug touched the tube wall and the light spot at the next downstream slug junction is the point at which the next aluminum dummy touched the tube wall. If the slug orientation is visualized it will be noted that the first aluminum dummy was cocked from the left rib (looking downstream in the tube) at the front of the slug and the next downstream aluminum dummy was cocked from the right rib at the front of the slug. It can then be seen that the distance between the left rib and the first dummy slug was at a maximum at the front of the slug and decreased uniformly to the downstream end of the slug, where the slug touched the rib. The decreasing annulus between the slug and tube rib apparently forced the water flow outward against the tube and the outward direction and velocity reached a maximum at the point where the rib was pitted as shown in Figure 9. A similar reconstruction can be made for the next downstream slug, the right rib and the hole shown in Figure 8. It is difficult to conceive that the force exerted by the water alone impinging on the tube was great enough to produce the observed concentrated attack. However, the mechanism of erosion-corrosion seems plausible if the fact is considered that raw river water contained an average turbidity of 12 ppm over the exposure period.

FIGURE 8
TUBE SECTION SHOWING HOLE NEAR RIB
Note: The hole was probably increased in size due to the efforts to seal the leak.

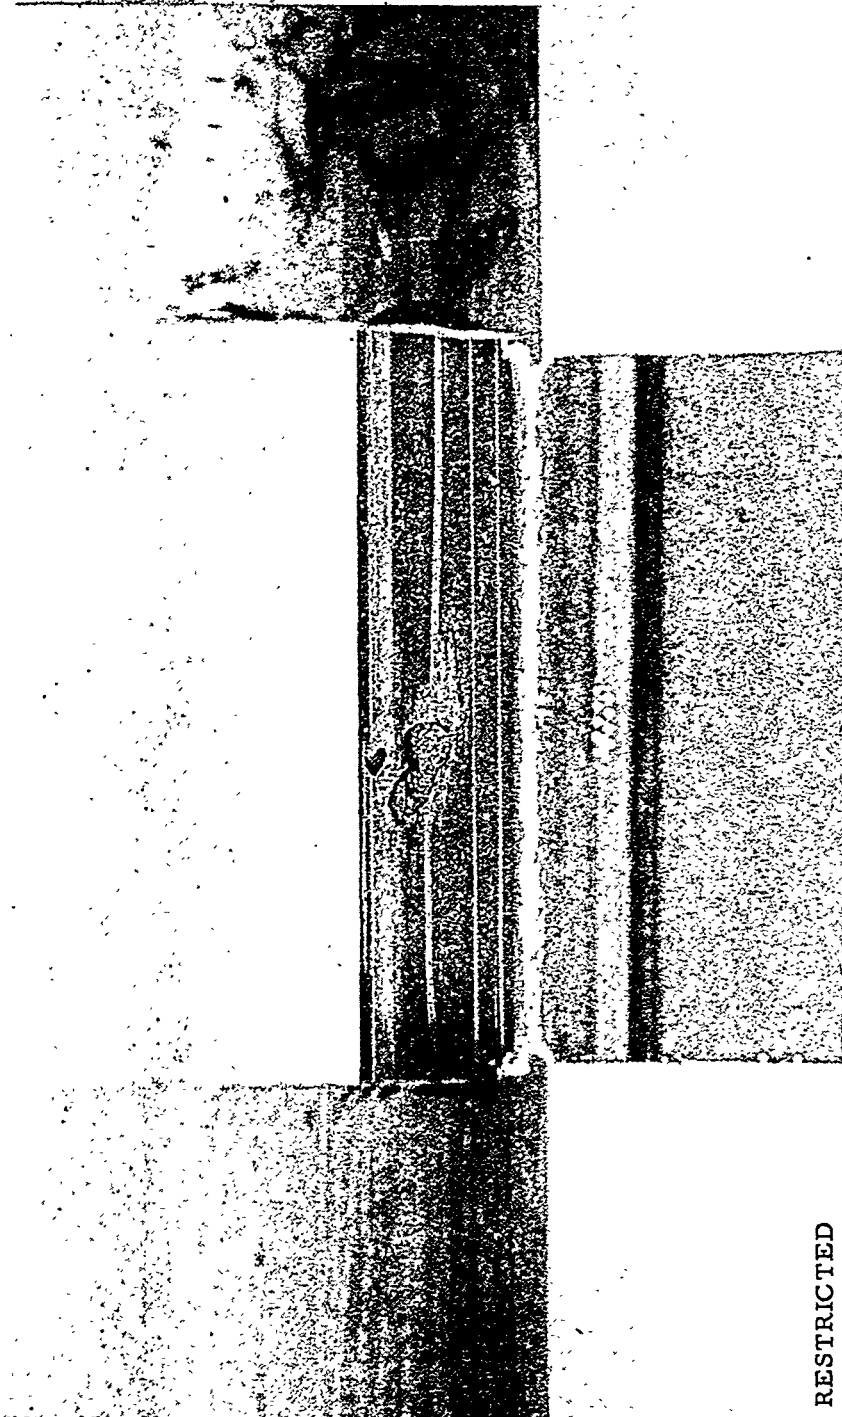
**FIGURE 9
PITTED RIB SECTION LOCATED ONE SLUG LENGTH
UPSTREAM OF SECTION SHOWN IN FIGURE 8**

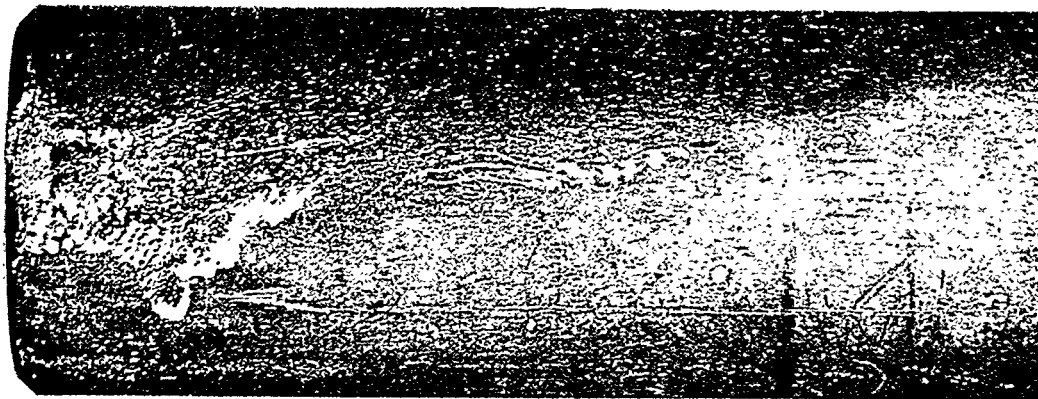
2. On July 14, 1952, a slug discharged from the test to determine the effect of velocity on 2-S slug jacket corrosion showed an extremely heavy pitting attack on the upstream end of the slug. This slug was the first upstream slug in a tube through which ferric sulfate treated, dichromate-free water flowed at 20 gpm and 95 C for 12 days. A photograph of the slug is presented in Figure 11. At the completion of the velocity test the tube was removed and examined. The tube was found to be pitted at the point corresponding to the position of the pitted area on the slug. Figure 12 is a photograph of the pitted section of the tube. During discharge of the slug and tube, pea-sized particles of calcium carbonate scale were found in the tube. Later, examination of the heat exchanger and connecting

FIGURE 11
SLUG FROM THE EFFECT OF VELOCITY TEST.
Note penetration to Al Si bond in badly corroded areas.

pipng revealed large deposits of scale in the process water system. The attack on the slug and tube was believed to be caused by the erosive action of scale in the water impinging on the slug and tube. The attack was probably localized by a high velocity segment in the annulus produced by an accumulation of scale around the front of the slug.

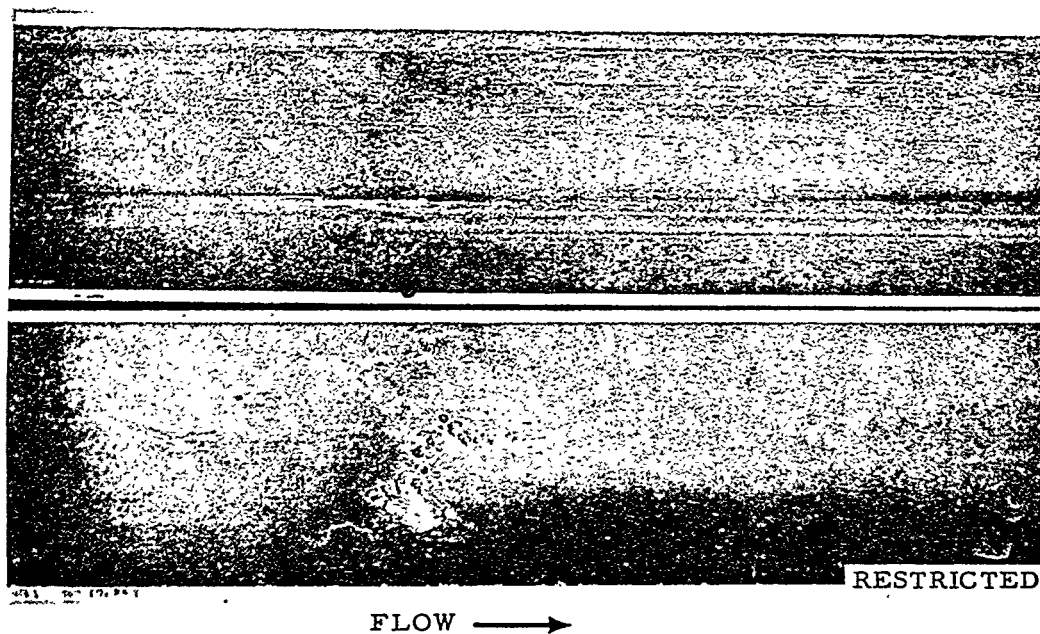
FIGURE 14
TUBE SECTION OPPOSITE LEAD DUMMY SHOWN IN FIGURE 13.

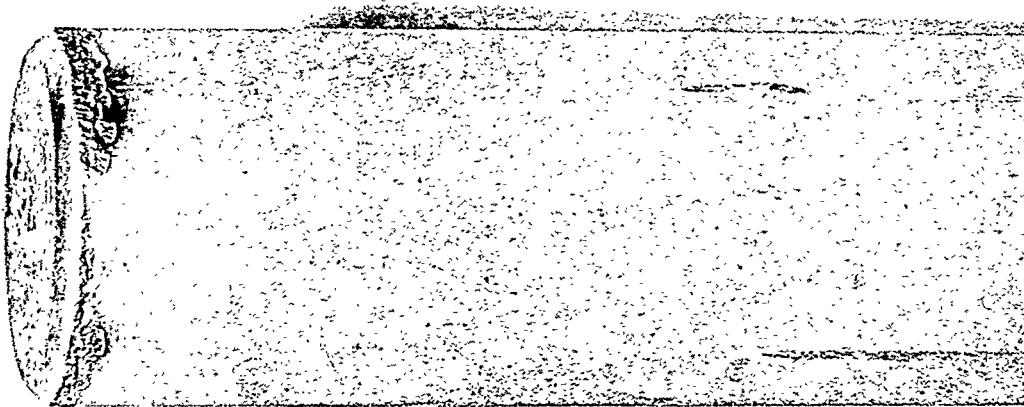
FIGURE 15
 ALUMINUM DUMMY SLUG EXPOSED IN SAME
 TUBE AS SLUG SHOWN IN FIGURE 13.

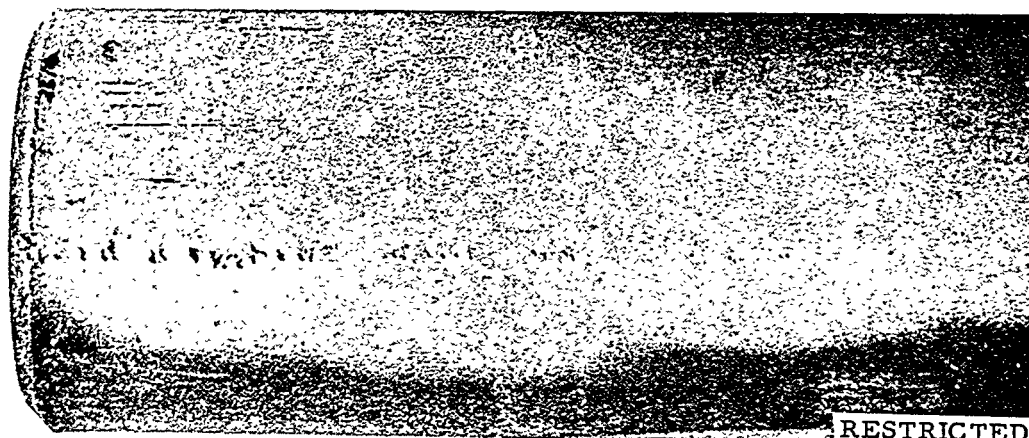
FIGURE 17
OPPOSITE SIDE OF SLUG SHOWN IN FIGURE 16.

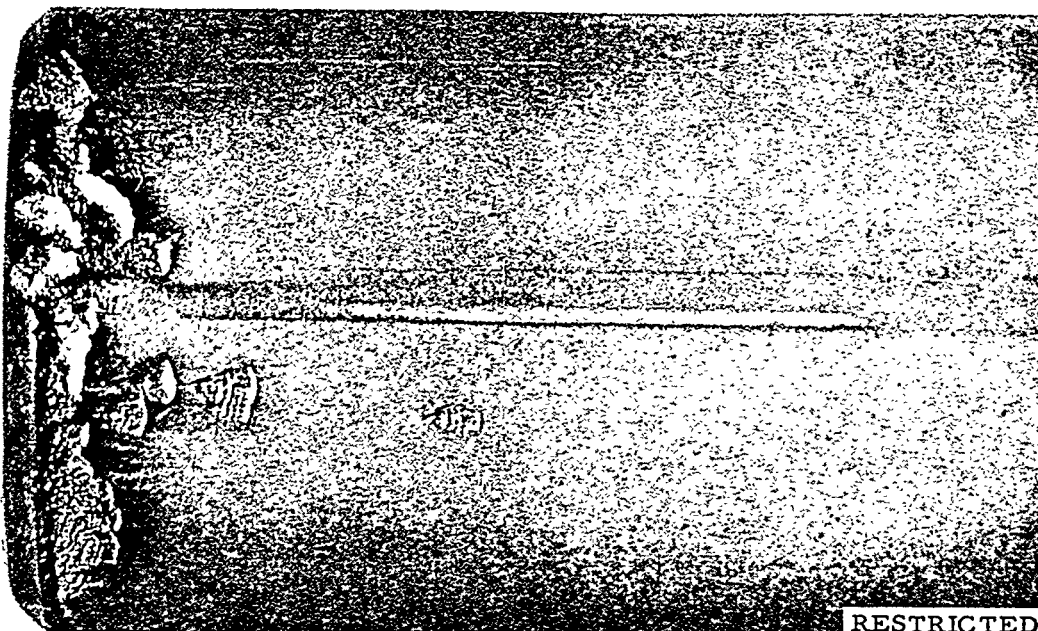
FIGURE 18
ALUMINUM DUMMY SLUG FROM SAME TUBE AS
SLUG SHOWN IN FIGURE 16.
Note triangular-shaped pits similar to "F-Type"
pits observed on in-pile exposed slugs.

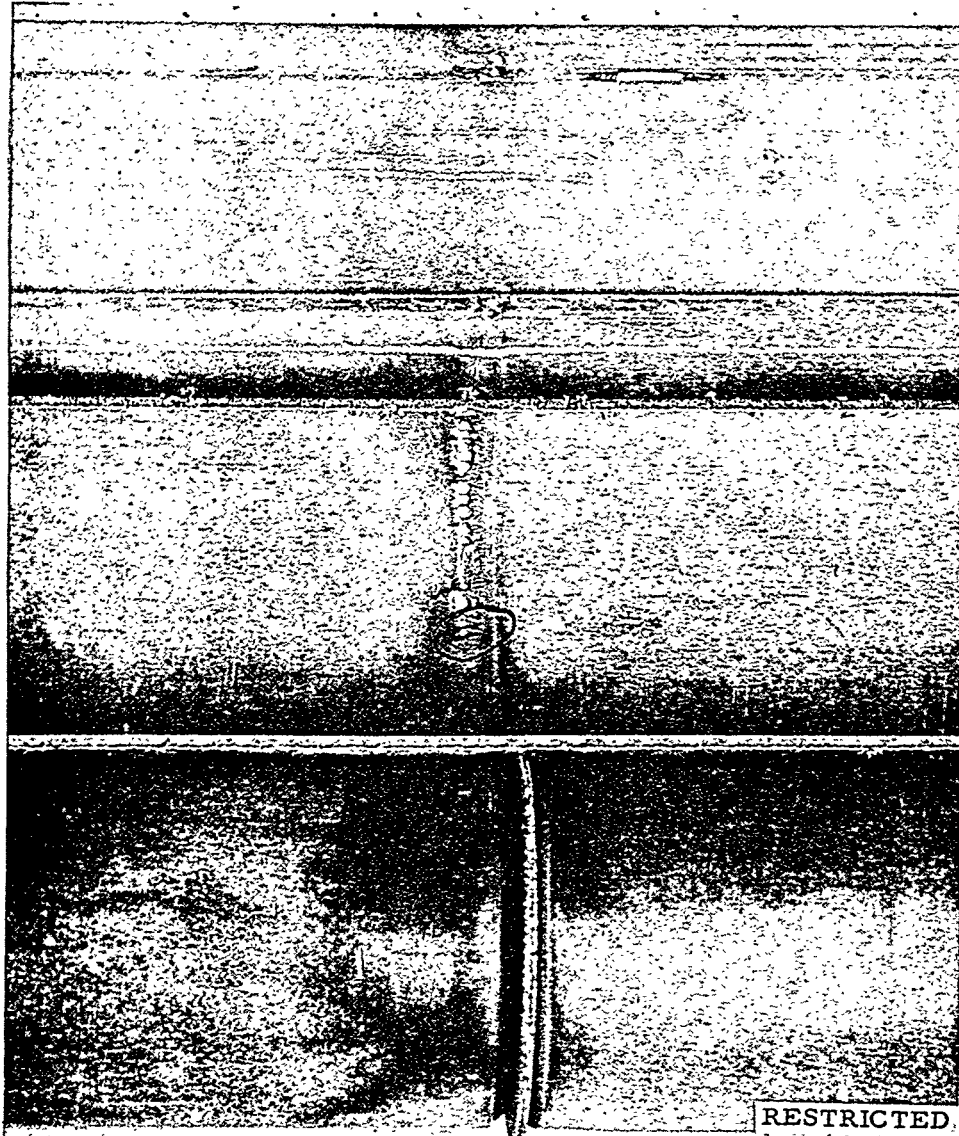
FIGURE 21
TUBE SECTION AND SLUGS AT "FINNED" SLUG
JUNCTION FROM TEST 5.

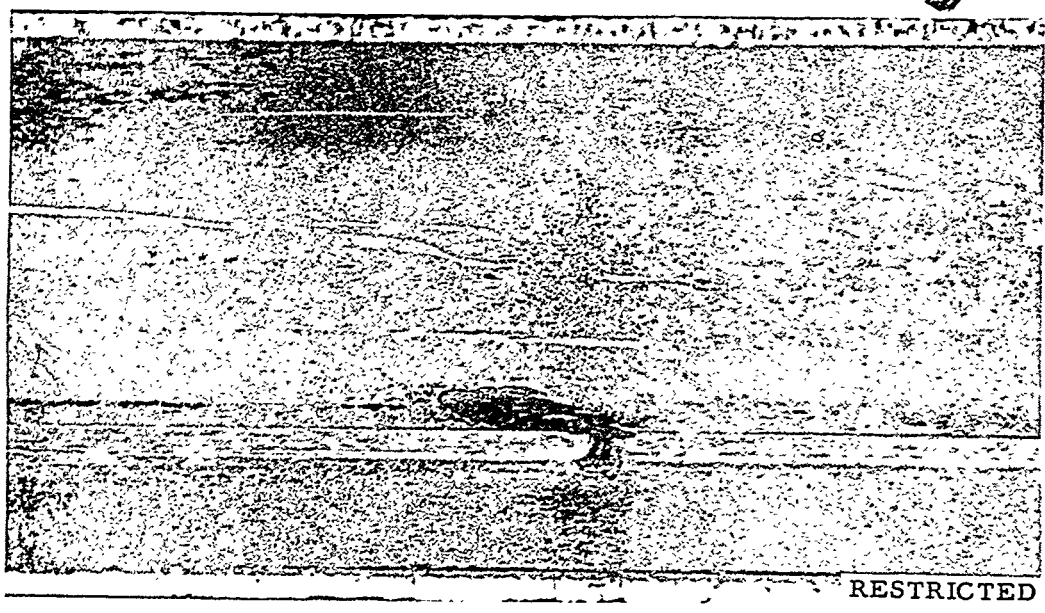
If a comparison is made of flow laboratory and in-pile tube corrosion data a very strong case for erosion-corrosion is evident. Figures 23 and 24 are photographs of an in-pile tube exposed at 105-F over the period of high turbidity and non-inhibited water during the summer of 1952. Note the similarity of these pitted ribs to those shown in Figure 22. Note in each case that the attack took place at a slug junction position. The pitted areas shown in Figures 25 and 26 were on and between the ribs of in-pile exposed tubes. Note the similarity of this attack to that shown on and between the ribs in Figures 8, 9, 21, and 22. The pitted slug junction marks shown in Figure 27 resemble very markedly the attack at the "finned" slug position seen in Figure 21. (The use of a "finned" slug to produce extreme turbulence and rapid corrosion can be justified by the reduction in testing time necessary to duplicate long time in-pile tube exposure.) The likeness of the attack noted on laboratory exposed tubes to that observed on in-pile exposed tubes leaves no doubt that the mechanism of attack is the same for both types of exposure; namely, erosion-corrosion.

FIGURE 23
 INSIDE VIEW OF A SECTION OF TUBE 3684-F,
 REMOVED FROM THE PILE ABOUT 8-8-52, SHOWING
 PITTING ON RIB AT A SLUG JUNCTION.

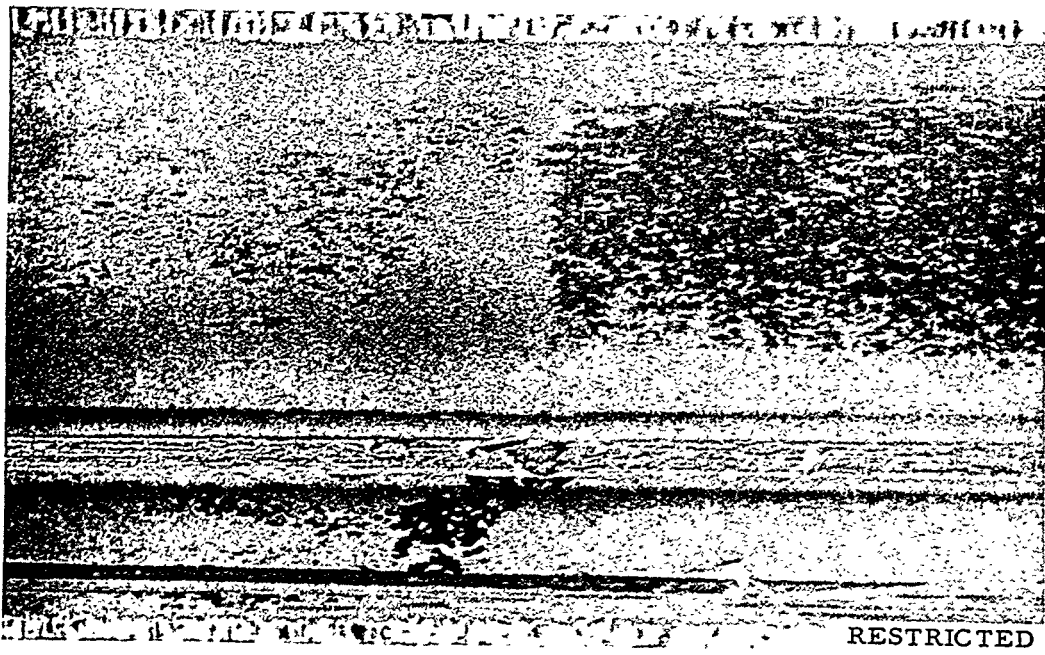
FIGURE 24
 ANOTHER SECTION OF TUBE 3684-F, SHOWING
 A DIFFERENT AREA OF PITTING ATTACK.

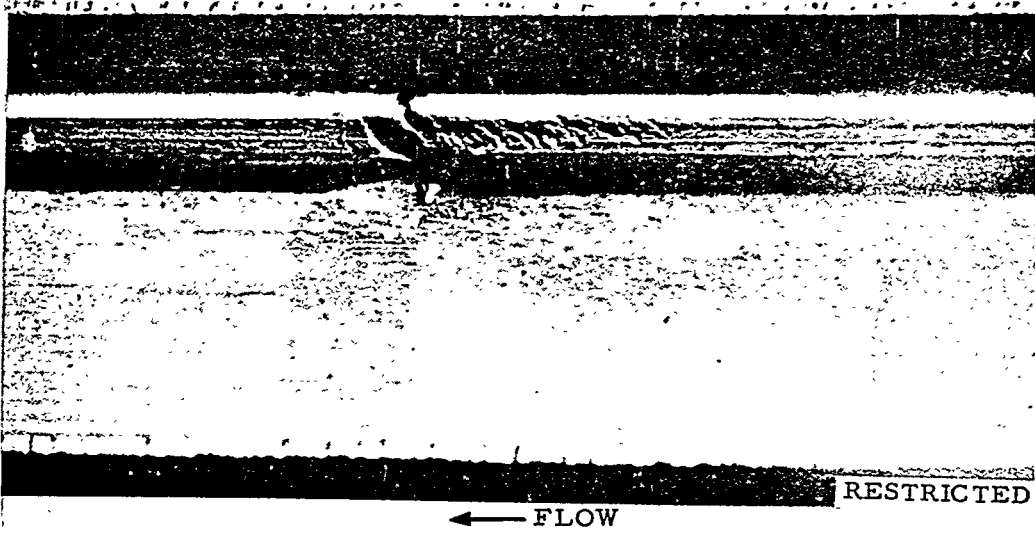
FIGURE 26
SECTION OF PROCESS TUBE 3175-D, REMOVED
FROM THE PILE ON 8-8-52.
The hole, located 8 feet from the rear Van Stone
flange, is in the bottom of the pit between the ribs.

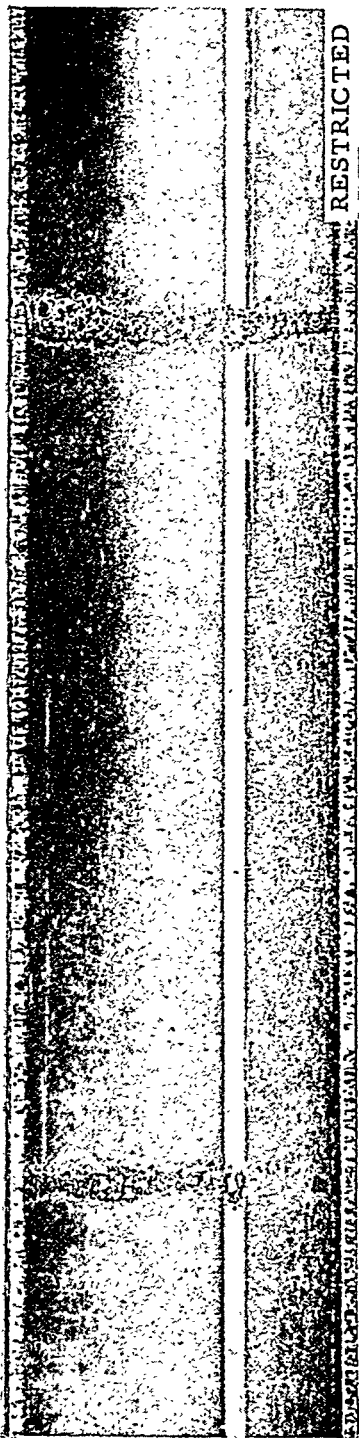
FIGURE 27
INSIDE VIEW OF TUBE 3184-D, REMOVED FROM THE PILE ON 1-22-53.
Note the pitting around the tube wall at slug junctions.

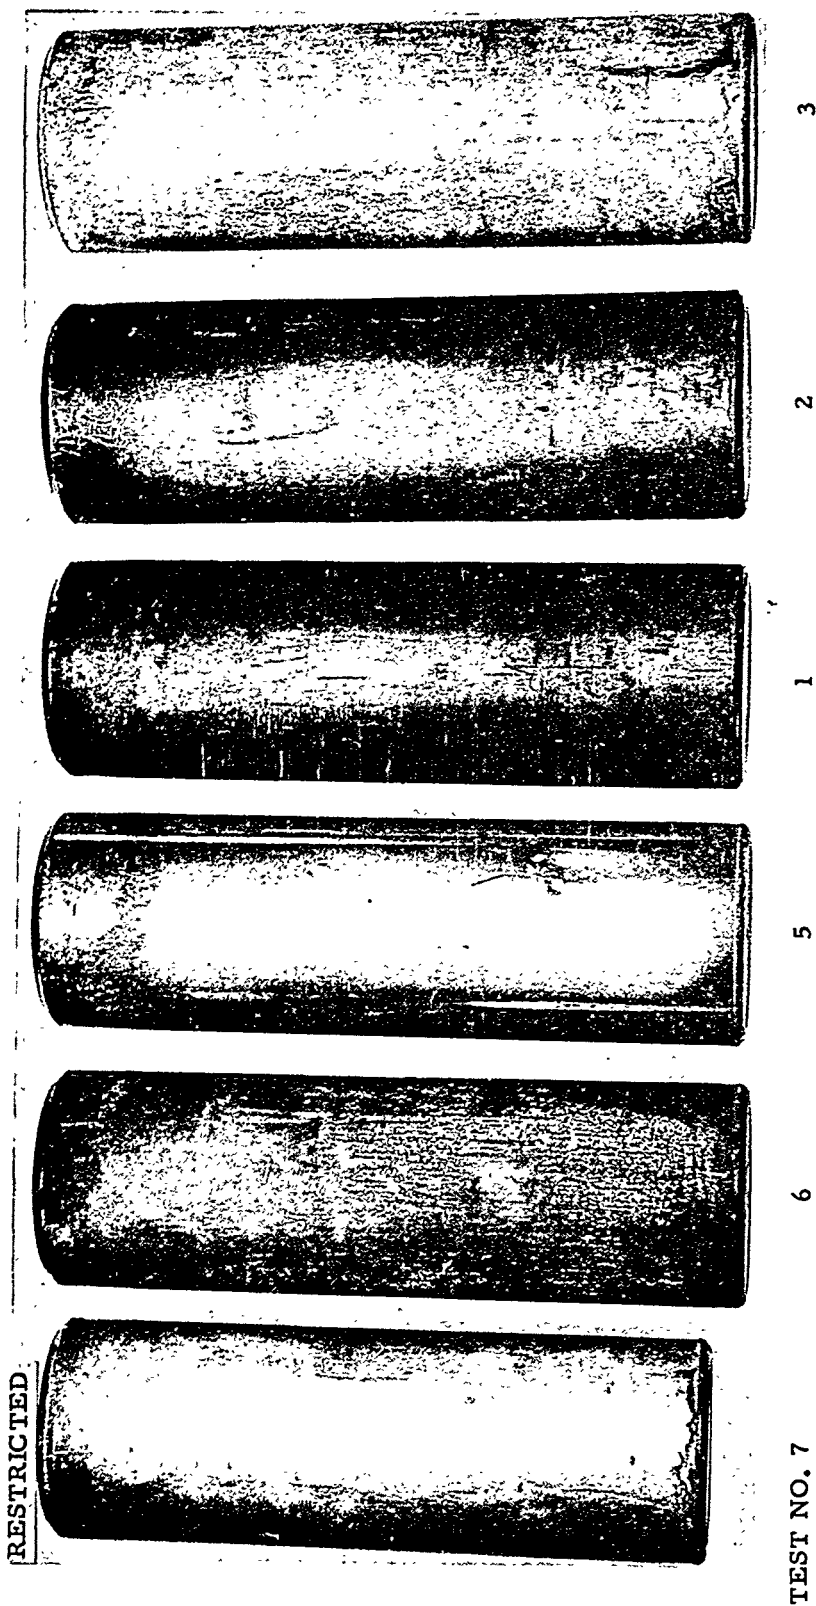
FIGURE 28
REPRESENTATIVE SLUGS FROM THE TURBIDITY TESTS.
 Note absence of attack on slugs exposed to water containing
 2 ppm dichromate (Tests 1 and 2).

into the slug jackets, while the slugs exposed to water containing 2 ppm sodium dichromate (Tests 1 and 2) show no breaks in the film or pits on the slug surfaces. From the results of the turbidity tests the mechanism of slug corrosion for both laboratory turbidity tests and "F-type" pitting observed on in-pile exposed slugs can be deduced as follows:

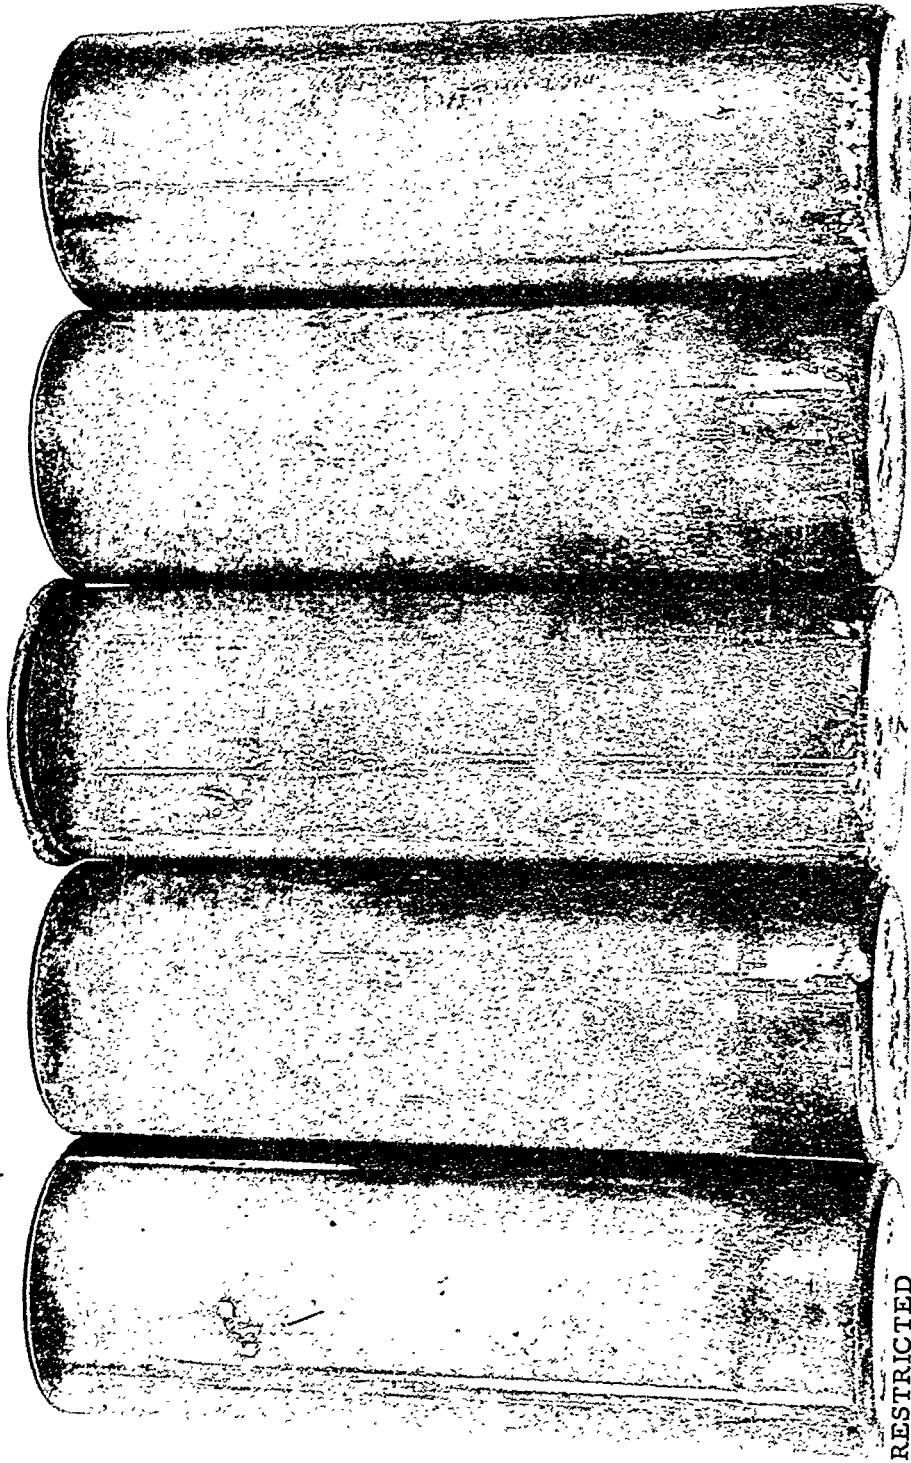
Figure 29 is a photograph of five slugs that were exposed to dichromate-free, Ferrifloc treated water containing 9.4 ppm diatomaceous earth at a flow rate of 17.5 gpm and temperature of 90 C for 17.3 days (Test 5). These test conditions were so severe that complete removal of the autoclave coating over most of the surfaces of four of the slugs shown in Figure 29 was accomplished. (The center slug is an unautoclaved lead dummy.) The slugs shown in Figure 30 were exposed in Test 3 (alum water without dichromate, 8.4 ppm turbidity, 90 C, 15 gpm, 17.3 days). The conditions of this test were not severe enough to produce complete removal of the autoclave coating. The surfaces of these slugs are very rough and many breaks in the autoclave coatings can be seen. An examination of the slugs from Test 6 (Ferrifloc water without dichromate, 1.1 ppm turbidity, 90 C, 22 gpm, 25.3 days) shows that the areas of film removal and pitting attack (not as severe as that noted for the two tests presented above) was similar to the attack that was observed on in-pile slugs exposed for a much longer time. A close examination of the surfaces of the slugs from the turbidity tests shows the relative areas and degrees of attack from the different tests. It also affords a means of comparison with longer exposure in-pile slug corrosion. Figures 31 through 40 are photographs of the slug surfaces from the various turbidity tests. Figures 31 and 32 are photographs of slug surfaces exposed in Test 5. Figure 31 shows an area where partial removal of the autoclave film is evident, while Figure 32 shows an area completely devoid of autoclave coating. The arrow-shaped pit seen in Figure 32 resembles the "F-type" pitting noted on in-pile slugs. The position of this pit on the slug can be seen near the upstream end of the slug on the right in Figure 29. Photographs of slug surfaces exposed in Test 3 (alum water without dichromate, 8.4 ppm turbidity, 15 gpm) are shown in Figures 33, 34, and 35. The extremely rough and heavily pitted surfaces of these slugs can be seen. The areas containing many small pits were quite prevalent on these slugs indicating that the test conditions were too severe to obtain discrete large pits. The slug surfaces shown in Figures 36, 37 and 38 are photographs of slugs from Test 6 (Ferrifloc water without dichromate, 1.1 ppm turbidity, 22 gpm). These slug surfaces exhibited areas of discrete pitting attack similar to that observed on in-pile slugs. Figures 39 and 40 are photographs of slug surfaces exposed in Test 1 and 2 (alum water with 2 ppm dichromate, 9.2 and 0.9 ppm turbidity, 23 gpm). These two photographs were taken of the areas at which the most severe pitting occurred. The extremely good condition of the slug surfaces should be

FIGURE 29
FIVE SLUGS FROM TURBIDITY TEST 5.
Note absence of the autoclave coating on the four outside slugs.

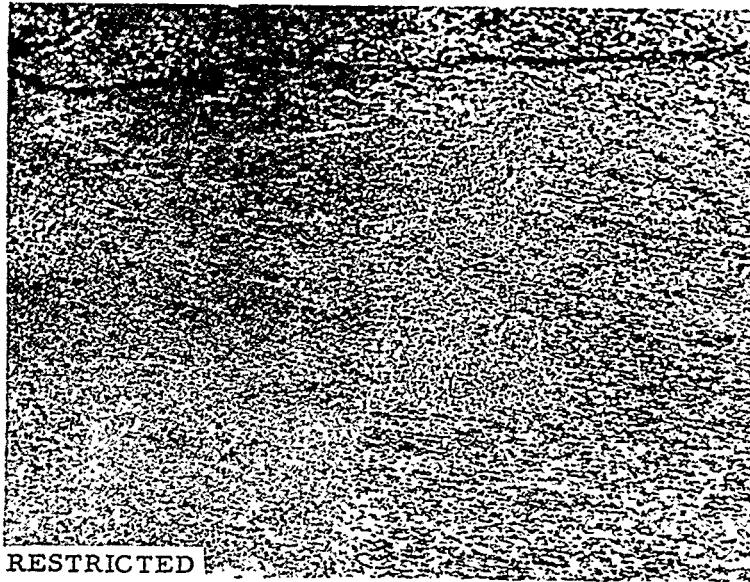
FIGURE 31
SURFACE OF SLUG FROM TEST 5 SHOWING PARTIAL
REMOVAL OF AUTOCLAVE COATING.
Black line is a pencil mark. 5.1X

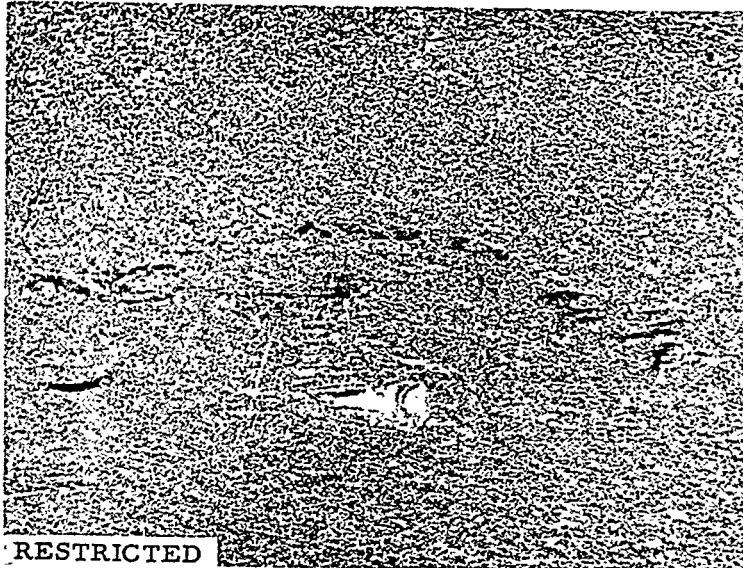
FIGURE 32
SLUG SURFACE (TEST 5) SHOWING COMPLETE
REMOVAL OF AUTOCLAVE COATING.
Note "F-Type" pit in surface. 5.1X

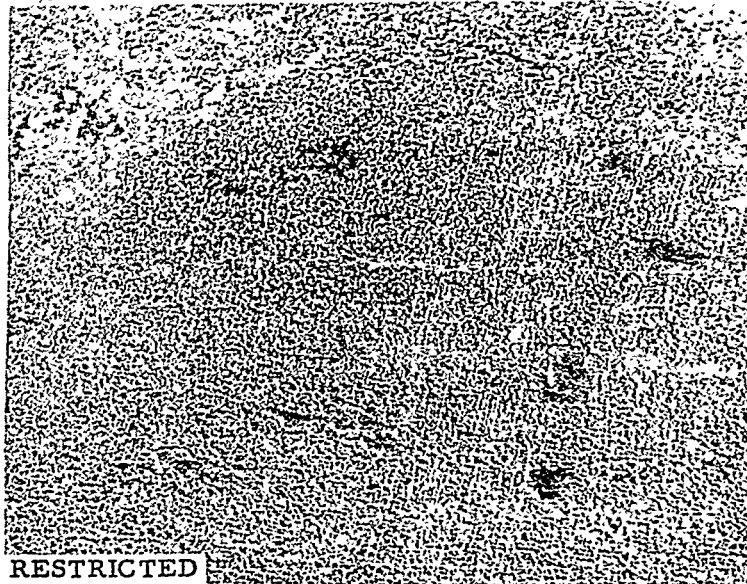
FIGURE 33
 SLUG SURFACE EXPOSED TO DICHROMATE-FREE
 ALUM WATER AT 8.4 ppm TURBIDITY (TEST 3).
 Note many breaks in autoclave coating and few large pits.
 5.1X

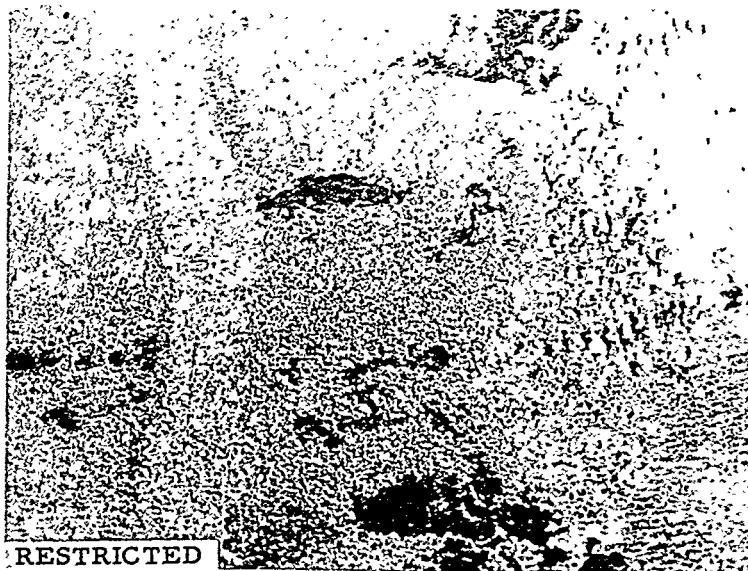
FIGURE 34
 SLUG SURFACE EXPOSED IN SAME TEST AS
 SURFACE SHOWN IN FIGURE 33.
 Note dark areas where autoclave coating is re-
 moved and pitting of aluminum has occurred.
 5.1X

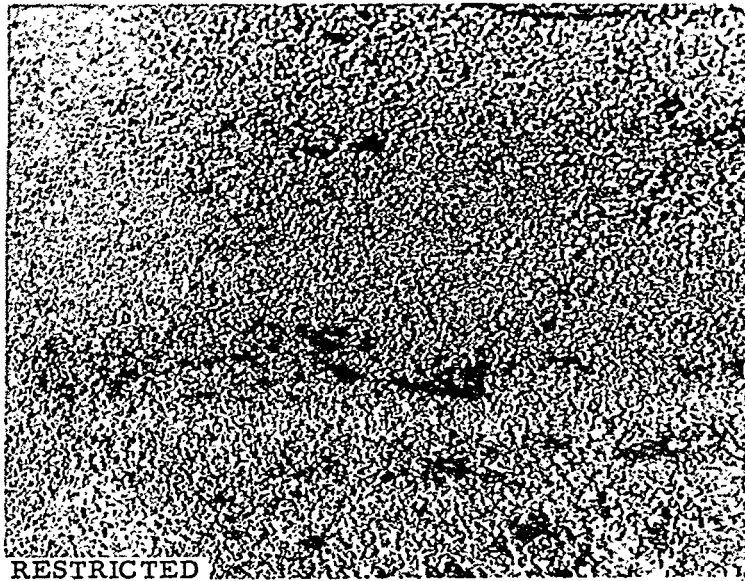
FIGURE 35

SLUG SURFACE EXPOSED IN TURBIDITY TEST 3.
Note extremely rough surface and many pits in
autoclave coating. 5.1X

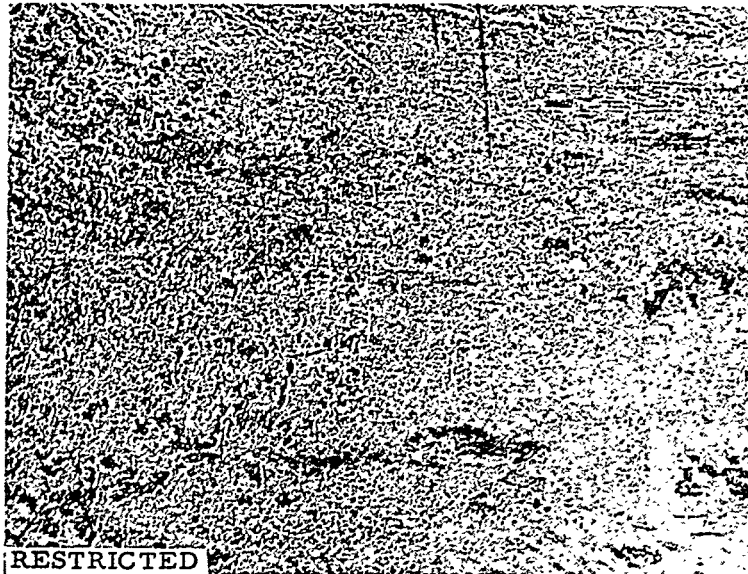
FIGURE 36

SLUG SURFACE EXPOSED TO DICHROMATE-FREE
FERRIFLOC WATER CONTAINING 1.1ppm TURBIDITY (TEST NO. 6).
Note many discrete areas of pitting on surface. 5.1X

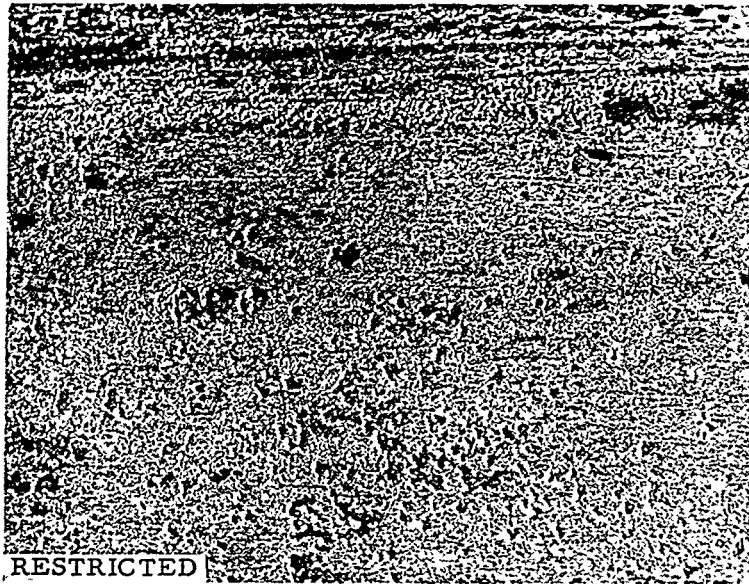
FIGURE 37
SLUG SURFACE EXPOSED IN TURBIDITY TEST 6.
Note shape of three consecutive pits at left center. 5.1X

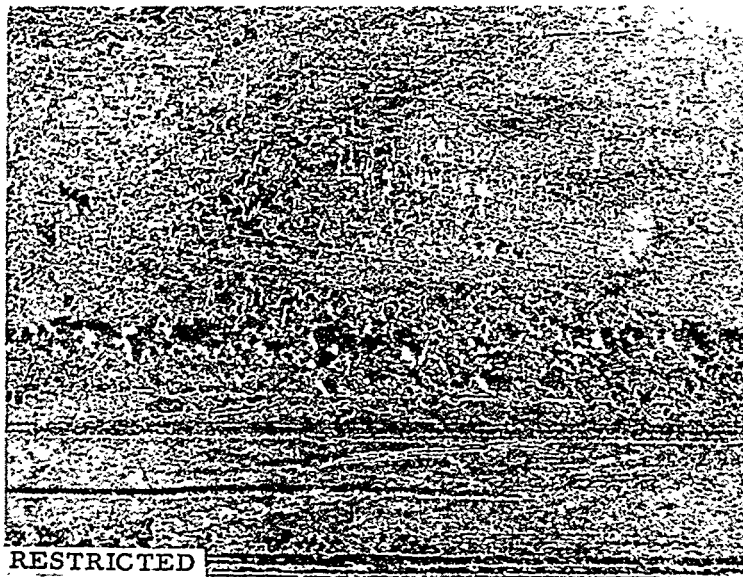
FIGURE 38
SLUG SURFACE EXPOSED IN TURBIDITY TEST 6.
Note line of deep pits just above a rib mark. 5.1X

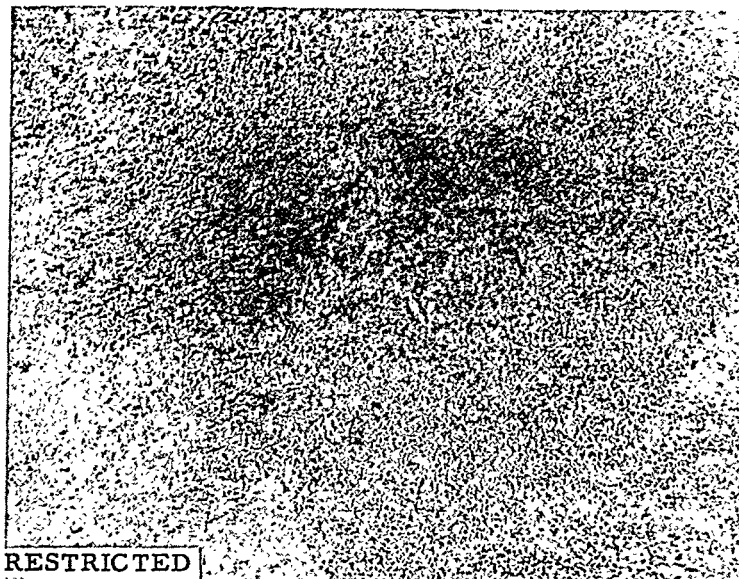
FIGURE 39
SLUG SURFACE EXPOSED TO ALUM WATER CONTAINING
2 ppm SODIUM DICHROMATE AND 9.2 ppm TURBIDITY (TEST 1).
Note extremely good condition of surface. 5.1X

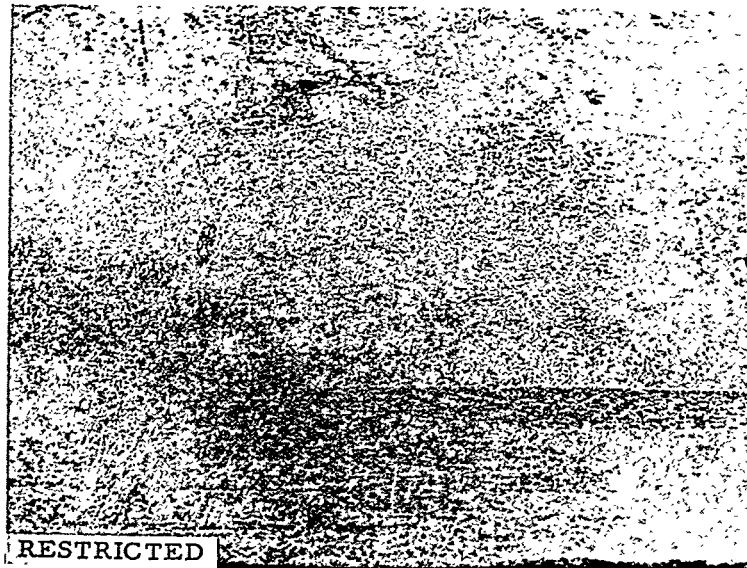
FIGURE 40
SLUG SURFACE EXPOSED TO ALUM WATER CONTAINING 2 ppm
SODIUM DICHROMATE AND 0.9 ppm TURBIDITY (TEST 2).
Note smooth, relatively unattacked surface. 5.1X
