Single-Shell Tanks Leak Integrity Elements/SX Farm Leak Causes and Locations - 12127

C. L. Girardot
J. B. Johnson
T. J. Venetz
D. J. Washenfelder
Washington River Protection Solutions

Date Published
January 2012

To Be Presented at
Waste Management 2012

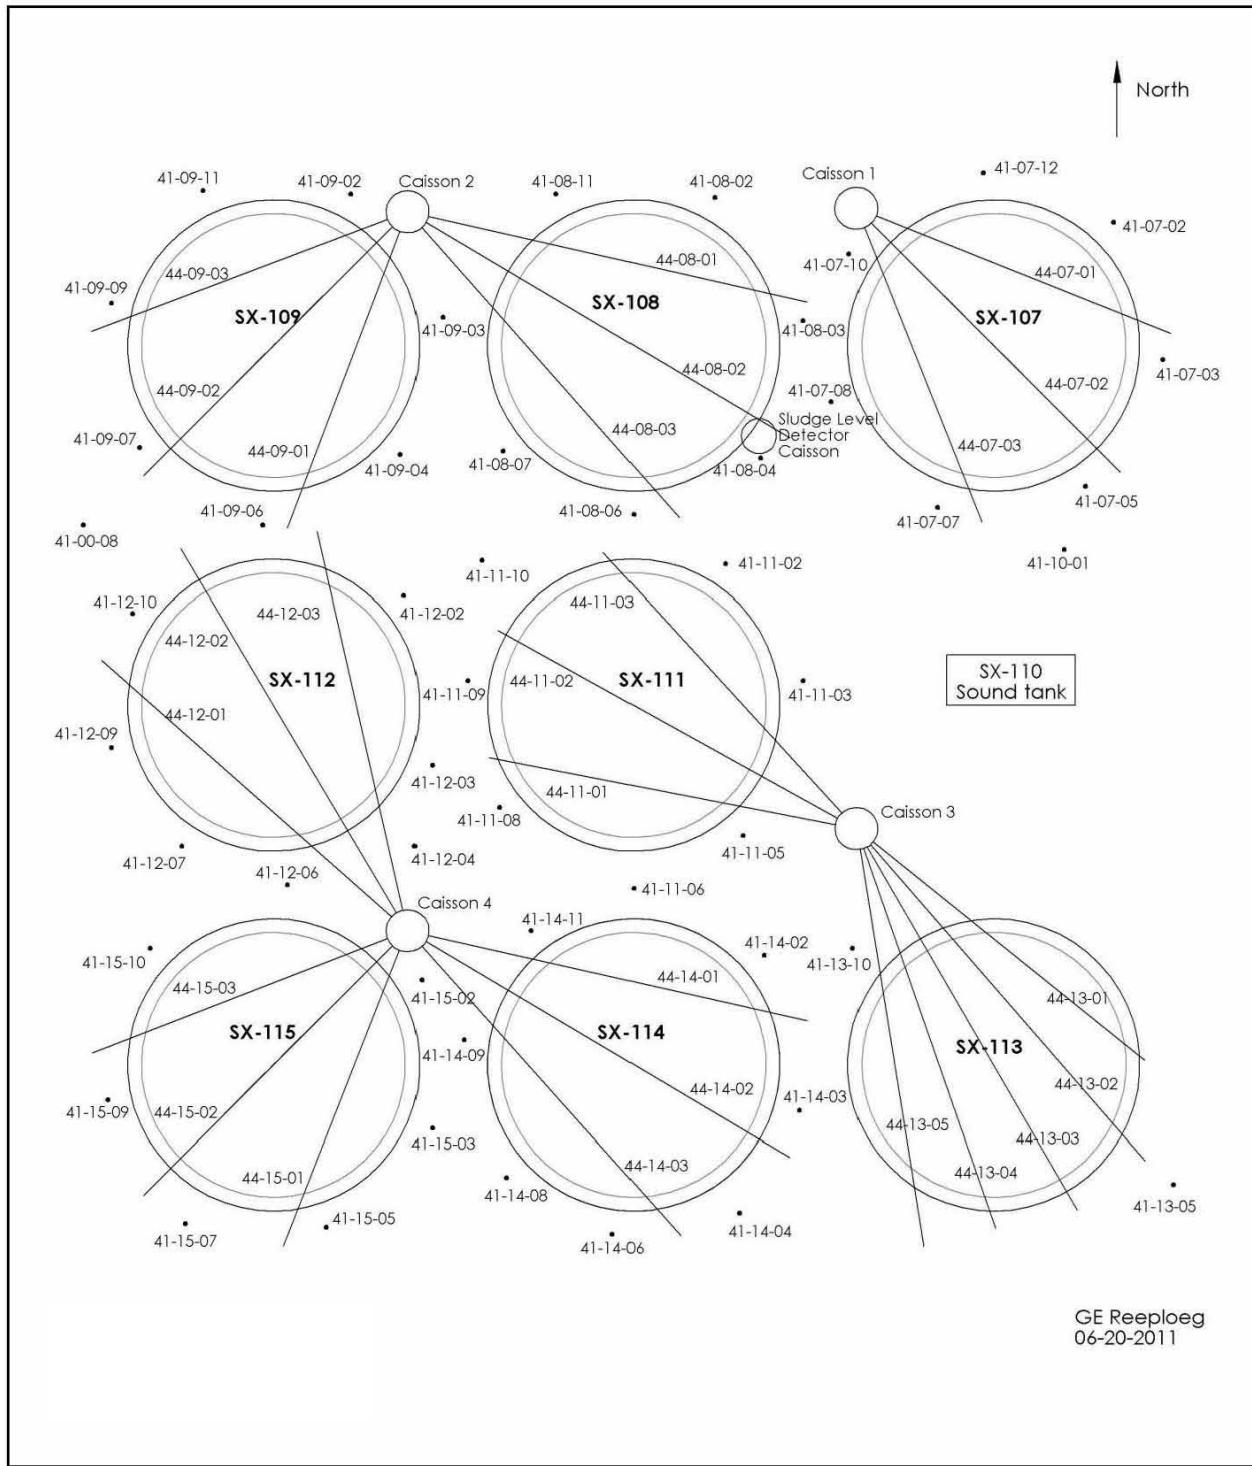
Figure 1. SX Farm Leaking Tanks with Laterals and Drywells
 Tank inner ring is steel liner, outer ring is outer edge of tank footing [5-8]

Note: Sound tanks SX-101 to SX-106 lie to the north of tanks SX-107, SX-108, and SX-109. Solid straight lines extending from the caissons represent laterals and solid black dots represent drywells.

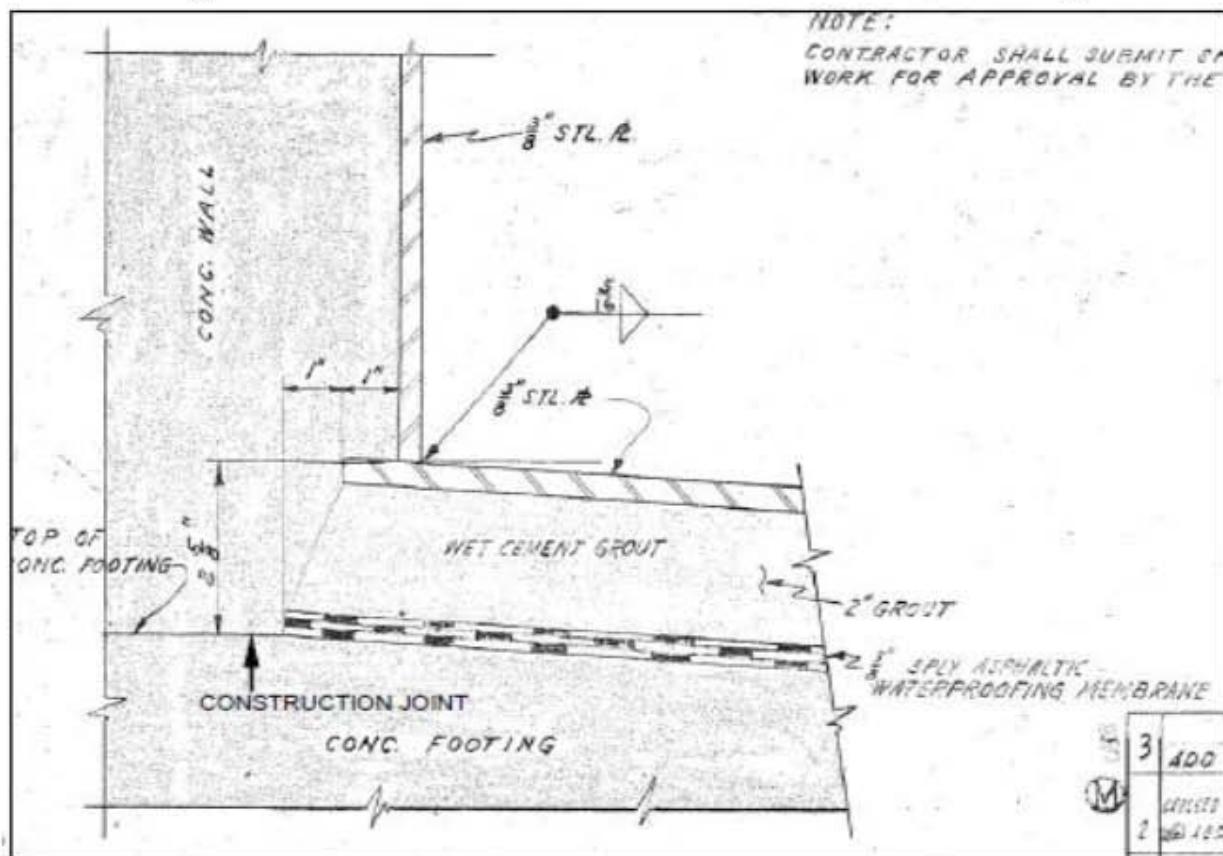
Figure 3. SX Farm Tank Bottom Liner to Sidewall Design Detail [6]

Note: The water stop at the construction joint between footing and middle of the concrete wall is to the left of the above detail.

The design of the SX Farm tanks was the first that diverged from the round bottom knuckle design used in the earlier waste tanks. A fillet weld was used to close the seam where the sidewall and tank bottom liners meet versus the butt welding of the knuckle transition of earlier tank designs. A review of the basic differences between fillet and butt welds indicates that the superior butt welds would be preferred for the tank farm waste tanks.

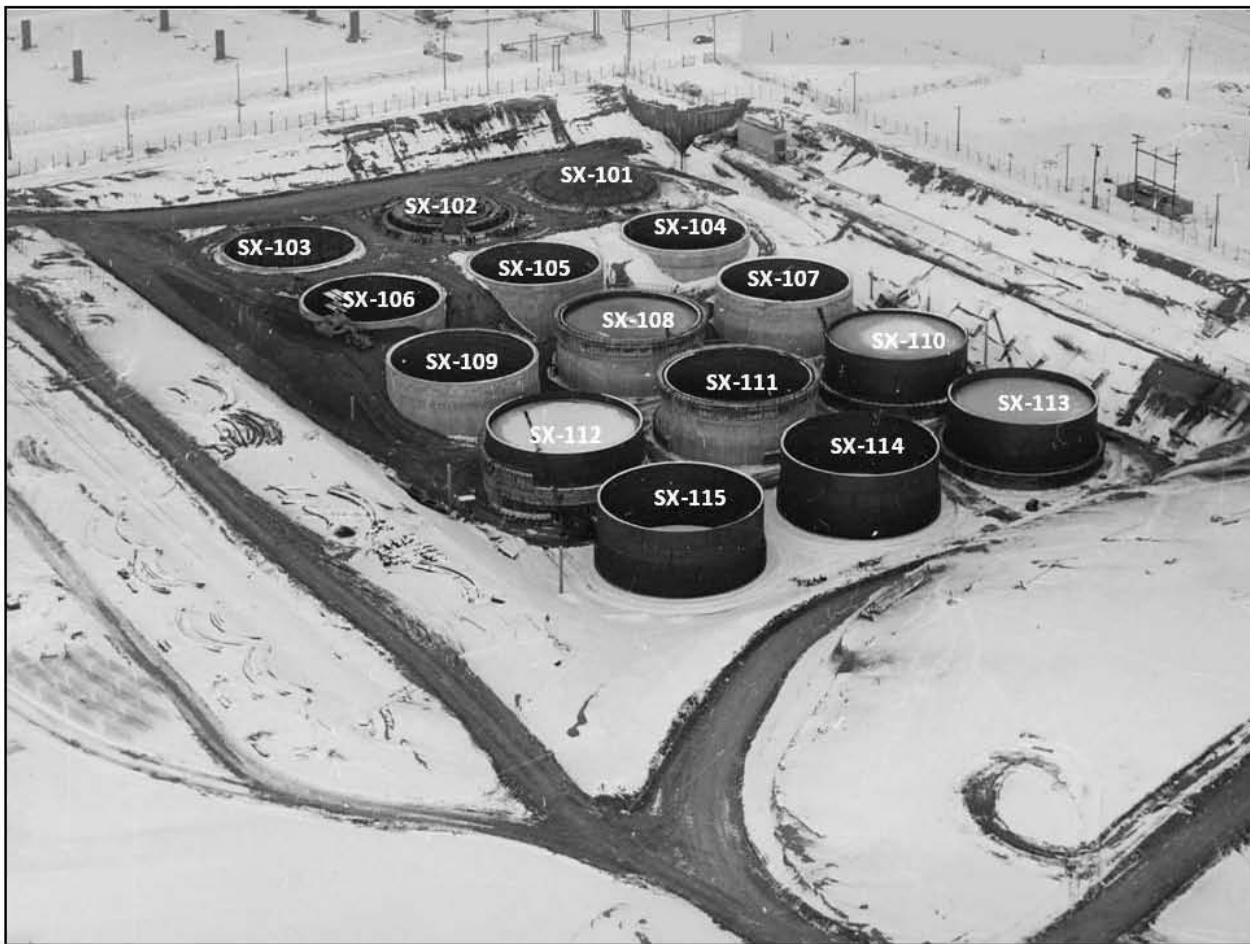
**Figure 5. SX Farm Construction Photograph
January 20, 1954 (N1D00585052)**

The outside temperature between January 16, 1954 and January 30, 1954 ranged from an average high of 24°F to an average low of 9°F. A photograph of the SX Farm under construction (see Figure 5), taken January 20, 1954 (high 11°F low -6°F), shows several of the tanks full of water either undergoing leak testing or for concrete wall pouring. During this cold period snow covered ice is seen in the water filled tanks. Some question exists on the ductile-brittle transition temperature during construction of the SX Farm at these low temperatures. There was also a delay on tank work pending installation of a high capacity vent system for tanks SX-107 through SX-115 based on S-104 steam eruptions [14, 15]. These tanks could have been exposed to the elements for a significant period of time.

Winter temperatures as low as -6°F occurred during the period when the SX Farm tank liners were being constructed and leak tested (see Figure 5). The limitations of carbon steels to resist impact at low temperature was perhaps not well understood when SX Farm was constructed. Issued only recently, the ASME B31T-2010 Code indicates that a \leq 10-mm thick Type A 283 steel plate had an unrestricted low temperature service limit of 20°F [17]. The SX Farm tank liners are 9.53-mm (3/8-in) thick A 283 carbon steel. The SX Farm tank construction specification stated that the storage tank liner shall conform to ASTM A-283-52T, grade A or B, with additional specific requirements on carbon composition are stated as “0.26 % maximum”

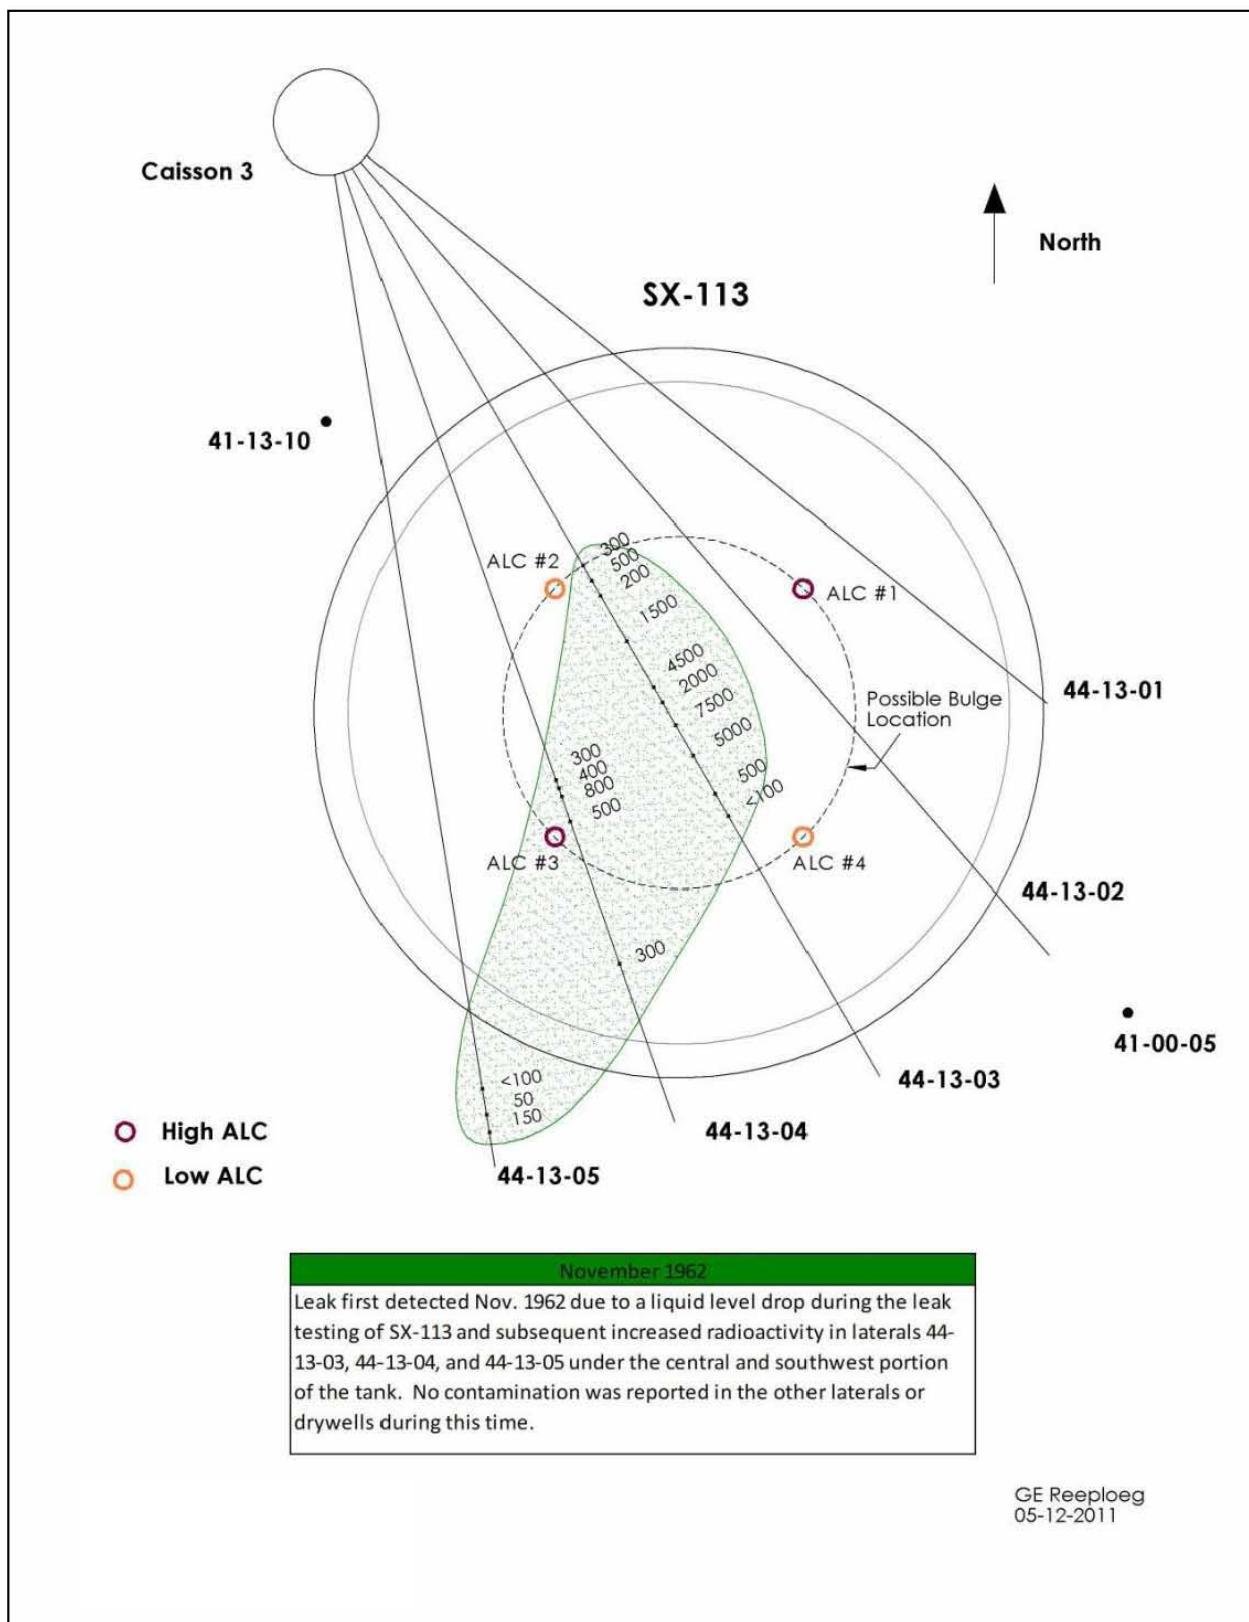
Figure 6. Tank SX-113 Possible Radial Leak Locations with Estimated Bulge [6-8, 29]

A prototype five lateral leak detection system was installed under tank SX-113 after indications of a >4-ft liner bulge in 1958. The tank SX-113 prototype laterals were installed 10-ft under the tank and varied between 6-ft and 12-ft below the bottom of the tank over the course of a lateral. The horizontal alignment was calculated to be within ~2-ft [8]. The alignment was addressed in HW-60749 and included the following: "The subcontractor was permitted to complete the five laterals to the best of his ability without official alignment checks because of the short time limit

A bulged tank bottom was present or possible in all of the eight leaking SX Farm tanks. A bulge of the tank bottom imparts stresses in the liner that could have predisposed it to stress corrosion cracking. A bulge of 4-ft developed when tank SX-113 was filled with a temperature rate of rise at more than 4.5 times the recommended rate. Tank SX-113 could have experienced a weakened sidewall and bottom liner to such an extent that the liner failed. In addition, the added effect of nitrate leachate stress corrosion cracking on an already stressed tank liner could have contributed to liner failure. The possible leak and bulge location for tank SX-113 is shown in Figure 6. Tank SX-113 was the first tank to fail in SX Farm in November 1962, shortly after waste was first added to the tank.
