Title: Los Alamos National Laboratory W76 Pit Tube Lifetime Study

Los Alamos National Laboratory W76 Pit Tube Lifetime Study

Number: W-9-TR-0143U LA-UR-XX-XXXX	Revision	Effective Date: April 3, 2012
	A

Terri Abeln, W-9, Surveillance Oversight

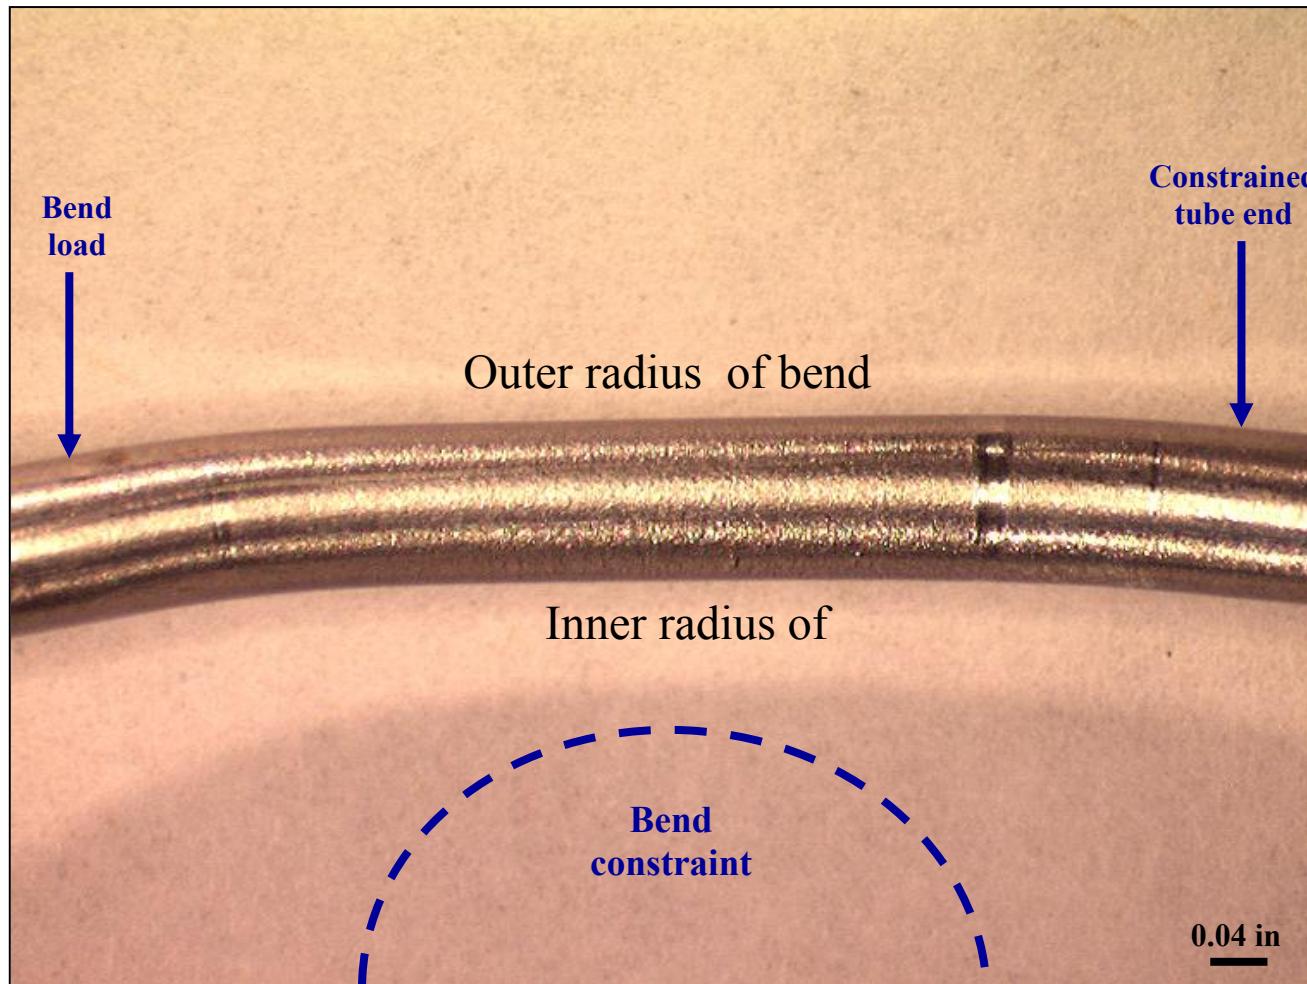
requiring a different set of tooling). See Figure 1. The first set of tubes, 18 total, underwent all three bends.

Figure 1 – Photo illustrating bend load and constraints using tube #18 (1st group / 15 bend cycles).

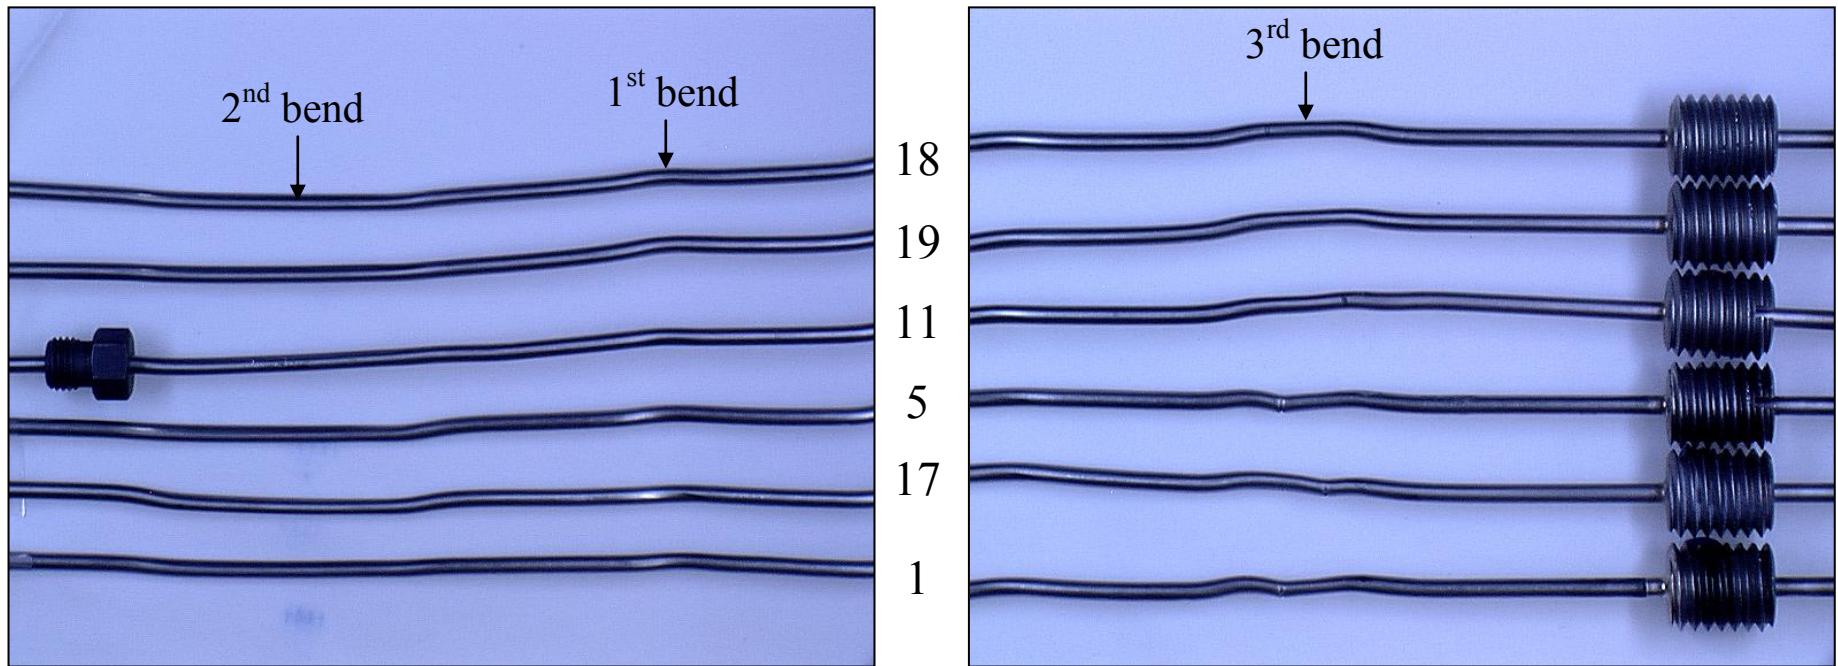
The first set of tubes were also pressure tested after 15 bends to 10,000 psi and held for 5 minutes, except for tube #'s 18 and 19. All tubes were tested until failure, except for tubes #'s 11, 18, and 19, which were only subjected to 15 bends each. See Figure 2.

Figure 2 – Overall photos of 6 submitted tubes from 1st set (#'s 5, 17, 1 with through wall fractures).*

- Tube # 18 – bent and unbent 15 times (Not Pressure Tested)
- Tube # 19 – bent and unbent 15 times (NPT)
- Tube # 11 – bent and unbent 15 times (Pressure Tested**)
- Tube # 5 - bent and unbent 29 times (PT)
- Tube # 17 - bent and unbent 23 times (PT)
- Tube # 1 - bent and unbent 19 times (PT)

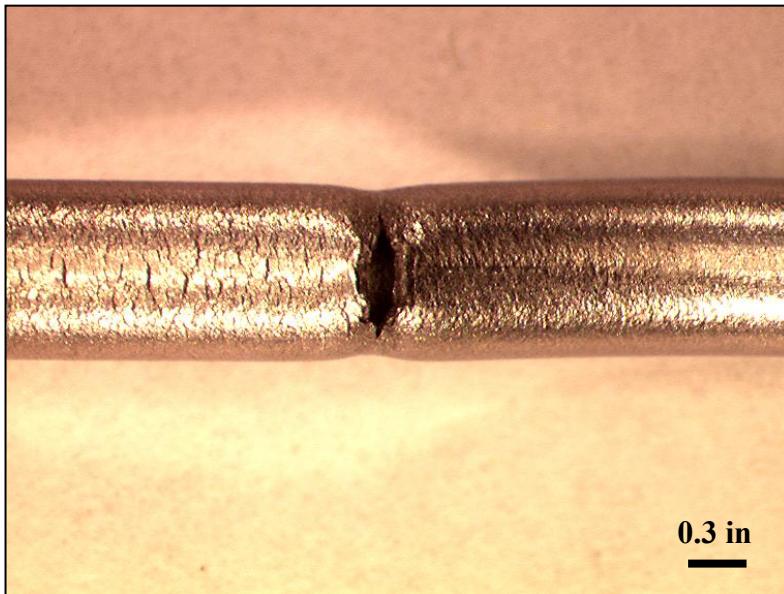
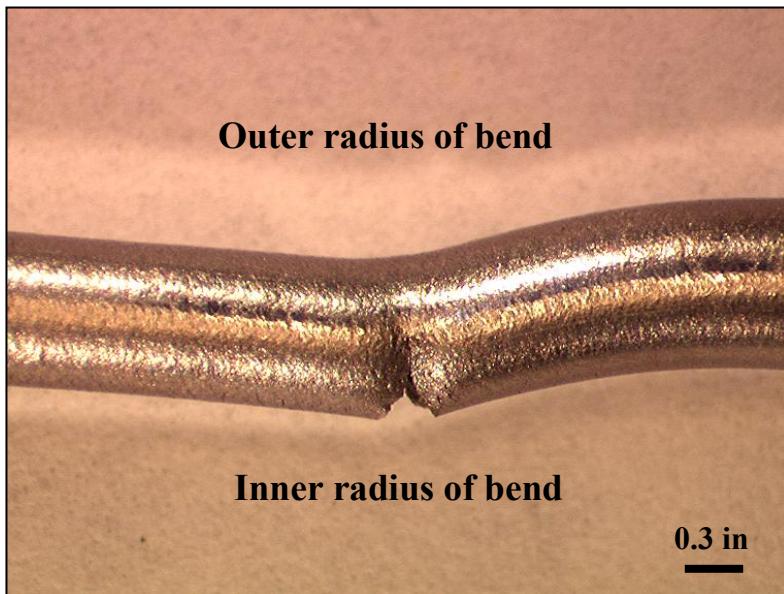
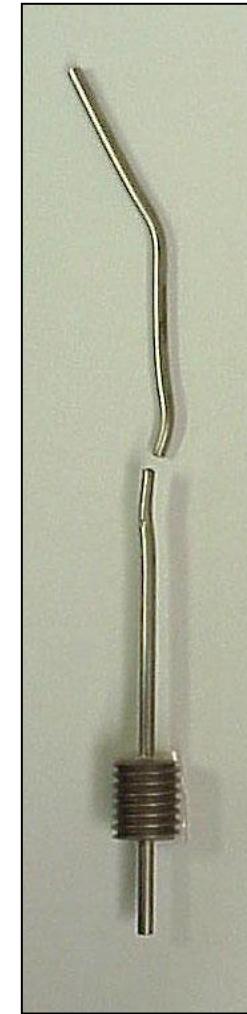
Tube failures were characterized as complete transverse separation or fracture through the tube wall thickness compromising functionality. It was noted in the first set that all the tube failures occurred at the third bend (180 degrees, 14.29 radius), in the inner radius area, during straightening. See Figure 3. Therefore, considering the limited amount of tubing available at the time, the second set of tubes, 21 total, were cut to 8 inch lengths and subjected to the third bend only. Fifteen tubes were subjected to 1 through 5 bends; three tubes per bend cycle. Five more tubes were given 6, 7, 8, 9, and 10 cycles. One tube was taken to failure and one non-cycled tube was used as a control specimen. See Figure 4. The second set of tubes was visually examined at 1X magnification for obvious fractures after every bend, as may be done during actual assembly and disassembly at Pantex. Fractures were not apparent before catastrophic overload.

Figure 3 – Example photos of failures with complete fractures and single-wall fractures at third bend location.

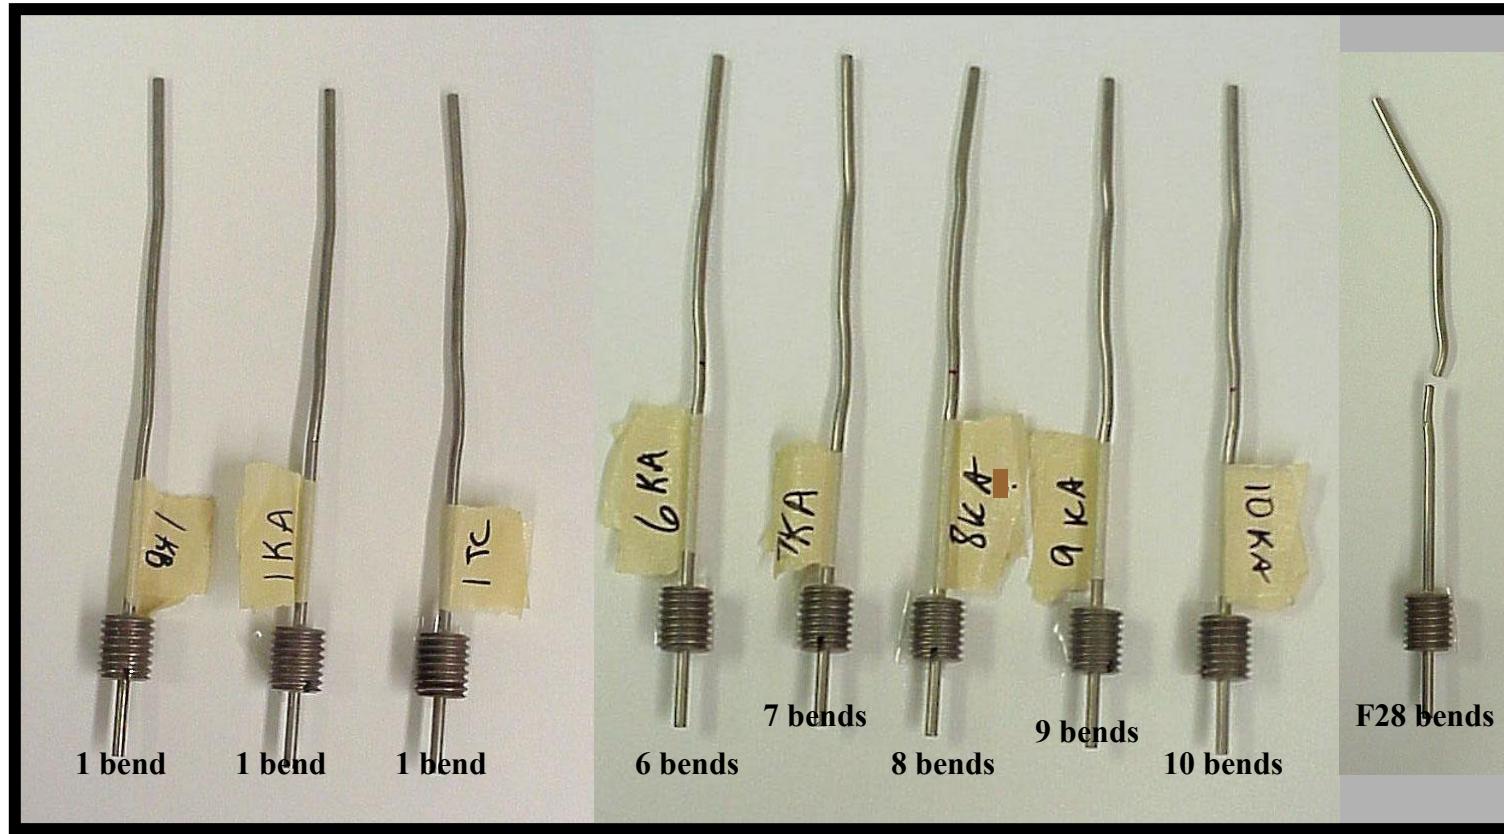
Figure 4 – Overall photo of some of the bent and straightened tubes from the second specimen group. The 3rd bend (see Figure 2) was the only one performed on this second group of tubes as it was determined to be the most critical bend.

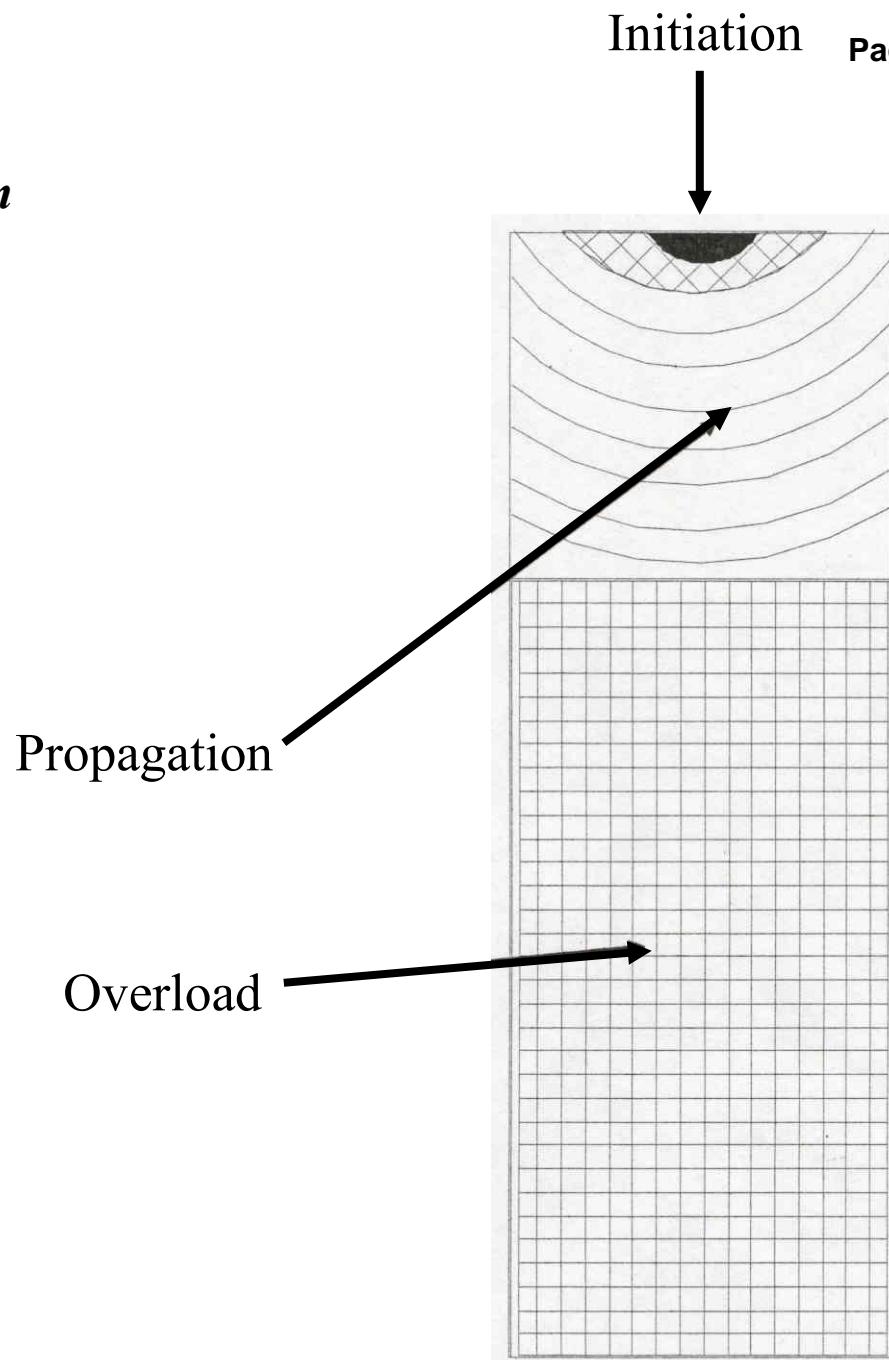
Figure 5 – Macro Fatigue

Fractography and Scanning Electron Microscopy (SEM) Analysis: Fractography, using SEM and light microscopy, revealed a fracture mode characteristic of multiple initiation, low cycle fatigue (LCF). There are three stages of fatigue: initiation, propagation, and overload. See Figure 5. All fracture surfaces exhibited an initiation site associated with the exterior surface of the tube, at the inner bend radius area of the third bend location. See Figure 6. Ratchet marks were evident at low magnification (Figure 6) and characteristic of multiple crack initiation and propagation. Cyclic arrest marks (also called clamshell or beach markings), characteristic of fatigue, were evident and indicative of crack propagation primarily in planes normal to the bending load. See Figure 7. The determinable number of markings was closely associated with the number of bend cycles. Both macro features (ratchet and cyclic arrest marks) pointed to a common initiation site on the fracture surface. The overload region exhibited both tensile and shear ductile dimples. See Figure 8. Features in the sidewall region indicated some torsional loads also. Macrofractography suggests that catastrophic failure occurs when $\frac{1}{2}$ to $\frac{3}{4}$ of the tube wall is compromised via crack propagation and wall thinning resultant of plastic deformation (necking). See Figure 9. SEM surface and cross-sectional analysis revealed that cracks initiated

Three Stages:
-Initiation
-Propagation
-Overload

Initiation: possible rubbing, possible ratchet marks

Propagation: cyclic arrest lines created if loading is interrupted or if stress amplitude changes

Overload: may contain shear lips depending on degree of constraint and inherent toughness

Size of fatigue and overload regions depend on nominal and local stress – high stress gives large overload region

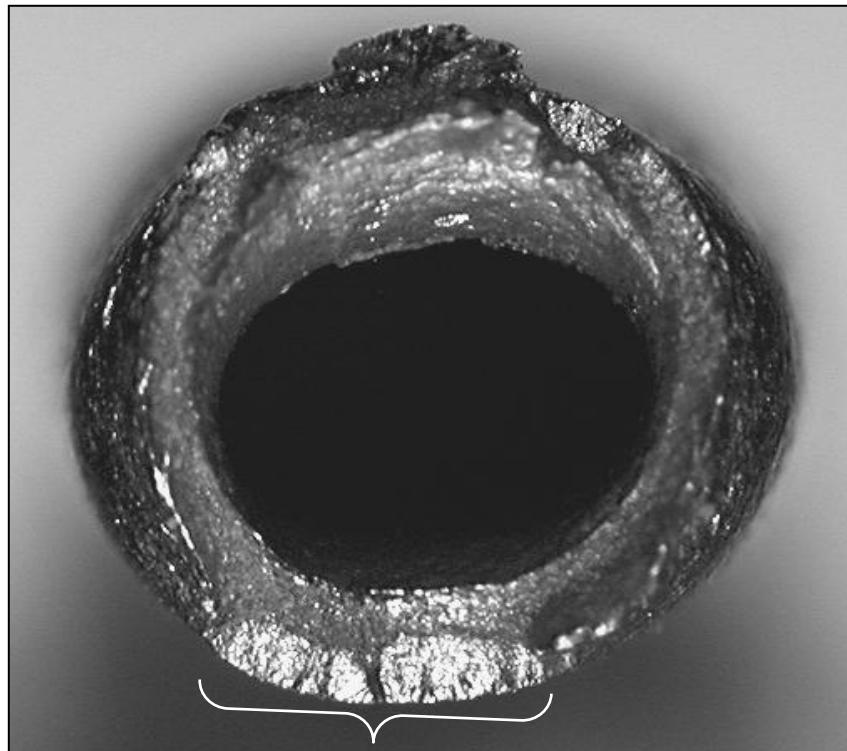
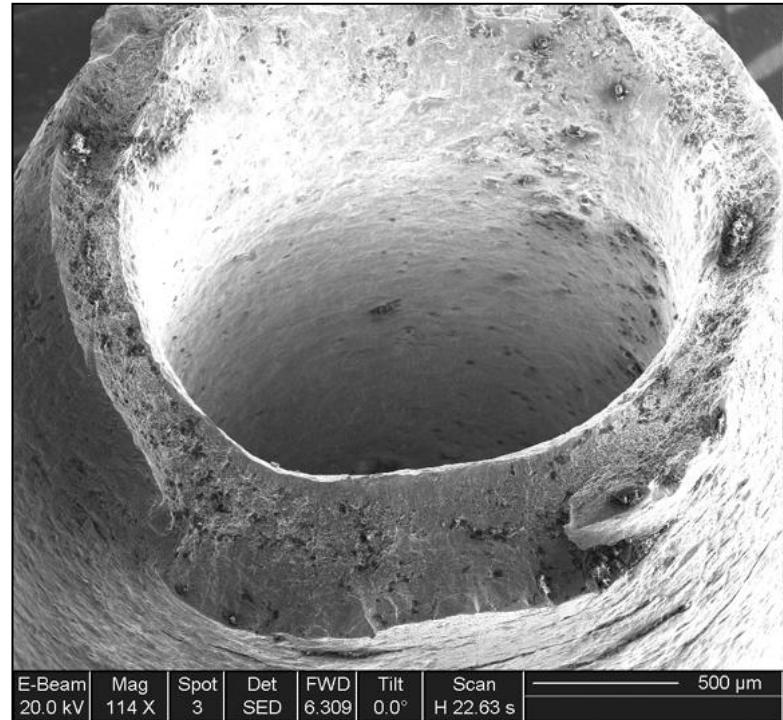
Figure 6 – Macro (left photo) and SEM fracture face photos of the failed tube from the second group of specimens (28 bend cycles). Fracture initiation sites illustrated with bracket.

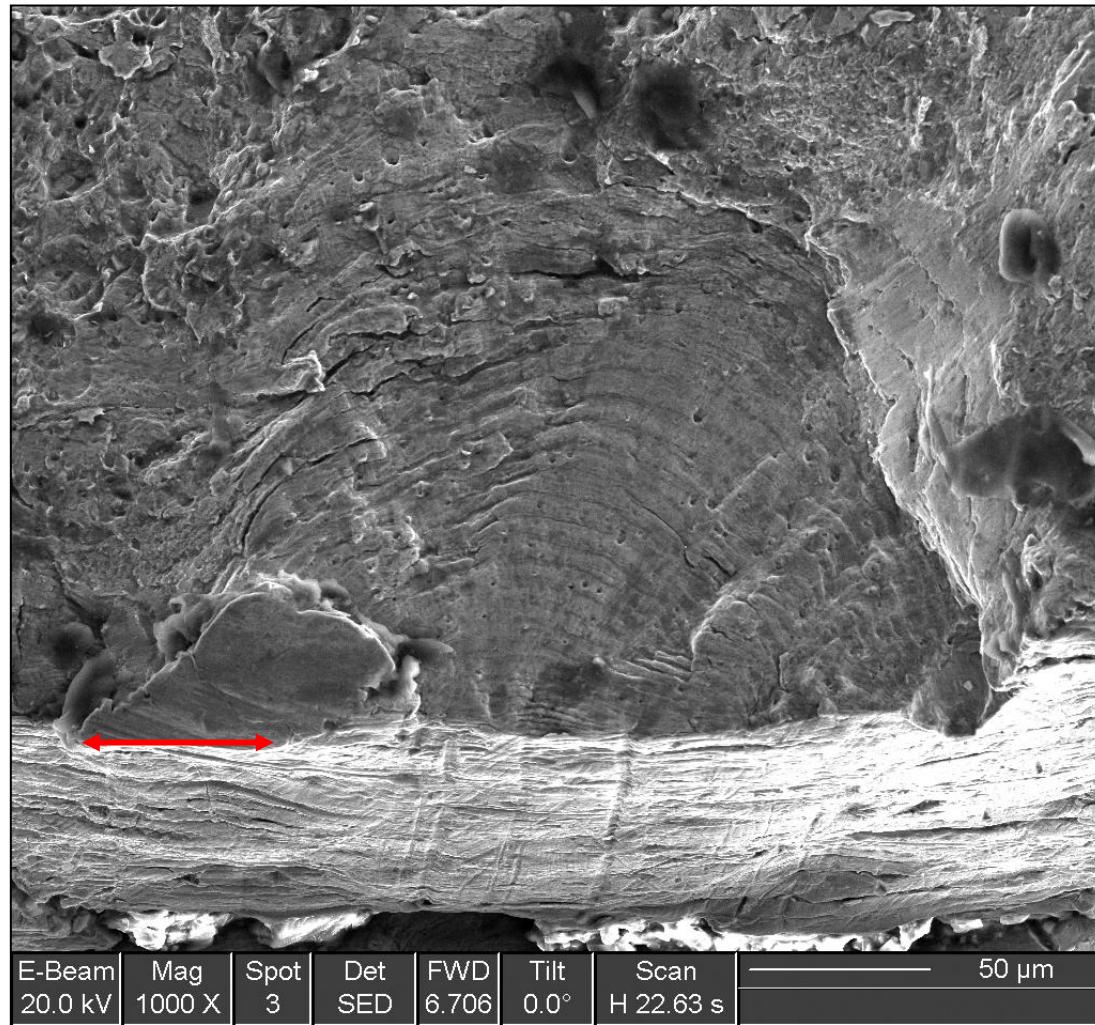
Figure 7 – SEM image of one initiation site on fracture surface of tube depicted in Figure 6. Note bend-induced cyclic arrest marks (clamshell pattern). Red arrows depict intersection of fracture surface and tube exterior surface.

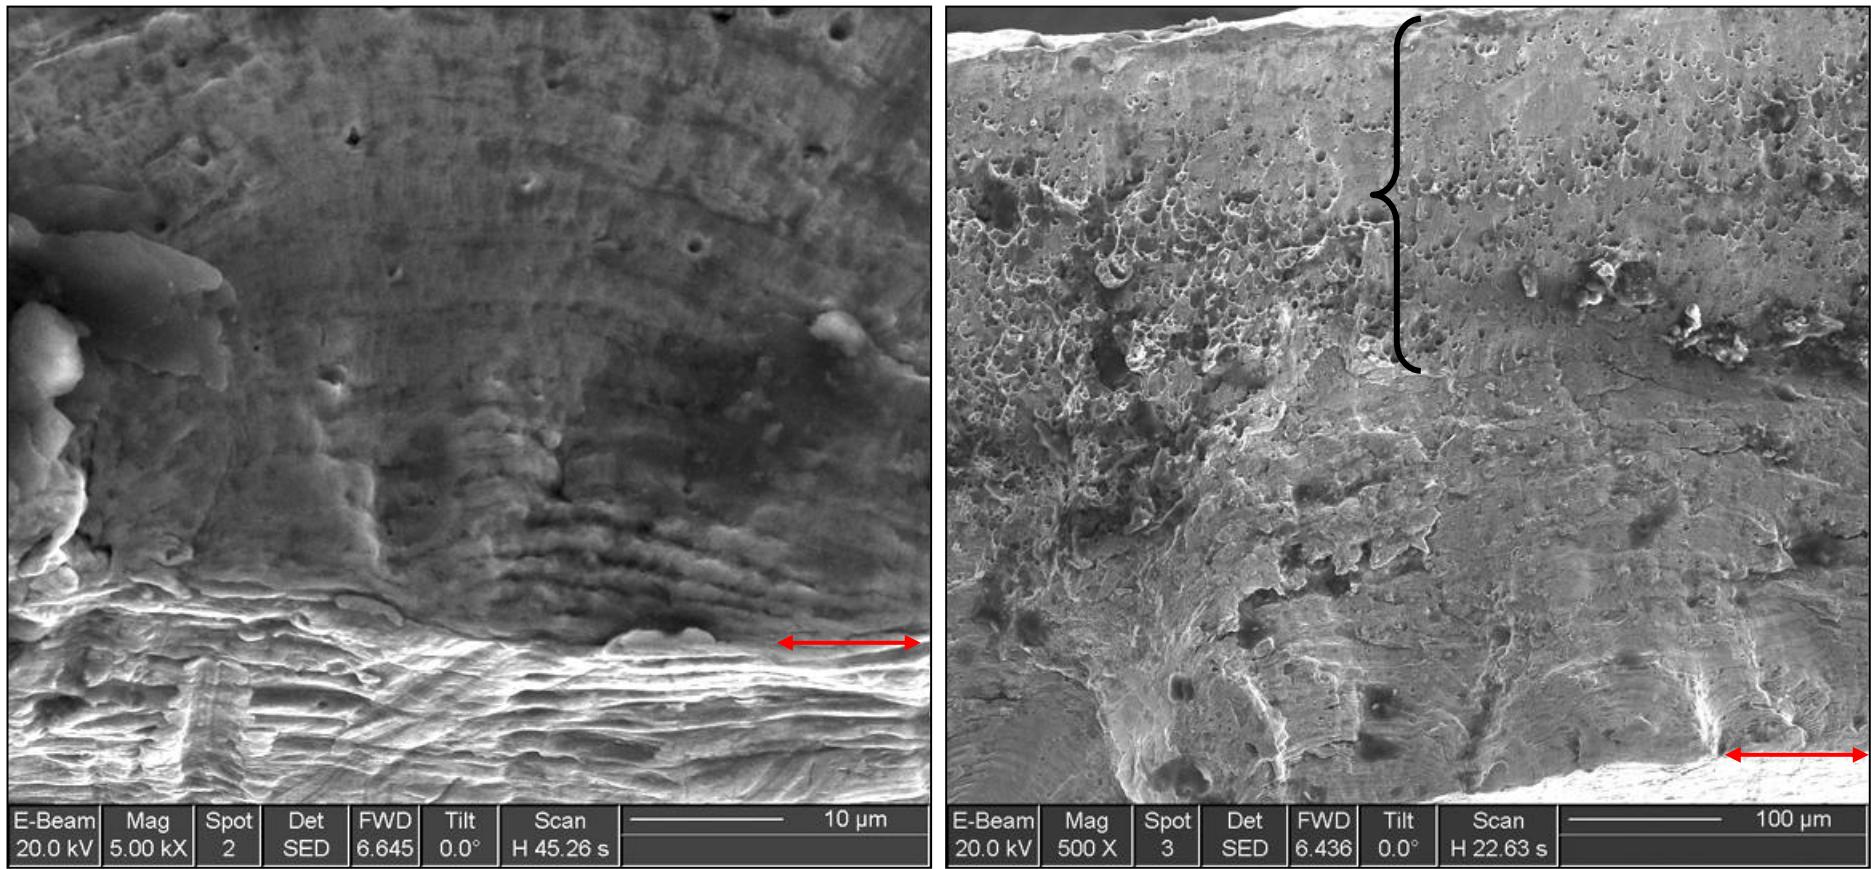
Figure 8 – Left image represents a higher magnification of the initiation site depicted in Figure 7 and right image is at lower magnification illustrating shear regions (bracket). Red arrows denote intersection of fracture surface and tube exterior surface.

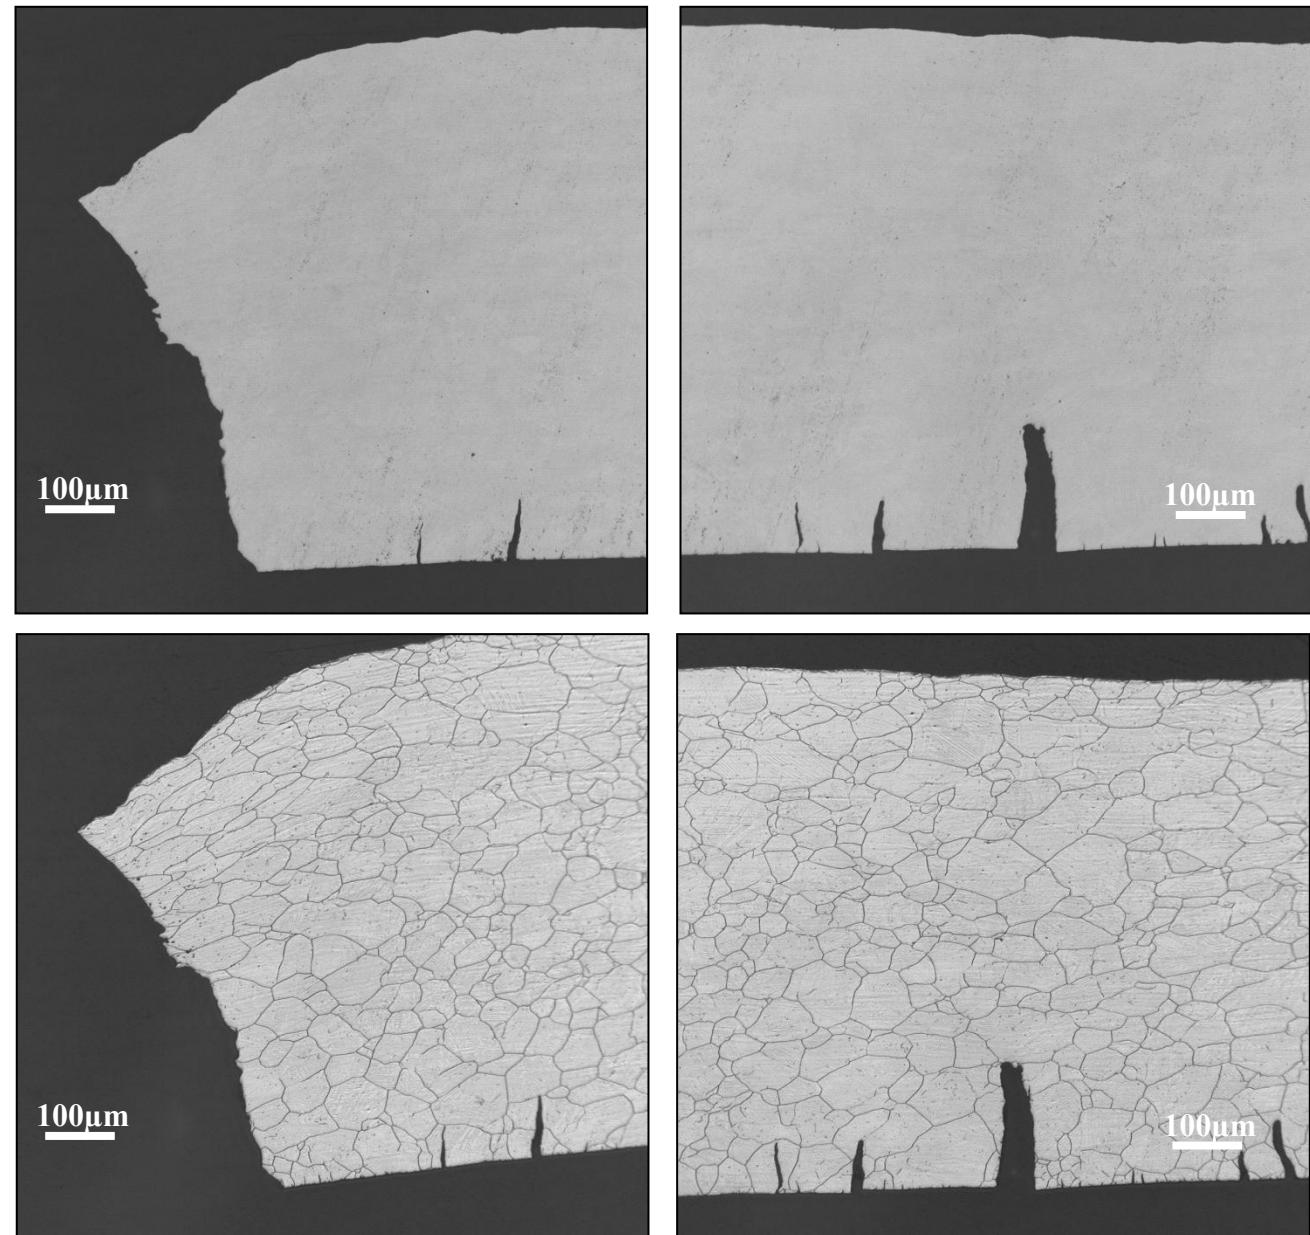
Figure 9 –
Photomicrographs of the polished and etched cross-sectional fracture area of the failed tube from group 2, 28 bend cycles. Etchant used was electrolytic nitric acid.

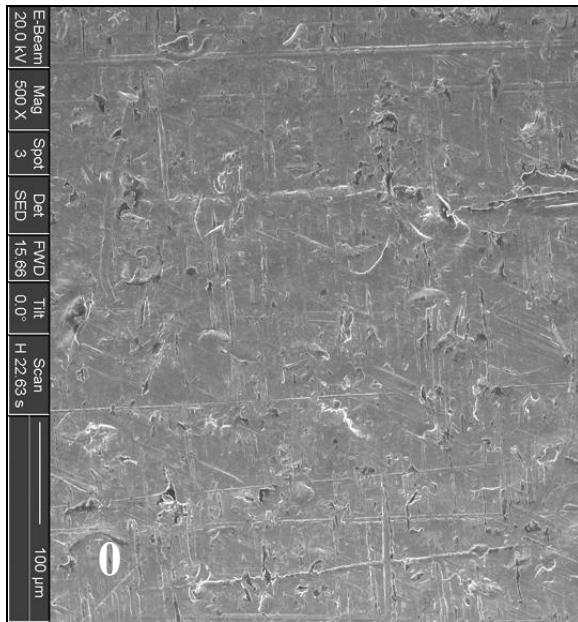
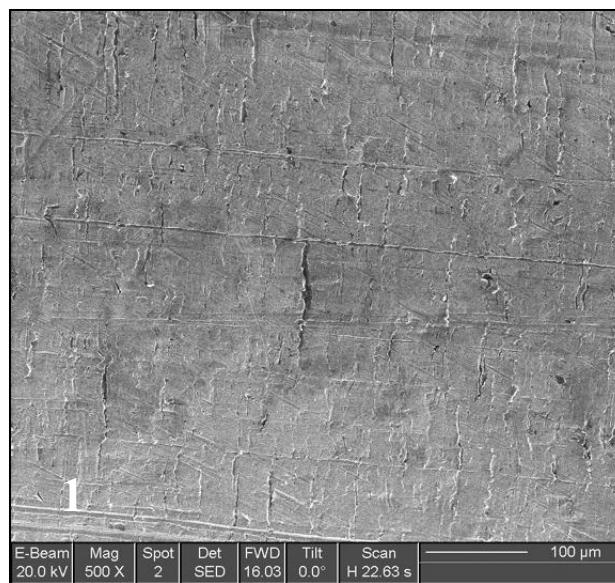
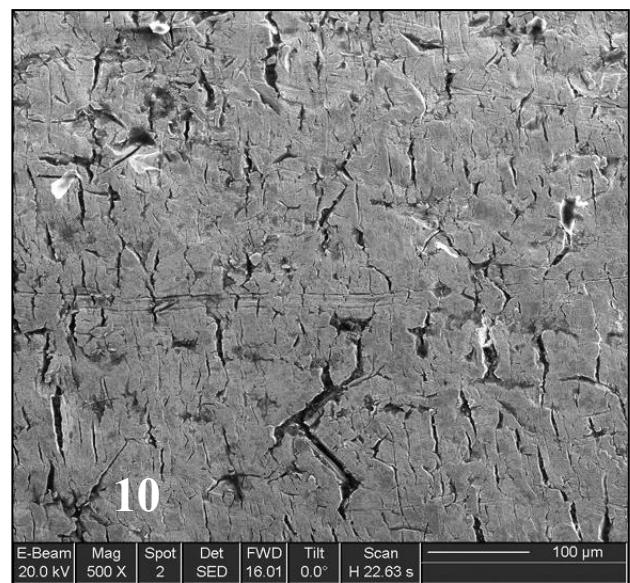
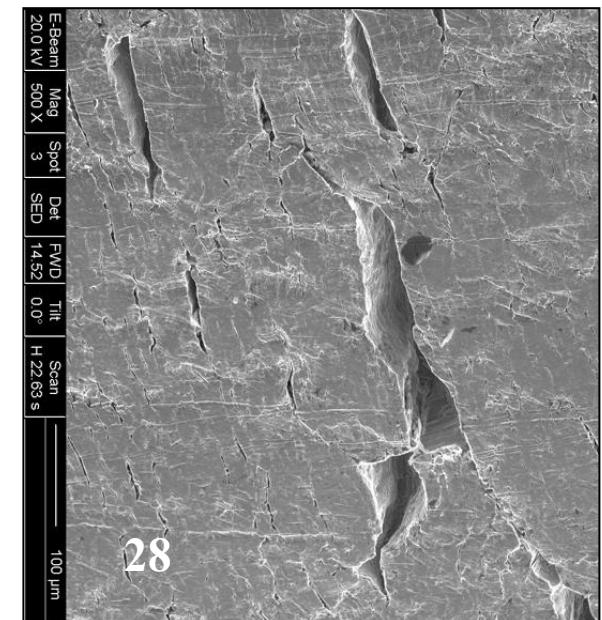
during the first bend cycle. Figures 10 and 11 illustrate surface initiated cracks in tubes subjected to differing numbers of bend cycles. Figure 12 shows apparent differences in the pre-test surface condition of all submitted tubes. Some circumferential, oval distortion was noted with a nominal aspect ratio (side diameter to bend radii diameter) of ~1.25.

Figure 10 – SEM images of the inner radius surface condition of tubes from group 2 comparing different # bend cycles (# denoted on photo). Note crack initiations after one bend cycle.

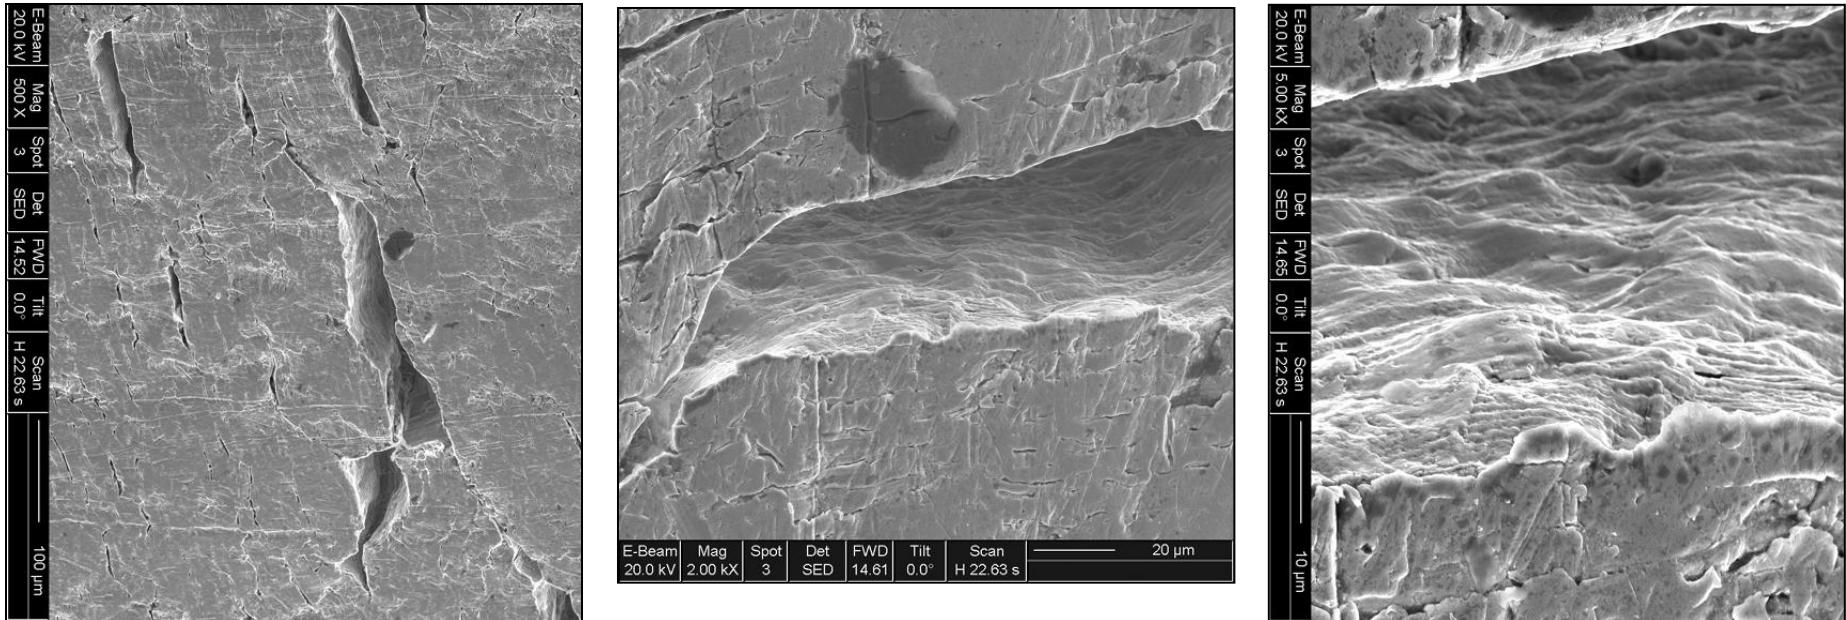
Figure 11 – Higher magnification SEM images of the surface condition of the 28 bend cycle tube surface depicted in Figure 10. Note cyclic arrest marks in right photo.

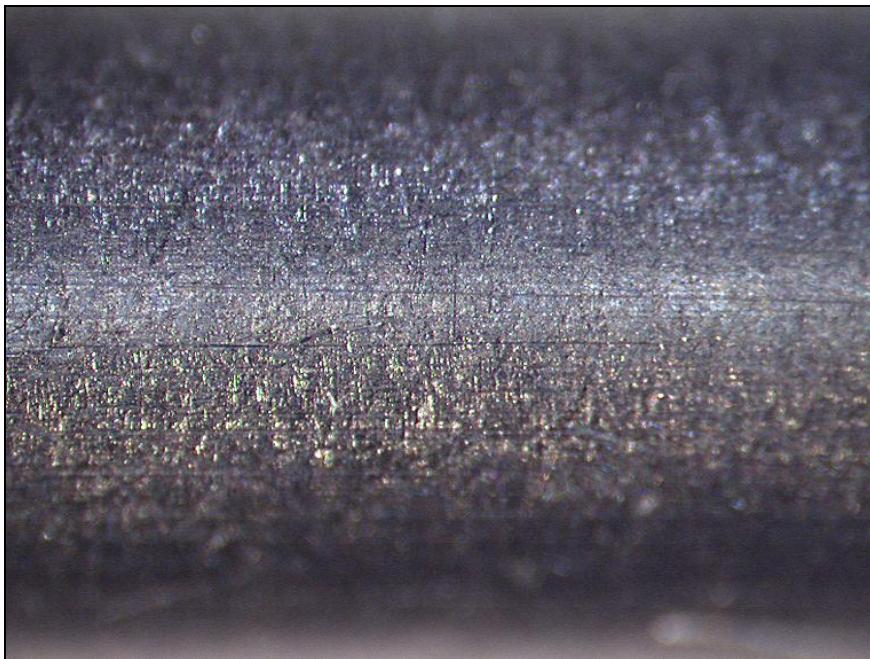
Tube 15 from group 1 (18 bend cycles)

Figure 12 - As-received tube surface conditions of two completely fractured tubes from both groups of specimens (originally photographed at 35X).

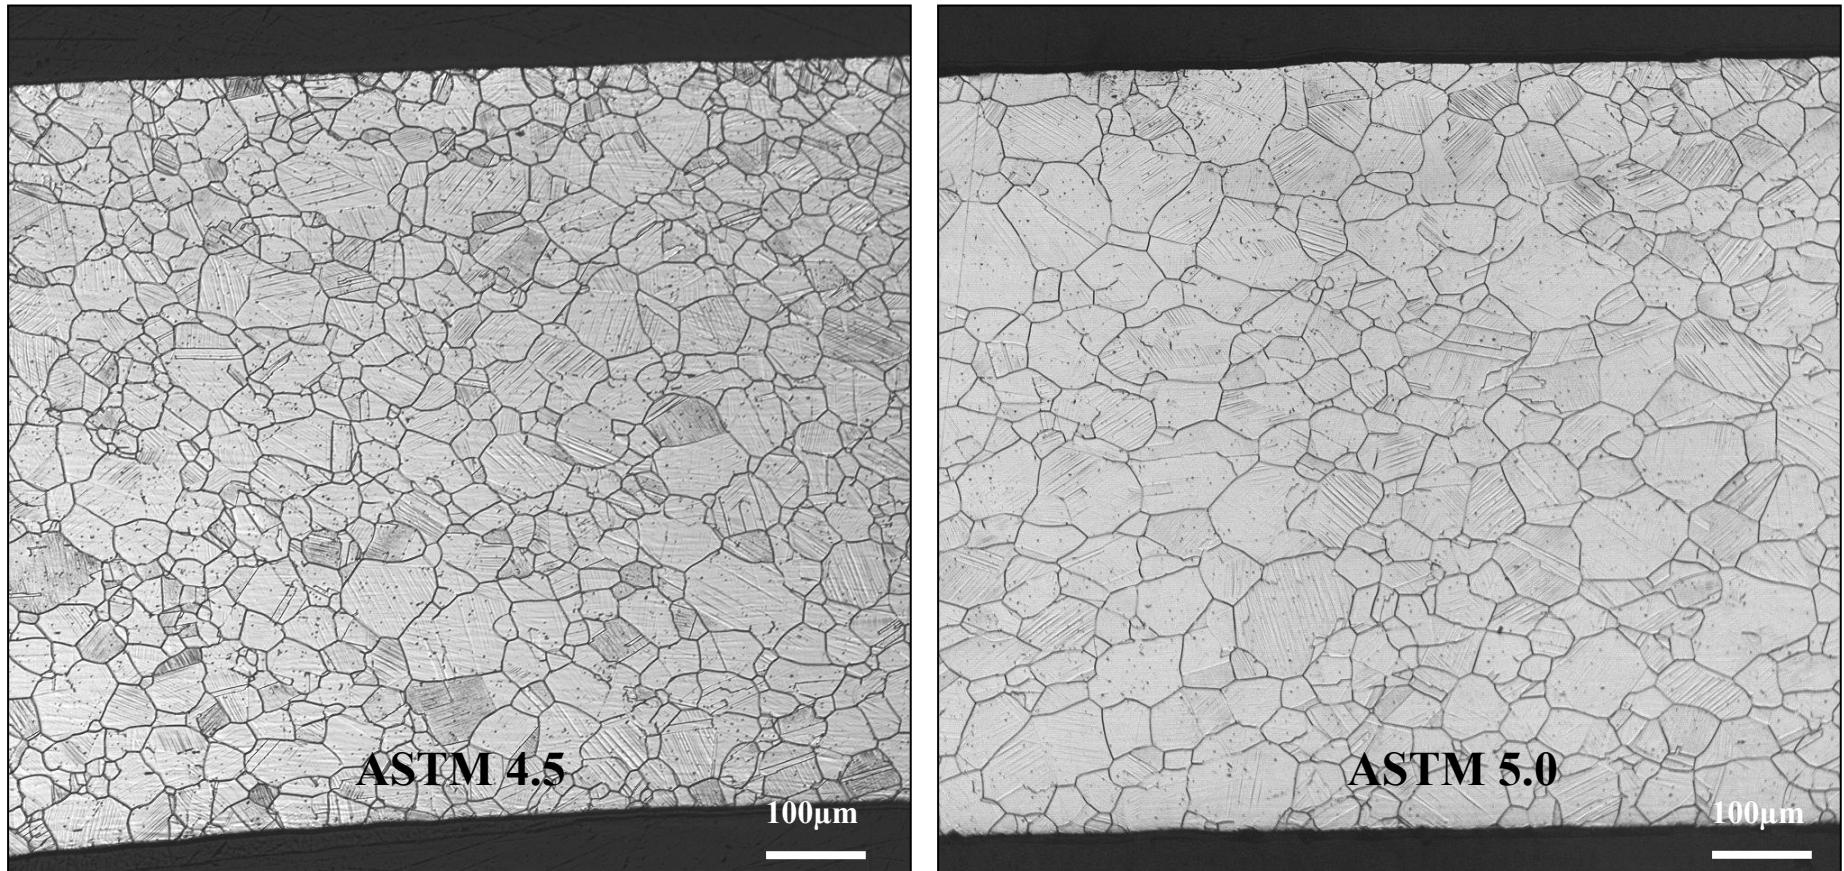
Figure 13 – Photomicrographs showing etched (electrolytic nitric acid) microstructural comparison between as-received (unbent) samples from the two groups of submitted tubes. Although no control tube was submitted in the 1st group, a section was examined that was adequately far away from the bend area and represented in the left photo. The right photo depicts the submitted control tube from the second group of tubes. There appears to be a similar amount of retained deformation but a difference in grain size (denoted on photo).

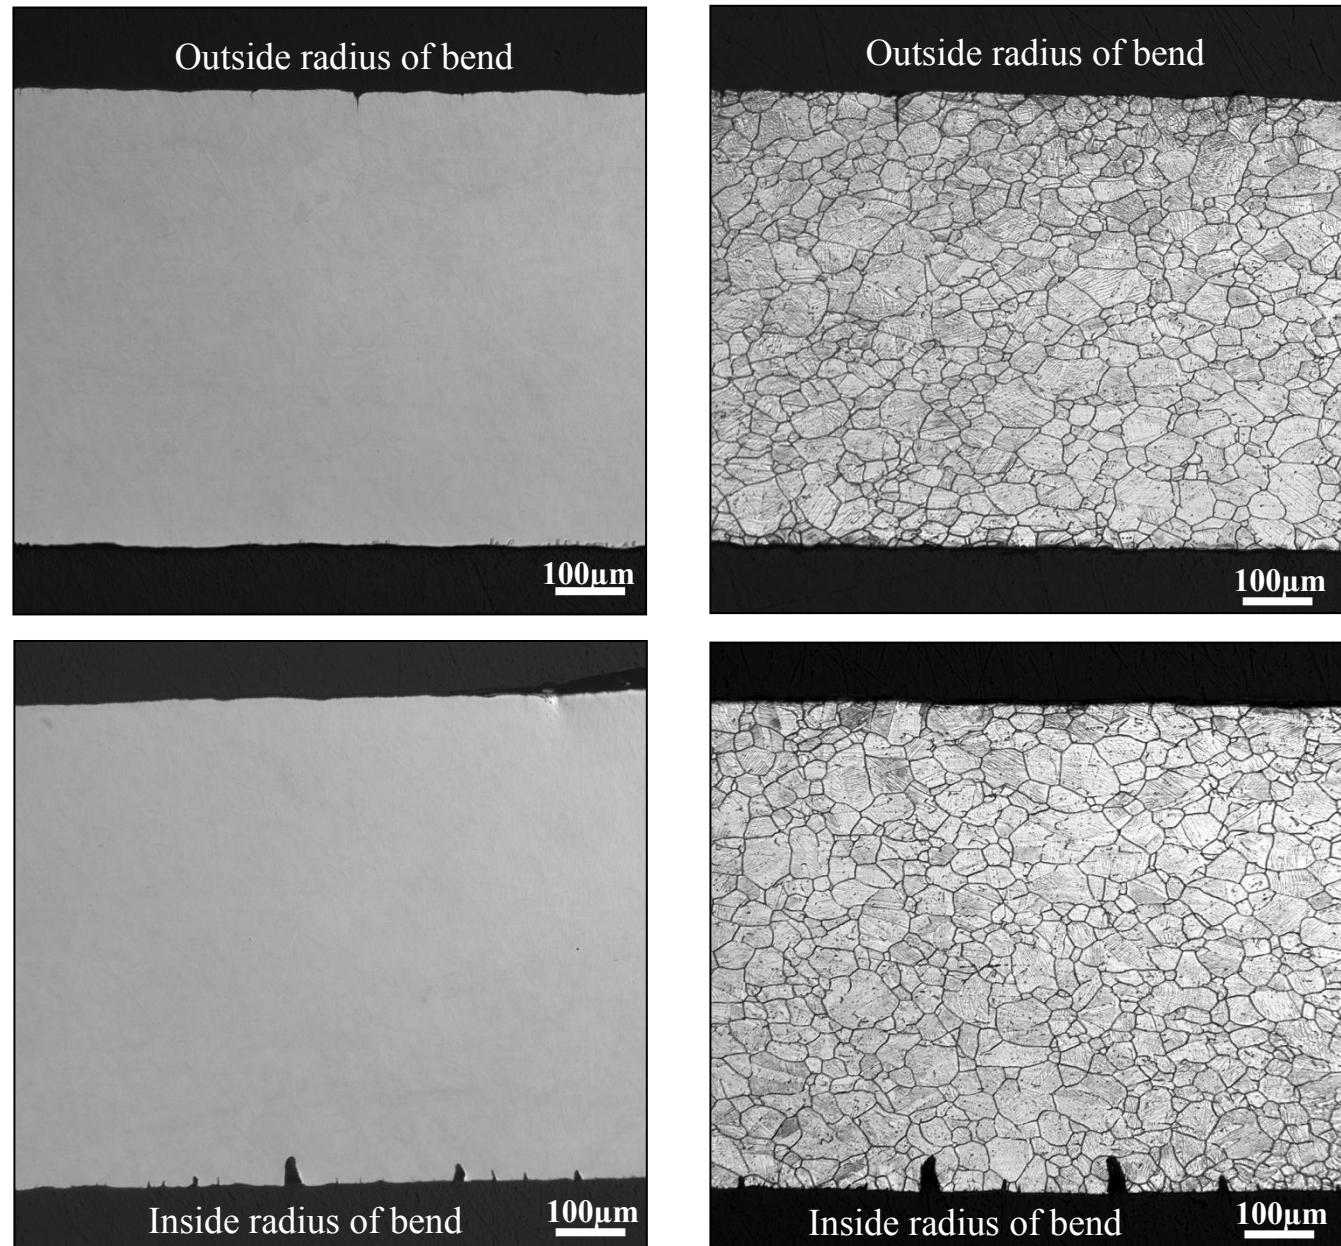
Figure 15 – As-polished and etched cross-sections of tube walls in tube #18 (group 1 / 15 bends). Note that the two conditions were not photographed in the exact same areas.

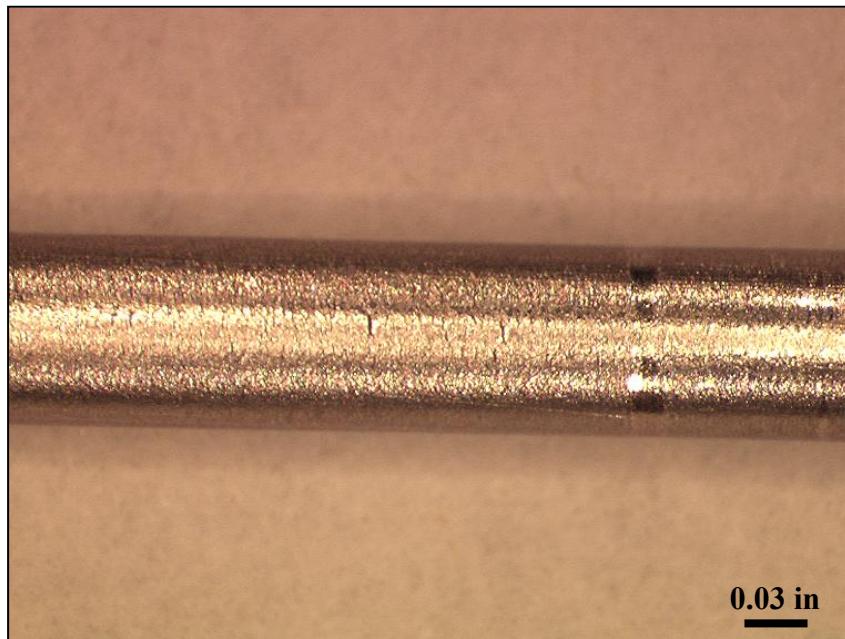
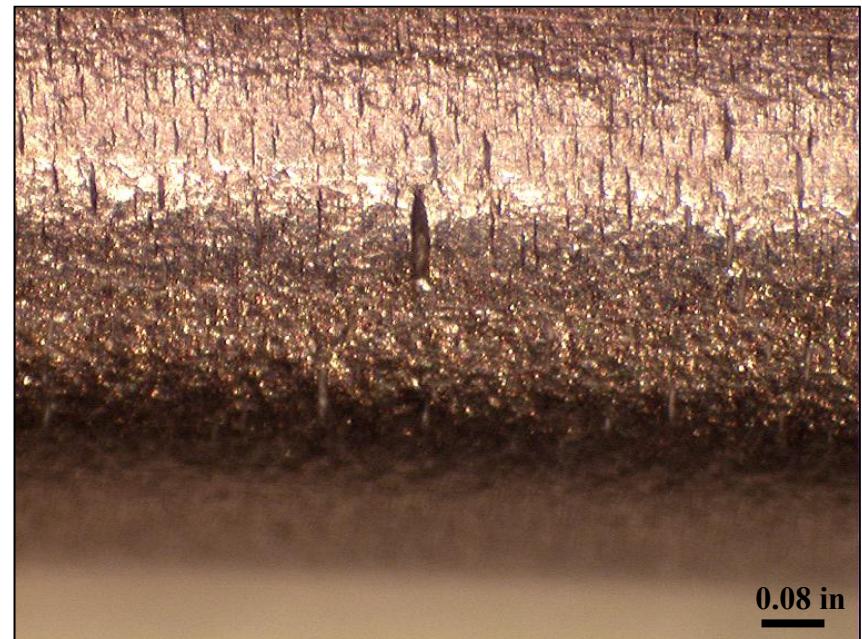
Figure 16 – Surface condition photos of tube #18 (group 1 / 15 bend cycles) inside radius of bend.
