Title: Los Alamos National Laboratory W76 Pit Tube Lifetime Study

Los Alamos National Laboratory W76 Pit Tube Lifetime Study

Number: W-9-TR-0143U LA-UR-XX-XXXX	Revision	Effective Date: April 3, 2012
	A

Terri Abeln, W-9, Surveillance Oversight

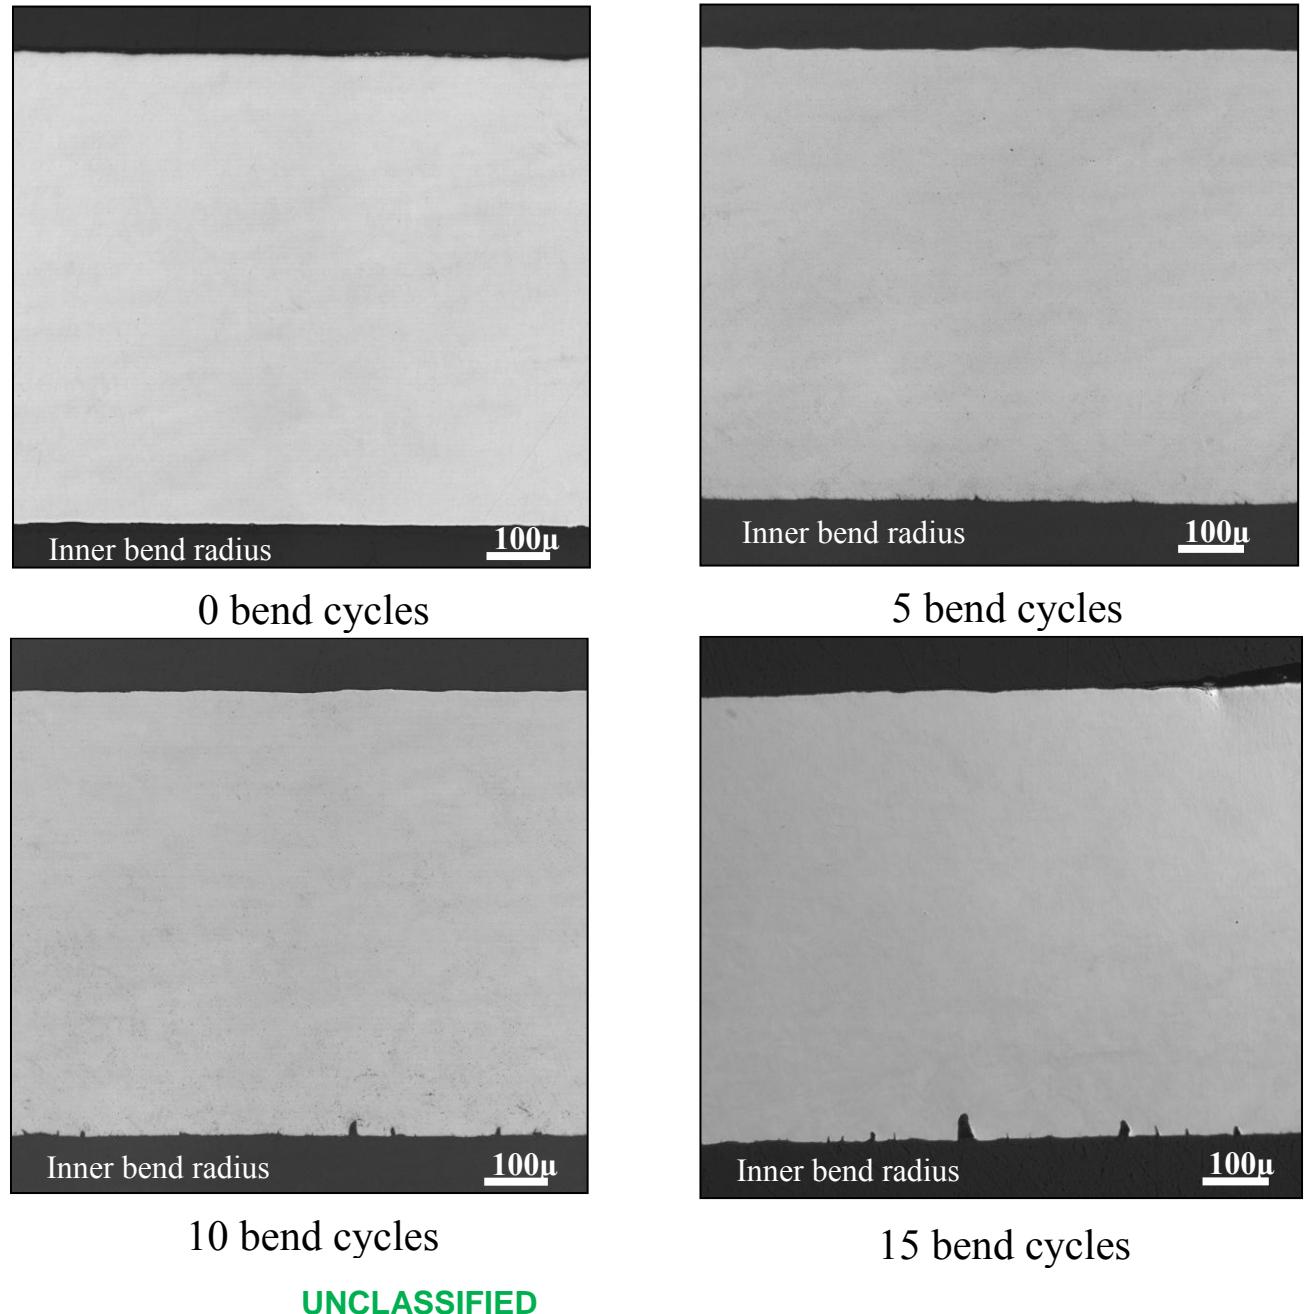
Allowable tube defects in both the outside surface and tube wall (ultrasonic inspection) were specified to be less than 0.002 inches in depth by 0.030 inches in length. Metallographic cross-sectional depth measurements of defects or cracks nearing the dimensions allowed by specification were not observed until the 15th bend cycle (maximum measurement was \sim 0.002 inches in depth). Cracks at 5 and 10 bend cycles measured to be as much as \sim 0.0003 inches and 0.001 inches in depth, respectively. See Figures 16 and 17. The deepest cracks were always observed propagating from the tube exterior surface associated with the inner bend radius, with more shallow cracks in the outer bend radius. No cracks were observed on the interior surfaces of the tubes when examined up to a maximum magnification of 1000X. Chemical composition limits were found in two specifications cited in RF tube specification P14548, RF bar stock specification P14510 and AMS 5560. Samples of two tubes from Set 1 and the one failed tube from Set 2 are compared with the specification limits in the following Table 2:

Figure 17 –
Photomicrographs of wall cross-sections depicting crack depths in differing # bend cycles.

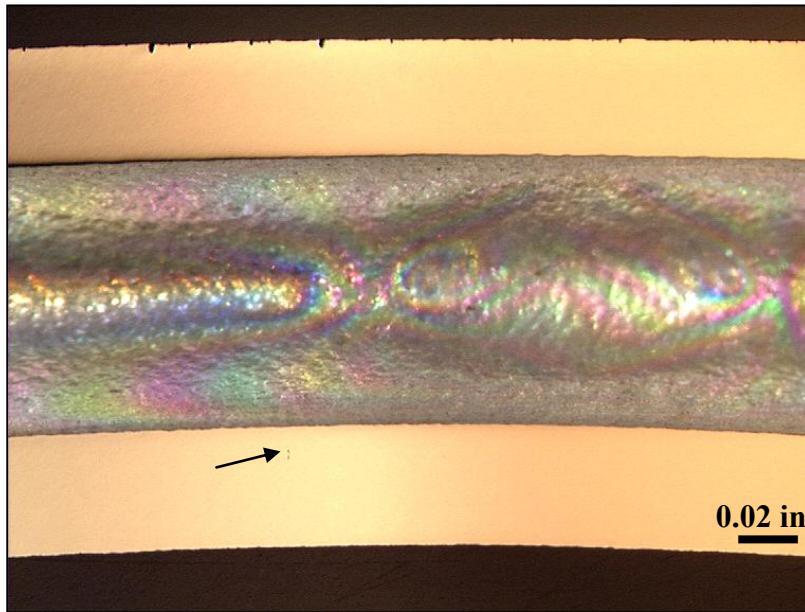
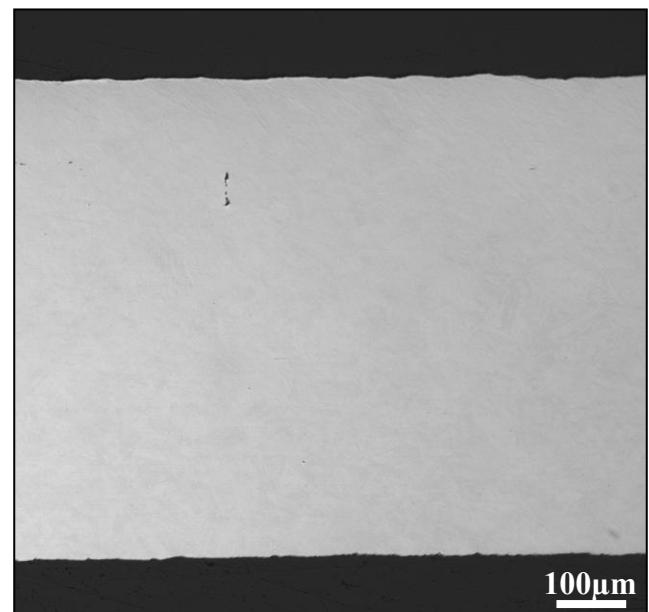
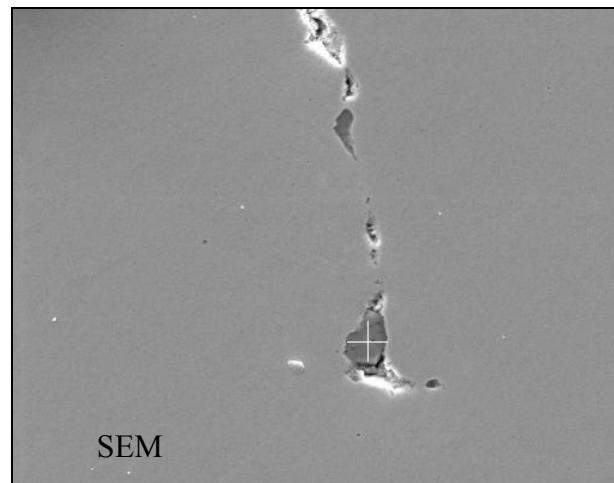
One inclusion, of considerable size, was revealed in metallographic longitudinal cross-section in Set 1 – Tube #11. The inclusion measured a little over 0.002 inches long by 0.0002 inches in width, with its length in parallel to crack propagation. The location of the inclusion was in the larger bend radius wall, not the smaller bend radius where cracks initiate. Chemical analysis of the inclusion, using Energy Dispersive Spectroscopy (EDS), revealed a predominate peak signal characteristic of silicon. Because the inclusion did not lie in the direction of tube working, i.e., drawing, it was suspected to be brittle in nature. See Figure 18.

Figure 18 –
Photomicrographs and
SEM image of tube #11
(group 1 / 15 bends)
cross-section exhibiting an
inclusion. Chemical
analysis revealed the
primarily carbon and
chromium constituents.
